WYMESWOLD CHURCHYARD WALL

Summary

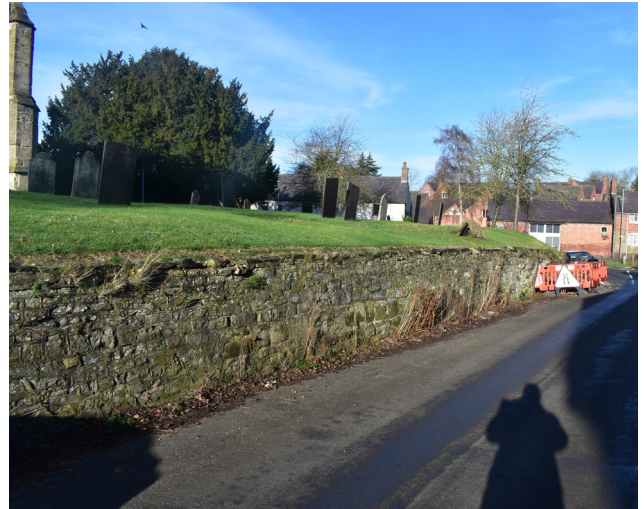
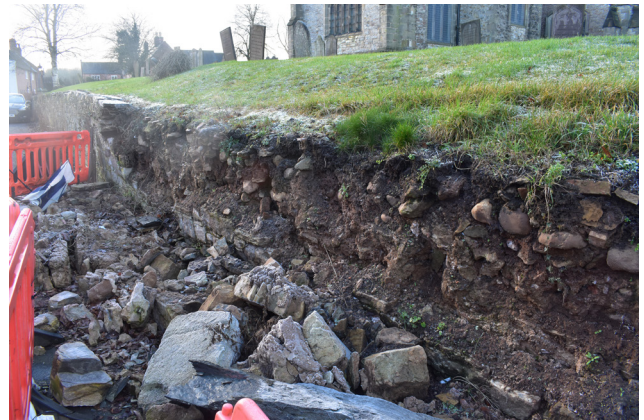
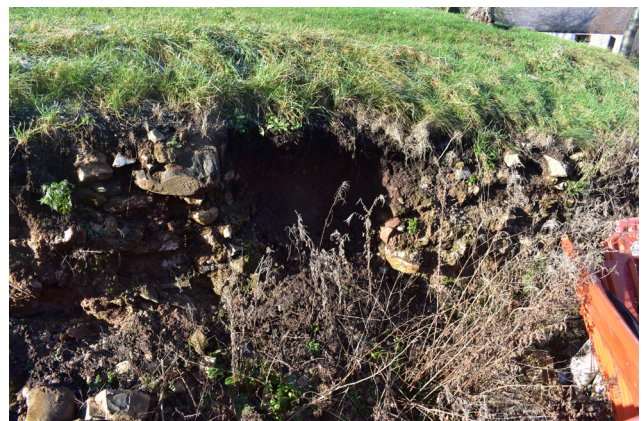
The foundations are intact and stable.

Some of the lower courses are in place but have a significant outward lean and fractured mortar.

The retained walls either side of the collapse have raking cracks from the outward lean of the collapsed section of the wall.

Behind the facings the ground has been backfilled with partially bonded stone, some 300mm deep and packed in earth mortar. Where this has collapsed the line of the graveyard earth remains intact.

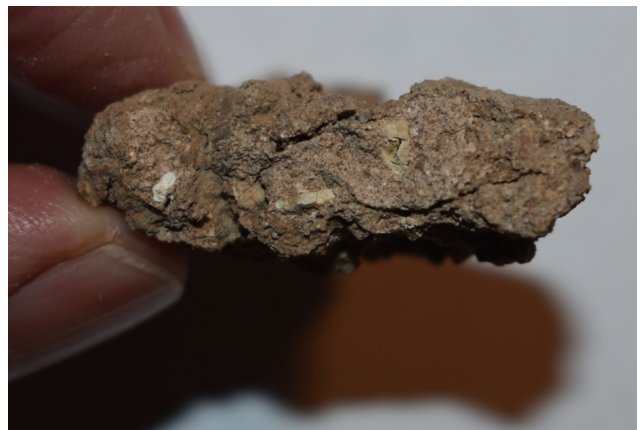
The original construction of the wall used a very porous lime mortar, which was open textured with some lime particles (likely to be reused mortar aggregate). The wall had been repointed in cementitious mortar which damaged the integrity of the construction by causing:

- the lime bedding mortar to remain saturated and become uncemented (i.e., turn to dust).
- Not allowing the wall to dry out and increasing the moisture content of the Lias causing dimensional instability.
- having limited capacity to accommodate cyclical movement of the masonry.

The base of the wall had no weep holes to relieve water pressure, a problem which has been exacerbated by repointing in cementitious mortar.

To reinstate the collapsed section of wall, taking account of the reasons for its failure without disturbing the churchyard earth and its potential archaeology.
