Swanage

The Bandstand

**Background, condition report, specification & methodology
for specialist restoration: Lost Art Ltd with supporting information
from Industrial Heritage Consulting**

Swanage Bandstand Condition report

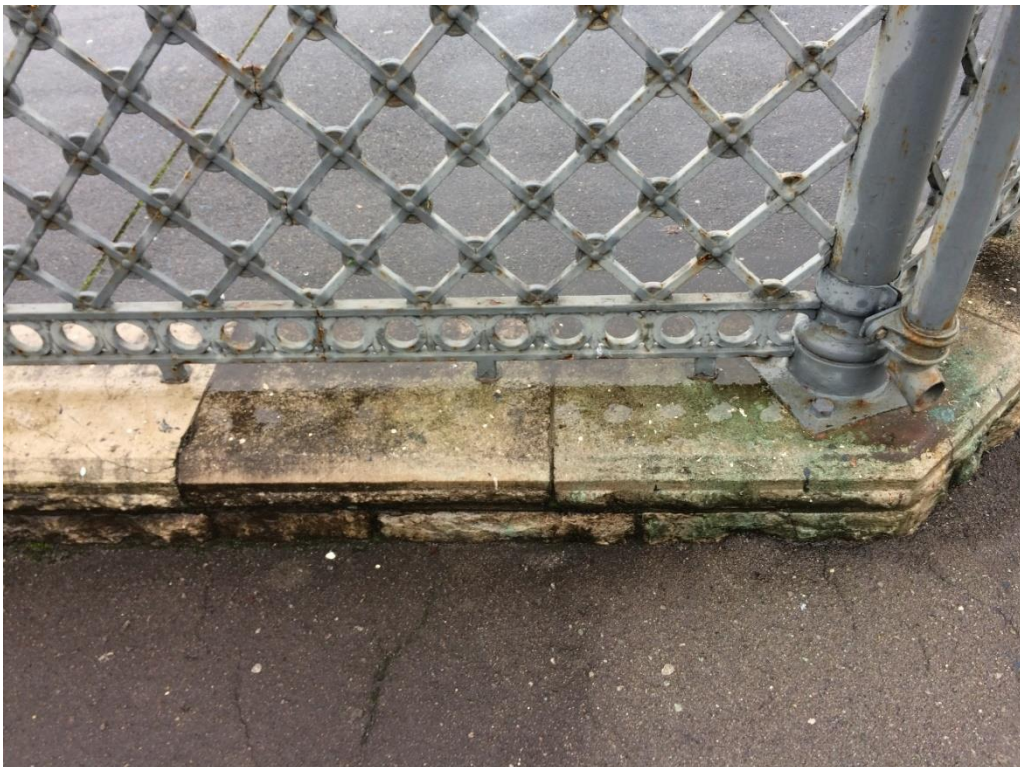
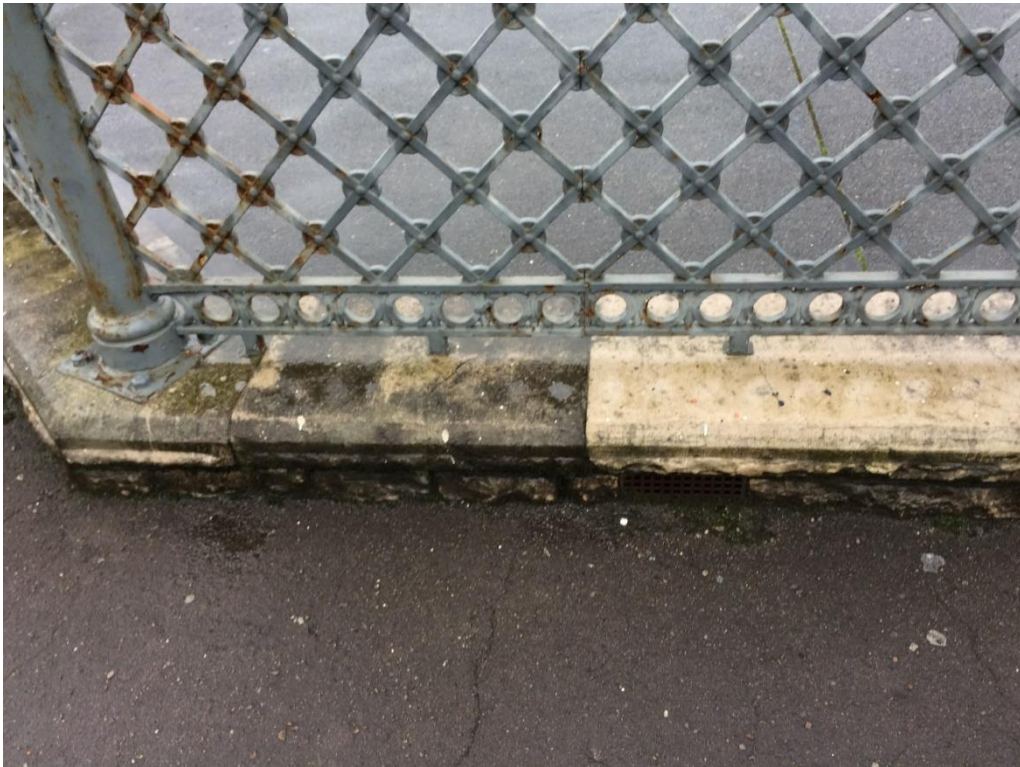
Section B – C: Coping 1 has paint staining, copings 3 & 4 are replaced by a concrete insert. Other copings are sound.

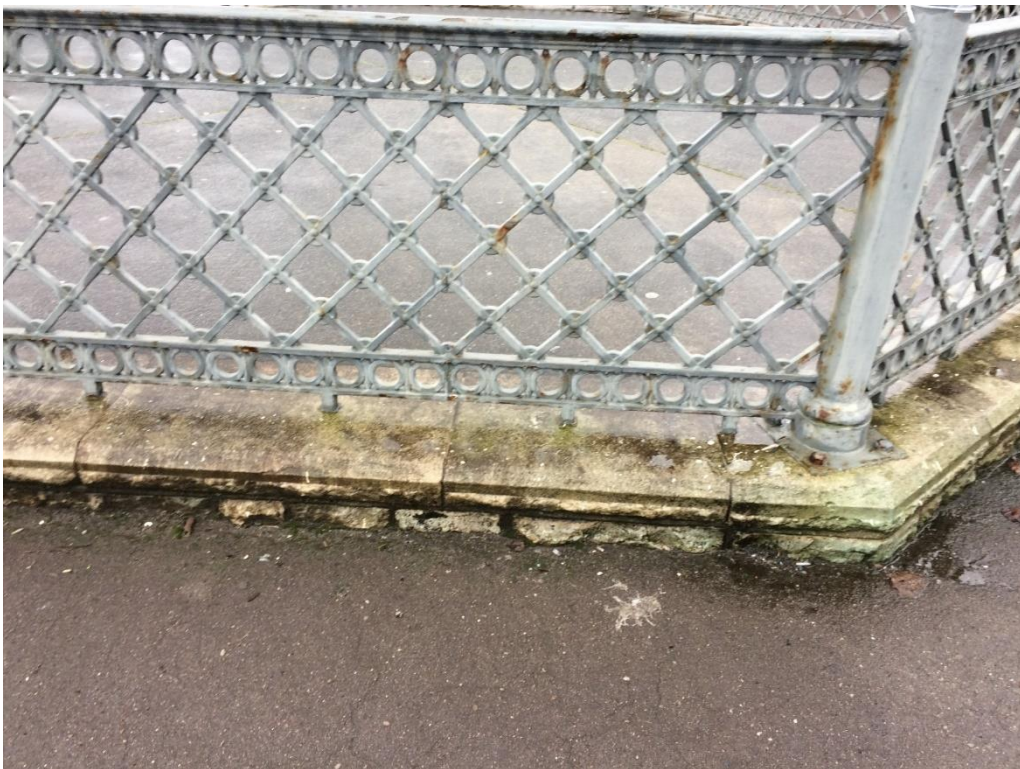
Section E – F: All copings appear sound – some paint staining to coping 1

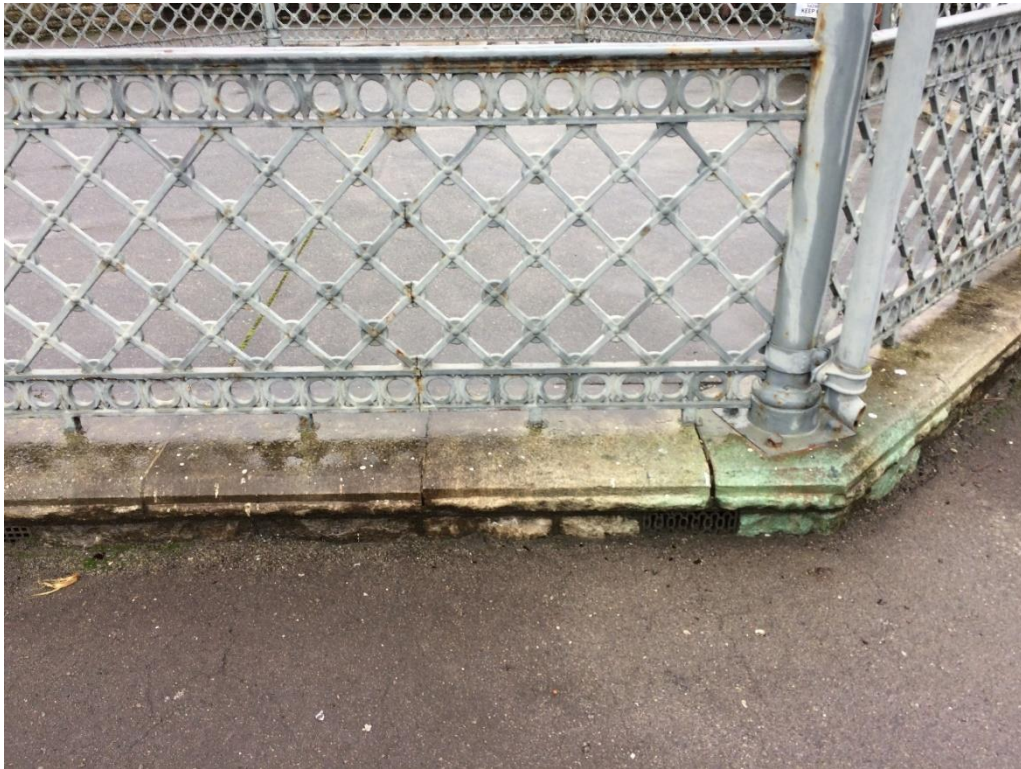
Section F – G: Coping 1 has a small crack to the left side. All other copings appear sound.

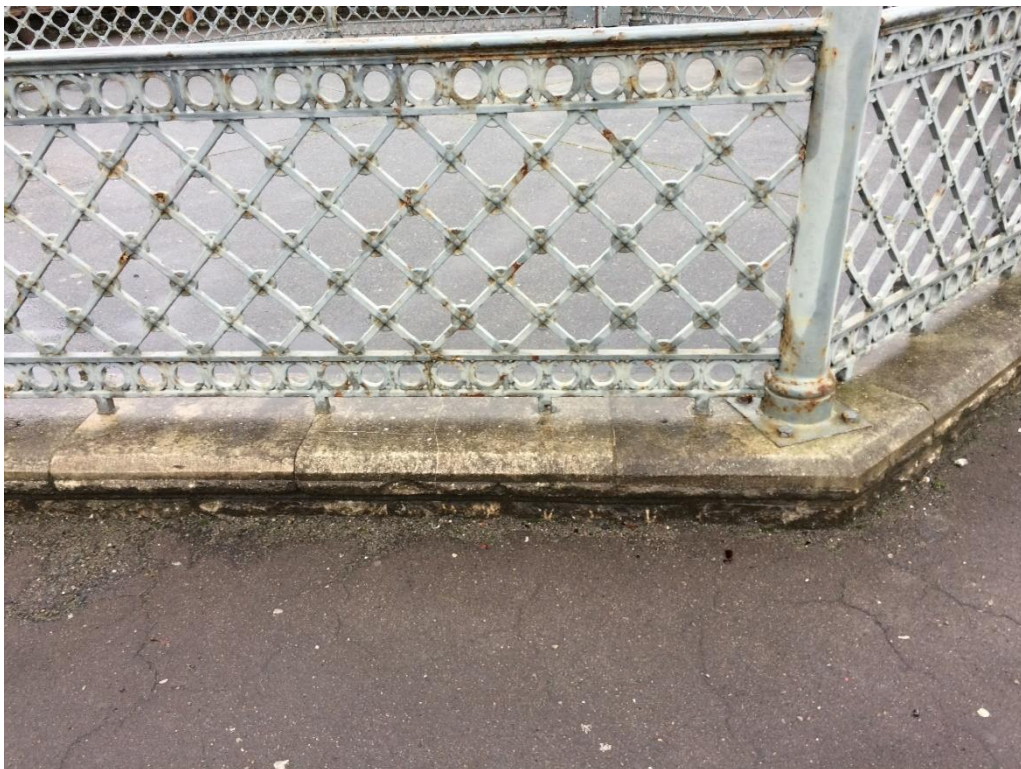
Section G – H: Coping 1 has a crack to the right-hand side. All remaining copings appear sound.

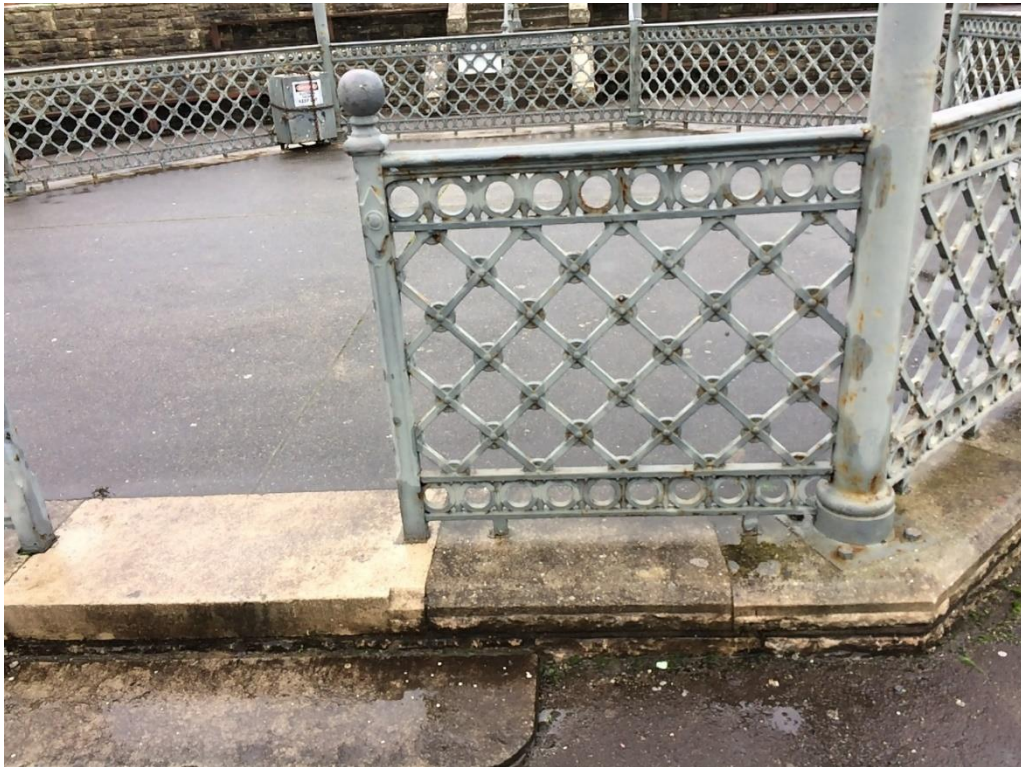
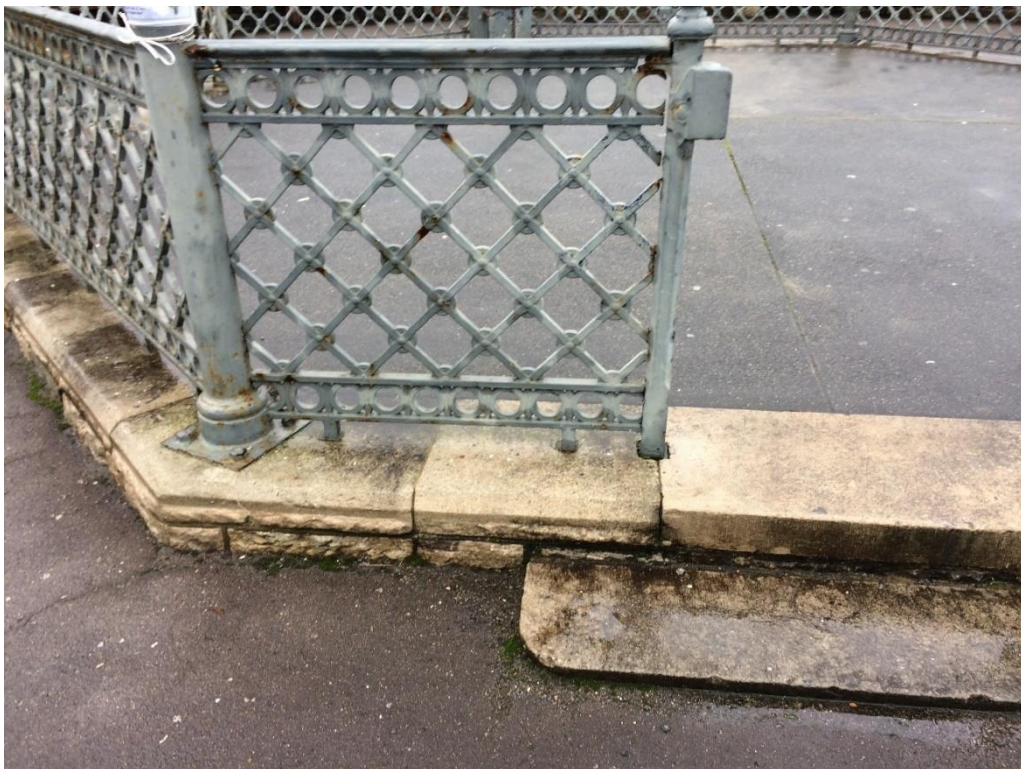
Section H – A: Copings 1 and 2 appear sound. Coping 3 at the entrance and above the step appears to be a replacement and also has no detail to the left edge. Coping 4 appears sound.

The base of the bandstand is largely intact and requires little restorative work. Similarly, the majority of the coping stones are intact and original, there is little requirement for repair and an experienced stonemason would identify the type of stone used for the copings and advise on sourcing replacements for the sections that have been replaced with an inferior product if this is desired within the available budget.

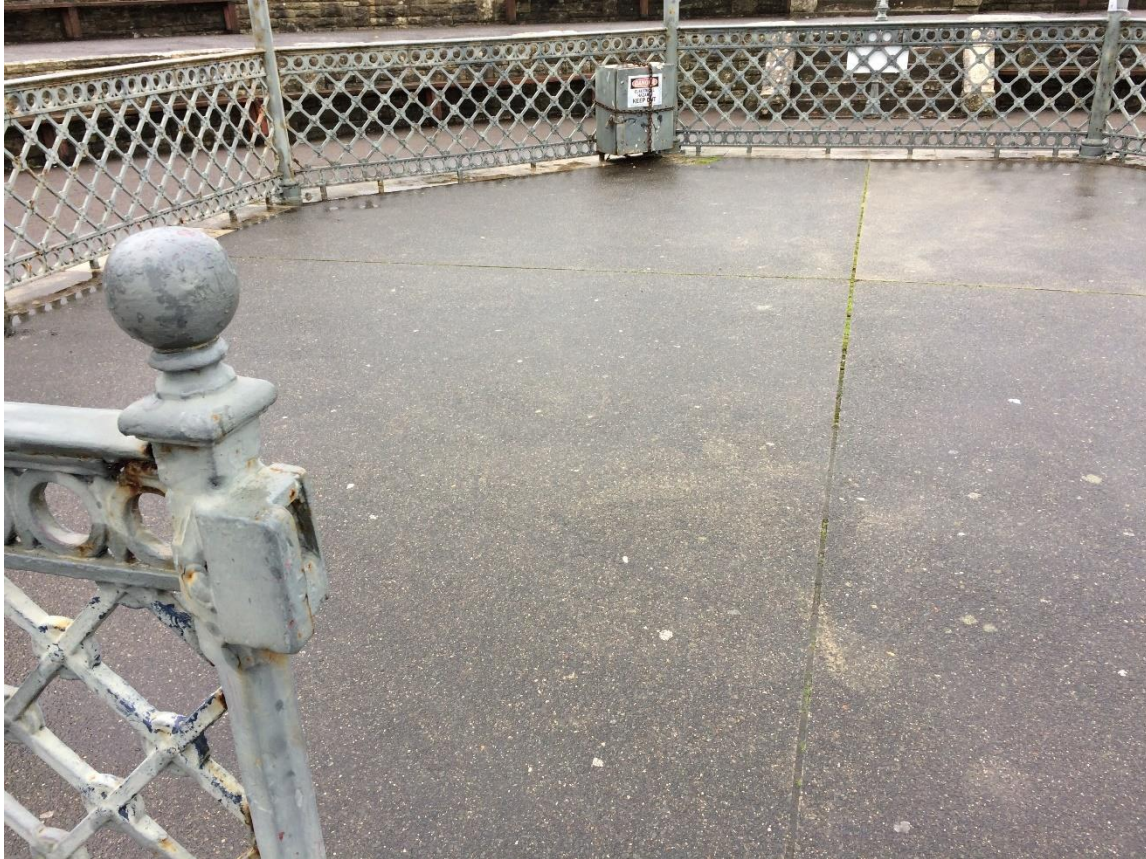
The electricity box shown to the top of the image above requires removal and an alternative location should be agreed. There is some damage to the surface in the area of the electricity box and this will require full reassessment once the electricity box has been removed. Any irregularities in the surface will constitute a Health and Safety risk and should be addressed as a matter of priority.

The electricity supply currently present is intrusive and unsuitable in the current position. It will require removal and replacement. Consideration should be given to the location and type of electrical supply, with options for a buried/raised type being explored.

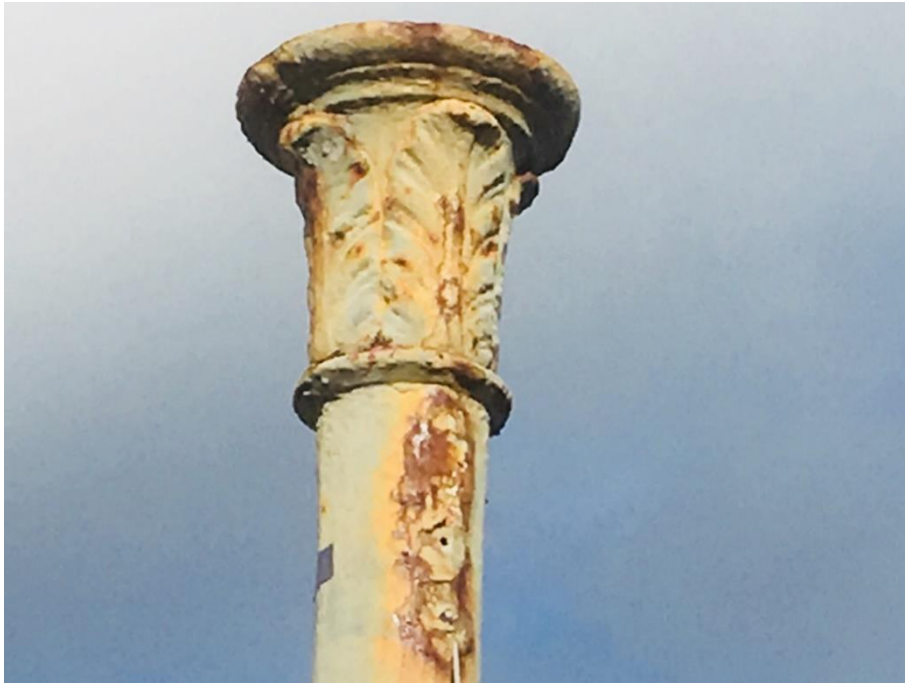
It should be noted that all columns do show signs of rusting and that, especially following the removal of the roof, water ingress to the columns and subsequent issues of rust heave etc will need to be further investigated during the restoration process.

The following is an example of the column capitals, (located at the top of the columns) showing the current rusted condition and the state of the paintwork:

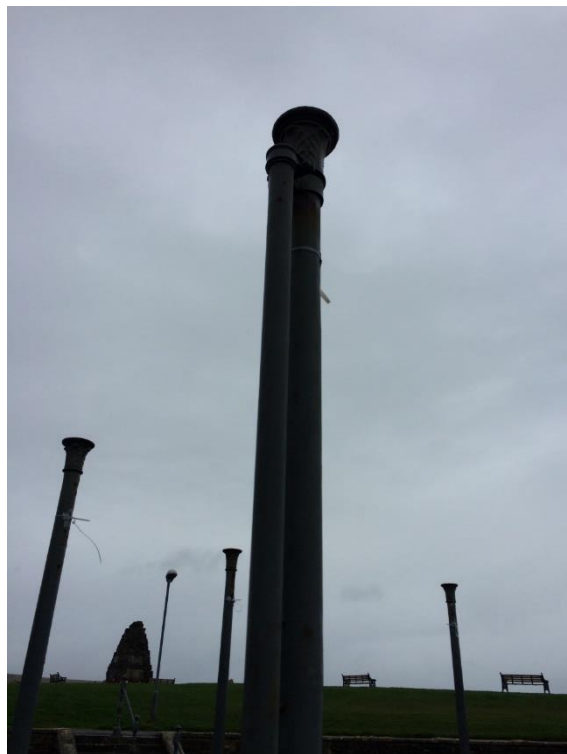
Image shows downpipe for drainage fixed to column B. The fixings for the drainage (also pictured below) are not original.

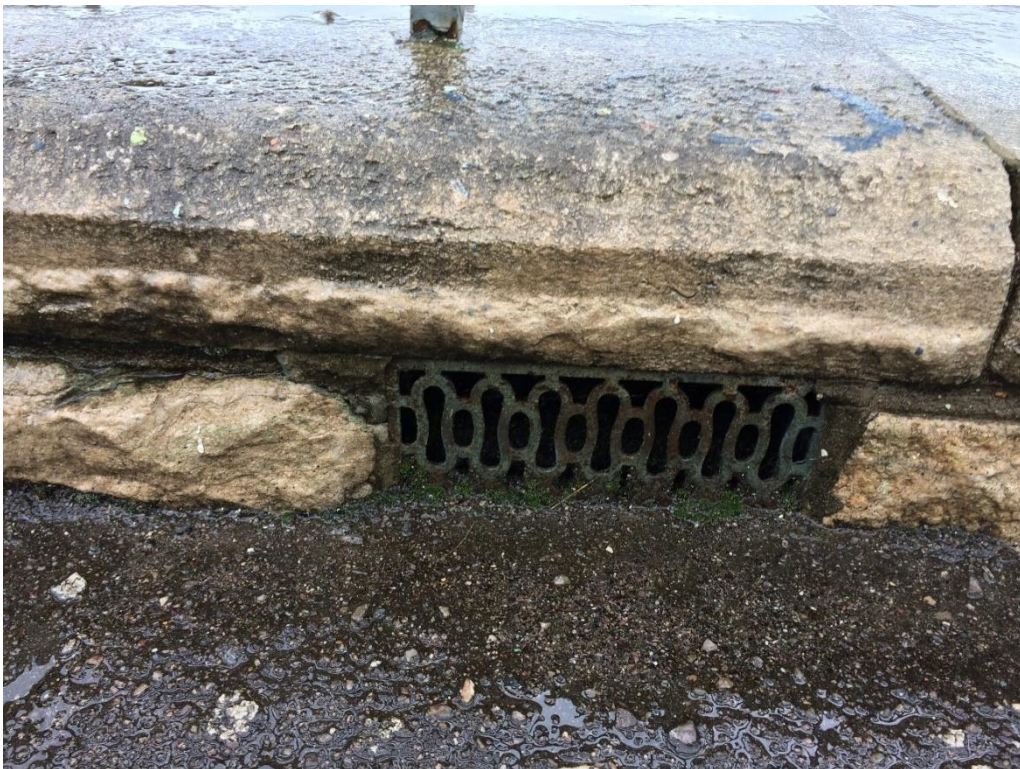
The cast iron air grilles located below the coping provide drainage, although this would not be the original intention and alternatives should be explored. There are 2 styles and all examples appear to be in sound condition.

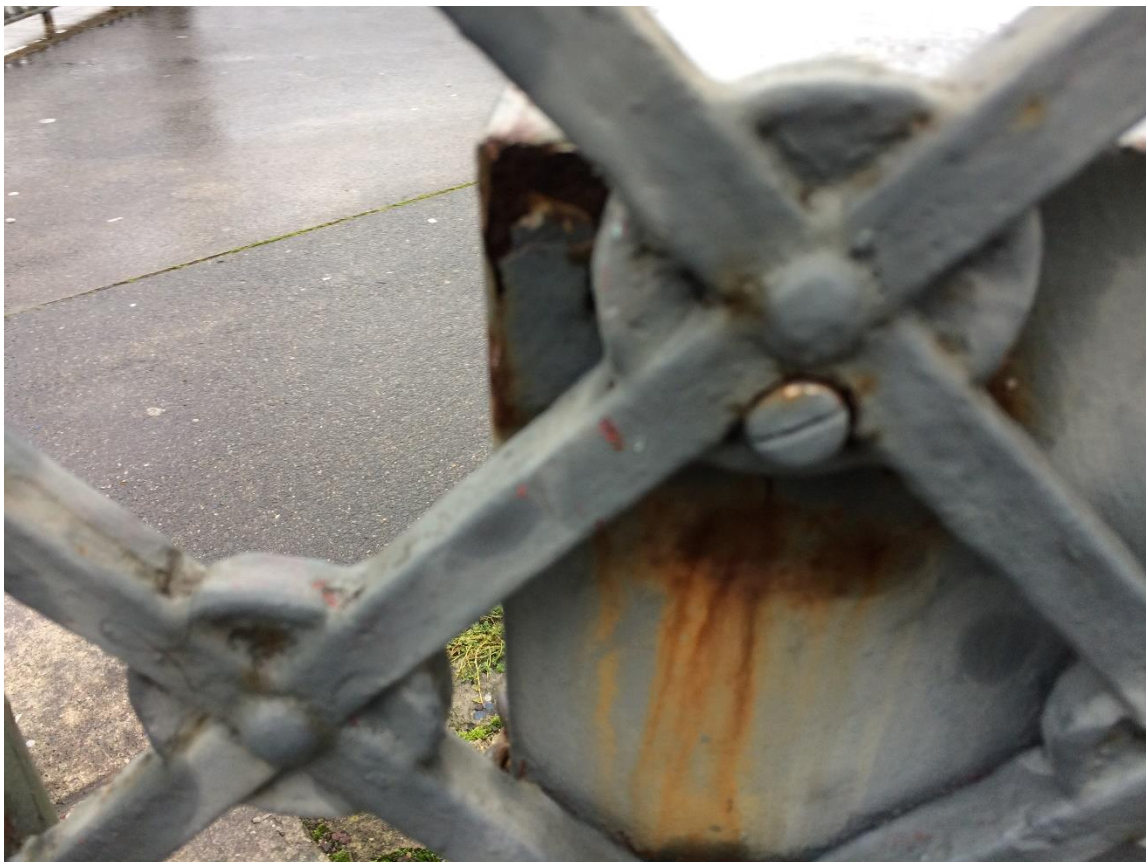
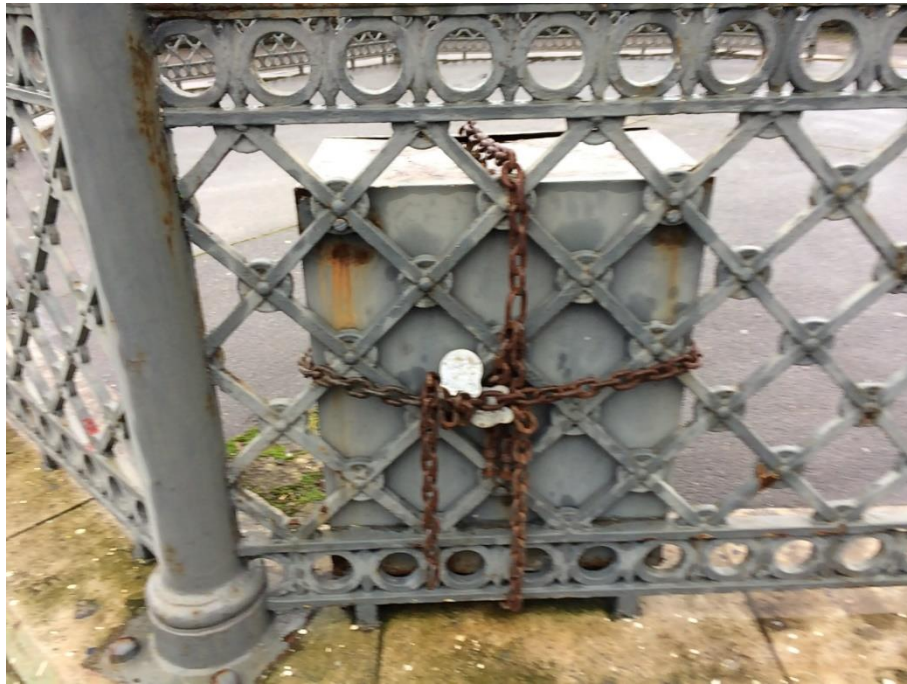
Section C – D: All basically sound - NOTE: electricity box is both chained and physically screwed to the adjacent railing panel.

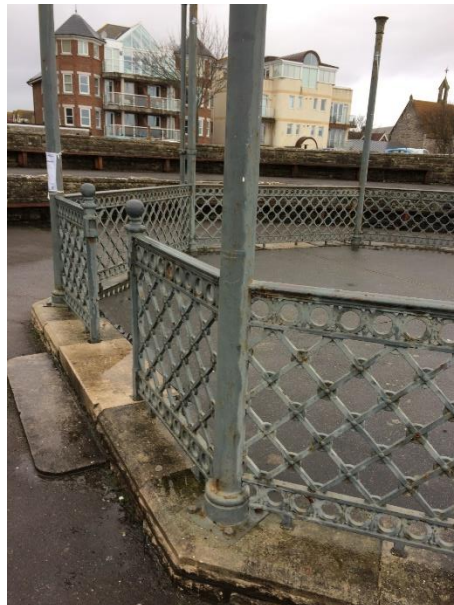
Short railing in section H-A: shows railings, posts and handrail:

Section D – E: All basically sound
Section E – F: All basically sound
Section F – G: All basically sound
Section G – H: All basically sound
Section H – A: Both side railings and the two posts are complete and in sound condition but the gate is missing. Additionally, the left hand panel is poorly fitted to the post.

NOTE: As is the traditional method, the railing panels are lead set into holes in the coping stones and this method of fixing should be replicated.

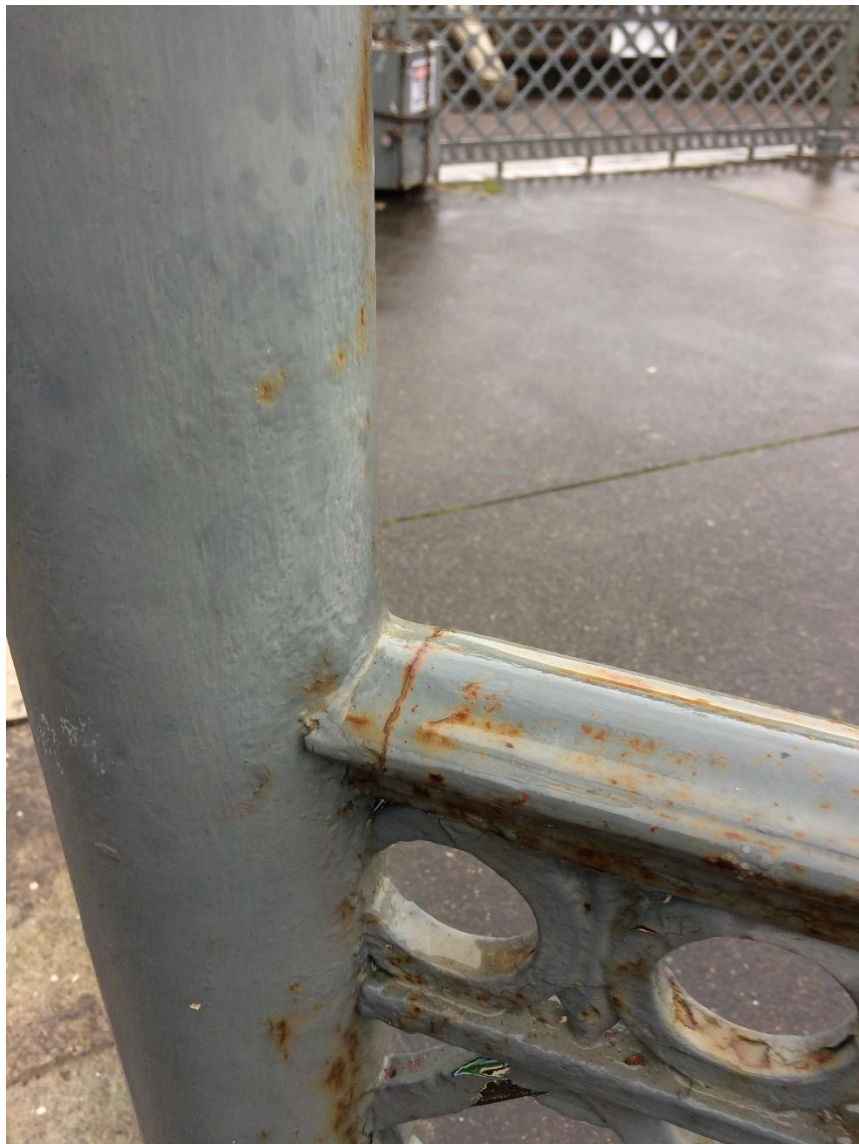
On this model of bandstand, there is a cast-iron section handrail that runs around the perimeter of the bandstand on top of the railing panels. The hand rail sections are then weld fixed to the columns – as shown in the image below.

As with the railing panels themselves, the handrail shows some signs of rust, occasional chipping but all sections are basically sound, requiring little other than cleaning and repainting.
