## ASBESTOS MANAGEMENT SURVEY REPORT

**Site:** Street Parish Council, Street Parish Rooms, 6 Leigh Road, Street, Somerset, BA16 0HA

**Job Number:** J091121

**Survey Date:** 25th September 2018

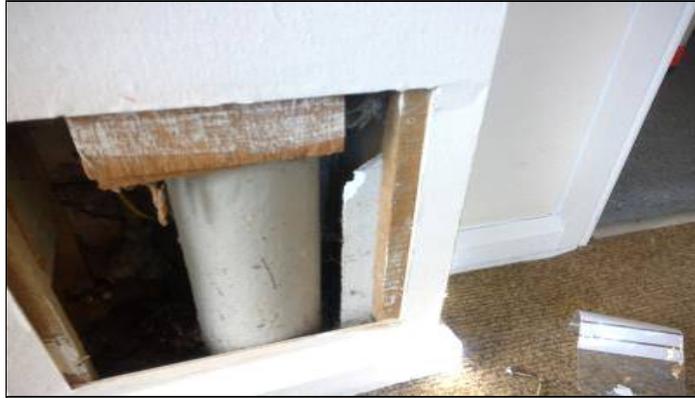
<b>Sample No.</b>	PQ002345	<b>Description</b>	Insulating board panel
-------------------	----------	--------------------	------------------------

<b>Location ID</b>	001	<b>Position</b>	within timber boxing		
<b>Building</b>	01 Main Building	<b>Floor</b>	Ground Floor	<b>Room/Area</b>	Lobby (001)
<b>Last Inspection Date</b>		25/09/2018	<b>Next Inspection Date</b>	N/A

<b>Product Type</b>	Insulating board	<b>Extent</b>	<1m <sup>2</sup>
<b>Surface Treatment</b>	Unsealed	<b>HSE Notifiable</b>	Non notifiable non licensed material
<b>Damage Extent</b>	Medium Damage	<b>Accessibility</b>	Usually inaccessible or unlikely to be disturbed
<b>Asbestos Type</b>	<b>No Asbestos Detected</b>		
<b>Material Risk No.</b>	0	<b>Certificate No.</b>	J091121
<b>Material Risk</b>	<b>NO ASBESTOS DETECTED</b>

<b>Comments</b>	Medium damage due to broken and missing edges.
<b>Recommendations</b>	No further action required

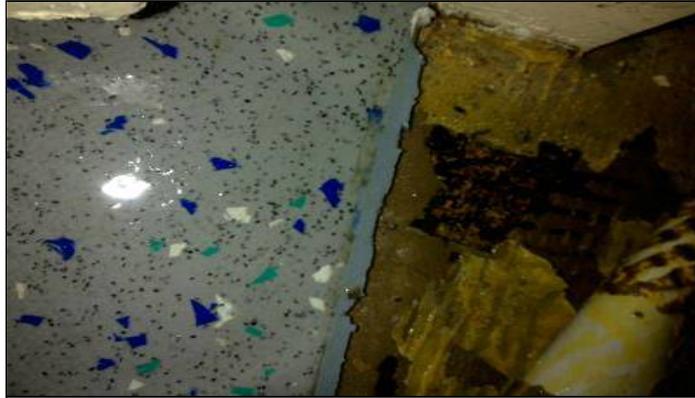
<b>Sample No.</b>	PQ002349	<b>Description</b>	Bitumen residue
-------------------	----------	--------------------	-----------------

<b>Location ID</b>	002	<b>Position</b>	to underside of vinyl sheeting to floor		
<b>Building</b>	01 Main Building	<b>Floor</b>	Ground Floor	<b>Room/Area</b>	Reception Area (002)
<b>Last Inspection Date</b>	25/09/2018	<b>Next Inspection Date</b>	25/09/2019

<b>Product Type</b>	Bitumen / felt	<b>Extent</b>	60m <sup>2</sup>		
<b>Surface Treatment</b>	Composite (Self sealed)	<b>HSE Notifiable</b>	Non notifiable non licensed material		
<b>Damage Extent</b>	Low Damage	<b>Accessibility</b>	Usually inaccessible or unlikely to be disturbed		
<b>Asbestos Type</b>	<b>Chrysotile</b>				
<b>Material Risk No.</b>	3	<b>Certificate No.</b>	J091121		
<b>Material Risk</b>	Very Low Risk

<b>Comments</b>	Found to be consistent throughout. Extent included.
<b>Recommendations</b>	The material was in a generally good condition and should therefore be managed, it may be prudent to consider labelling where necessary

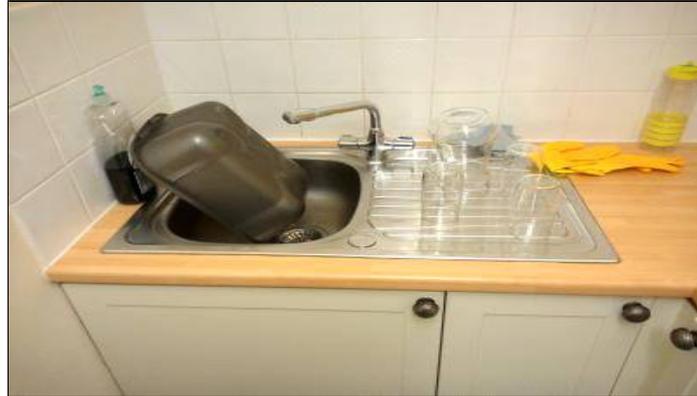
<b>Sample No.</b>	PQ002347	<b>Description</b>	Mastic pad
-------------------	----------	--------------------	------------

<b>Location ID</b>	006	<b>Position</b>	to the underside of the metal sink		
<b>Building</b>	01 Main Building	<b>Floor</b>	Ground Floor	<b>Room/Area</b>	Kitchen (006)
<b>Last Inspection Date</b>	25/09/2018	<b>Next Inspection Date</b>	N/A

<b>Product Type</b>	Mastic pad	<b>Extent</b>	2no.		
<b>Surface Treatment</b>	Composite (Self sealed)	<b>HSE Notifiable</b>	Non notifiable non licensed material		
<b>Damage Extent</b>	Low Damage	<b>Accessibility</b>	Usually inaccessible or unlikely to be disturbed		
<b>Asbestos Type</b>	<b>No Asbestos Detected</b>				
<b>Material Risk No.</b>	0	<b>Certificate No.</b>	J091121		
<b>Material Risk</b>	<b>NO ASBESTOS DETECTED</b>

<b>Comments</b>	
<b>Recommendations</b>	No further action required

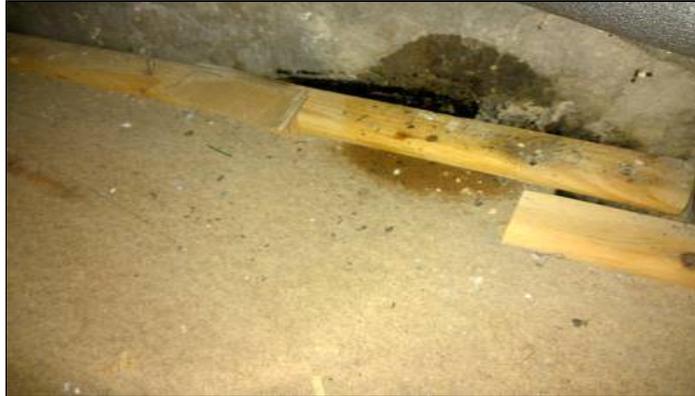
<b>Sample No.</b>	PQ002348	<b>Description</b>	Bitumen residue
-------------------	----------	--------------------	-----------------

<b>Location ID</b>	009	<b>Position</b>	to walls at low level		
<b>Building</b>	01 Main Building	<b>Floor</b>	Ground Floor	<b>Room/Area</b>	Store (009)
<b>Last Inspection Date</b>	25/09/2018	<b>Next Inspection Date</b>	N/A

<b>Product Type</b>	Bitumen / felt	<b>Extent</b>	4m <sup>2</sup>		
<b>Surface Treatment</b>	Composite (Self sealed)	<b>HSE Notifiable</b>	Non notifiable non licensed material		
<b>Damage Extent</b>	Low Damage	<b>Accessibility</b>	Usually inaccessible or unlikely to be disturbed		
<b>Asbestos Type</b>	<b>No Asbestos Detected</b>				
<b>Material Risk No.</b>	0	<b>Certificate No.</b>	J091121		
<b>Material Risk</b>	<b>NO ASBESTOS DETECTED</b>

<b>Comments</b>	
<b>Recommendations</b>	No further action required

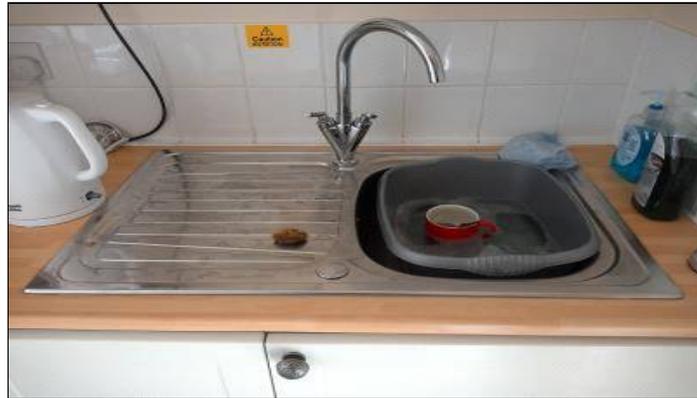
<b>Sample No.</b>	PQ002350	<b>Description</b>	Mastic pad
-------------------	----------	--------------------	------------

<b>Location ID</b>	011	<b>Position</b>	to the underside of the metal sink		
<b>Building</b>	01 Main Building	<b>Floor</b>	Ground Floor	<b>Room/Area</b>	Tea Room (011)
<b>Last Inspection Date</b>	25/09/2018	<b>Next Inspection Date</b>	N/A

<b>Product Type</b>	Mastic pad	<b>Extent</b>	1no.		
<b>Surface Treatment</b>	Composite (Self sealed)	<b>HSE Notifiable</b>	Non notifiable non licensed material		
<b>Damage Extent</b>	Low Damage	<b>Accessibility</b>	Usually inaccessible or unlikely to be disturbed		
<b>Asbestos Type</b>	<b>No Asbestos Detected</b>				
<b>Material Risk No.</b>	0	<b>Certificate No.</b>	J091121		
<b>Material Risk</b>	<b>NO ASBESTOS DETECTED</b>

<b>Comments</b>	
<b>Recommendations</b>	No further action required

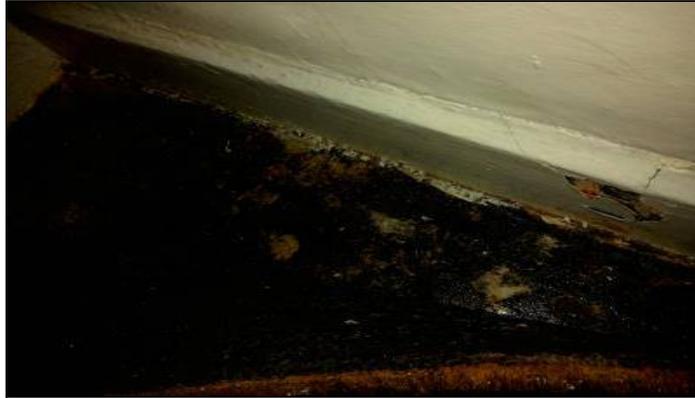
<b>Sample No.</b>	PQ002351	<b>Description</b>	Bitumen residue
-------------------	----------	--------------------	-----------------

<b>Location ID</b>	015	<b>Position</b>	to the floor beneath carpet		
<b>Building</b>	01 Main Building	<b>Floor</b>	Ground Floor	<b>Room/Area</b>	Hall (015)
<b>Last Inspection Date</b>	25/09/2018	<b>Next Inspection Date</b>	N/A

<b>Product Type</b>	Bitumen / felt	<b>Extent</b>	6m <sup>2</sup>		
<b>Surface Treatment</b>	Composite (Self sealed)	<b>HSE Notifiable</b>	Non notifiable non licensed material		
<b>Damage Extent</b>	Low Damage	<b>Accessibility</b>	Usually inaccessible or unlikely to be disturbed		
<b>Asbestos Type</b>	<b>No Asbestos Detected</b>				
<b>Material Risk No.</b>	0	<b>Certificate No.</b>	J091121		
<b>Material Risk</b>	<b>NO ASBESTOS DETECTED</b>

<b>Comments</b>	Found to be consistent beneath carpet in 016 Stairwell
<b>Recommendations</b>	No further action required

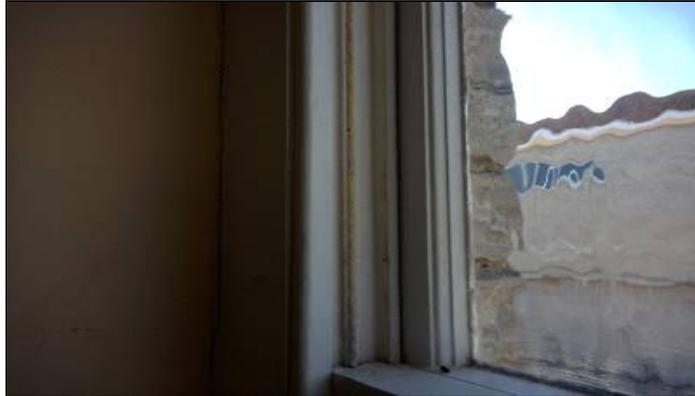
<b>Sample No.</b>	PQ002352	<b>Description</b>	Sash cord
-------------------	----------	--------------------	-----------

<b>Location ID</b>	001	<b>Position</b>	to small timber framed window		
<b>Building</b>	01 Main Building	<b>Floor</b>	1st Floor	<b>Room/Area</b>	Office (001)
<b>Last Inspection Date</b>	25/09/2018	<b>Next Inspection Date</b>	N/A

<b>Product Type</b>	String / cloth / ropes / yarns	<b>Extent</b>	2lm		
<b>Surface Treatment</b>	Unsealed	<b>HSE Notifiable</b>	Non notifiable non licensed material		
<b>Damage Extent</b>	Low Damage	<b>Accessibility</b>	Occasionally likely to be disturbed		
<b>Asbestos Type</b>	<b>No Asbestos Detected</b>				
<b>Material Risk No.</b>	0	<b>Certificate No.</b>	J091121		
<b>Material Risk</b>	<b>NO ASBESTOS DETECTED</b>

<b>Comments</b>	
<b>Recommendations</b>	No further action required

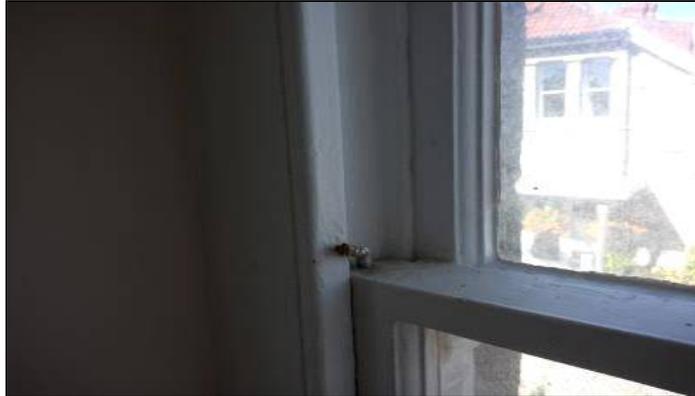
<b>Sample No.</b>	PQ002353	<b>Description</b>	Sash cord
-------------------	----------	--------------------	-----------

<b>Location ID</b>	001	<b>Position</b>	to left side of large timber framed window		
<b>Building</b>	01 Main Building	<b>Floor</b>	1st Floor	<b>Room/Area</b>	Office (001)
<b>Last Inspection Date</b>	25/09/2018	<b>Next Inspection Date</b>	N/A

<b>Product Type</b>	String / cloth / ropes / yarns	<b>Extent</b>	2lm
<b>Surface Treatment</b>	Unsealed	<b>HSE Notifiable</b>	Non notifiable non licensed material
<b>Damage Extent</b>	Medium Damage	<b>Accessibility</b>	Occasionally likely to be disturbed
<b>Asbestos Type</b>	<b>No Asbestos Detected</b>		
<b>Material Risk No.</b>	0	<b>Certificate No.</b>	J091121
<b>Material Risk</b>	<b>NO ASBESTOS DETECTED</b>

<b>Comments</b>	Medium damage due to rope being frayed
<b>Recommendations</b>	No further action required

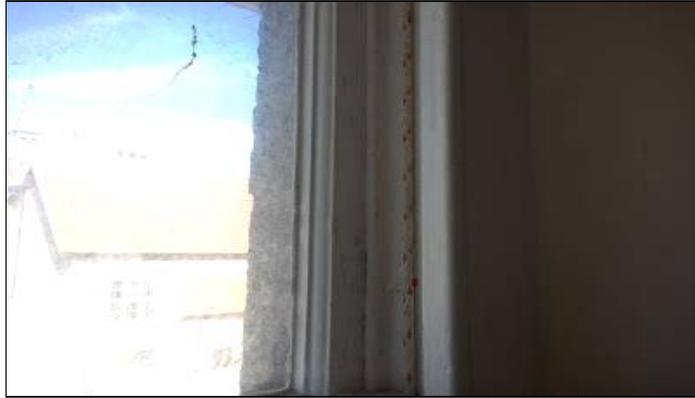
<b>Sample No.</b>	PQ002354	<b>Description</b>	Sash cord
-------------------	----------	--------------------	-----------

<b>Location ID</b>	001	<b>Position</b>	to right side of large timber framed window		
<b>Building</b>	01 Main Building	<b>Floor</b>	1st Floor	<b>Room/Area</b>	Office (001)
<b>Last Inspection Date</b>	25/09/2018	<b>Next Inspection Date</b>	N/A

<b>Product Type</b>	String / cloth / ropes / yarns	<b>Extent</b>	2lm		
<b>Surface Treatment</b>	Unsealed	<b>HSE Notifiable</b>	Non notifiable non licensed material		
<b>Damage Extent</b>	Low Damage	<b>Accessibility</b>	Occasionally likely to be disturbed		
<b>Asbestos Type</b>	<b>No Asbestos Detected</b>				
<b>Material Risk No.</b>	0	<b>Certificate No.</b>	J091121		
<b>Material Risk</b>	<b>NO ASBESTOS DETECTED</b>

<b>Comments</b>	
<b>Recommendations</b>	No further action required

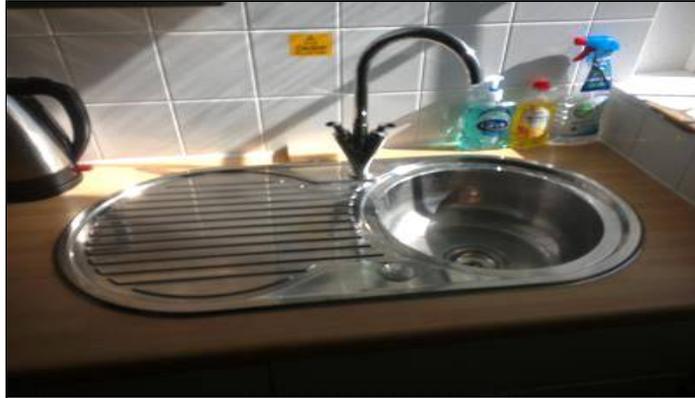
<b>Sample No.</b>	PQ002355	<b>Description</b>	Mastic pad
-------------------	----------	--------------------	------------

<b>Location ID</b>	002	<b>Position</b>	to the underside of the metal sink		
<b>Building</b>	01 Main Building	<b>Floor</b>	1st Floor	<b>Room/Area</b>	Kitchen (002)
<b>Last Inspection Date</b>	25/09/2018	<b>Next Inspection Date</b>	N/A

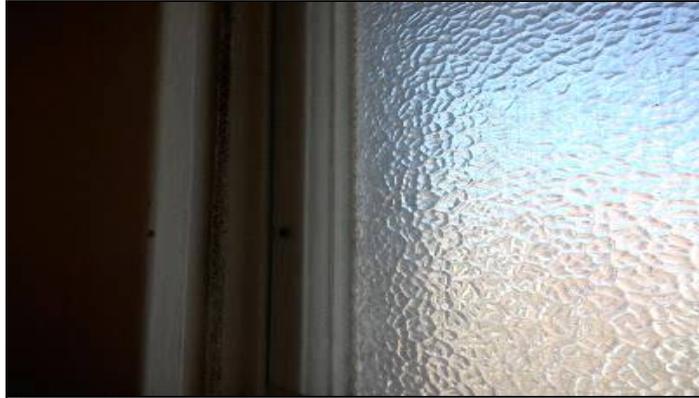
<b>Sample No.</b>	Ref PQ002352	<b>Description</b>	Sash cord
-------------------	--------------	--------------------	-----------

<b>Location ID</b>	004	<b>Position</b>	to timber framed window		
<b>Building</b>	01 Main Building	<b>Floor</b>	1st Floor	<b>Room/Area</b>	Male WC (004)
<b>Last Inspection Date</b>	25/09/2018	<b>Next Inspection Date</b>	N/A

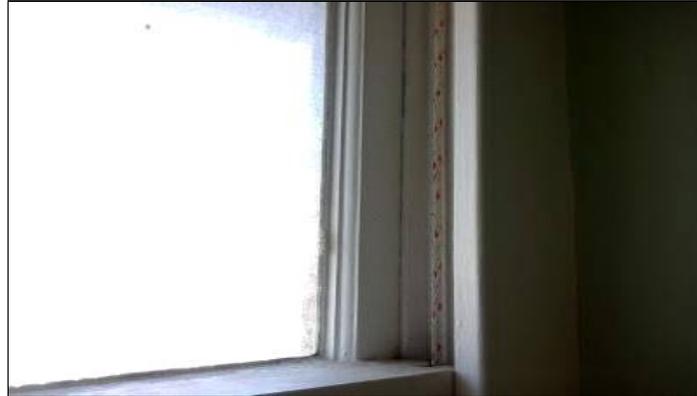
<b>Sample No.</b>	Ref PQ002354	<b>Description</b>	Sash cord
-------------------	--------------	--------------------	-----------

<b>Location ID</b>	005	<b>Position</b>	to timber framed window		
<b>Building</b>	01 Main Building	<b>Floor</b>	1st Floor	<b>Room/Area</b>	Landing (005)
<b>Last Inspection Date</b>	25/09/2018	<b>Next Inspection Date</b>	N/A

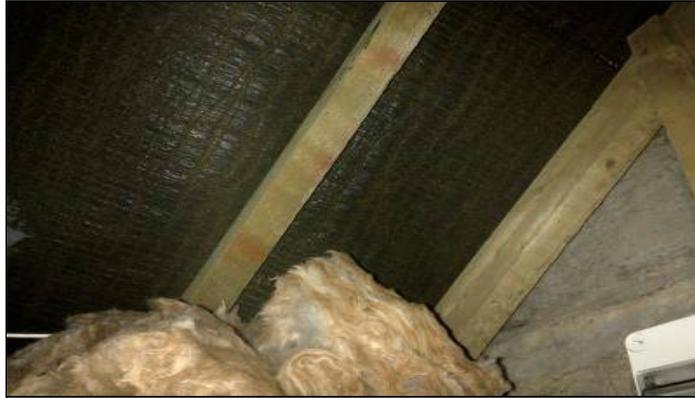
<b>Sample No.</b>	PQ002346	<b>Description</b>	Felt lining
-------------------	----------	--------------------	-------------

<b>Location ID</b>	001	<b>Position</b>	to the underside of the pitched roof		
<b>Building</b>	01 Main Building	<b>Floor</b>	Roof Void	<b>Room/Area</b>	Roof Void (001)
<b>Last Inspection Date</b>	25/09/2018	<b>Next Inspection Date</b>	N/A

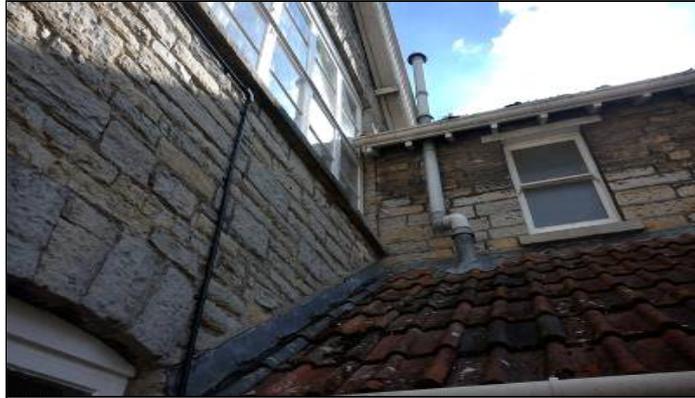
<b>Sample No.</b>	Visual 017	<b>Description</b>	Cement undercloak
-------------------	------------	--------------------	-------------------

<b>Location ID</b>	001	<b>Position</b>	to high level roof		
<b>Building</b>	01 Main Building	<b>Floor</b>	External	<b>Room/Area</b>	External (001)
<b>Last Inspection Date</b>		25/09/2018	<b>Next Inspection Date</b>		25/09/2019

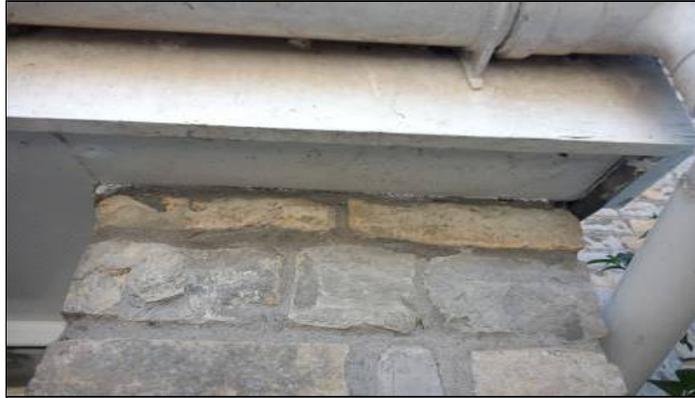
<b>Sample No.</b>	PQ002356	<b>Description</b>	Insulating board soffit
-------------------	----------	--------------------	-------------------------

<b>Location ID</b>	001	<b>Position</b>	to entrance canopy		
<b>Building</b>	01 Main Building	<b>Floor</b>	External	<b>Room/Area</b>	External (001)
<b>Last Inspection Date</b>		25/09/2018	<b>Next Inspection Date</b>		N/A

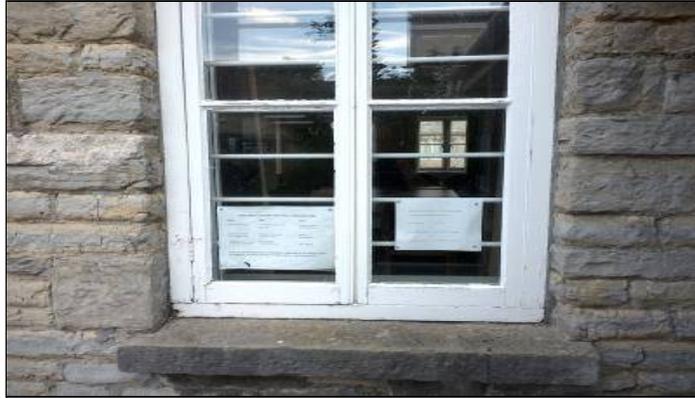
<b>Sample No.</b>	PQ002357	<b>Description</b>	Putty sealant
-------------------	----------	--------------------	---------------

<b>Location ID</b>	001	<b>Position</b>	to timber framed window		
<b>Building</b>	01 Main Building	<b>Floor</b>	External	<b>Room/Area</b>	External (001)
<b>Last Inspection Date</b>		25/09/2018	<b>Next Inspection Date</b>	N/A

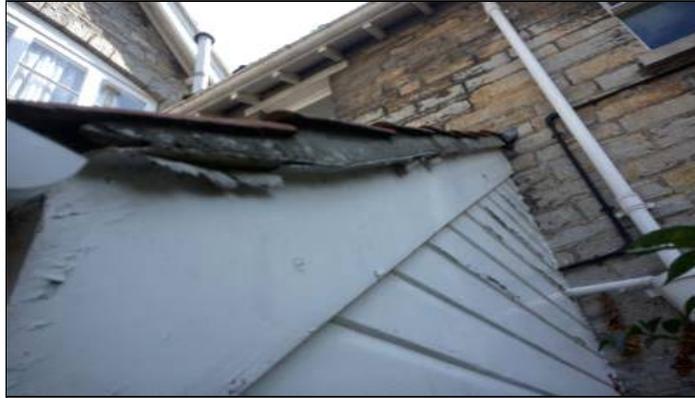
<b>Sample No.</b>	PQ002358	<b>Description</b>	Insulating board undercloak
-------------------	----------	--------------------	-----------------------------

<b>Location ID</b>	001	<b>Position</b>	to low level roof		
<b>Building</b>	01 Main Building	<b>Floor</b>	External	<b>Room/Area</b>	External (001)
<b>Last Inspection Date</b>		25/09/2018	<b>Next Inspection Date</b>		N/A

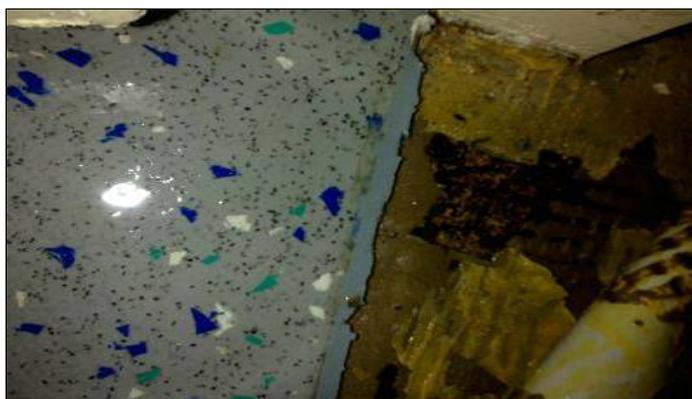
Street Parish Council					
<b>UPRN</b>			<b>Building</b>	01 Main Building	
<b>Site</b>	Street Parish Council, Street Parish Rooms, 6 Leigh Road, Street, Somerset		<b>Floor</b>	Ground Floor	
<b>Location</b>	002		<b>Room/Area</b>	Reception Area (002)	
<b>Sample No</b>	PQ002349	<b>Description</b>	Bitumen residue to underside of vinyl sheeting to floor	<b>Extent</b>	60m <sup>2</sup>

<b>Product Type</b>	Bitumen / felt	<b>Surface Treatment</b>	Composite (Self sealed)
<b>Asbestos Type</b>	Chrysotile	<b>Damage Extent</b>	Low Damage

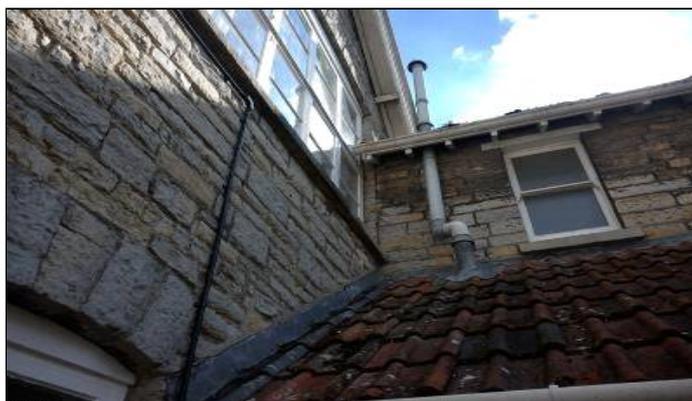
Street Parish Council					
<b>UPRN</b>			<b>Building</b>	01 Main Building	
<b>Site</b>	Street Parish Council, Street Parish Rooms, 6 Leigh Road, Street, Somerset		<b>Floor</b>	External	
<b>Location</b>	001		<b>Room/Area</b>	External (001)	
<b>Sample No</b>	Visual 017	<b>Description</b>	Cement undercloak to high level roof	<b>Extent</b>	40lm

<b>Product Type</b>	Cement	<b>Surface Treatment</b>	Sealed
<b>Asbestos Type</b>	Crocidolite (or unknown)	<b>Damage Extent</b>	Low Damage
