C78 Glasson Family Monument

Drawing:
Proposed Monument Elevations
C78

Client:
Falmouth Town Council

Job Title:
Heritage Restoration of Falmouth's
Ponsharden Cemeteries

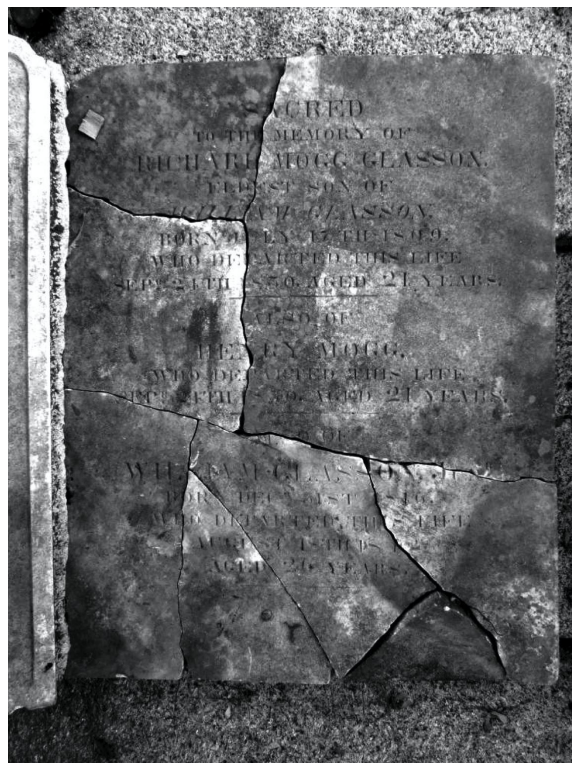
Inscribed top panel to monument with corner post loosely assembled for illustration purposes (Panel A)

Pin 25mm thick marble fragments to 25mm thick slate slab backing pieces to form the four original top panels, two with inscriptions, two plain. Make good any missing areas with lime mortar plastic repair. Consult CA for orientation of inscribed panels if this cannot be determined from the salvaged sections.

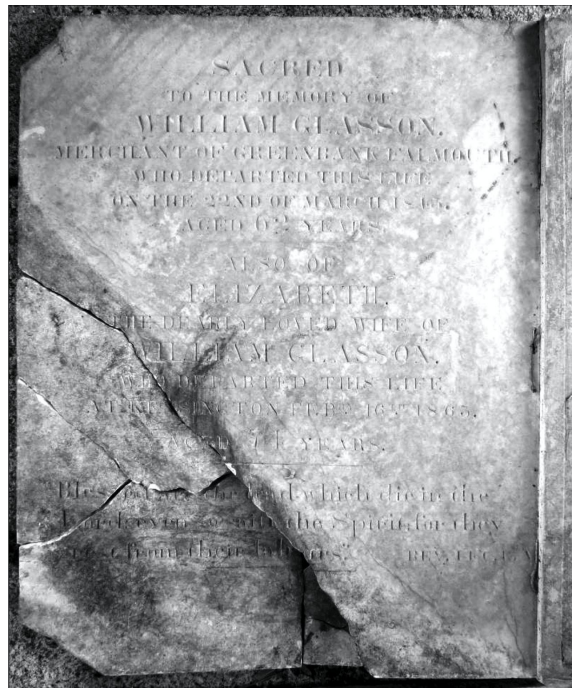
Inscribed top panel to monument with corner post loosely assembled for illustration purposes (Panel B)

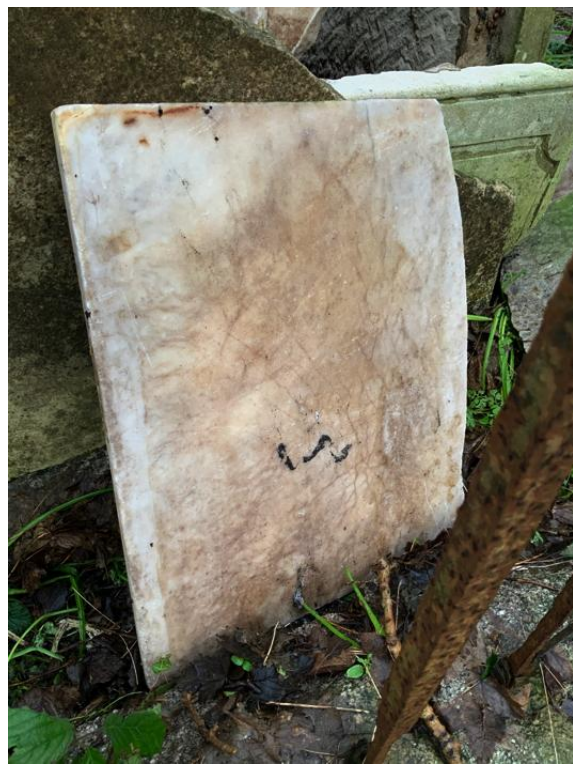
Plain top panel to monument with corner post still attached (along bottom edge as shown)

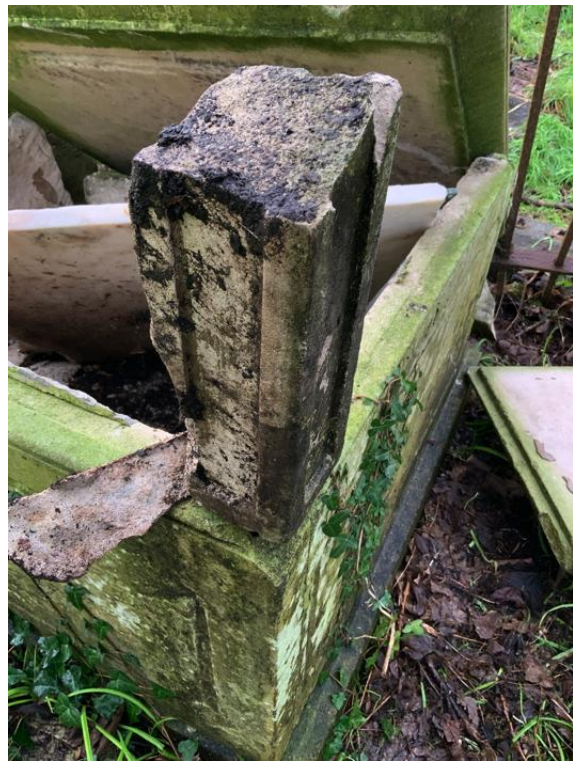
Fragment of corner post placed on bottom panels for illustration purposes

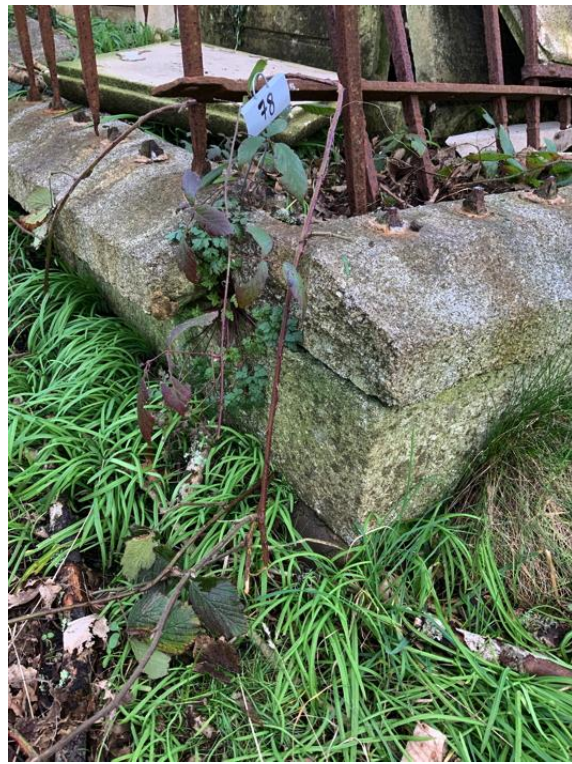
Spalled section of granite plinth, south west corner

Repair spalled south west corner of granite plinth with new indent if missing piece cannot be found.

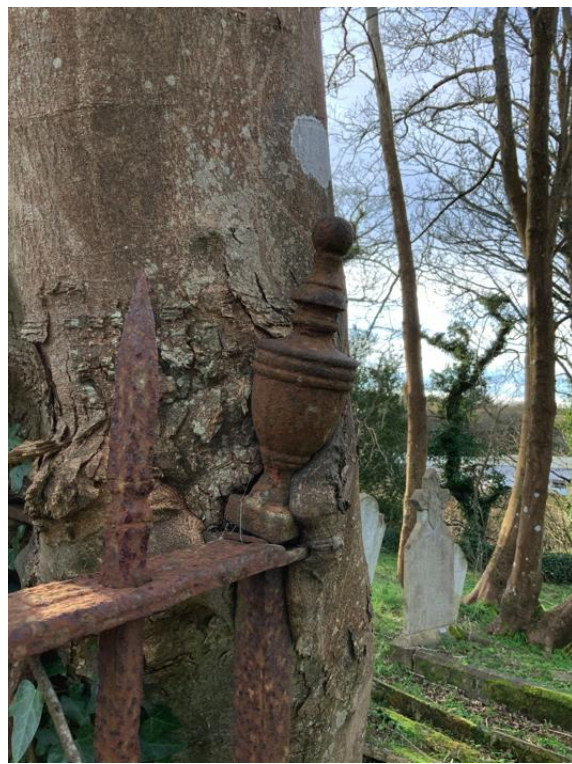
Tree grown around top cap of railings, north west corner

Kerbs
Following removal of tree and roots, remove granite kerbs. Reset and re-bed granite kerbs to existing plinth as closely as possible to original line and level. Repoint joints between kerb stones.

Ironwork
Chain drill to remove railings from lead caulked sockets and remove to workshop. Disassemble and salvage re-usable elements. Obtain replacement matching elements and reassemble railings including gate. Thoroughly de-rust ironwork and decorate. Fix back in place with molten lead caulk

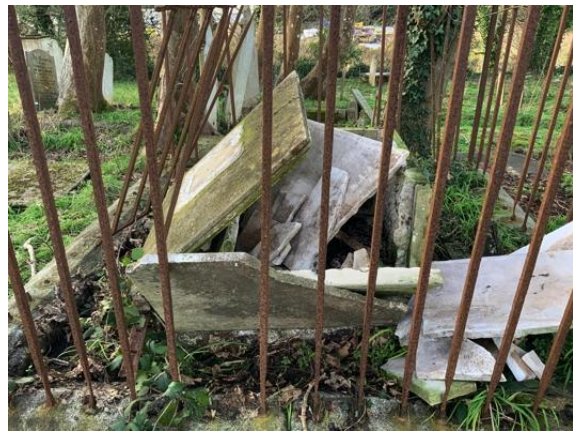
Detail of fragmented marble panels within and outside monument base

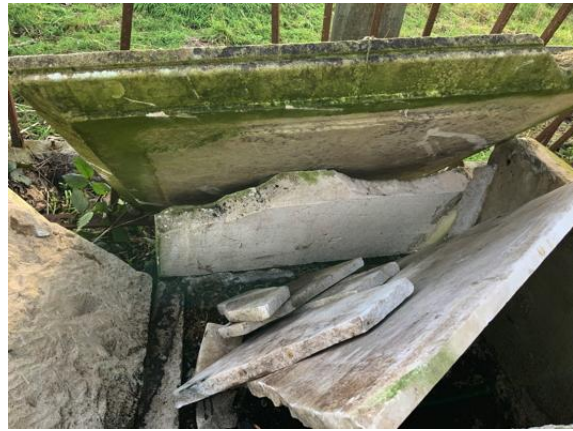
Detail of fractured south base panel of monument

Allow for repair of spalls to top corners of all four panels at top and bottom sections of monument where rusting cramps have fractured stone.

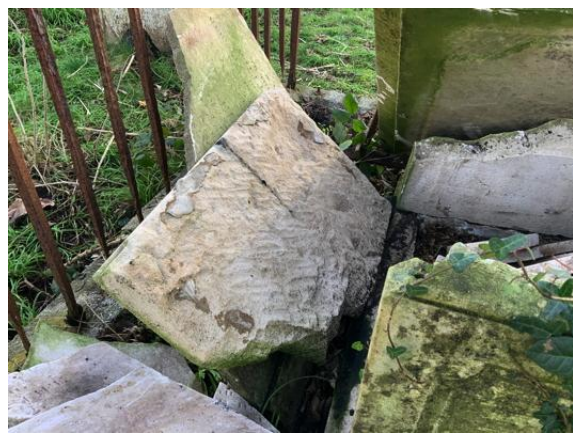
Detail of fractured east base panel of monument
