## **CCTV Survey**

Edmonds Park

Didcot

Job No: N8988

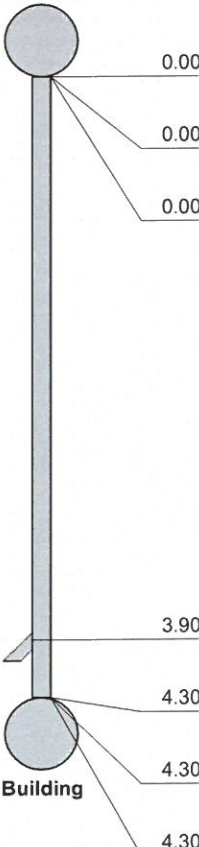
Section Number : <b>1</b>	Date : <b>18/04/2018</b>	Client's Ref :	Weather : <b>No rain or snow</b>	Critical Drain/Sewer:	PLR : <b>BuildingX</b>
Operator :	Vehicle : <b>Van 1</b>	Camera : <b>Camera 1</b>	Preset :	Cleaned : <b>no</b>	Type of Drain : <b>Gravity drain/sewer</b>

0.00		MH	Start node type, manhole, reference number: FW01(e)	0				
	0.00		WL	Water level, 05% of the vertical dimension	0				
	0.00	S01	DEG	Attached deposits, grease from 12 o'clock to 12 o'clock, 50% cross-sectional area loss, Start	0				
	3.90		JN	Junction at 3 o'clock, diameter: 100mm	0				
	4.30	F01	DEG	Attached deposits, grease from 12 o'clock to 12 o'clock, 50% cross-sectional area loss, Finish	4				
	4.30		JN	Junction at 6 o'clock, diameter: 100mm: Trap	0				
4.30		REM	General remark: Survey Finished at Trap	0					
Depth:									
STR no def	STR peak	STR mean	STR total	STR grade	SER no def	SER peak	SER mean	SER total	SER grade
0	0.0	0.0	0.0	1.0	1	8.0	1.9	8.0	4.0

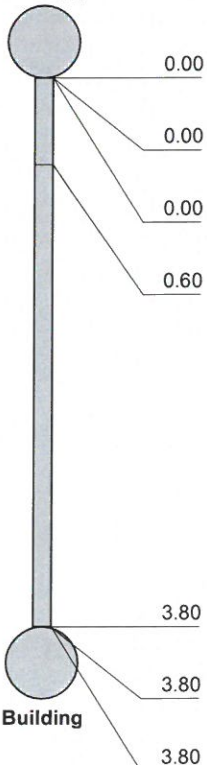
Section Number : <b>2</b>	Date : <b>18/04/2018</b>	Client's Ref :	Weather : <b>No rain or snow</b>	Critical Drain/Sewer:	PLR : <b>BuildingX</b>
Operator :	Vehicle : <b>Van 1</b>	Camera : <b>Camera 1</b>	Preset :	Cleaned : <b>no</b>	Type of Drain : <b>Gravity drain/sewer</b>

0.00	MH	Start node type, manhole, reference number: FW01(g)	0
	0.00	WL	Water level, 00% of the vertical dimension	0
	0.00	S01	Settled deposits, fine, 05% cross-sectional area loss, Start	0
	0.60	DER	Settled deposits, coarse, 25% cross-sectional area loss	4
	3.80	JN	Junction at 6 o'clock, diameter: 100mm: Trap	0
<b>Building</b>	3.80	F01	Settled deposits, fine, 05% cross-sectional area loss, Finish	3
	3.80	REM	General remark: Survey Finished at Trap	0
Depth:

STR no def	STR peak	STR mean	STR total	STR grade	SER no def	SER peak	SER mean	SER total	SER grade
0	0.0	0.0	0.0	1.0	2	5.0	1.8	7.0	4.0
