TASK NO.	TASK/DESCRIPTION	NOTES
H4.03	<p data-bbox="408 389 660 423"><b>Upper Deck Doors</b></p>

TASK NO.	TASK/DESCRIPTION	NOTES
	H4 EXTERNAL DOORS, OPENINGS AND HATCHES	
H4.04	<p><b>Bridge Wing Access Panels to Light Boom</b></p>

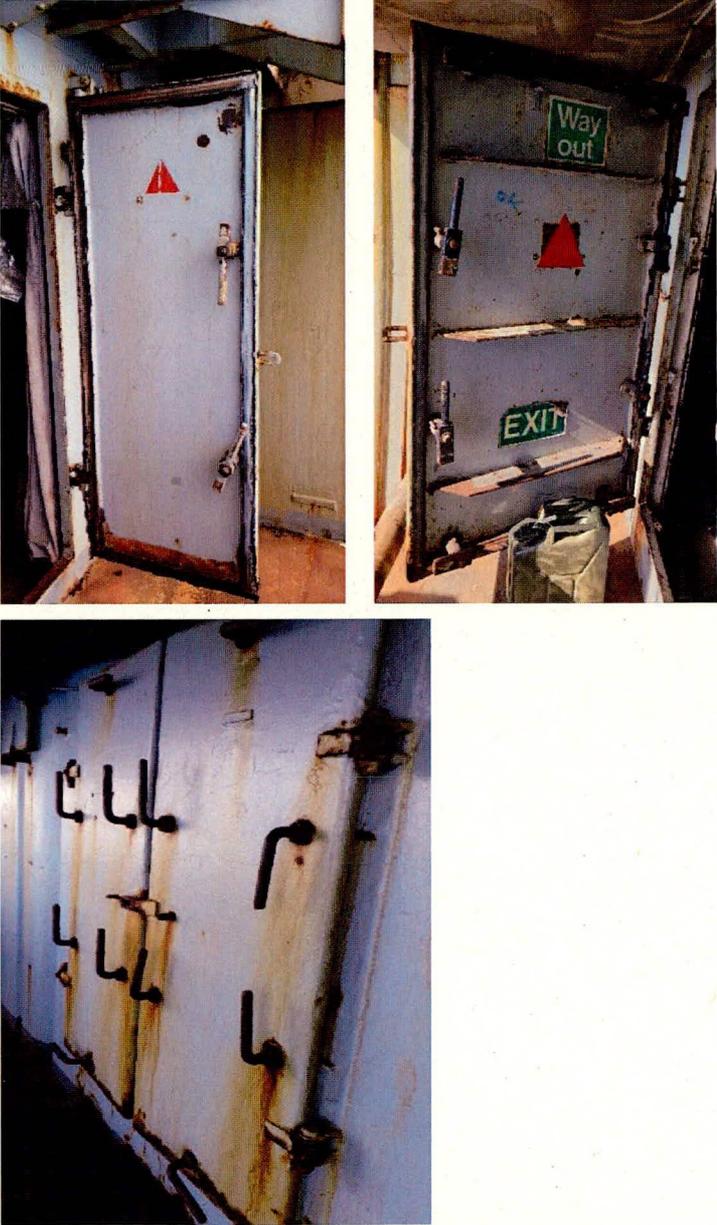
<p data-bbox="408 1682 1214 1850">Many upper deck doors are seized or stiff to move with no ability to securely close. REFURBISH doors to include renewal of rubber seals and repair any excessively corroded areas. All clips to be freed up and greased, or RENEWED if beyond repair. Doors will be placed in priority order with list provided to the Contractor prior to RPSD. REPRESENTATION on completion of any required work.</p> <p data-bbox="408 1865 1098 1895">ALLOW for 30 doors. ALLOW for 60m<sup>2</sup> REPRESENTATION.</p>	<p data-bbox="1249 394 1437 566">Awaiting Escape, Evacuation and Rescue report to aid priority listing.</p> <p data-bbox="1249 595 1437 703">IAW Paint scheme -General 12 and Annex B refer.</p>

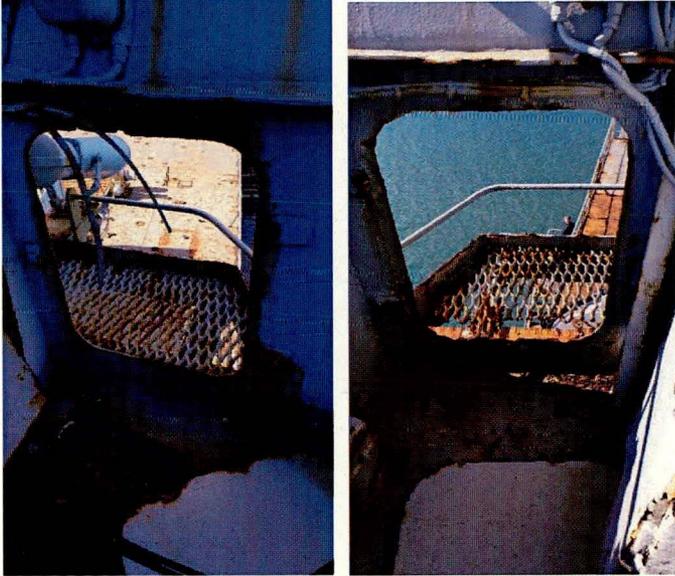
<p>Port and stbd bridge wing access doors to flight lighting booms have both suffered excessive corrosion on hinges resulting in doors becoming detached. RENEW door hinges and refit doors. REPRESENT on completion.</p> <p>ALLOW for 4m<sup>2</sup> REPRESENTATION.</p>	<p>Hotwork Required – Appropriate precautions to be taken iaw General 8.4.</p> <p>IAW Paint scheme -General 12 and Annex B refer.</p> <p>To be completed in conjunction with H2.15 and H3.05.</p>

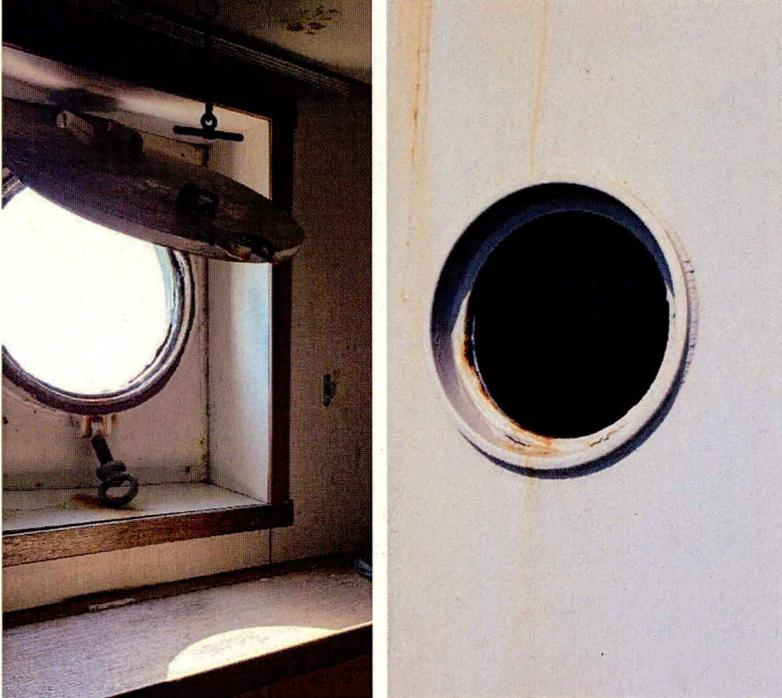
</div> <p data-bbox="411 1155 1214 1240">Cabin 01Z0 porthole flap is seized open and porthole glass has become detached leaving an opening for rain ingress. Hinged flap to be freed up and sealed shut with appropriate weatherproof sealant.</p>
