19-0213

INSPECTION REPORT REGARDING THE
CONDITION OF STRUCTURAL CONCRETE

MARKET MULTI STOREY CAR PARK
NORTHMINSTER, PETERBOROUGH PE1 1AY

REV S2-P02

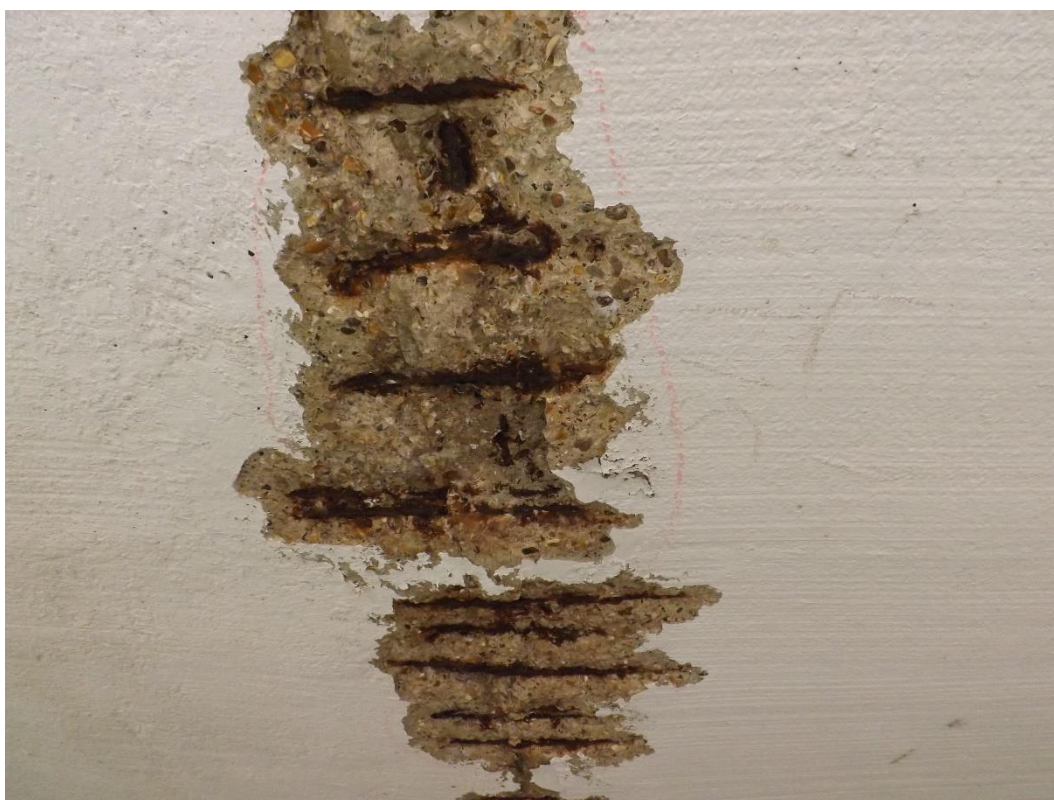
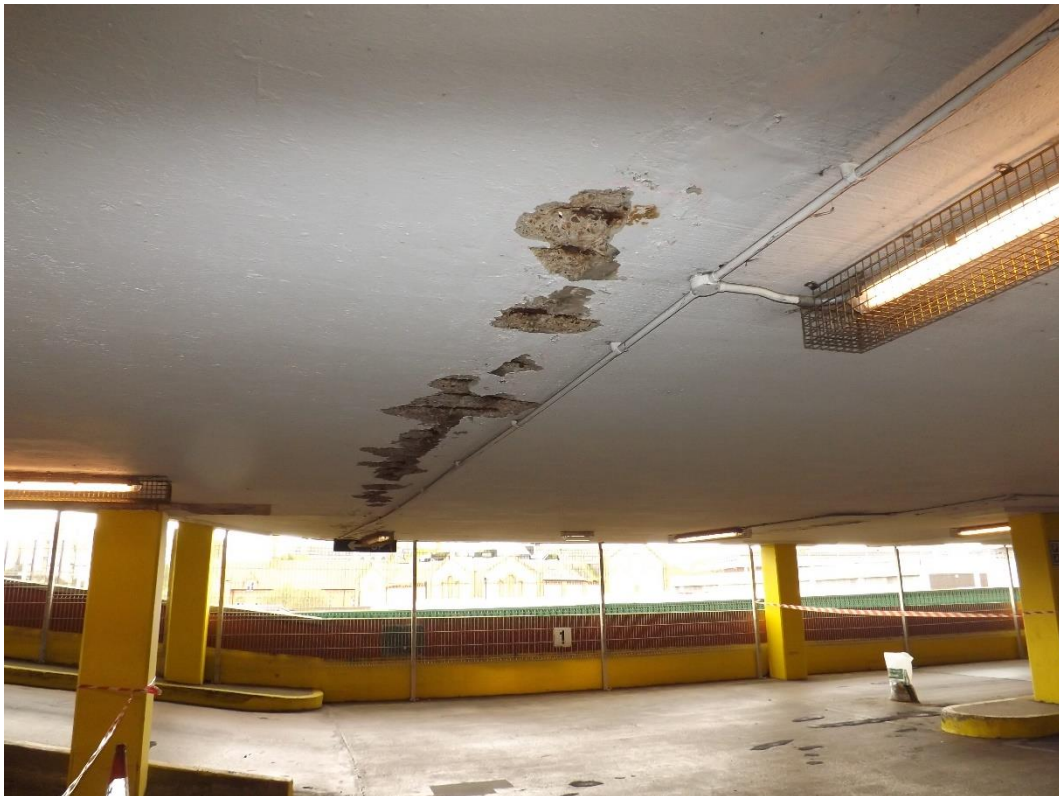
Visually corroded slab reinforcement. – Where spalling concrete cover had been lost, or removed on safety grounds, significantly corroded reinforcement bars were noted on slab soffits and also upon the top surfaces of the decks.

Photograph 4 – Typical instance of corroded reinforcement in deck soffit.

Photograph 5 - Typical instance of corroded reinforcement in deck soffit.

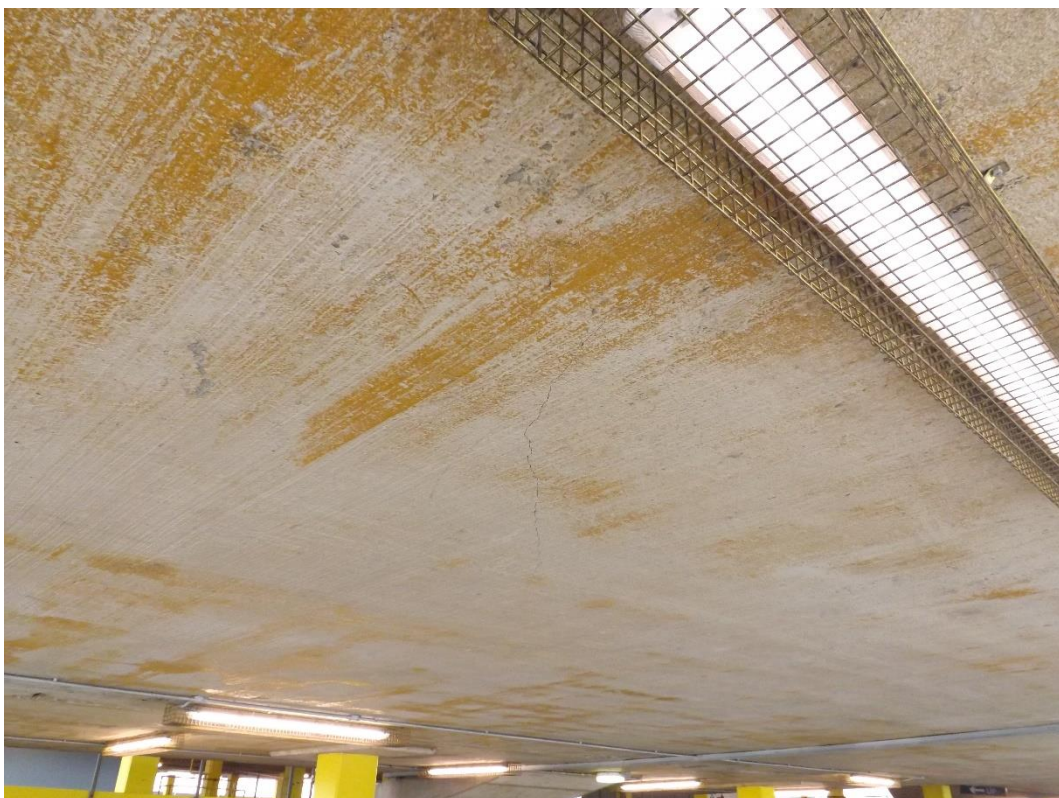
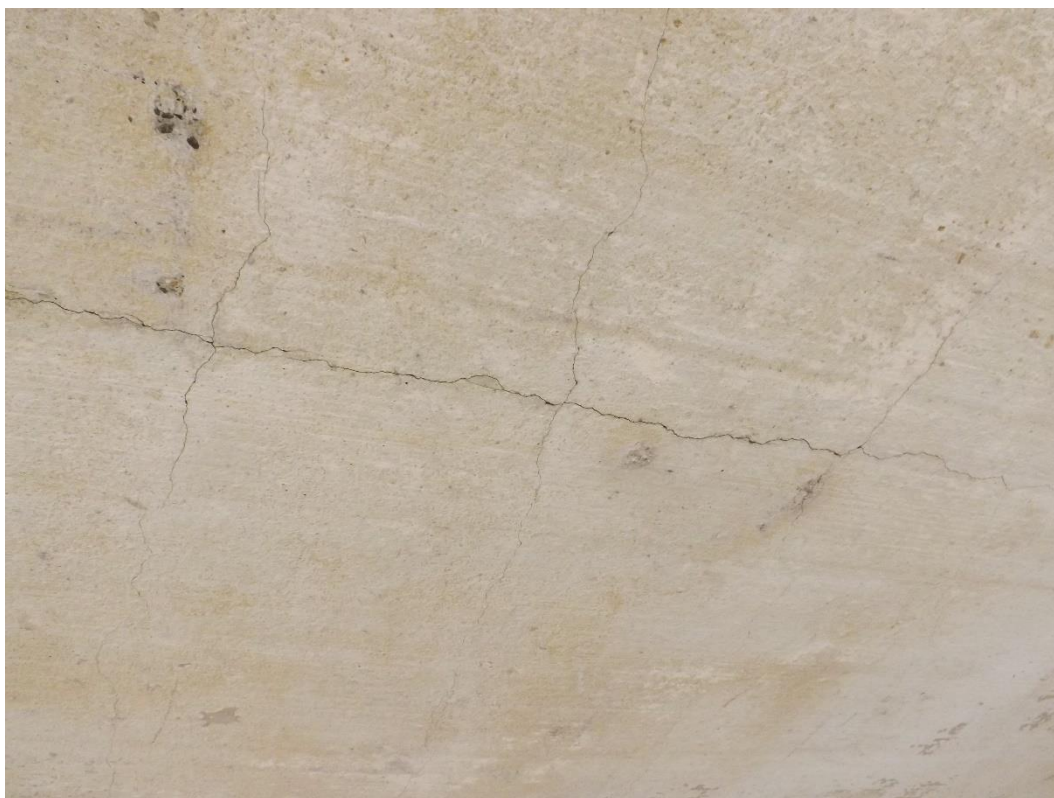
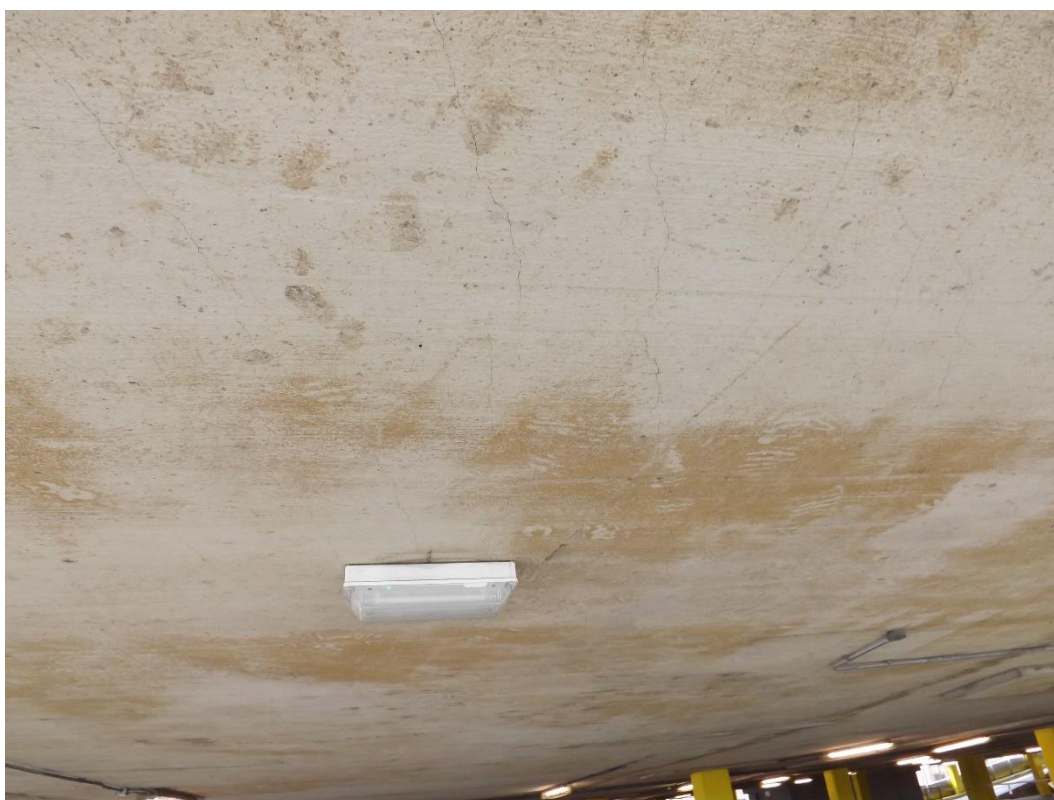
Further indications of corroded reinforcement. – Instances of multiple parallel longitudinal cracks in slab soffits and also significant areas of 'hollow when tapped' slab soffits and deck top surfaces are also deemed to be indicative of reinforcement corrosion that is yet to manifest itself as spalling concrete.

Photograph 6 – Typical instance of cracked deck soffit.

Photograph 7 – Typical instance of cracked deck soffit.

Photograph 8 - Typical instance of cracked deck soffit.

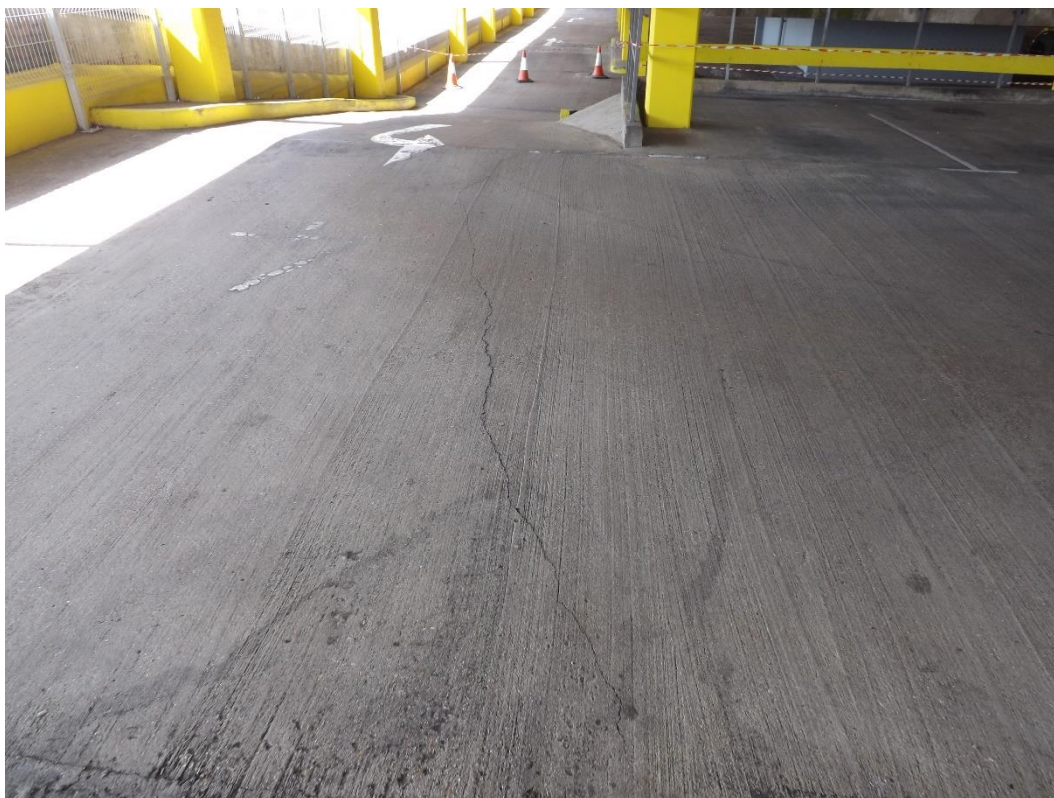
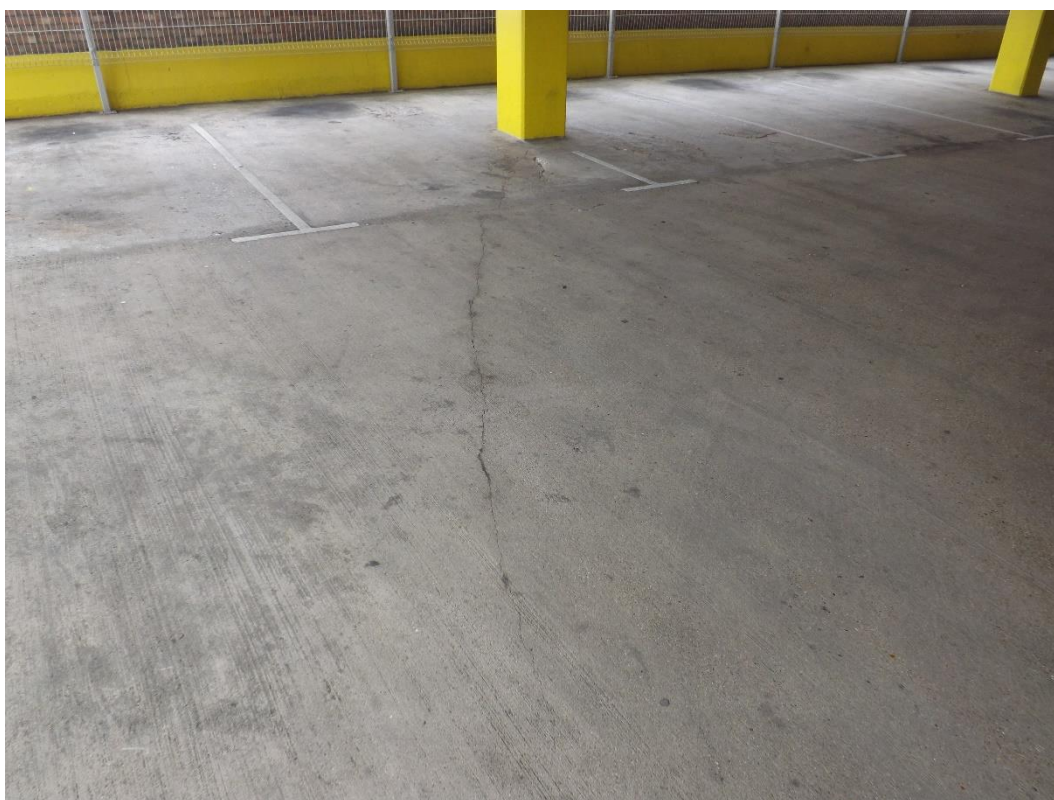
General cracking of decks. – There are various instances of crack repairs and current cracks within the carpark deck soffits and deck top surfaces throughout the carpark. Some of these are longitudinal, others are diagonal with regard to the building footprint. There appear to be instances where the former crack repairs have nominally, re-cracked.

Photograph 9 – Typical cracking within deck.

Photograph 10 – Typical cracking within deck.

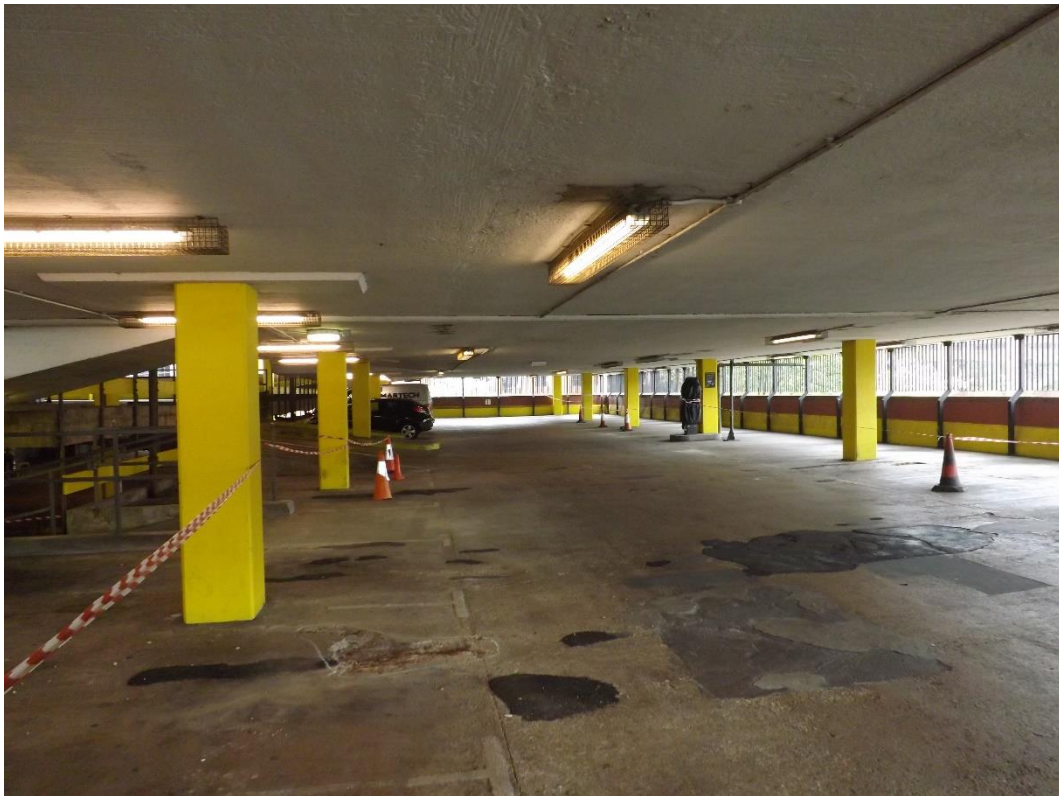
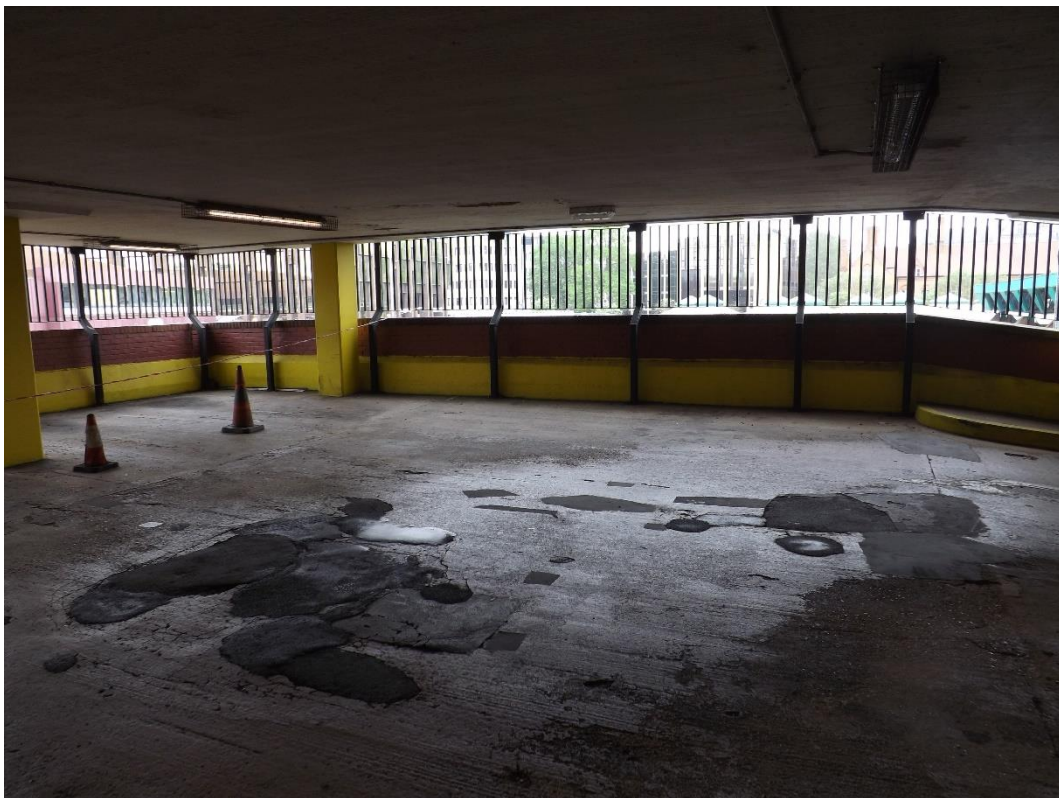
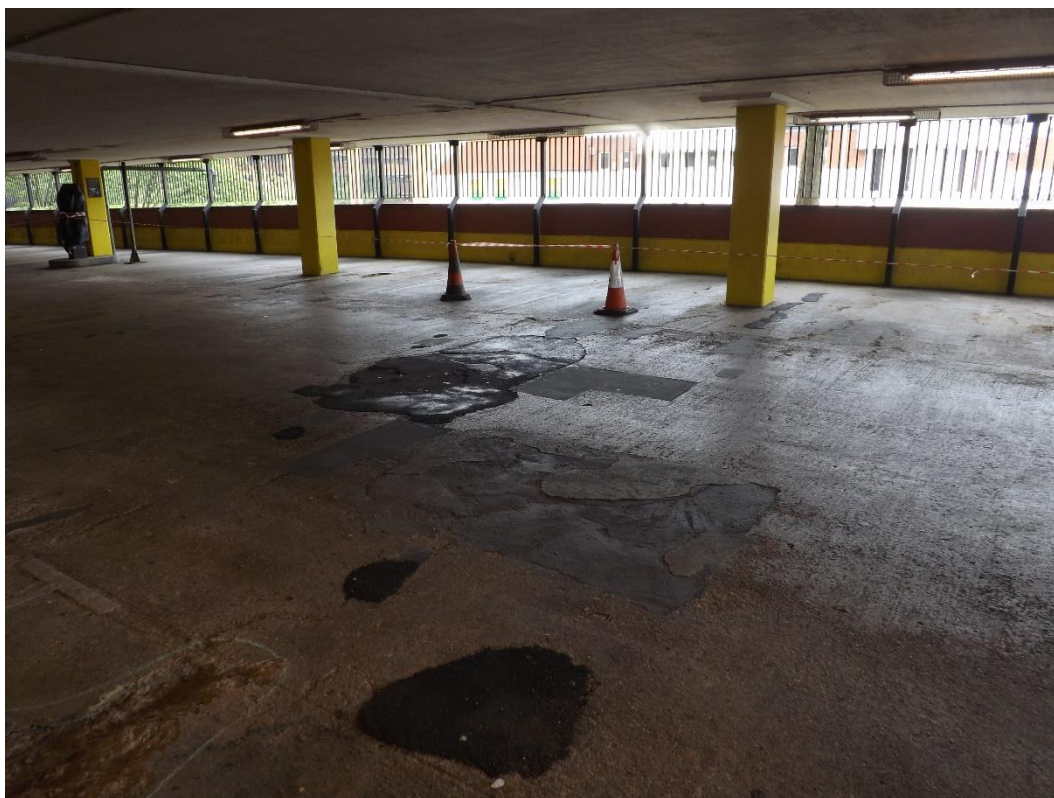
Historic repairs to previously spalled areas of soffits and deck top surfaces. – There are numerous instances of previous 'patch' repairs to assumed historic spalling damage throughout the carpark. We cannot advise with regard to the adequacy of those repairs albeit, many of them are now showing signs of further cracking and loss of adhesion. Some areas of historic 'patch' repairs within deck top surfaces are relatively significant in size and bear evidence of having been potentially repaired on more than one occasion.

Photograph 11 - Typical historic 'patch' repairs in deck.

Photograph 12 - Typical historic 'patch' repairs in deck.

Photograph 13 – Typical historic 'patch' repairs in deck.

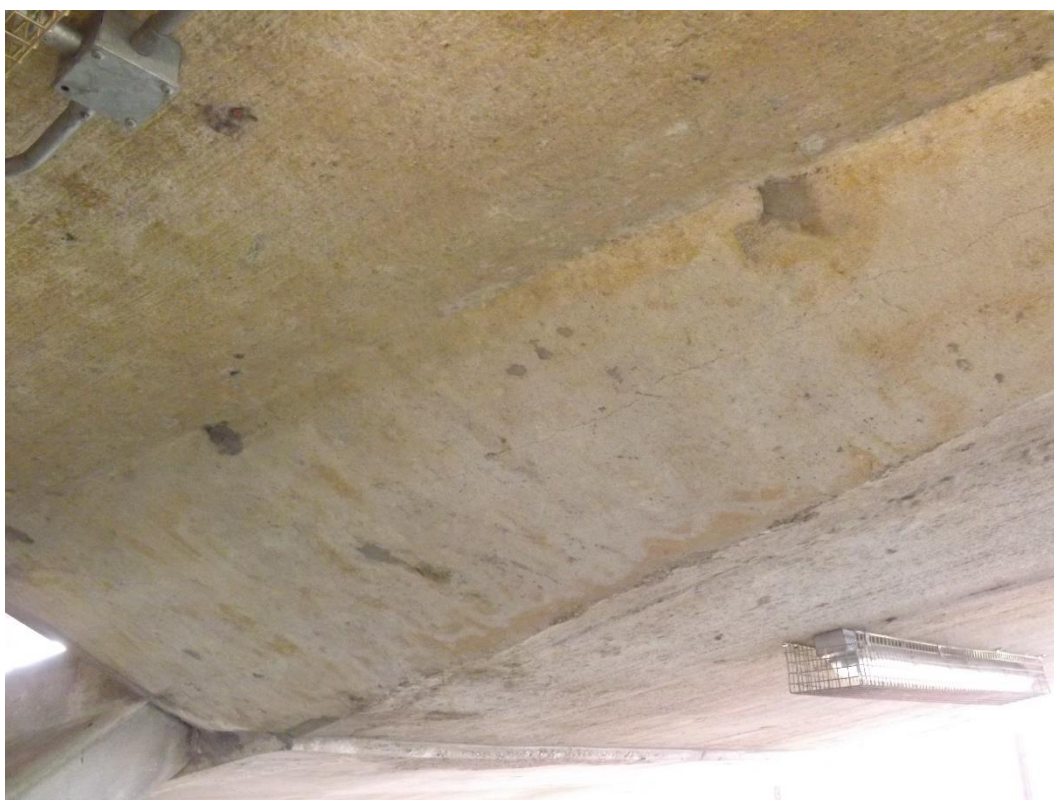
Cracking within vehicular ramp edge. – There is an instance of an isolated longitudinal crack along the vertical edge of a vehicular ramp, the structural significance of which has not been established at this time.

Photograph 14 - Longitudinal crack along ramp edge.

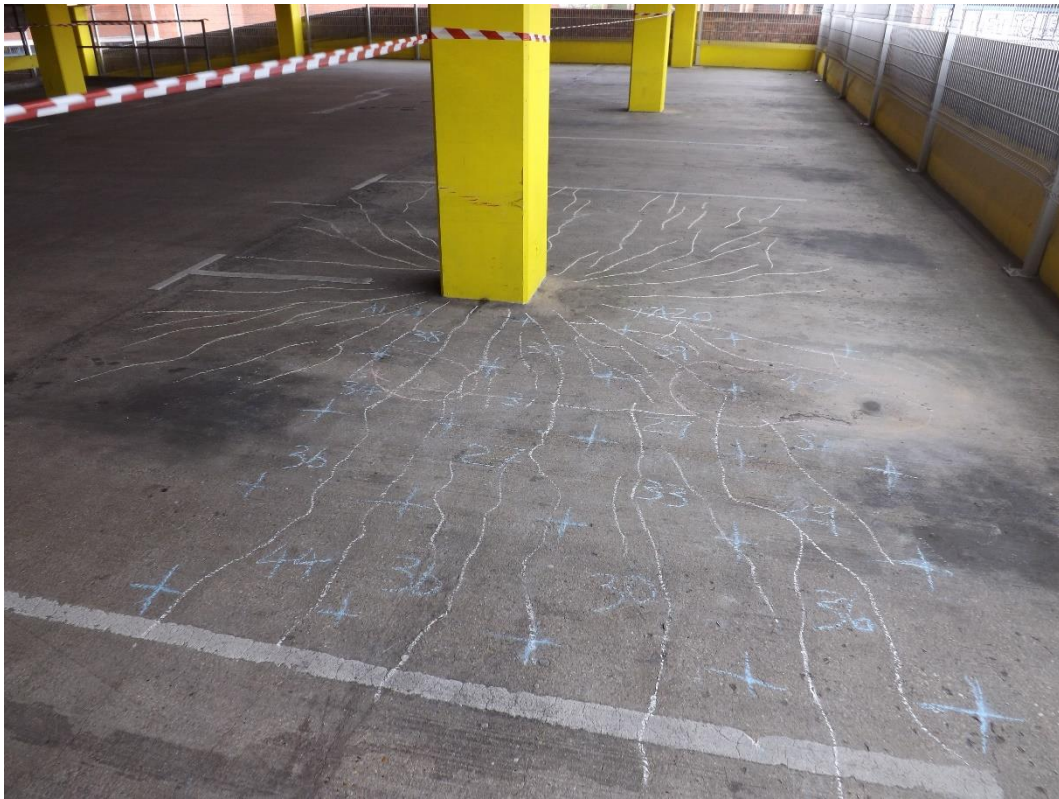
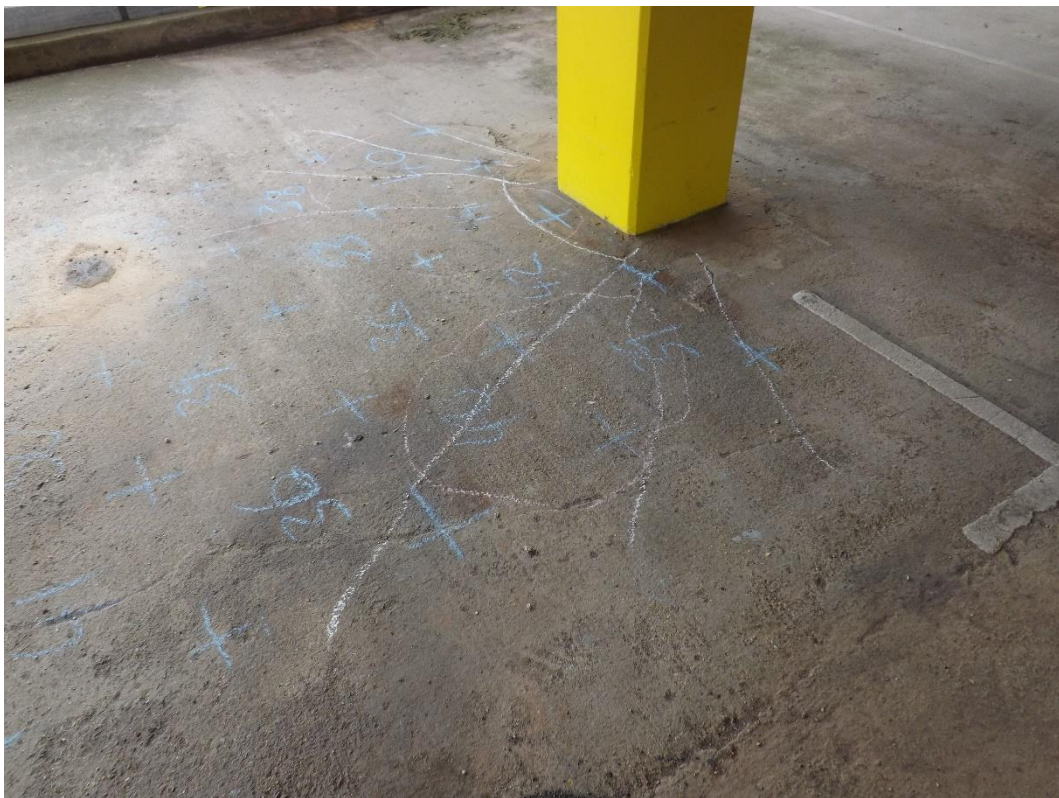
Cracked deck slabs local to columns. – The decks have multiple ‘radial’ cracks centred at column positions. This is the case at a significant number of columns at all levels and throughout the building. At a number of columns the radial cracks have joined close to the columns via the course of a single crack part ‘curving’ around the column. This latter described crack profile is of particular significance with regard to the potential for ‘punching shear’ failure and must be closely monitored.

At a number of column locations it appears that repairs have been carried out in the past to cracks seemingly similar to those described above, both ‘radial’ and ‘curved.’ We cannot confirm at this time the adequacy or nature of the past repairs albeit, at a number of locations re-cracking of the repaired area has occurred.

Photograph 15 – Typical deck cracking at column locations.

Photograph 16 – Typical deck cracking at column locations.

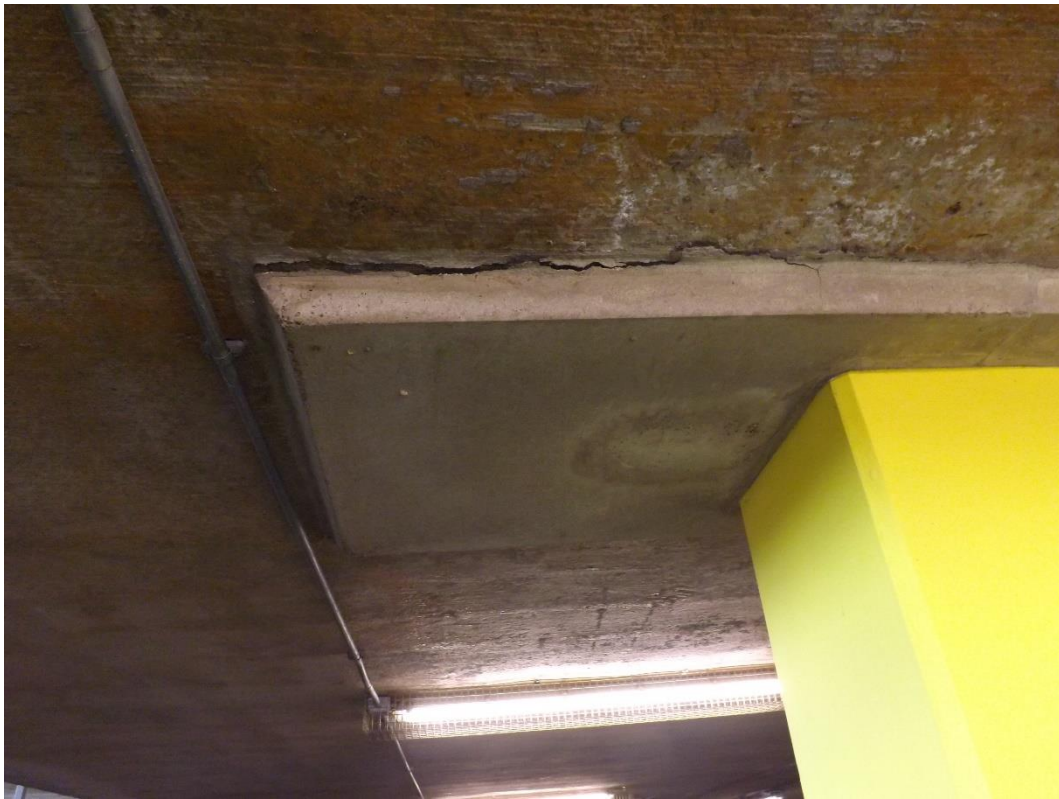
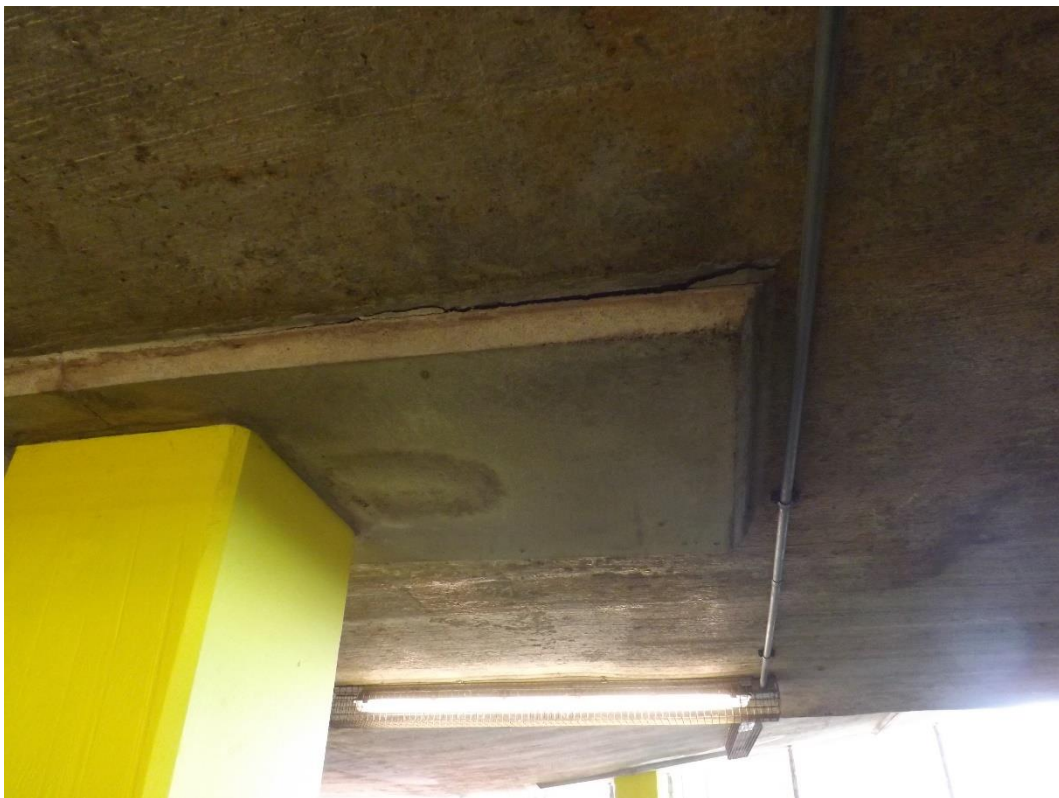
Cracked and part detached deck soffit down-stands at column heads. – Rectangular concrete down-stands are installed around column heads to provide corrosion and fire protection. However, at widespread locations throughout the carpark these down-stands have become cracked, poorly adhered, have fallen or have been removed in full or part. At a short row of columns, the detached concrete down-stands have apparently been replaced with ply-wood boxing of similar size and profile albeit, that does not appear to be an adequate substitution in terms of protection.

Photograph 17 – Cracked/part detached soffit down-stand at column head prior to removal.

Photograph 18 – Cracked/part detached soffit down-stand at column head prior to removal.

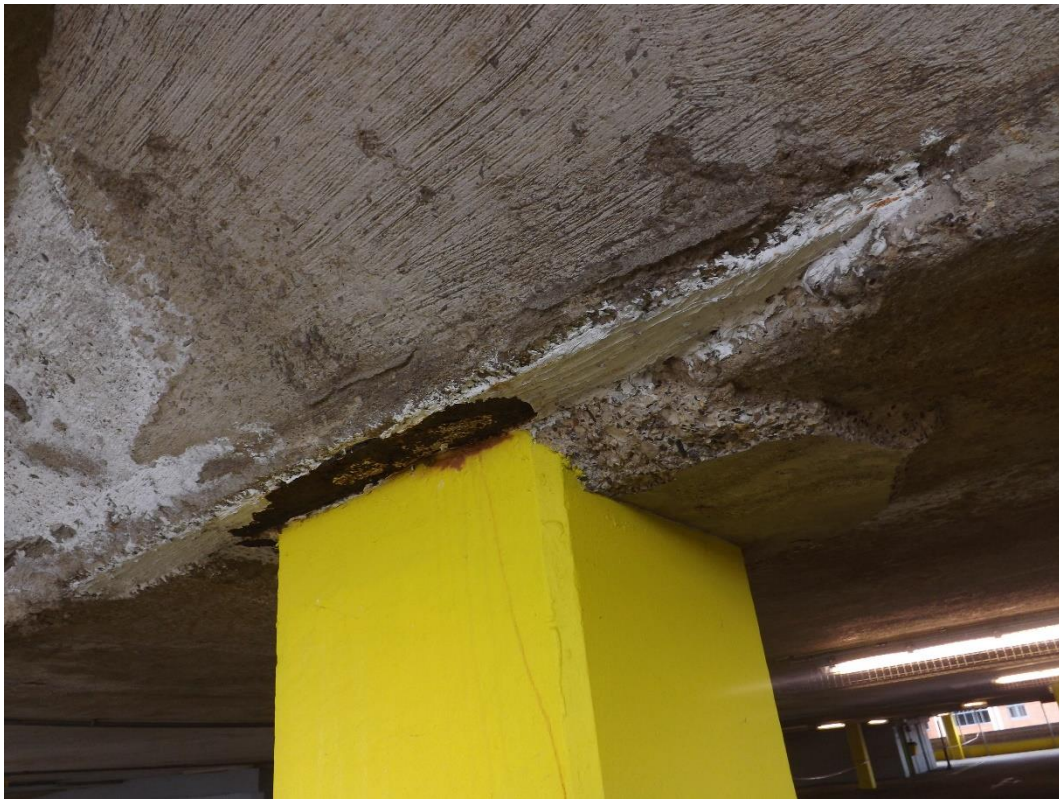
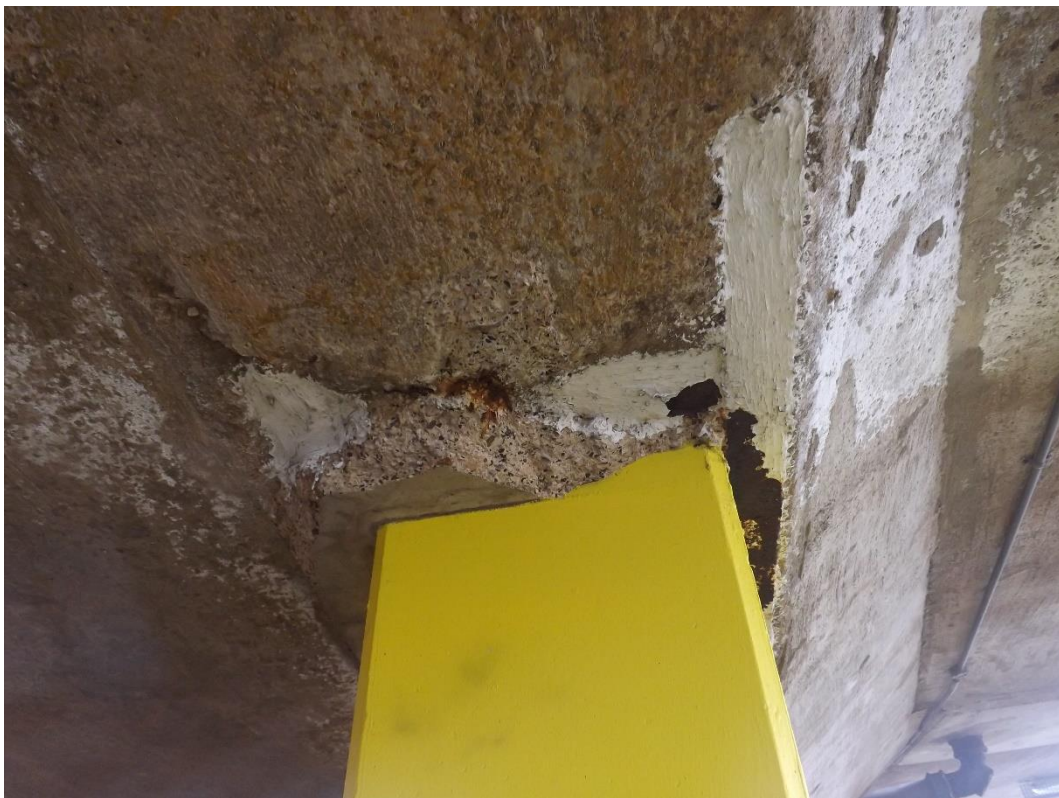
Exposed and corroded deck support frames at column heads. – Where the ‘protective’ concrete down-stands have been lost in full or part the deck slab steel support frames are exposed to fire and corrosion risks. There are a number of locations where pronounced corrosion in the exposed column head deck support frames has occurred. At one location probed at close quarters, a piece of corroded support frame metal, approximately equal to 30% of the original steel section thickness (when adjusted to take into account corrosion expansion), came away easily in the hand. It would appear also that the rectangular concrete down-stands are not necessarily always effective in preventing corrosion within the steel support frames. It is evident at a number of locations that it is corrosion related expansion within the deck support frames that is ‘pushing’ the concrete down-stands away from the deck soffit. This was indeed the case where we witnessed Martech Ltd. removing a cracked and unstable concrete ‘protective’ cover behind which was found the corroded support frame probed at close quarters as described in the immediately preceding paragraph.

It appears that the corrosion protected remedial coating added in the past to the exposed deck support frames has only been partially effective.

Photograph 19 – Exposed and corroded column head deck support frame.

Photograph 20 – Exposed and corroded column head deck support frame.

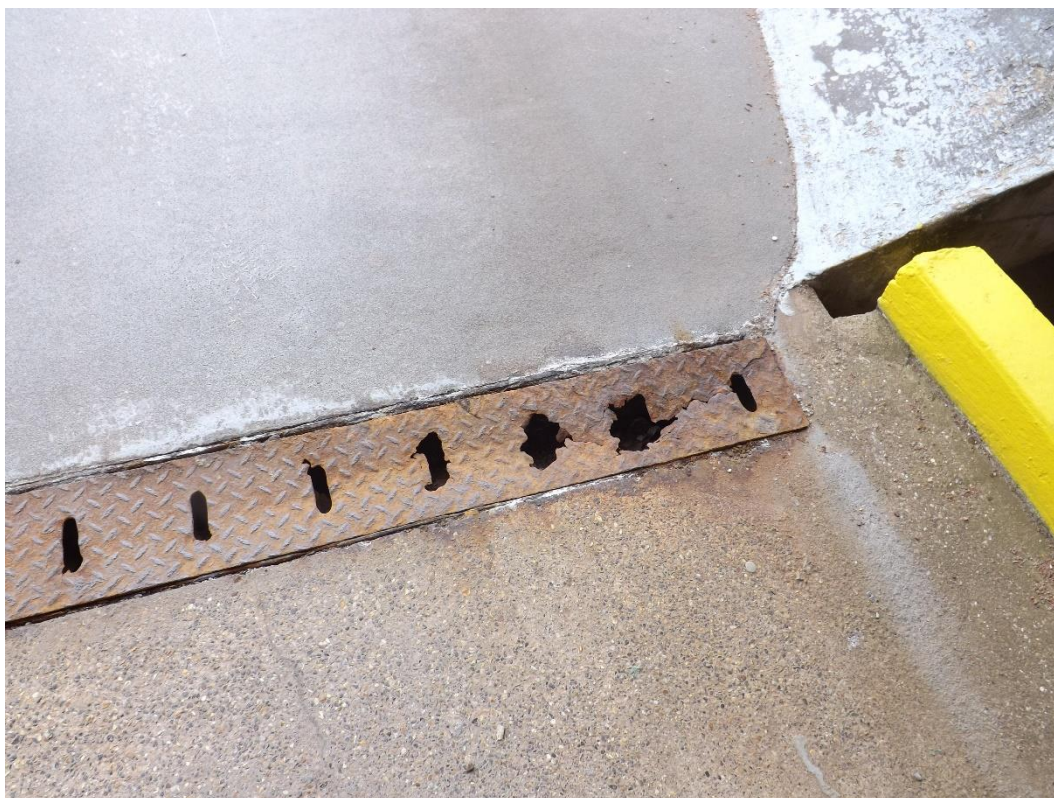
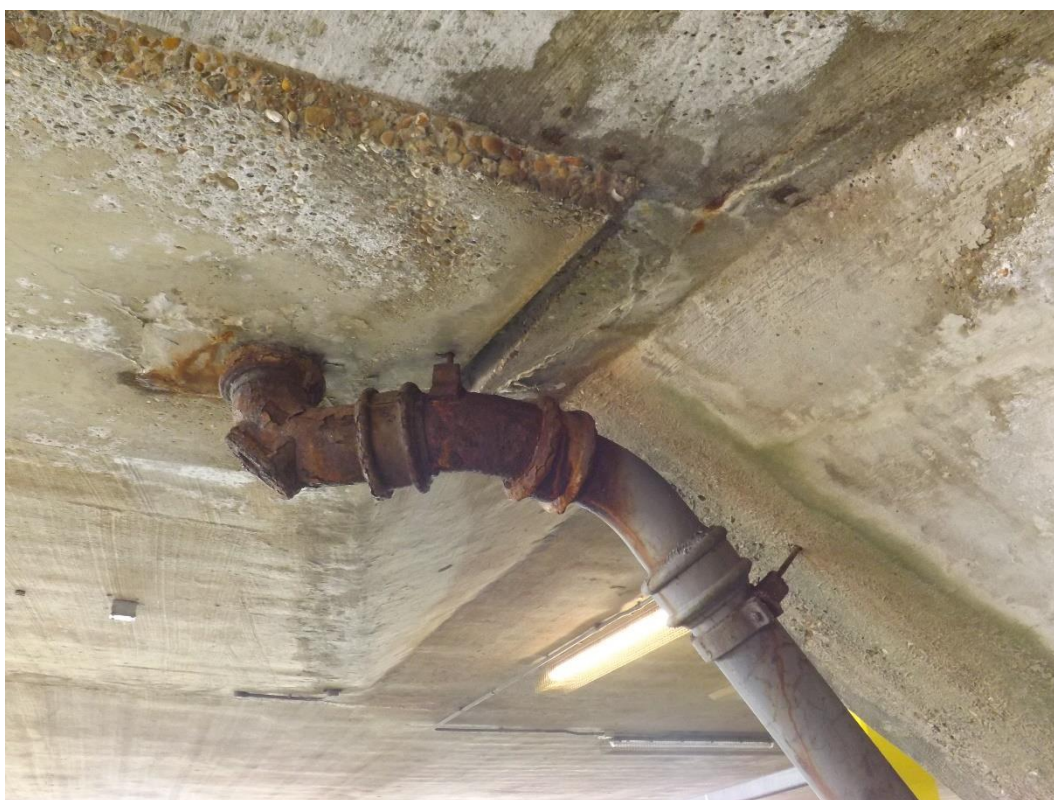
Severely corroded/leaking rainwater pipes and gullies. – There are various, pronounced instances of defects, leakage and severe corrosion within rainwater pipes and gullies throughout the carpark. This leakage is acting to compound the deterioration in the structure. There is additionally an instance of a broken ramp related gulley that poses a significant trip hazard. This latter aspect has been notified verbally to NPS during the course of a joint site inspection.

Photograph 21 – Example of defective corroded drainage items.

Photograph 22 –Example of defective corroded drainage items.
