Dovecot West of St Dunstons Church, Mill Lane, Monks Risborough, HP27 9LB

Roof Works Specification

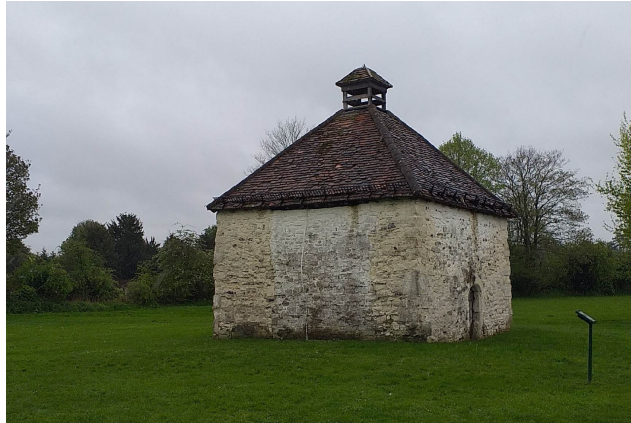
2.2.1 *Photograph of the North Elevation*

- 2.1 A large number of roof tiles have slipped or are missing with a few of the existing tiles

broken including those on the lantern, as shown on the photographs below. These are to be carefully removed and any moss removed ready for refitting.

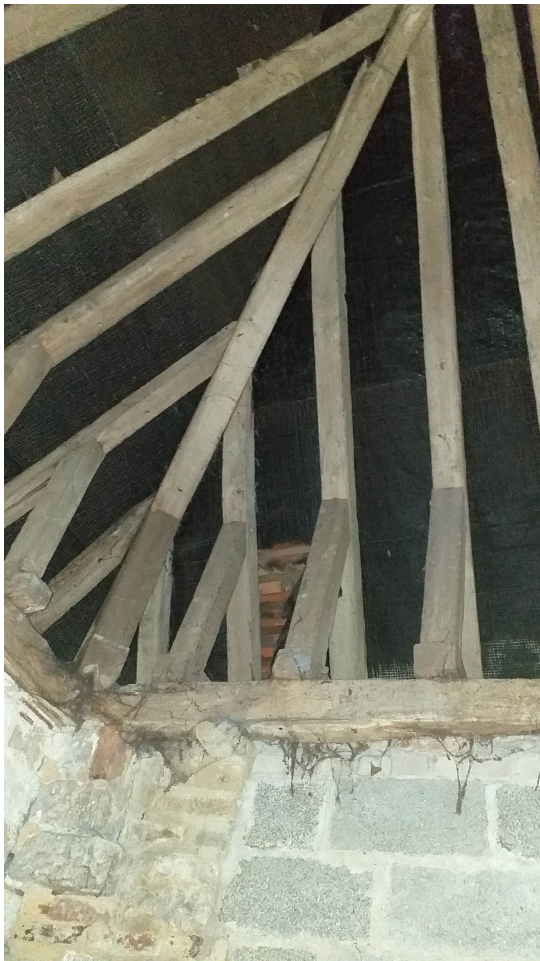
6.2 There are a number of holes within the roofing membrane as shown in the photographs.

6.4.1 P.1 of holes in existing roofing felt

6.3 Therefore the existing modern battens and roofing membrane are to be removed, leaving the existing roof structure.

- 7.0 Over the existing roof structure new TLX Batsafe Breather Membrane is to be laid to manufacturers details.
- 8.0 New 25 x 38 treated softwood battens are to be fitted to a gauge to work with the existing roof tiles.
- 9.0 Existing roof tiles to be refitted.

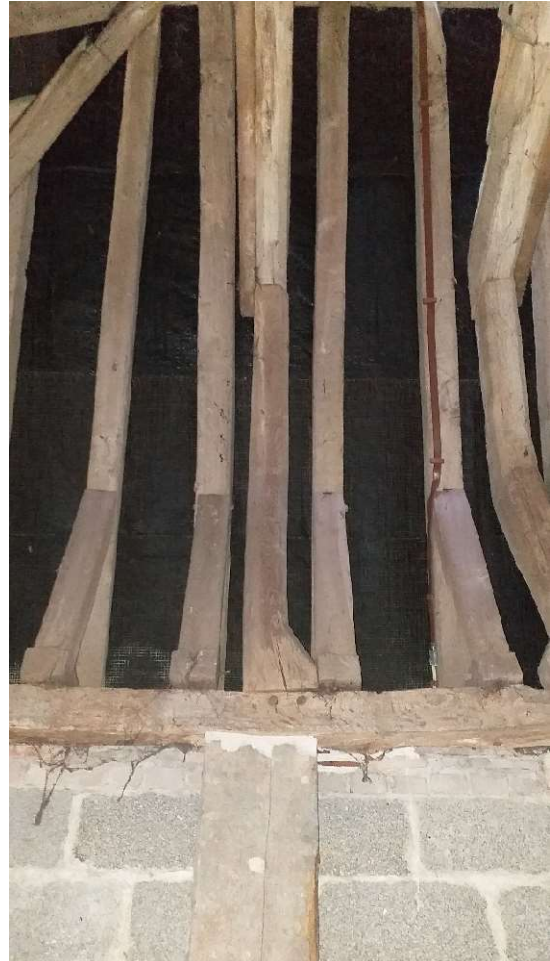
6.4.2 P.2 of holes in existing roofing felt

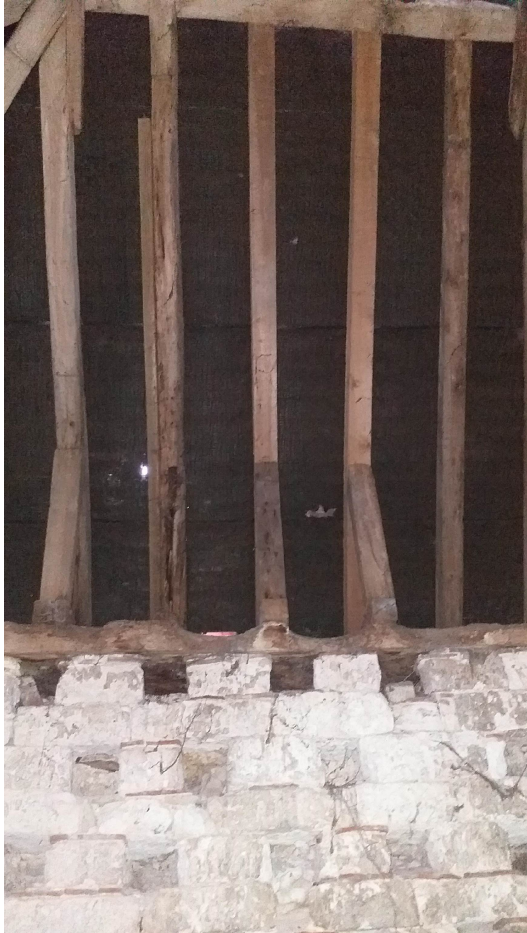
6.4.3 P.3 of holes in existing roofing felt

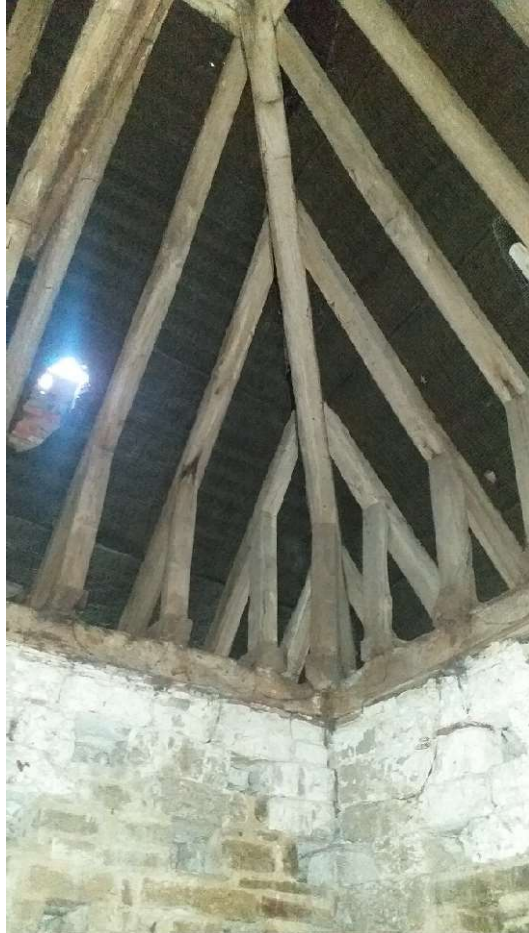
6.4.4 P.4 of holes in existing roofing felt

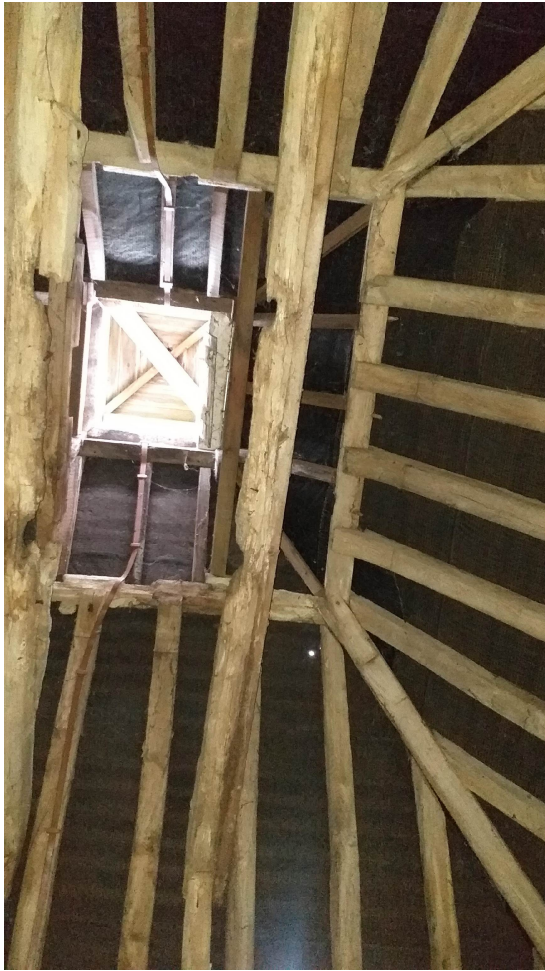
6.4.5 P.5 of holes in existing roofing felt
