Report No.: J296744
Nature of Work: Refurbishment Survey
Issue Date: 21/06/2023
Client Name: Oswestry Town Council
The Guildhall, Bailey Head, Oswestry, SY11 1PZ
Site Address: English Walls Public Toilets, English Walls, Oswestry, SY11 2PA

Drawing title:
Asbestos Survey Plan (J296744/01)

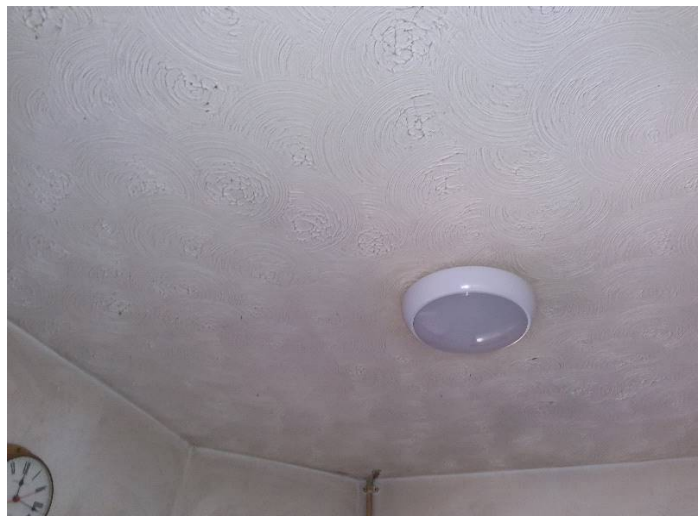
Location:	01 Office	Block:	Public toilet	Floor Level: Ground Floor
Sample No.:	NS000202	Portal Ref No.:	1

Item:	Textured coating to plasterboard ceiling			
Asbestos Content:		Result Based on:		
No Asbestos Detected		Analysis of sample using PLM		
Sample Analysed By:	S Williams	Extent:	2 m²	
Comments:

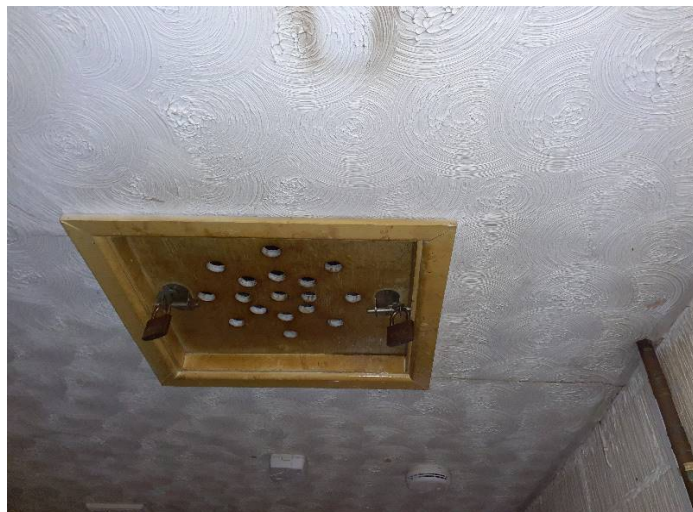
Location:	02 Supply room	Block:	Public toilet	Floor Level: Ground Floor
Sample No.:	As NS000202	Portal Ref No.:	3

Item:	Textured coating to plasterboard ceiling			
Asbestos Content:		Result Based on:		
No Asbestos Detected		Strongly presumed		
Sample Analysed By:	Not applicable	Extent:	10 m ²	
Comments:

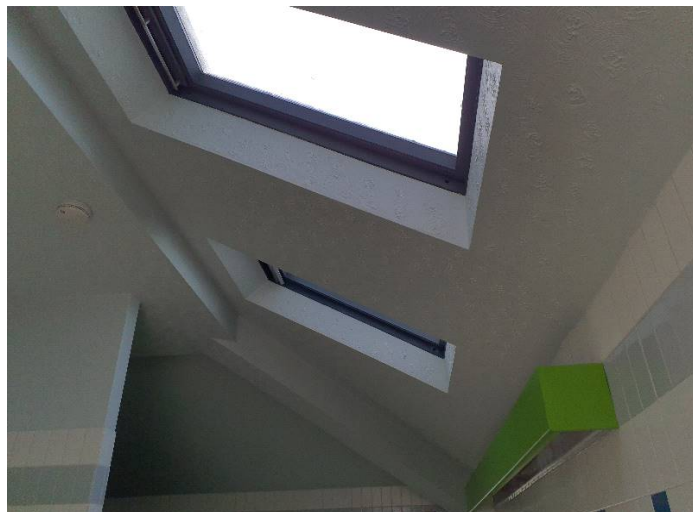
Location:	03 Male WC	Block:	Public toilet	Floor Level: Ground Floor
Sample No.:	NS000203	Portal Ref No.:	6

Item:	Textured coating to plasterboard ceiling			
Asbestos Content:		Result Based on:		
No Asbestos Detected		Analysis of sample using PLM		
Sample Analysed By:	S Williams	Extent:	21 m²	
Comments: Also continues to upstands of skylight

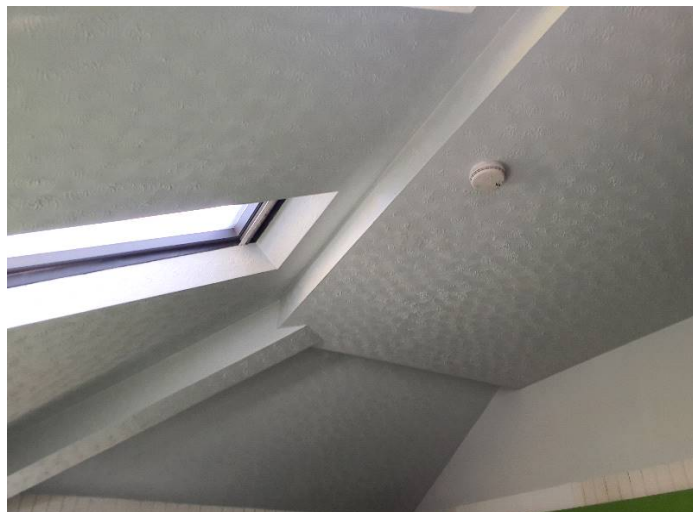
Location:	04 Female WC	Block:	Public toilet	Floor Level: Ground Floor
Sample No.:	NS000204	Portal Ref No.:	10

Item:	Textured coating to plasterboard ceiling			
Asbestos Content:		Result Based on:		
No Asbestos Detected		Analysis of sample using PLM		
Sample Analysed By:	S Williams	Extent:	21 m²	
Comments: Also continues to upstands of skylight

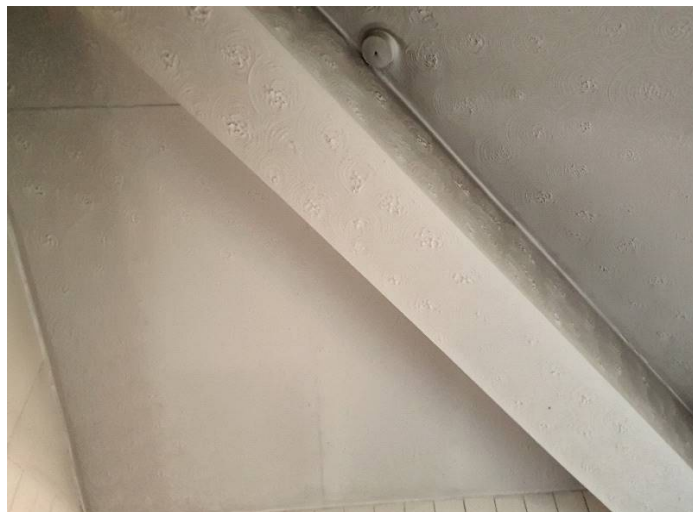
Location:	05 Baby Change	Block:	Public toilet	Floor Level: Ground Floor
Sample No.:	As NS000202	Portal Ref No.:	15

Item:	Textured coating to plasterboard ceiling			
Asbestos Content:		Result Based on:		
No Asbestos Detected		Strongly presumed		
Sample Analysed By:	Not applicable	Extent:	4 m²	
Comments:

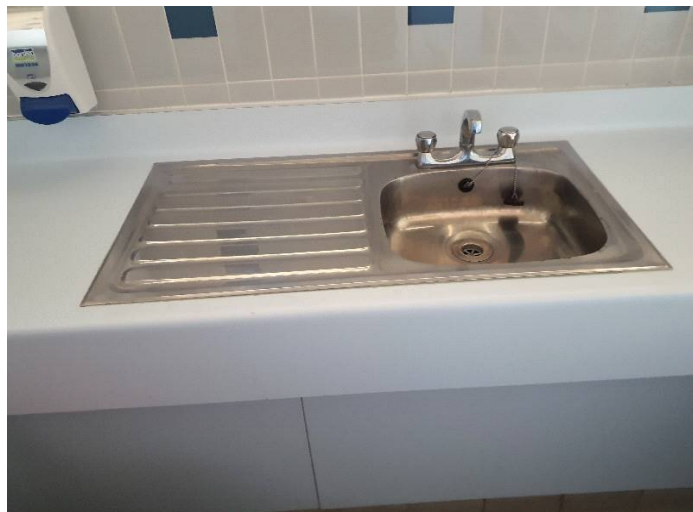
Location:	05 Baby Change	Block:	Public toilet	Floor Level: Ground Floor
Sample No.:	NS000205	Portal Ref No.:	18

Item:	Bitumen sink pad			
Asbestos Content:		Result Based on:		
No Asbestos Detected		Analysis of sample using PLM		
Sample Analysed By:	S Williams	Extent:	2 units	
Comments: To bowl and drainer

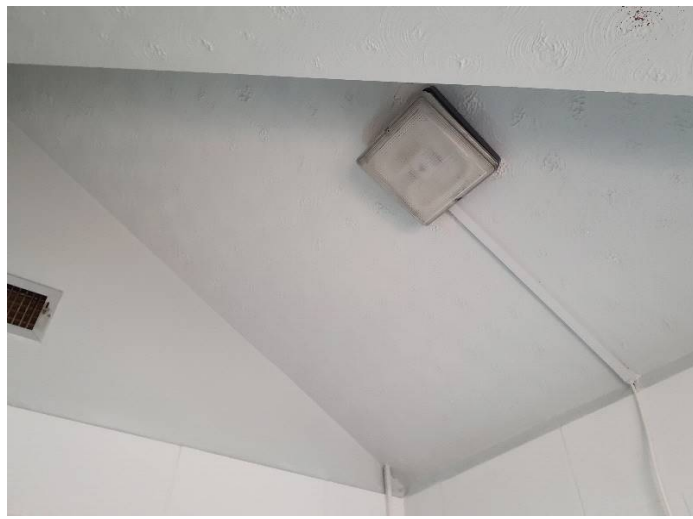
Location:	06 Accessible WC	Block:	Public toilet	Floor Level: Ground Floor
Sample No.:	As NS000202	Portal Ref No.:	21

Item:	Textured coating to plasterboard ceiling			
Asbestos Content:		Result Based on:		
No Asbestos Detected		Strongly presumed		
Sample Analysed By:	Not applicable	Extent:	4 m²	
Comments:
