Congregationalist Cemetery, Ponsharden

Proforma Condition and Repairs Schedule

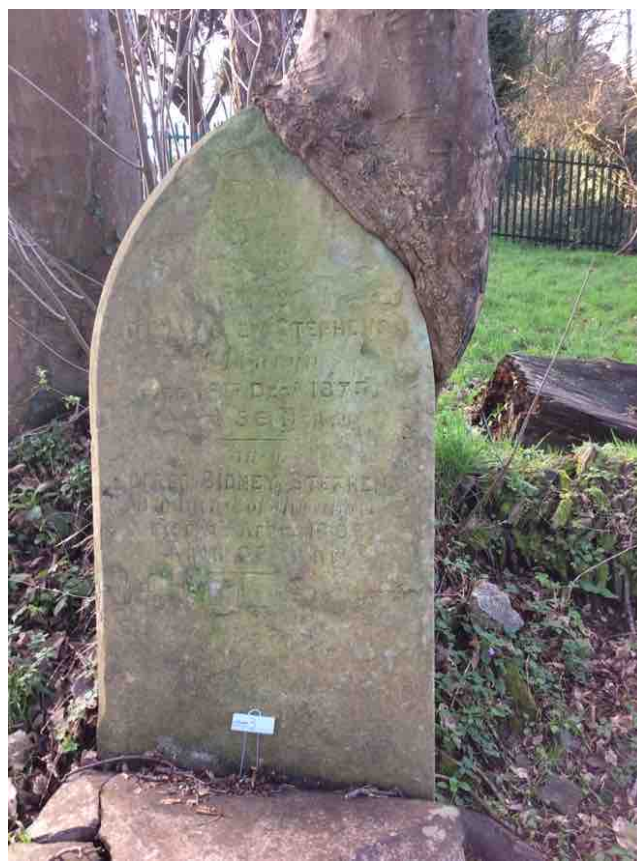
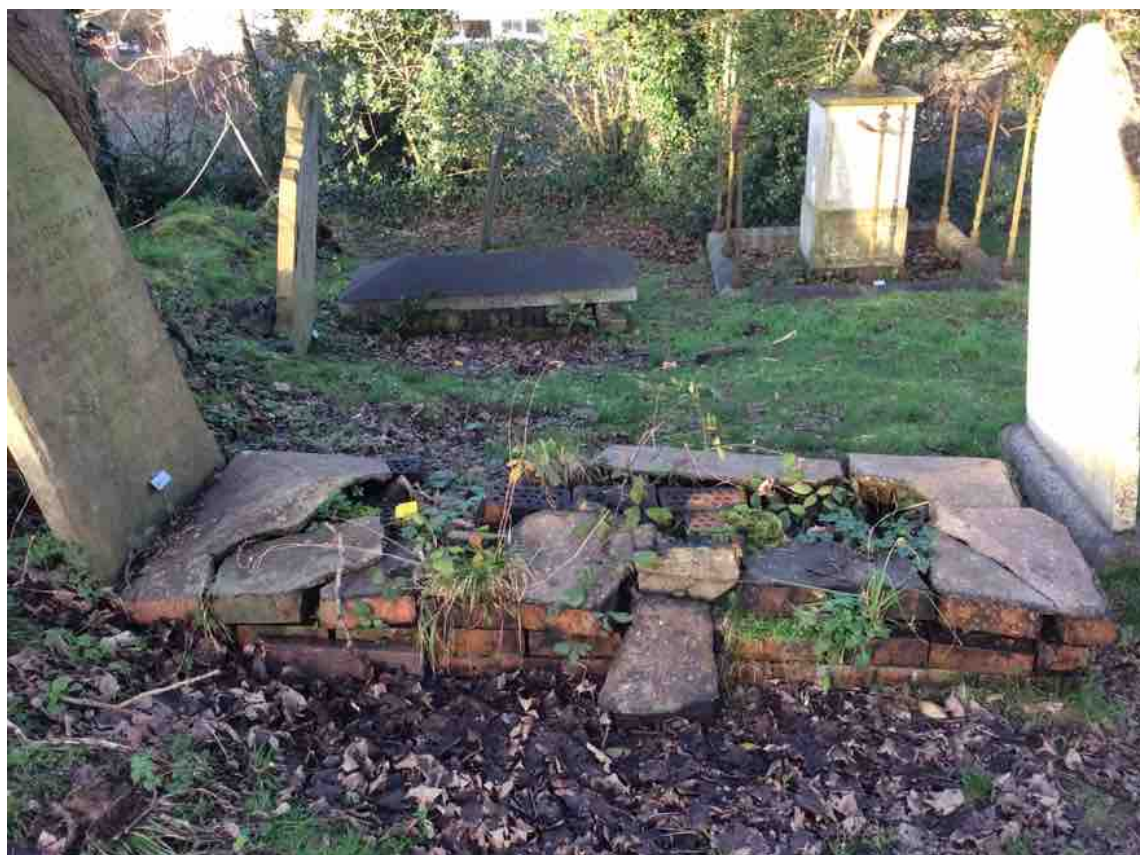
Tree growing into gravestone. Grave coping extensively smashed and damaged

Headstone supported by tree at present which adds to character, but may cause damage in future

Headstone embedded in tree (CT10), leave in situ, and monitor regularly. Clean off organic growth and dirt. Salvage and discard broken elements of capping, and salvage loose bricks for re-use. Rebuild 4 courses of brickwork in stretcher bond. Form core of new hipped capping with salvaged bricks and rubble stone bedded in mortar and finish with minimum 25mm thick 3 coat lime render to match original profile.

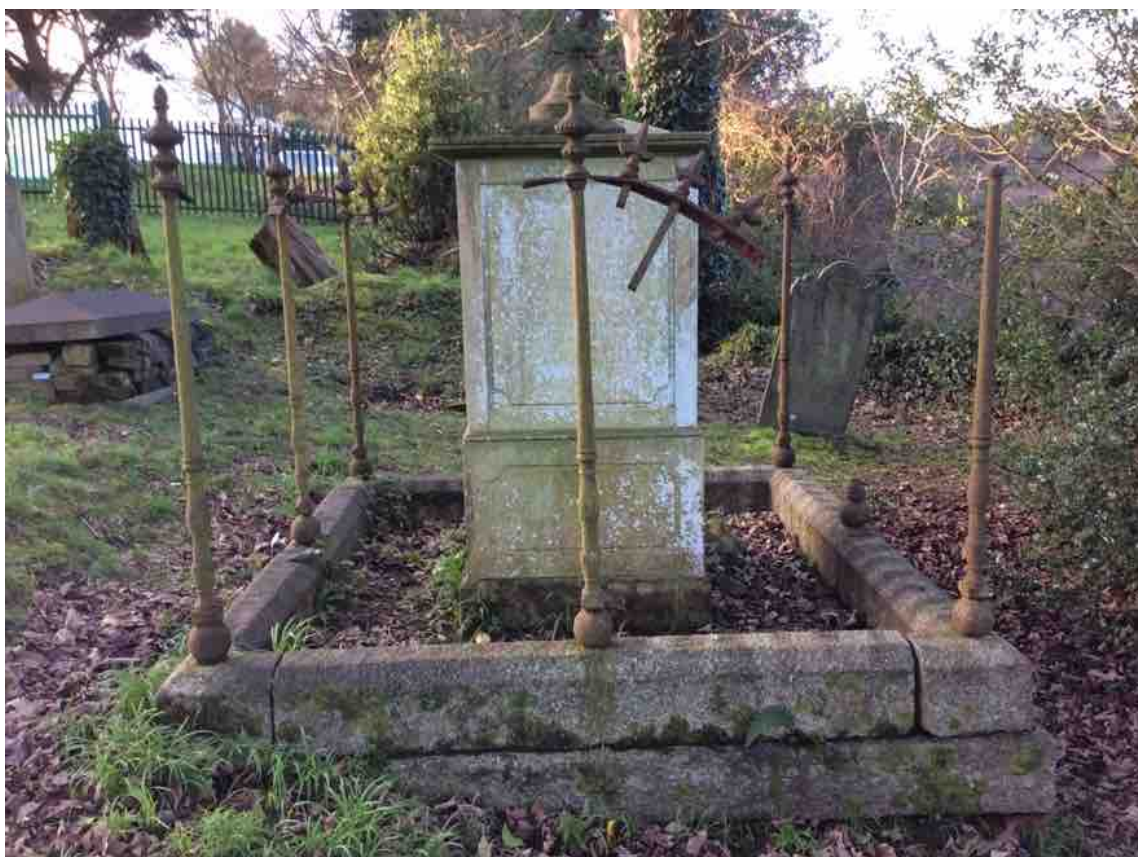
All sections slightly misaligned, cement infill cracked and missing in places. Base stones misaligned, most of railings missing

Part of urn lying on ground, misaligned masonry, particularly lid and kerbs, concrete slab cracked with holes

Parts of railings missing, remaining parts broken off. Leaded into plinth sockets, no spalling

Some further damage to railings since 2012 survey. Kelland comments that it was once topped by an urn - bits of which are around the site - this could be a future project to reinstate, but is not proposed at this stage

Clean stonework, realign kerb stones and repoint, reset displaced plinth sections and repoint joints. Round off sharp edges of broken balusters and horizontal bars. Clean off rust and redecorate. Repair cracked concrete slab and infill holes using matching pebbles. Refer to drawing.

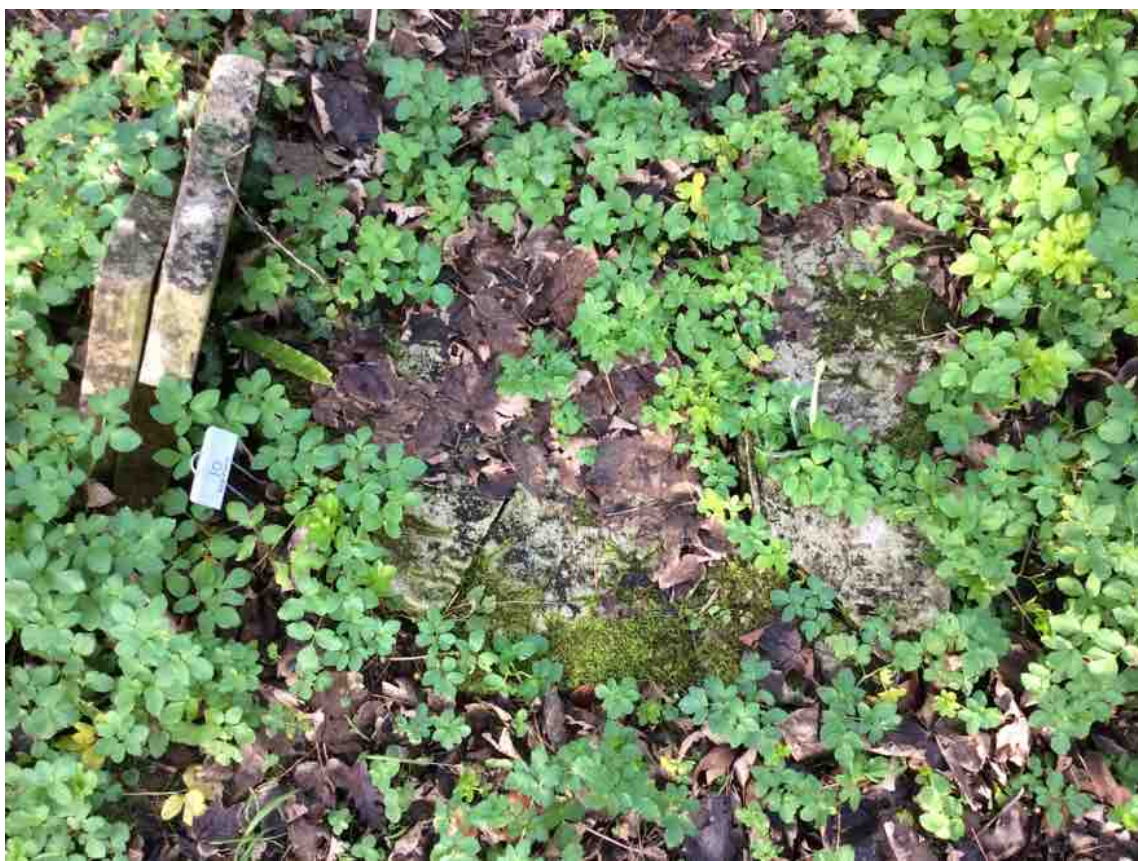
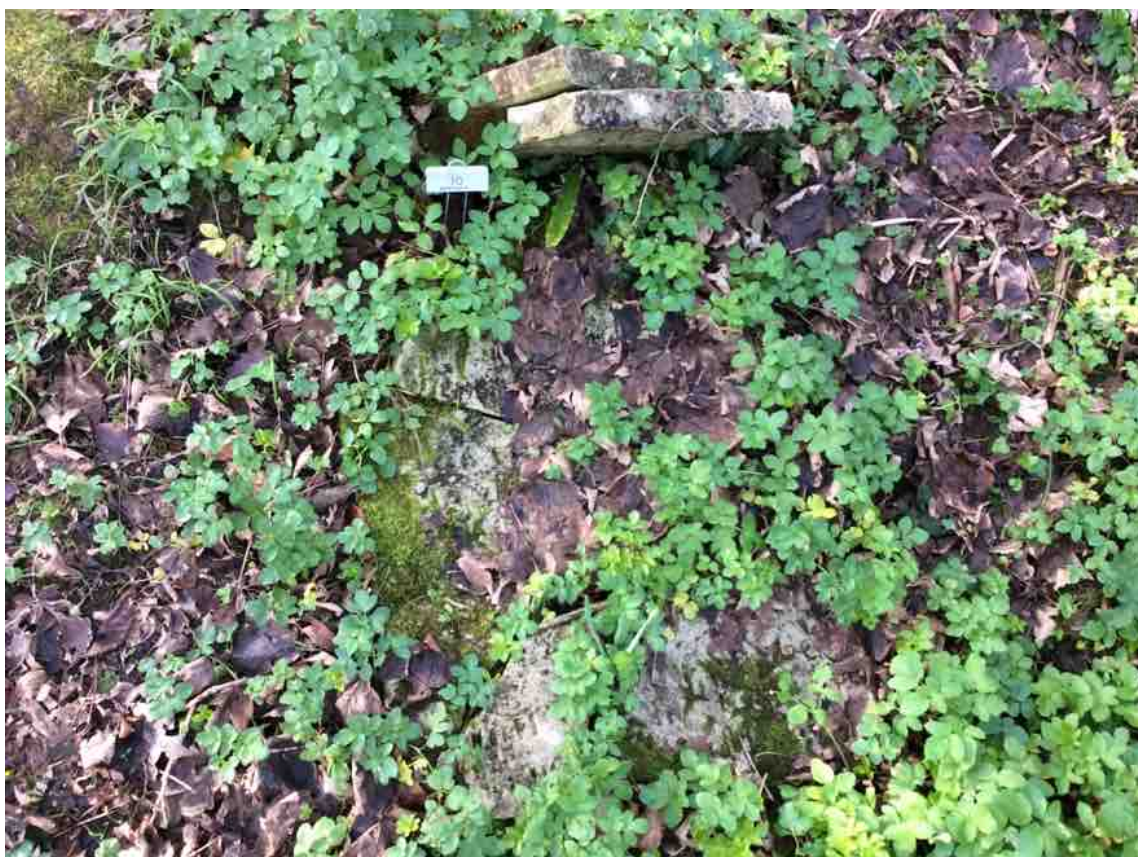
Very damaged, most of marker missing. No works possible unless pieces found

Excavate broken pieces from the ground (approximately 7 including stub in ground), and piece together on new limecrete bed.

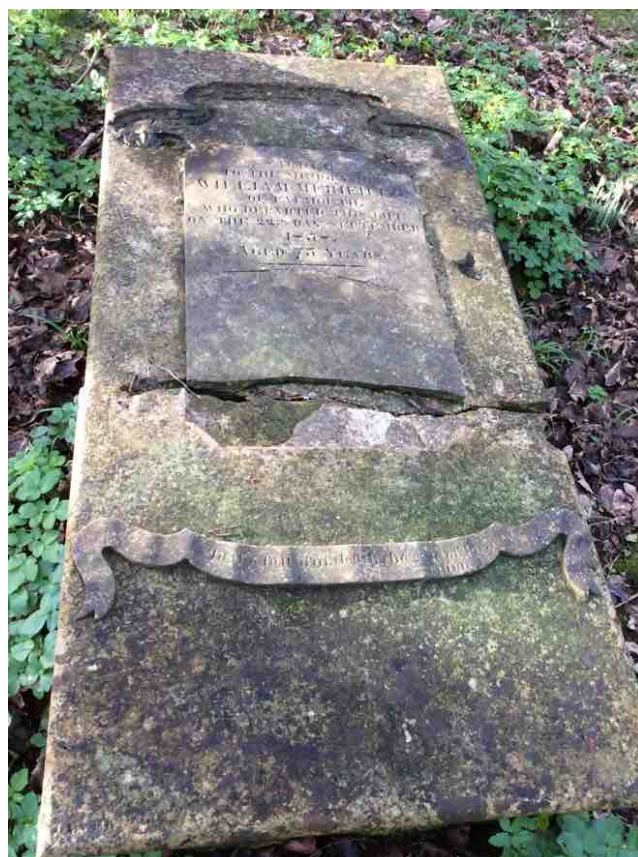
Lid broken, side panels (some broken) laid inside, north side base stones broken and misaligned

High risk of further damage

Remove lid, remove iron cramps and disassemble side panels. Off slate slab base, construct core of honeycomb brickwork just higher than side panels. Reassemble 3 broken side panels (2 in 3 pieces, 1 in 4 pieces) with stainless steel dowels or cramps. Cramp side panels to block work core with stainless steel cramps, and point joints and broken pieces with mortar. Reassemble broken lid with stainless steel dowels or cramps. Bed lid onto core, point lid/side panel joints and joints between broken sections of lid with mortar. Clean.

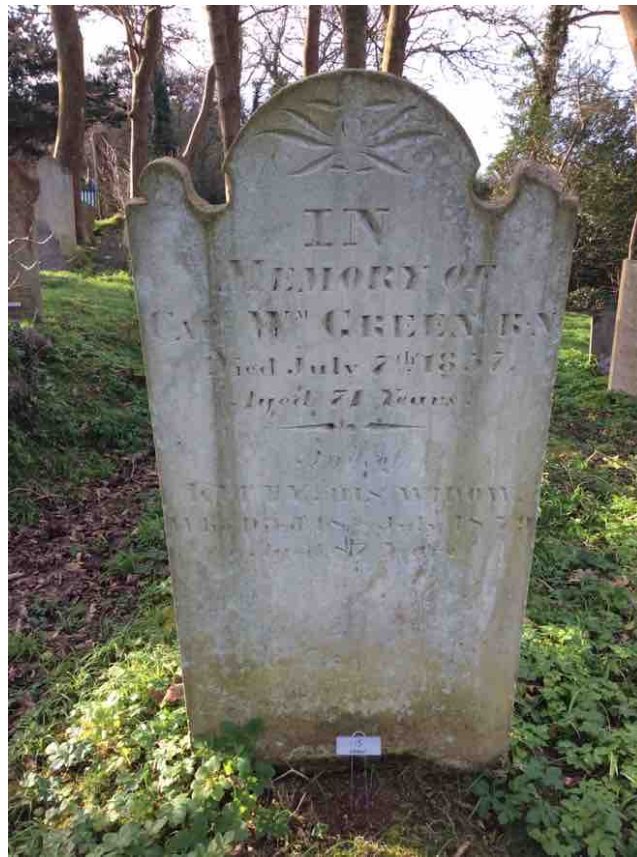
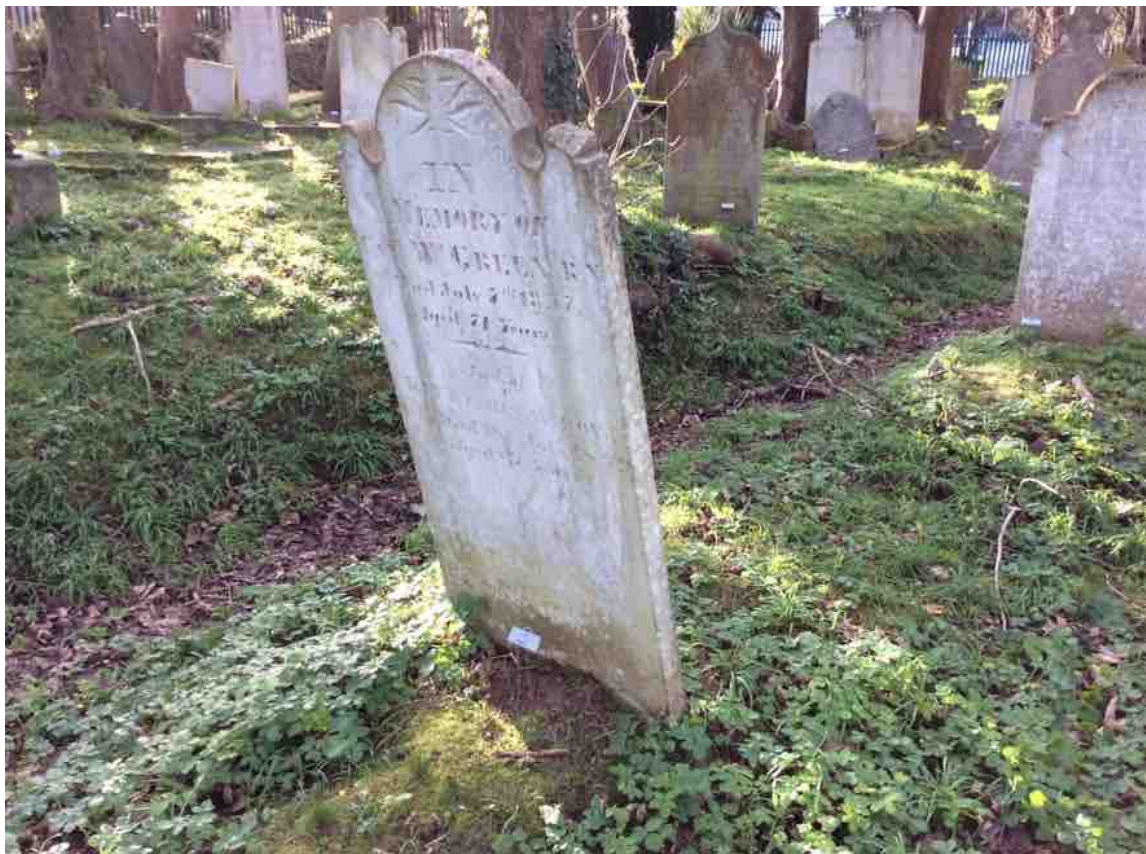
Slightly leading headstone, seems stable

Clean off organic growth and dirt. Undertake minor mortar/grouting repairs to eroded cavity on top

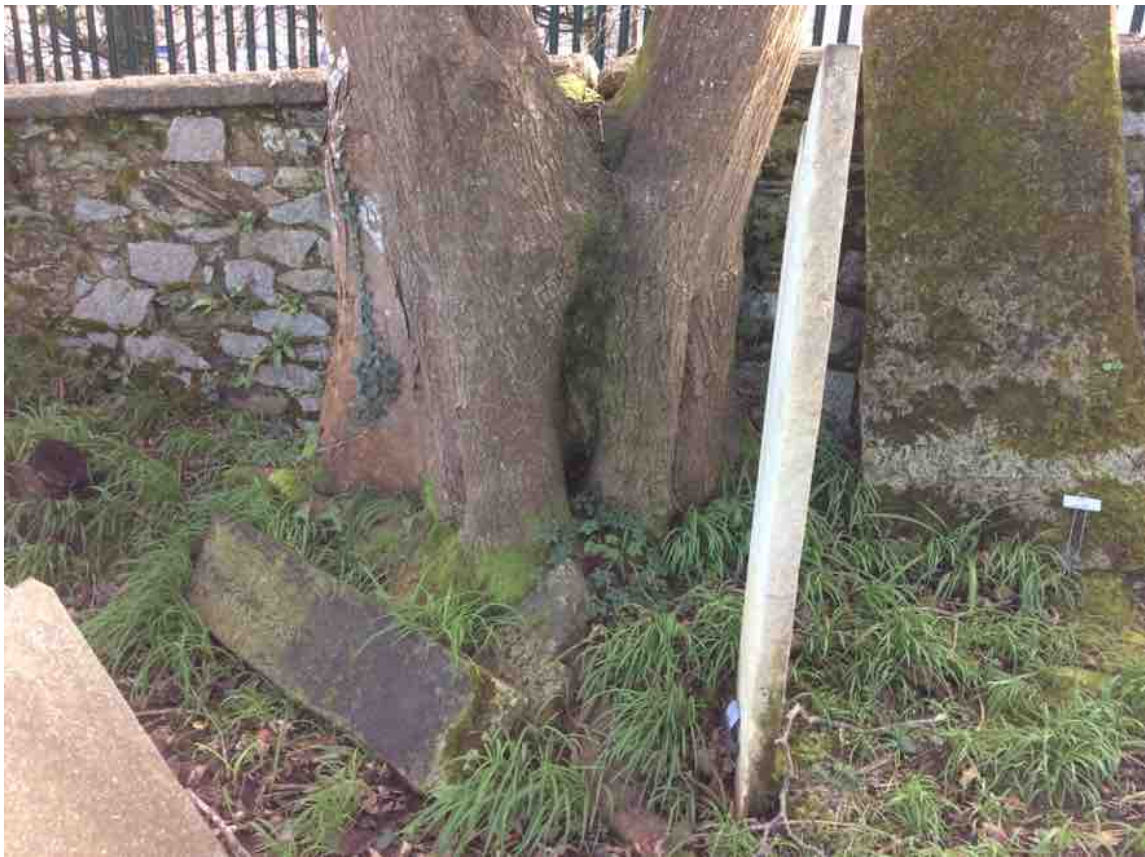
Vertical split caused by tree root

High risk of further damage/loss. Kelland report states current upright section is over a tree root and cannot be reassembled upright due to this

Trees CT2 and CT3 to be monolithed under separate enabling contract. Remove upright section and remove section of tree root to allow for re-erection. Pin 3 pieces together with stainless steel dowels and pin to 25mm thick slate backing. Make good joints with mortar. Clean off organic growth and dirt, and re-erect at the location of the existing base.

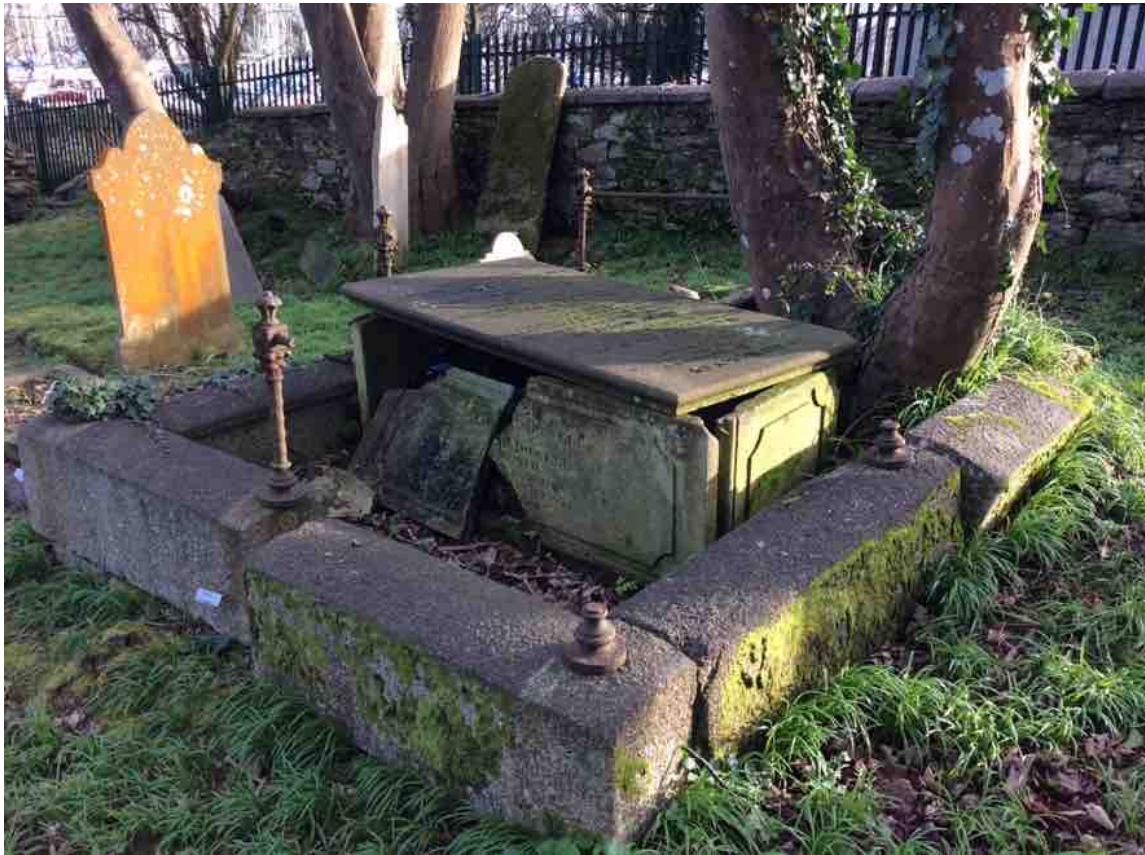
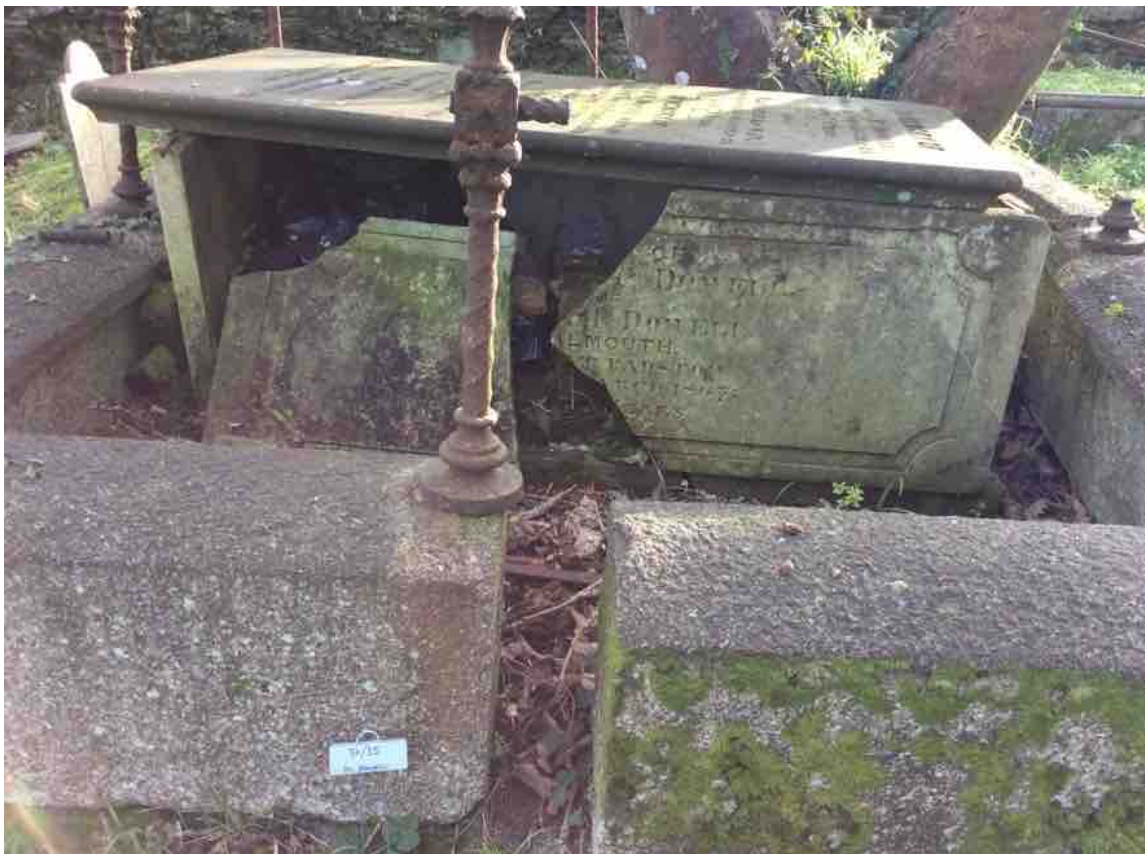
Side panel fixings corroding, most of main balusters missing or broken, all railings missing

Tomb vandalised and extensively damaged, further damage since 2012 survey (broken side to chest tomb) ongoing damage by tree. High risk of further damage

Tree CT18 to be felled under separate enabling contract. Remove roots disrupting monument. Salvage parts of probable second monument stored within tomb and enclosed by tree roots, and set aside for possible re-use. Clean stonework. Remove lid and build up core off base slabs with honeycomb brickwork slightly higher than side panels. Pin or cramp broken side panel (in 5 fragments) together with stainless steel dowels or cramps, and cramp side panels to core with stainless steel fixings. Point joints. Rebed lid. De-rust and decorate surviving ironwork. Re-bed kerbs. Remove organic material within

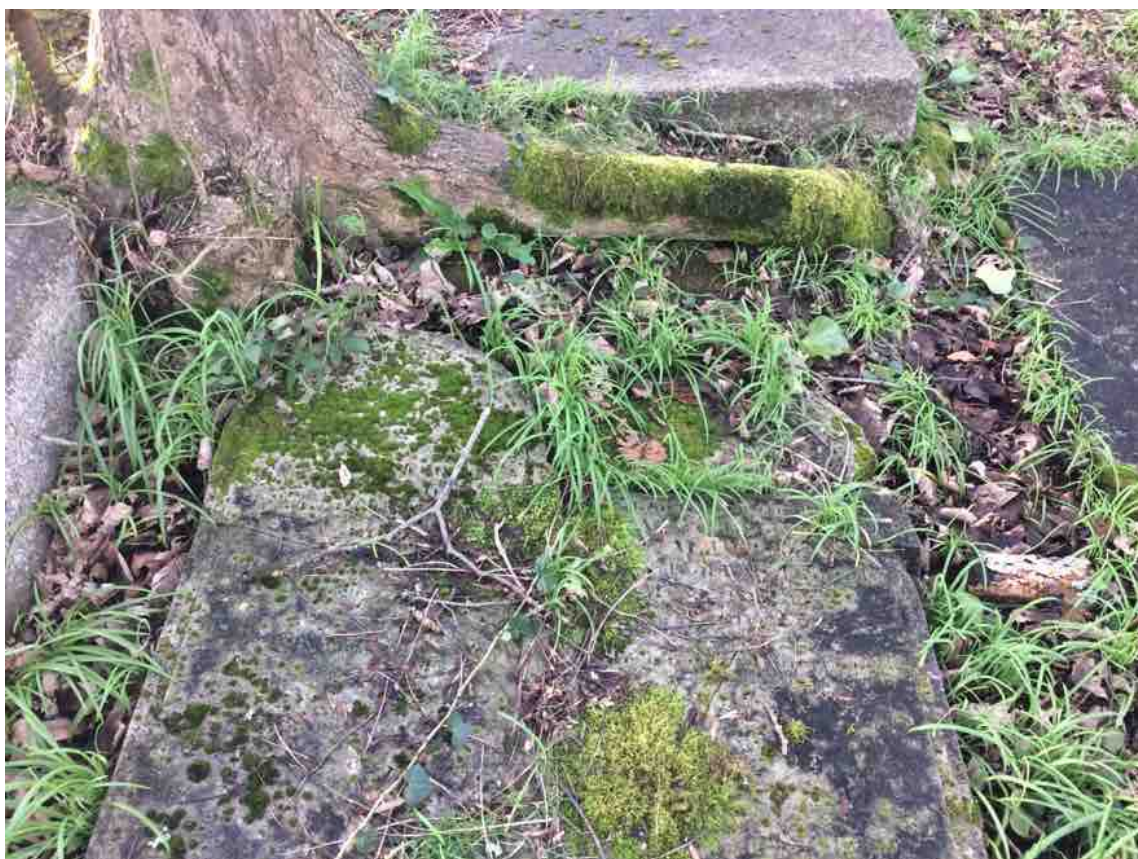
Both headstones cracked and broken in several places

Two headstones same size in dimensions. Both lying down, cracked and broken in several places. High risk of further damage. Granite kerb around graves.

Clean off organic growth and dirt. Pin broken sections together with stainless steel dowels, and pin to 25mm thick slate backing. One headstone is in 3 pieces, the other is in 5 pieces. Make good joints with mortar. Investigate within kerbs for evidence of rendered grave capping and chippings. Allow to re-erect in original locations, pinned to bases with stainless steel dowels. If this proves impractical, pin or cramp sections together and lay back down on limecrete bed at a slope, but slightly relocated to avoid tree root.

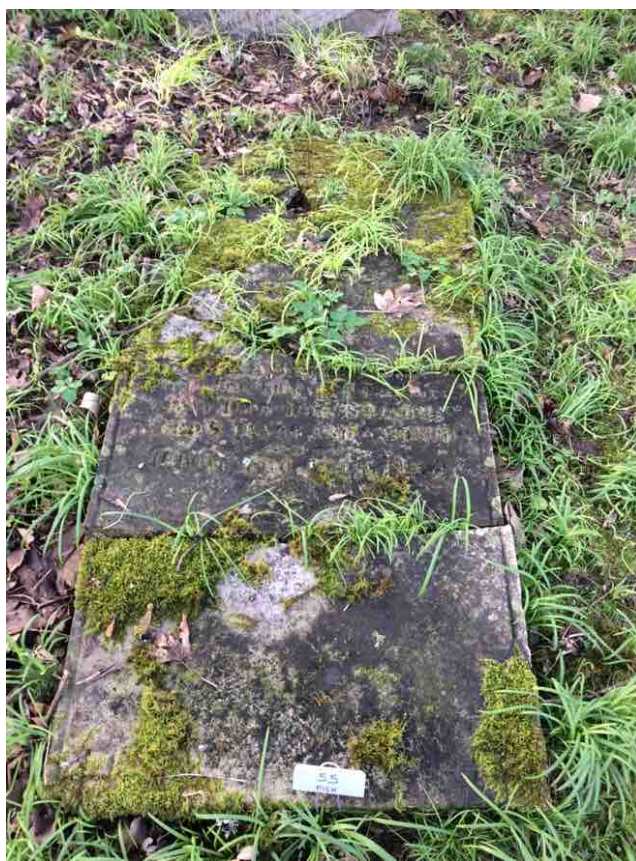
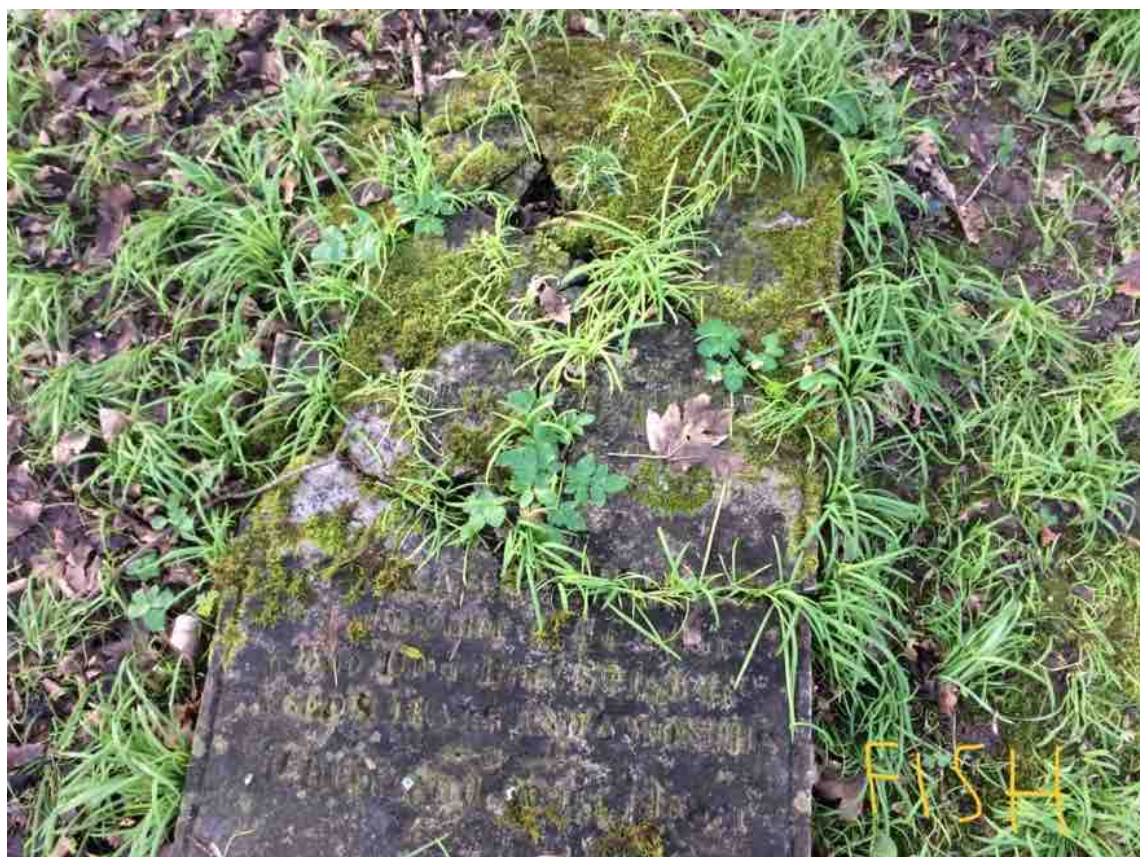
Broken into multiple small pieces

High risk of further damage and loss. Original site of grave unknown

Remove broken pieces from ground. Piece together on new limecrete bed (approximately 27 pieces) laid to slope and make good voids and joints with mortar. Clean off organic growth and dirt following re-assembly.

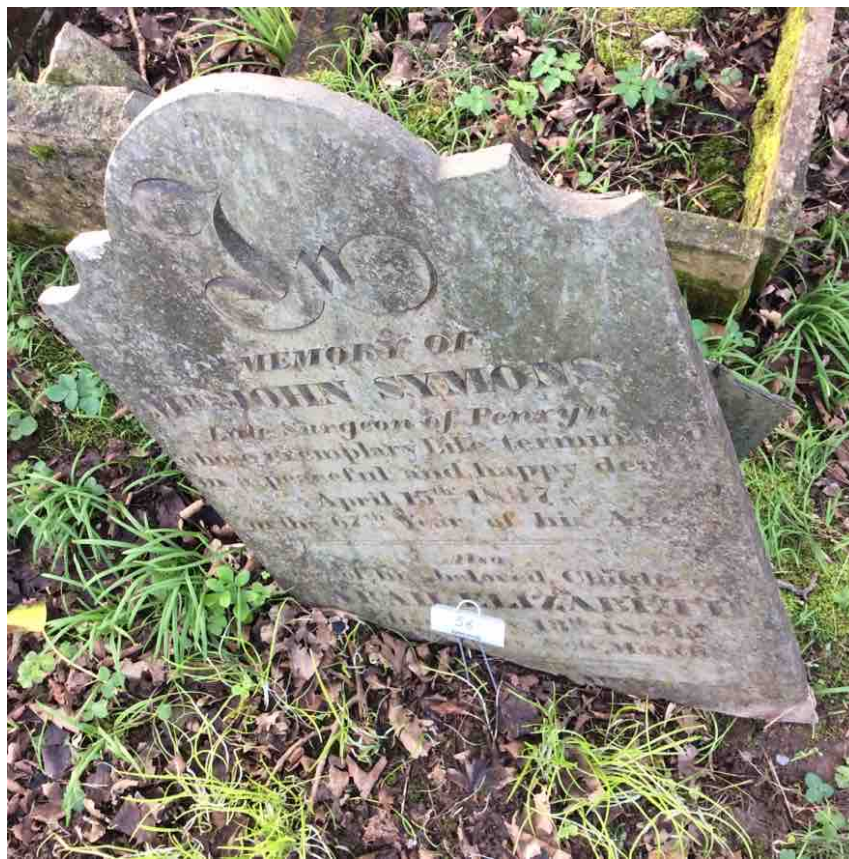
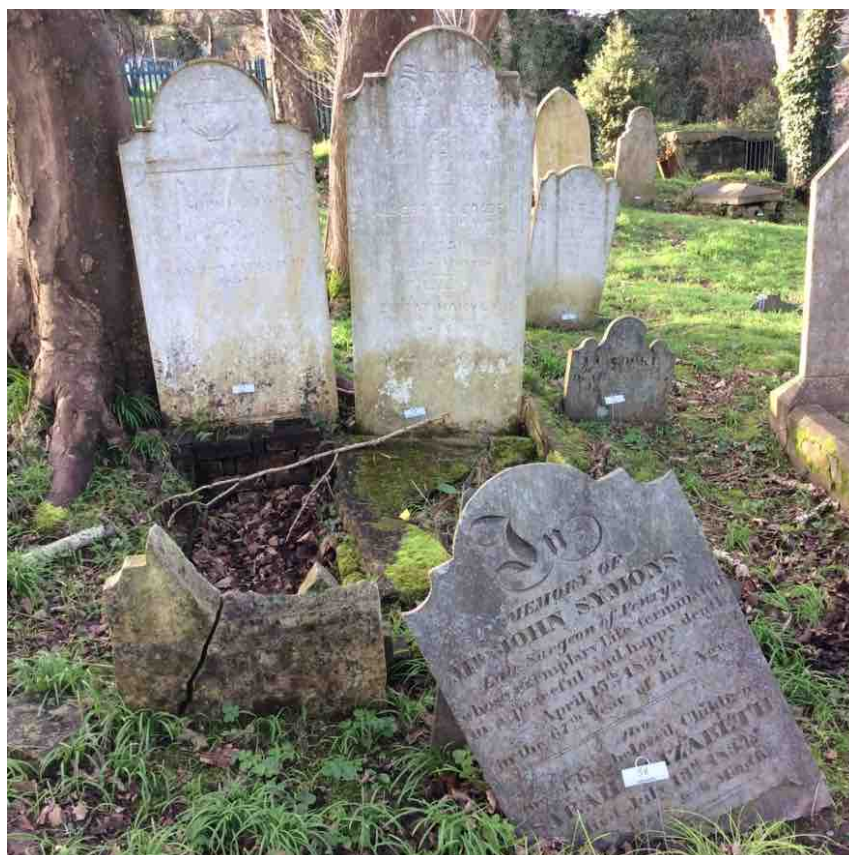
Broken, top half leaning against bottom section, which is still upright in the ground

Stone broken in half, top half leaning against bottom piece. High risk of further damage

Clean off organic growth and dirt. Excavate and remove base section. Pin broken sections to 25mm thick slate backing. Make good joints with mortar. Re-erect at the location of the existing base.

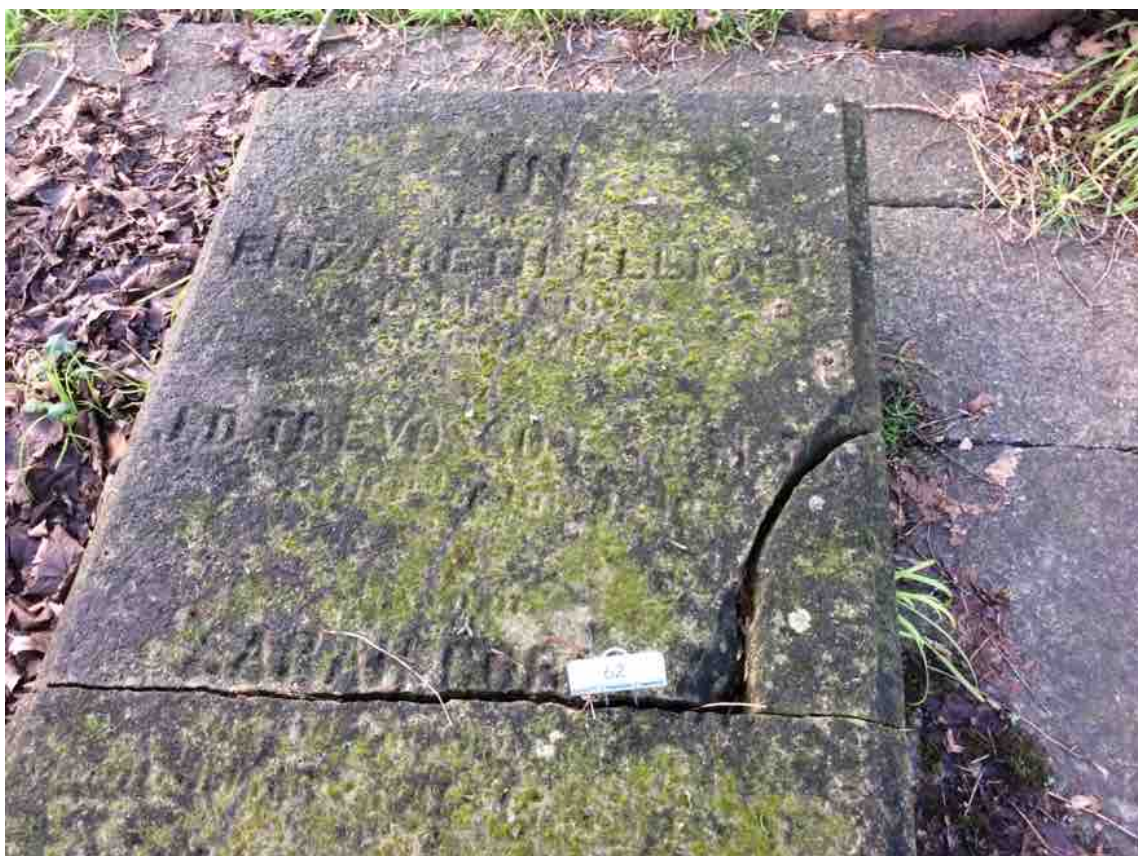
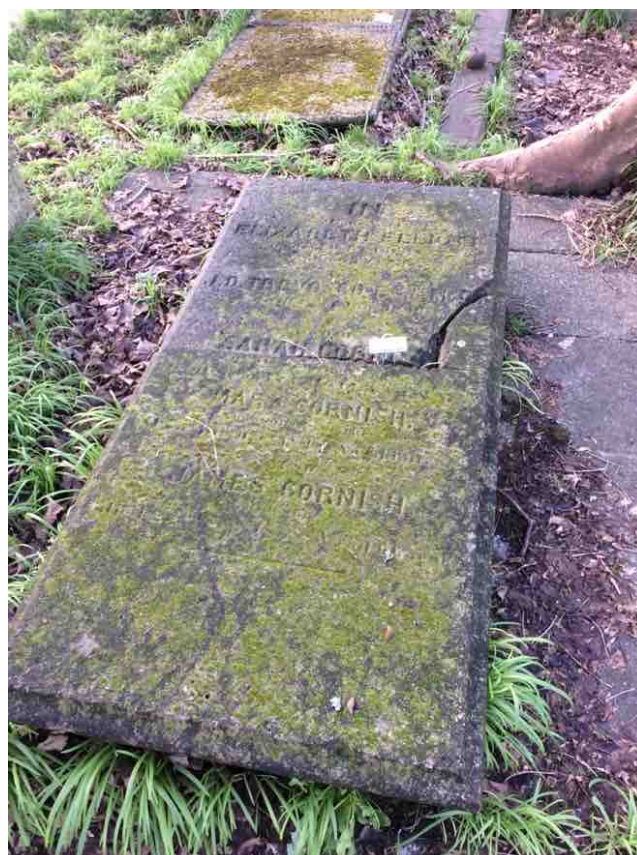
Ledger slab is broken into 3 pieces

Broken ledger slab, cracked side supports
