# Refurbishment Survey

Dales Countryside Museum Station Yard Burtersett Rd  
Hawes  
DL8 3NT

Name and address of site:	Dales Countryside Museum Station Yard Burtersett Rd Hawes , DL8 3NT		
Name and address of client:	Day Cummins Limited,Unit 4a, Lakeland Business Park, Lamplugh Rd, Cockermouth, CA13 0QT		
Client contact:	Peter Bromiley		
Type of survey:	Refurbishment Survey		
Date of survey:	27 Nov 2018		
Project Number:	J006382		
Lead surveyor[s]:	Wayne Jones	Signature:

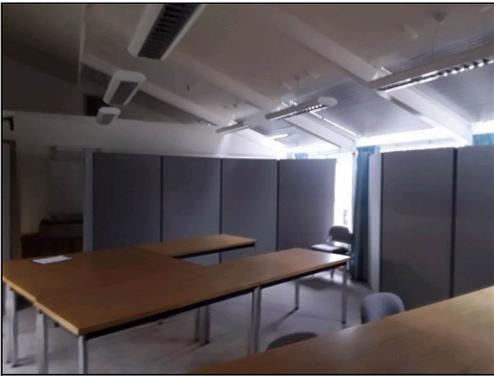
<b>Survey Date:</b>	<b>Lead Surveyor</b>	<b>Survey Type</b>	<b>Floor</b>	<b>Analysis</b>
	27 Nov 2018 to 29 Nov 2018	Wayne Jones	Refurbishment Survey	1st Floor	N/A
	<b>Building</b>	<b>Room</b>	<b>Item</b>	<b>Quantity</b>	
	Purpose Built Museum	Education Room 2 & Store - 109	No asbestos bearing materials were identified at the time of survey	N/A	
	<b>Sample No (S,SP,P,As)</b>	<b>Product Type</b>	<b>Surface Treatment</b>	<b>Condition</b>	<b>Accessibility</b>
	N/A	N/A	N/A	N/A	N/A
	<b>Material Risk Score</b>				
N/A					
<b>Recommended action</b>	No futher action required				
<b>Surveyor comments</b>	N/A

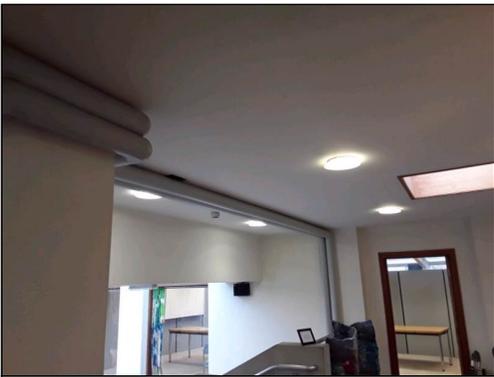
<b>Survey Date:</b>	<b>Lead Surveyor</b>	<b>Survey Type</b>	<b>Floor</b>	<b>Analysis</b>
	27 Nov 2018 to 29 Nov 2018	Wayne Jones	Refurbishment Survey	1st Floor	N/A
	<b>Building</b>	<b>Room</b>	<b>Item</b>	<b>Quantity</b>	
	Purpose Built Museum	Landing - 110	No asbestos bearing materials were identified at the time of survey	N/A	
	<b>Sample No (S,SP,P,As)</b>	<b>Product Type</b>	<b>Surface Treatment</b>	<b>Condition</b>	<b>Accessibility</b>
	N/A	N/A	N/A	N/A	N/A
	<b>Material Risk Score</b>				
N/A					
<b>Recommended action</b>	No futher action required				
<b>Surveyor comments</b>	N/A

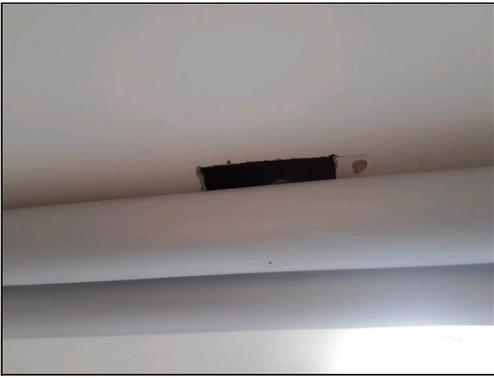
<b>Survey Date:</b>	<b>Lead Surveyor</b>	<b>Survey Type</b>	<b>Floor</b>	<b>Analysis</b>
	27 Nov 2018 to 29 Nov 2018	Wayne Jones	Refurbishment Survey	1st Floor	N/A
	<b>Building</b>	<b>Room</b>	<b>Item</b>	<b>Quantity</b>	
	Purpose Built Museum	Landing - 110	Timber roof above plasterboard ceiling	N/A	
	<b>Sample No (S,SP,P,As)</b>	<b>Product Type</b>	<b>Surface Treatment</b>	<b>Condition</b>	<b>Accessibility</b>
	N/A	N/A	N/A	N/A	N/A
	<b>Material Risk Score</b>				
N/A					
<b>Recommended action</b>	No further action required				
<b>Surveyor comments</b>	N/A

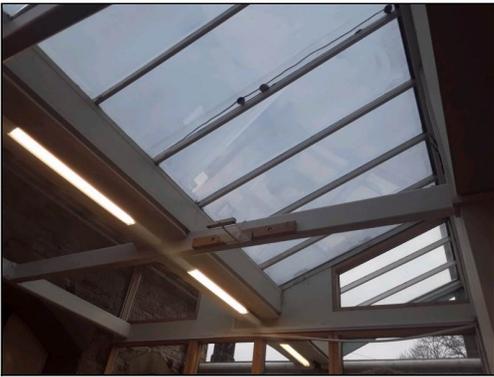
<b>Survey Date:</b>	<b>Lead Surveyor</b>	<b>Survey Type</b>	<b>Floor</b>	<b>Analysis</b>
	27 Nov 2018 to 29 Nov 2018	Wayne Jones	Refurbishment Survey	Ground Floor	N/A
	<b>Building</b>	<b>Room</b>	<b>Item</b>	<b>Quantity</b>	
	Purpose Built Museum	Entrance hall and glass atrium - G01	Glass Atrium	N/A	
	<b>Sample No (S,SP,P,As)</b>	<b>Product Type</b>	<b>Surface Treatment</b>	<b>Condition</b>	<b>Accessibility</b>
	N/A	N/A	N/A	N/A	N/A
	<b>Material Risk Score</b>				
N/A					
<b>Recommended action</b>	No further action required				
<b>Surveyor comments</b>	N/A

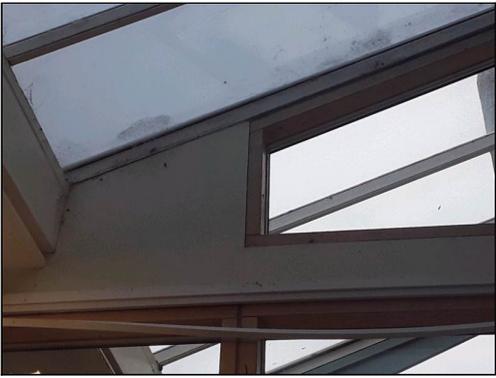
<b>Survey Date:</b>	<b>Lead Surveyor</b>	<b>Survey Type</b>	<b>Floor</b>	<b>Analysis</b>
	27 Nov 2018 to 29 Nov 2018	Wayne Jones	Refurbishment Survey	Ground Floor	N/A
	<b>Building</b>	<b>Room</b>	<b>Item</b>	<b>Quantity</b>	
	Purpose Built Museum	Entrance hall and glass atritium - G01	Plasterboard panels above entrance doorway	N/A	
	<b>Sample No (S,SP,P,As)</b>	<b>Product Type</b>	<b>Surface Treatment</b>	<b>Condition</b>	<b>Accessibility</b>
	N/A	N/A	N/A	N/A	N/A
	<b>Material Risk Score</b>				
N/A					
<b>Recommended action</b>	No futher action required				
<b>Surveyor comments</b>	N/A

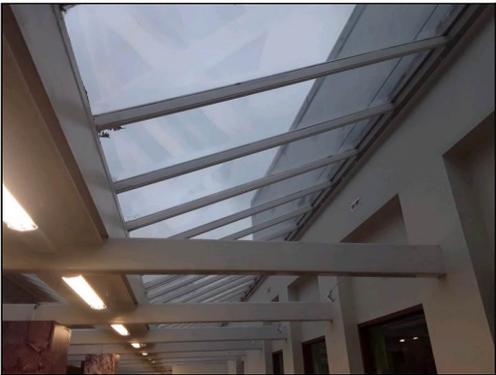
<b>Survey Date:</b>	<b>Lead Surveyor</b>	<b>Survey Type</b>	<b>Floor</b>	<b>Analysis</b>
	27 Nov 2018 to 29 Nov 2018	Wayne Jones	Refurbishment Survey	Ground Floor	N/A
	<b>Building</b>	<b>Room</b>	<b>Item</b>	<b>Quantity</b>	
	Purpose Built Museum	Entrance hall and glass atritium - G01	No asbestos bearing materials were identified at the time of survey	N/A	
	<b>Sample No (S,SP,P,As)</b>	<b>Product Type</b>	<b>Surface Treatment</b>	<b>Condition</b>	<b>Accessibility</b>
	N/A	N/A	N/A	N/A	N/A
	<b>Material Risk Score</b>				
N/A					
<b>Recommended action</b>	No futher action required				
<b>Surveyor comments</b>	N/A

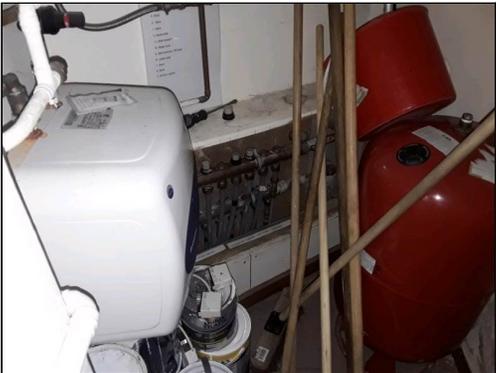
<b>Survey Date:</b>	<b>Lead Surveyor</b>	<b>Survey Type</b>	<b>Floor</b>	<b>Analysis</b>
	27 Nov 2018 to 29 Nov 2018	Wayne Jones	Refurbishment Survey	Ground Floor	N/A
	<b>Building</b>	<b>Room</b>	<b>Item</b>	<b>Quantity</b>	
	Purpose Built Museum	Cleaners Cupboard - G02	Refurb location: timber boxings revealed no suspect materials	N/A	
	<b>Sample No (S,SP,P,As)</b>	<b>Product Type</b>	<b>Surface Treatment</b>	<b>Condition</b>	<b>Accessibility</b>
	N/A	N/A	N/A	N/A	N/A
	<b>Material Risk Score</b>				
N/A					
<b>Recommended action</b>	No futher action required				
<b>Surveyor comments</b>	N/A

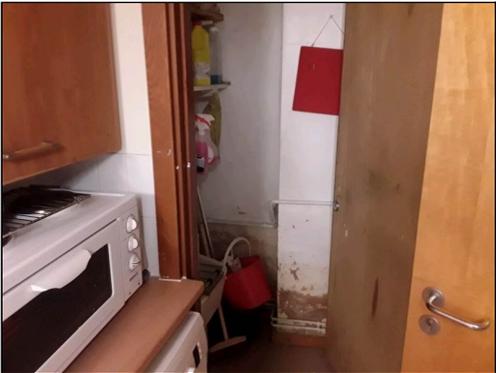
<b>Survey Date:</b>	<b>Lead Surveyor</b>	<b>Survey Type</b>	<b>Floor</b>	<b>Analysis</b>
	27 Nov 2018 to 29 Nov 2018	Wayne Jones	Refurbishment Survey	Ground Floor	N/A
	<b>Building</b>	<b>Room</b>	<b>Item</b>	<b>Quantity</b>	
	Purpose Built Museum	Cleaners Cupboard - G02	No asbestos bearing materials were identified at the time of survey	N/A	
	<b>Sample No (S,SP,P,As)</b>	<b>Product Type</b>	<b>Surface Treatment</b>	<b>Condition</b>	<b>Accessibility</b>
	N/A	N/A	N/A	N/A	N/A
	<b>Material Risk Score</b>				
N/A					
<b>Recommended action</b>	No futher action required				
<b>Surveyor comments</b>	N/A

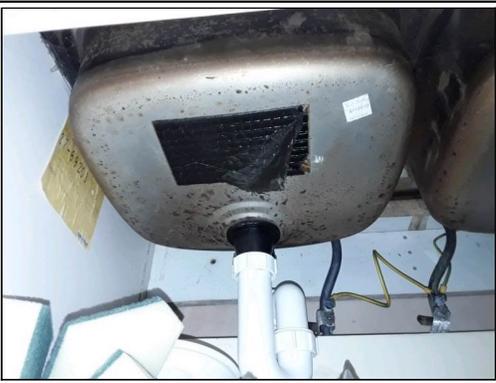
<b>Survey Date:</b>	<b>Lead Surveyor</b>	<b>Survey Type</b>	<b>Floor</b>	<b>Analysis</b>
	27 Nov 2018 to 29 Nov 2018	Wayne Jones	Refurbishment Survey	Ground Floor	No Asbestos Detected (0)
	<b>Building</b>	<b>Room</b>	<b>Item</b>	<b>Quantity</b>	
	Purpose Built Museum	Kitchen - G03	Sink pad	2no.	
	<b>Sample No (S,SP,P,As)</b>	<b>Product Type</b>	<b>Surface Treatment</b>	<b>Condition</b>	<b>Accessibility</b>
	S XA000767	Reinforced Composite (1)	N/A	N/A	N/A
	<b>Material Risk Score</b>				
N/A					
<b>Recommended action</b>	No futher action required				
<b>Surveyor comments</b>	N/A

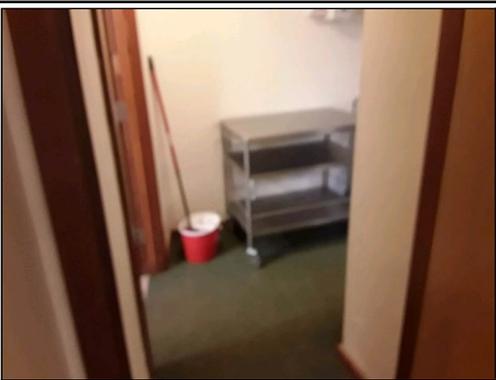
<b>Survey Date:</b>	<b>Lead Surveyor</b>	<b>Survey Type</b>	<b>Floor</b>	<b>Analysis</b>
	27 Nov 2018 to 29 Nov 2018	Wayne Jones	Refurbishment Survey	Ground Floor	N/A
	<b>Building</b>	<b>Room</b>	<b>Item</b>	<b>Quantity</b>	
	Purpose Built Museum	Lobby to Kitchen - G04	No asbestos bearing materials were identified at the time of survey	N/A	
	<b>Sample No (S,SP,P,As)</b>	<b>Product Type</b>	<b>Surface Treatment</b>	<b>Condition</b>	<b>Accessibility</b>
	N/A	N/A	N/A	N/A	N/A
	<b>Material Risk Score</b>				
N/A					
<b>Recommended action</b>	No futher action required				
<b>Surveyor comments</b>	N/A

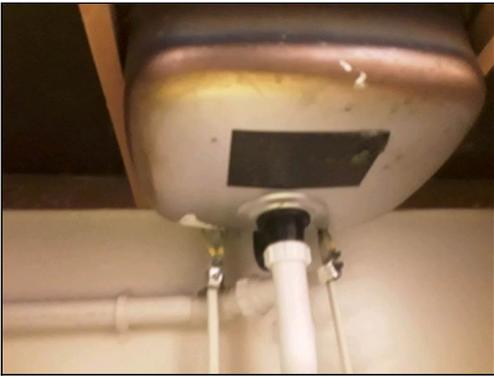
<b>Survey Date:</b>	<b>Lead Surveyor</b>	<b>Survey Type</b>	<b>Floor</b>	<b>Analysis</b>
	27 Nov 2018 to 29 Nov 2018	Wayne Jones	Refurbishment Survey	Ground Floor	
	<b>Building</b>	<b>Room</b>	<b>Item</b>	<b>Quantity</b>	
	Purpose Built Museum	Store/Staffroom - G05	Sink Pad	1no.	
	<b>Sample No (S,SP,P,As)</b>	<b>Product Type</b>	<b>Surface Treatment</b>	<b>Condition</b>	<b>Accessibility</b>
	S XA000768	Reinforced Composite (1)	N/A	N/A	N/A
	<b>Material Risk Score</b>				
N/A					
<b>Recommended action</b>	No further action required				
<b>Surveyor comments</b>	N/A

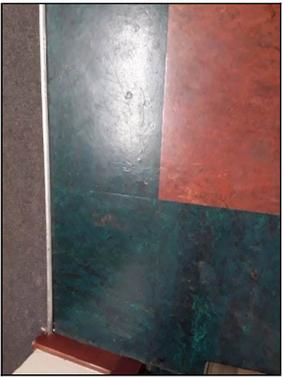
<b>Survey Date:</b>	<b>Lead Surveyor</b>	<b>Survey Type</b>	<b>Floor</b>	<b>Analysis</b>
	27 Nov 2018 to 29 Nov 2018	Wayne Jones	Refurbishment Survey	Ground Floor	
	<b>Building</b>	<b>Room</b>	<b>Item</b>	<b>Quantity</b>	
	Purpose Built Museum	Store/Staffroom - G05	Green and Red vinyl floor tiles	8m <sup>2</sup>	
	<b>Sample No (S,SP,P,As)</b>	<b>Product Type</b>	<b>Surface Treatment</b>	<b>Condition</b>	<b>Accessibility</b>
	S XA000769	Reinforced Composite (1)	N/A	N/A	N/A
	<b>Material Risk Score</b>				
N/A					
<b>Recommended action</b>	No further action required				
<b>Surveyor comments</b>	N/A

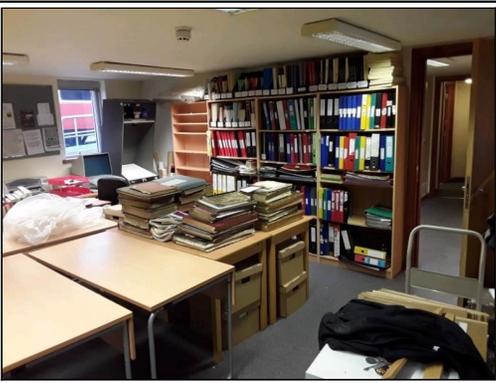
<b>Survey Date:</b>	<b>Lead Surveyor</b>	<b>Survey Type</b>	<b>Floor</b>	<b>Analysis</b>
	27 Nov 2018 to 29 Nov 2018	Wayne Jones	Refurbishment Survey	Ground Floor	N/A
	<b>Building</b>	<b>Room</b>	<b>Item</b>	<b>Quantity</b>	
	Purpose Built Museum	Education Room 1 - G06	No asbestos bearing materials were identified at the time of survey	N/A	
	<b>Sample No (S,SP,P,As)</b>	<b>Product Type</b>	<b>Surface Treatment</b>	<b>Condition</b>	<b>Accessibility</b>
	N/A	N/A	N/A	N/A	N/A
	<b>Material Risk Score</b>				
N/A					
<b>Recommended action</b>	No futher action required				
<b>Surveyor comments</b>	N/A

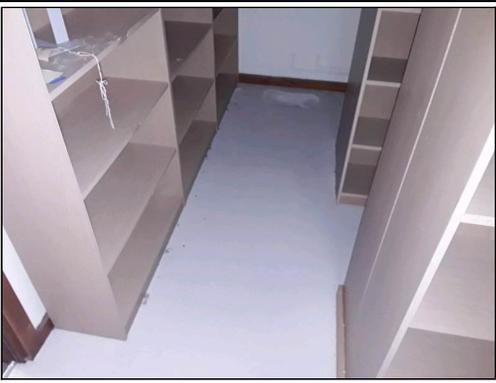
<b>Survey Date:</b>	<b>Lead Surveyor</b>	<b>Survey Type</b>	<b>Floor</b>	<b>Analysis</b>
	27 Nov 2018 to 29 Nov 2018	Wayne Jones	Refurbishment Survey	Ground Floor	N/A
	<b>Building</b>	<b>Room</b>	<b>Item</b>	<b>Quantity</b>	
	Purpose Built Museum	Store 1 - G07	No asbestos bearing materials were identified at the time of survey	N/A	
	<b>Sample No (S,SP,P,As)</b>	<b>Product Type</b>	<b>Surface Treatment</b>	<b>Condition</b>	<b>Accessibility</b>
	N/A	N/A	N/A	N/A	N/A
	<b>Material Risk Score</b>				
N/A					
<b>Recommended action</b>	No futher action required				
<b>Surveyor comments</b>	N/A

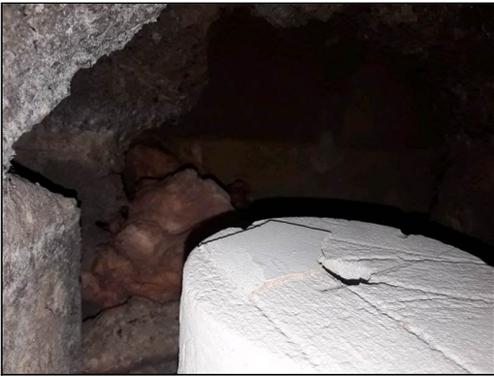
<b>Survey Date:</b>	<b>Lead Surveyor</b>	<b>Survey Type</b>	<b>Floor</b>	<b>Analysis</b>
	27 Nov 2018 to 29 Nov 2018	Wayne Jones	Refurbishment Survey	Ground Floor	N/A
	<b>Building</b>	<b>Room</b>	<b>Item</b>	<b>Quantity</b>	
	Purpose Built Museum	Store 1 - G07	MMMF insulation within external wall cavity	N/A	
	<b>Sample No (S,SP,P,As)</b>	<b>Product Type</b>	<b>Surface Treatment</b>	<b>Condition</b>	<b>Accessibility</b>
	N/A	N/A	N/A	N/A	N/A
	<b>Material Risk Score</b>				
N/A					
<b>Recommended action</b>	No further action required				
<b>Surveyor comments</b>	N/A

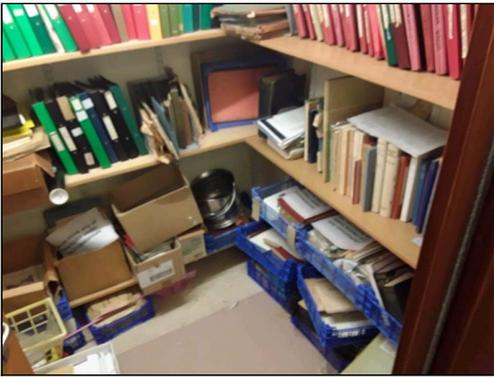
<b>Survey Date:</b>	<b>Lead Surveyor</b>	<b>Survey Type</b>	<b>Floor</b>	<b>Analysis</b>
	27 Nov 2018 to 29 Nov 2018	Wayne Jones	Refurbishment Survey	Ground Floor	N/A
	<b>Building</b>	<b>Room</b>	<b>Item</b>	<b>Quantity</b>	
	Purpose Built Museum	Store 2 - G08	No asbestos bearing materials were identified at the time of survey	N/A	
	<b>Sample No (S,SP,P,As)</b>	<b>Product Type</b>	<b>Surface Treatment</b>	<b>Condition</b>	<b>Accessibility</b>
	N/A	N/A	N/A	N/A	N/A
	<b>Material Risk Score</b>				
N/A					
<b>Recommended action</b>	No further action required				
<b>Surveyor comments</b>	N/A
