Basset Community Hub

Architectural Enabling Schedule of Works

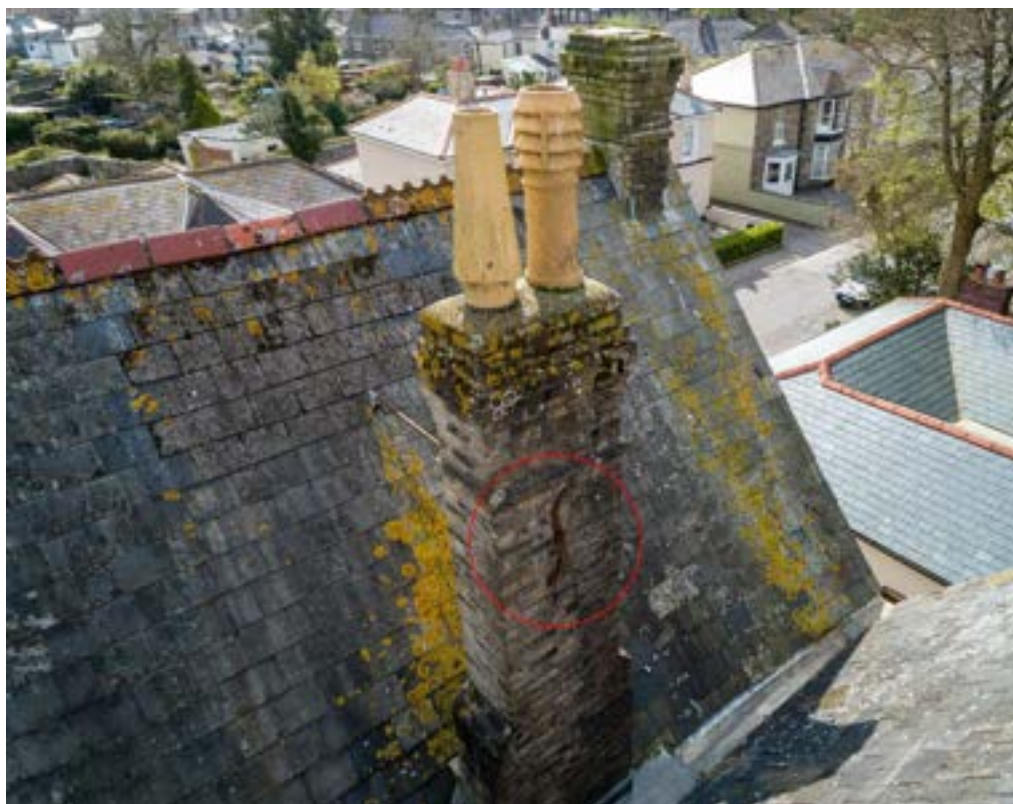
Chimney 4

Both flues require rain cowl inserts to prevent water ingress, and maintain ventilation, colour to match existing pots.

Extra over cost for re-pointing to exposed masonry to the stack, upon inspection of condition.

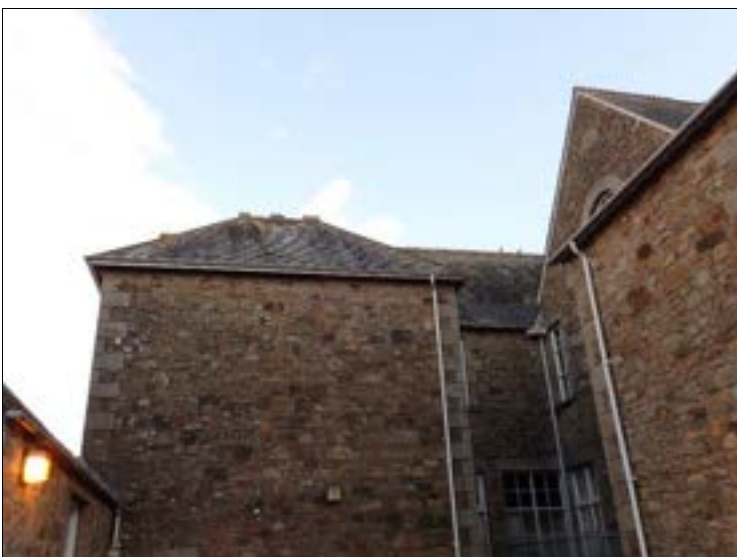
Photo Number	2	Sample Reference	S06
	Plan Ref	External		
	Location	Main Building		
	Position / Description	Asbestos Cement replacement roof tiles		
	Note / Comments	Manage and re-inspect or remove by an Unlicensed Asbestos Removal Contractor who has the appropriate insurance, training and following a safe system of work

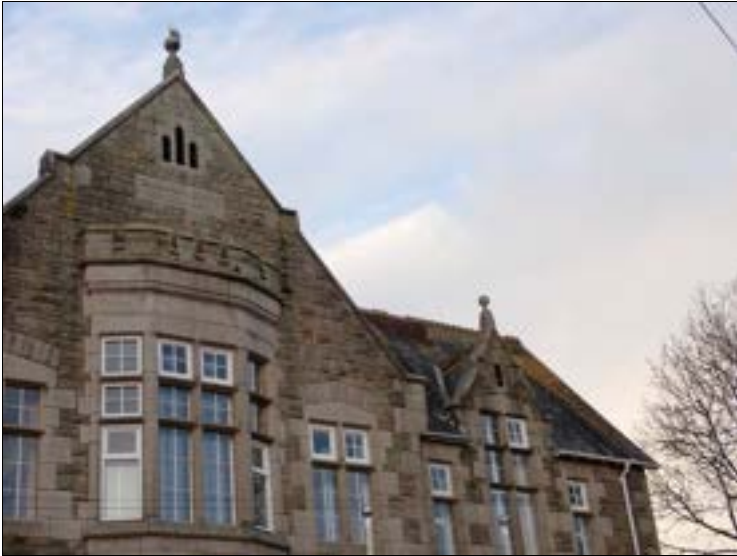
Photo Number	3	Sample Reference	S06
	Plan Ref	External		
	Location	Main Building		
	Position / Description	Asbestos Cement replacement roof tiles		
	Note / Comments	Manage and re-inspect or remove by an Unlicensed Asbestos Removal Contractor who has the appropriate insurance, training and following a safe system of work

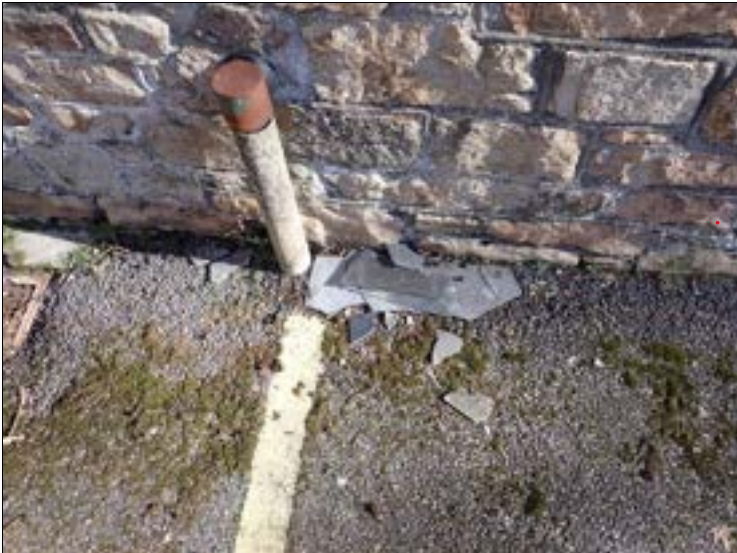
Photo Number	4	Sample Reference	S06
	Plan Ref	External		
	Location	Main Building		
	Position / Description	Asbestos Cement replacement roof tiles		
	Note / Comments	Manage and re-inspect or remove by an Unlicensed Asbestos Removal Contractor who has the appropriate insurance, training and following a safe system of work

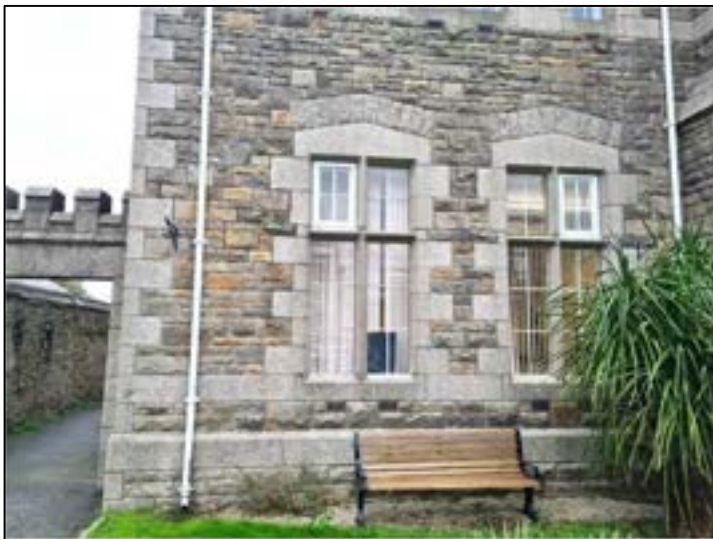
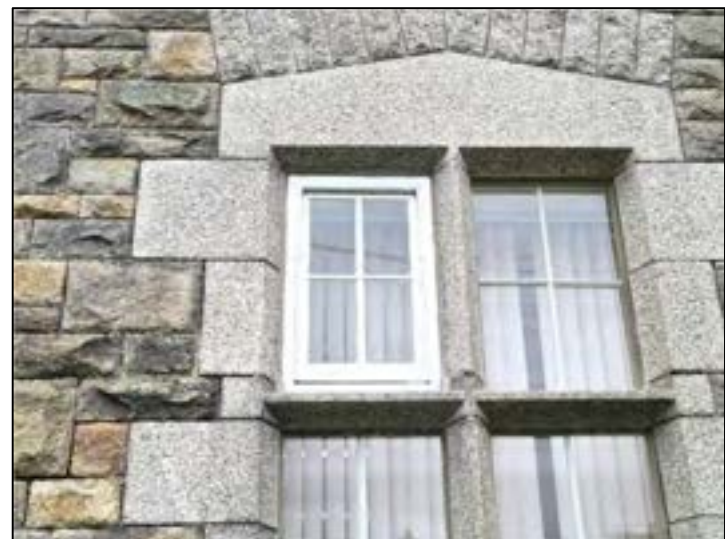
Comments: This window is outside the scope of our survey however, for the purpose of thoroughness we include the timber sub frame to the top left hand side. We recommend that this subframe is sanded, filled and decorated but is generally, in good serviceable condition.

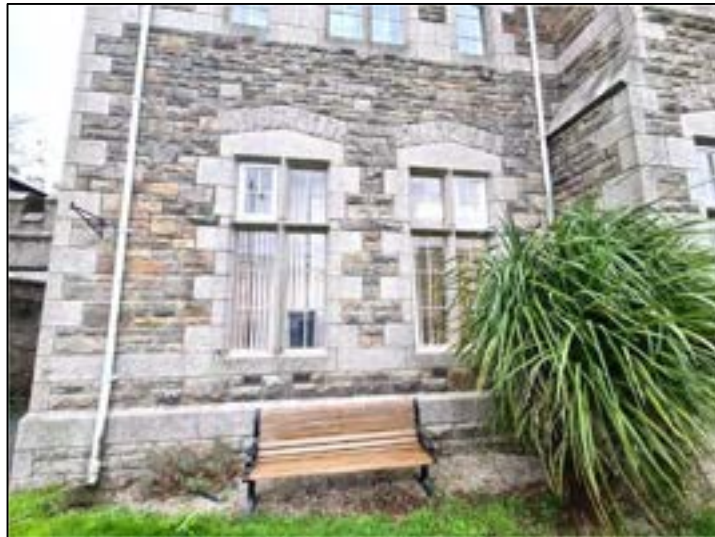
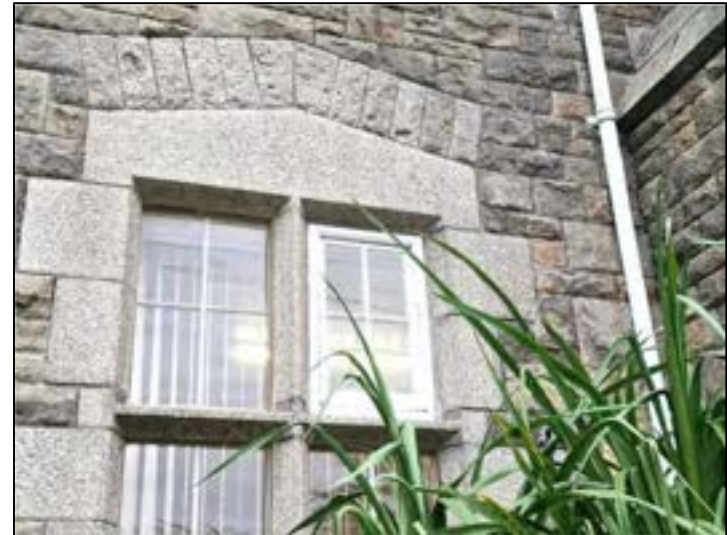
WINDOW NUMBER: BC – W02

Comments: This window is outside the scope of our survey however for the purpose of thoroughness we include the timber sub frame to the top right hand side. We recommend that this subframe is sanded, filled and decorated but is generally, in good serviceable condition however the window is painted shut.

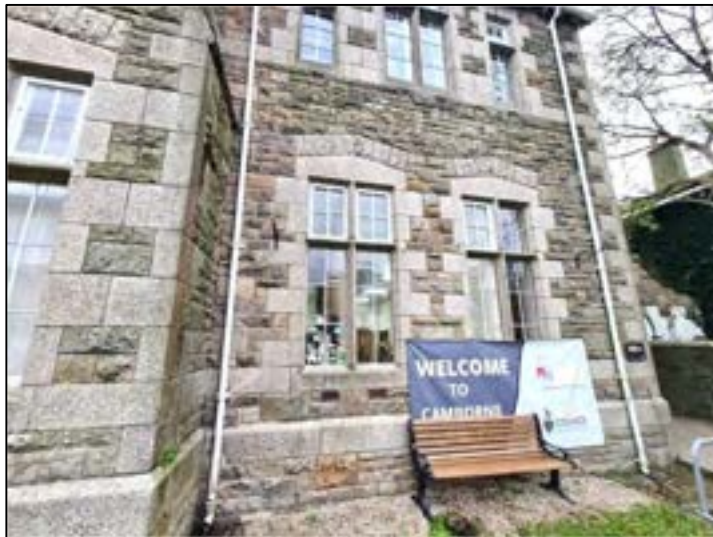
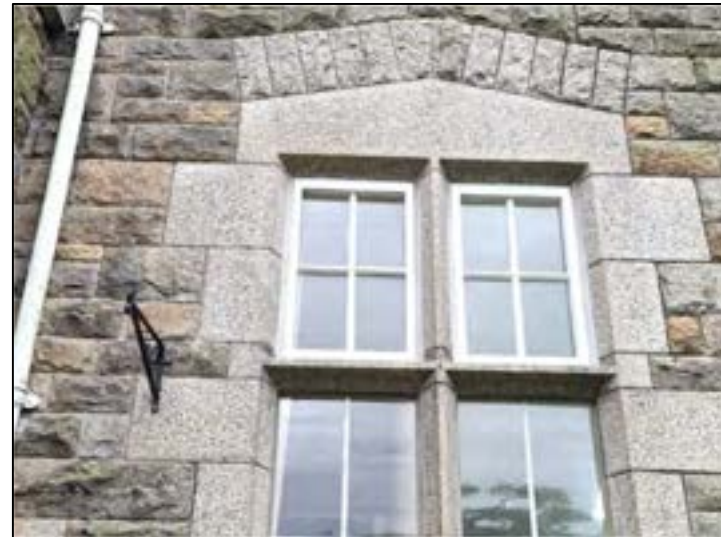
Comments: This window is outside the scope of our survey however for the purpose of thoroughness we include the timber sub frames to the top right and left hand sides. We recommend that these subframes are sanded, filled and decorated. Stone mullions require repointing.

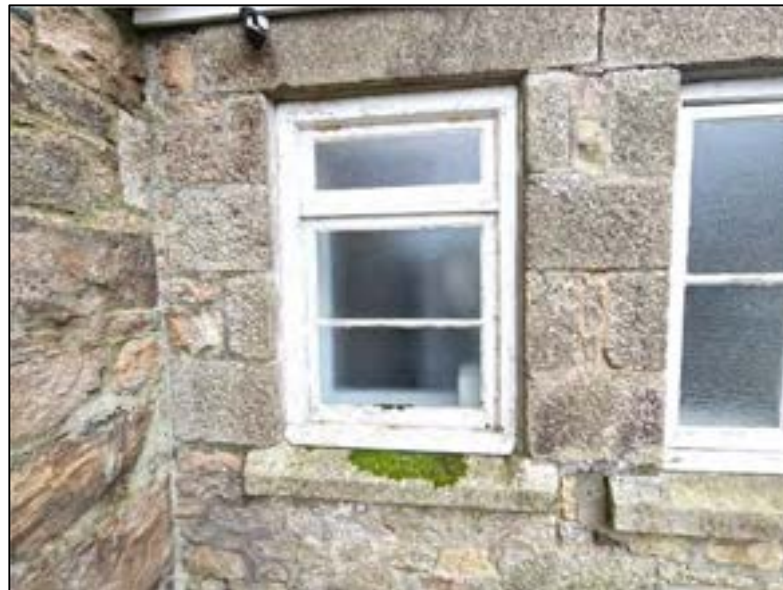
Comments: Some moss build up to the lower section. Previous scarf joint to left hand side of frame requires replacement. Recommend all putty is removed, glazing removed, full sand down and fill. Install glazing with new putty and paint. Replace hinges to operable top section. Note: Pointing to right hand side of lintel and masonry is poor and requires repointing with NHL 3.5.

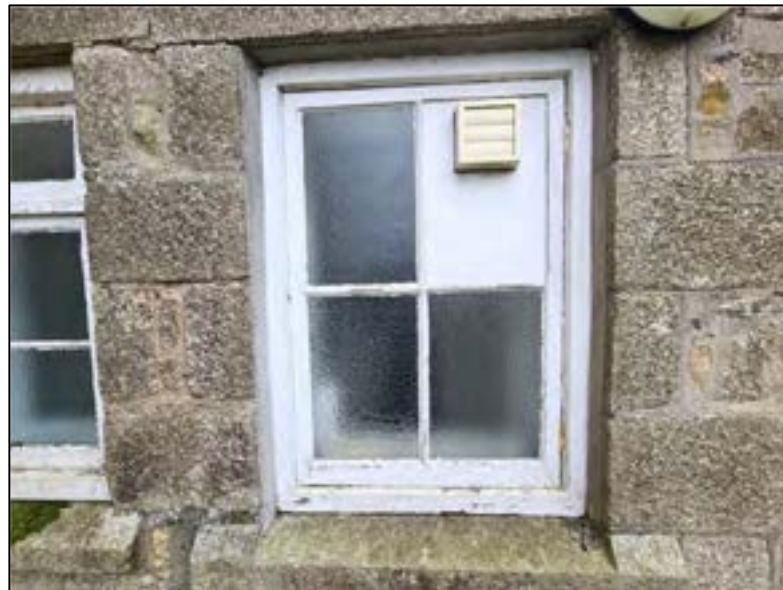
WINDOW NUMBER: BC – W18

Comments: Similar to BC-W17 the lintel to the left hand side requires repointing with NHL 3.5. Recommend entire cill is replaced. Hinges also require replacement. Recommend putty is removed, window is sanded, new putty applied and allowed to cure before painting. Additionally, apply sealant around extractor cowl.

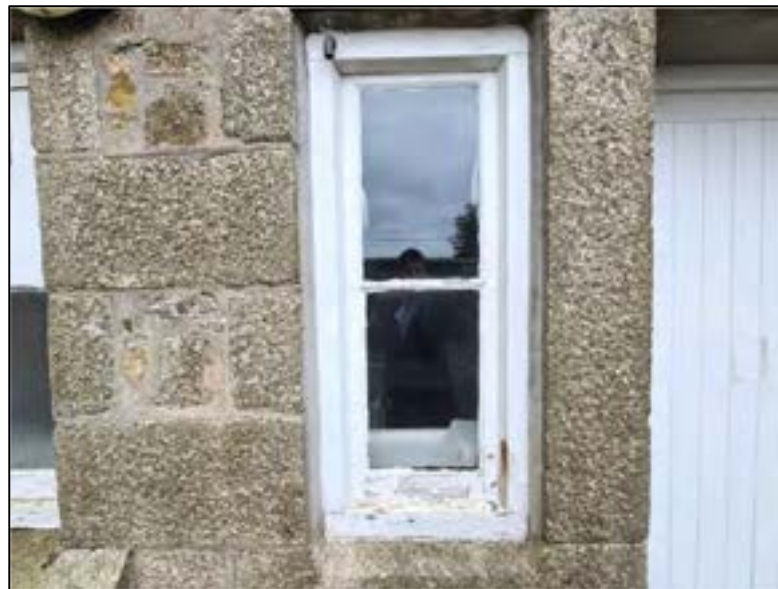
WINDOW NUMBER: BC – W19

Comments: Remove copper pipe if redundant and make good hole. Replace entire cill. Rake out putty and remove glazing. Sand frame, stiles and rails (check bottom rail) and fill/make good as required. Check condition of glazing bar once putty has been removed. Replace putty, allow to cure and paint.

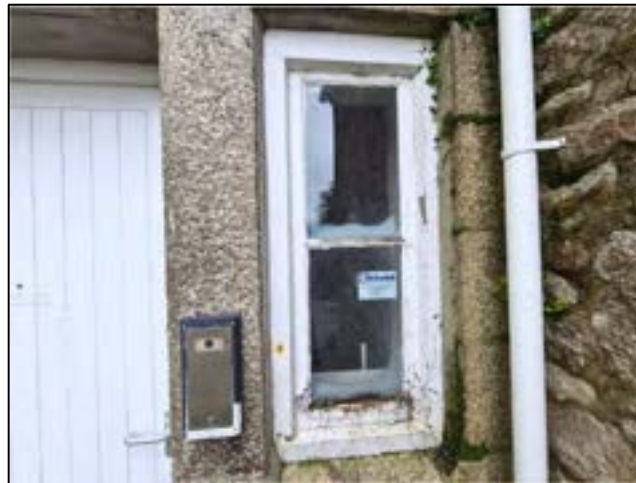
WINDOW NUMBER: BC – W20

Comments: Remove all putty and replace glazing. Replace the right hand side of the frame, replace right hand stile and the glazing bar. Replace the bottom rail. Replace cill. Fixings to left hand side of frame should be removed and replaced with galvanised or stainless steel fixing. Given the extent of the works we recommend that the entire window is removed including pointing. Sand, fill and paint. Repoint in NHL3.5 and seal with external graded silicone. Remove surrounding flora and treat masonry with Hydrochloric acid/peroxide bleach/D2 Biological Solution.

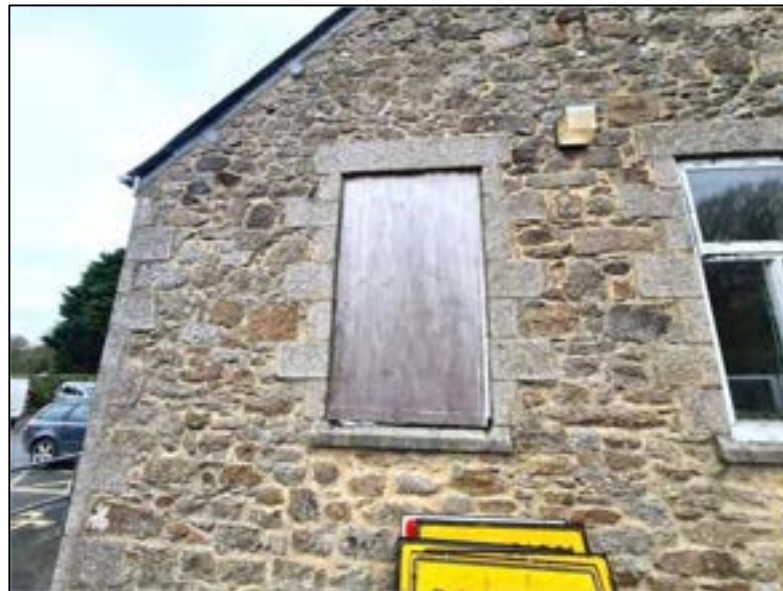
WINDOW NUMBER: BC - W26

Comments: Currently boarded. Replace whole window to match existing elevation.

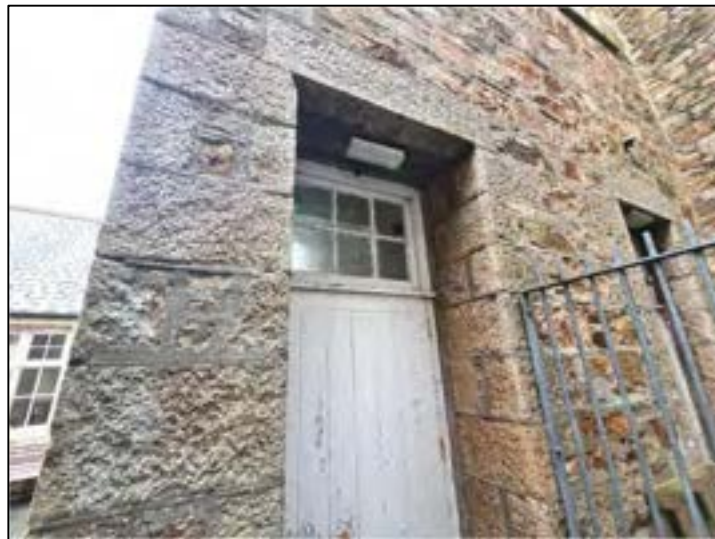
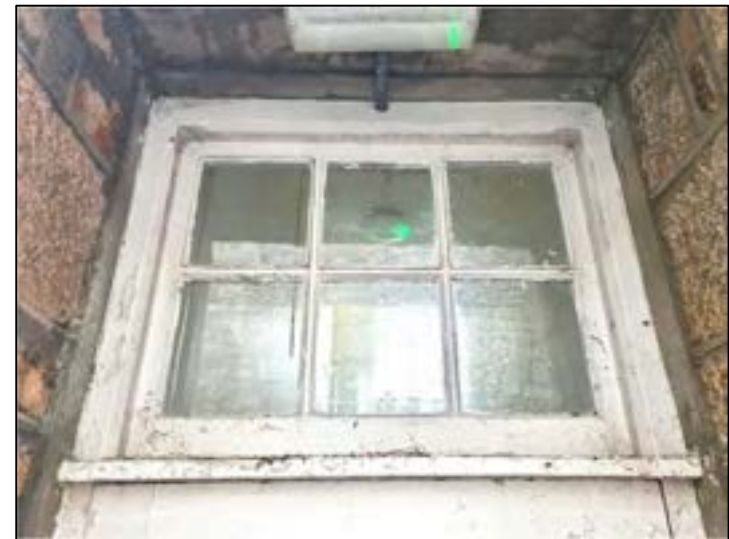
Comments: Generally, in good order. Sand, fill and paint. Recommend pointing is sealed with external graded flexible sealant.

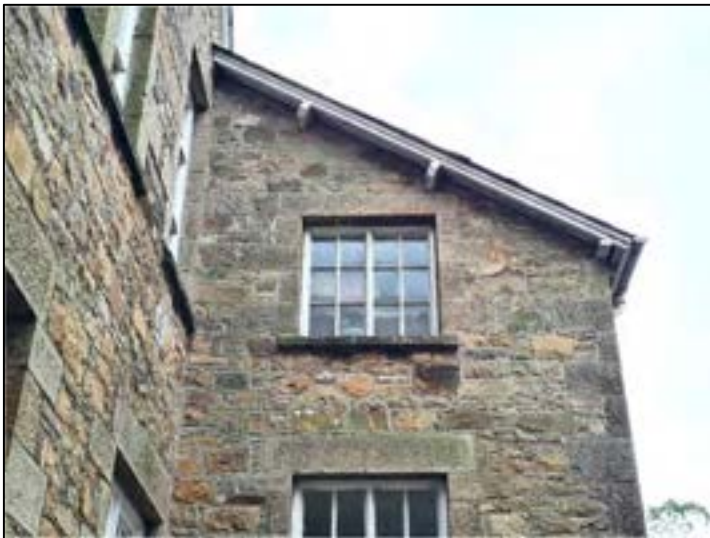
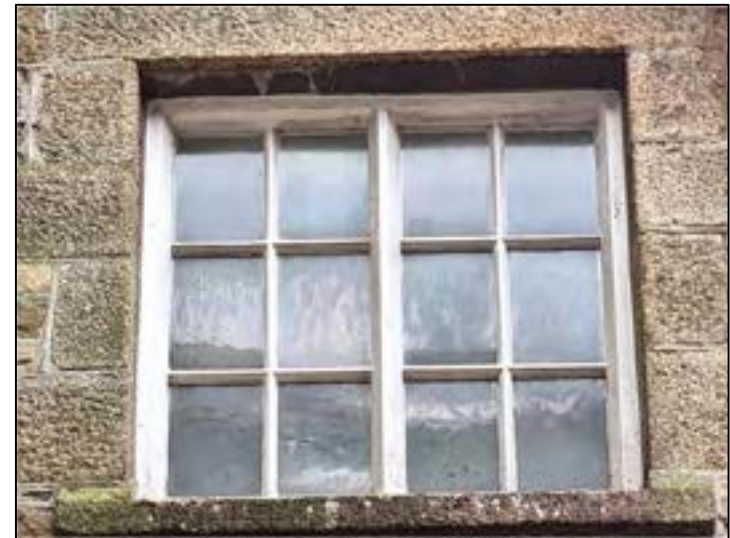
Comments: Rake out putty and replace broken pane. Sand down window and fill where required. Apply putty and allow to cure prior to priming and painting. We would recommend that a fungicidal wash is applied to the granite cill and a flexible sealant suitable for external use is applied to the pointing particularly above the head of the frame. Given the limitations of the survey we were unable to fully inspect the bottom rail, jambs, glazing bars and cill.

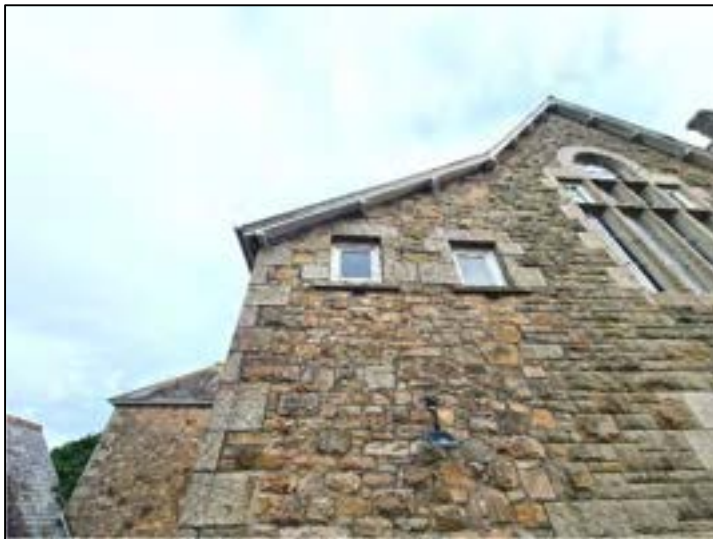
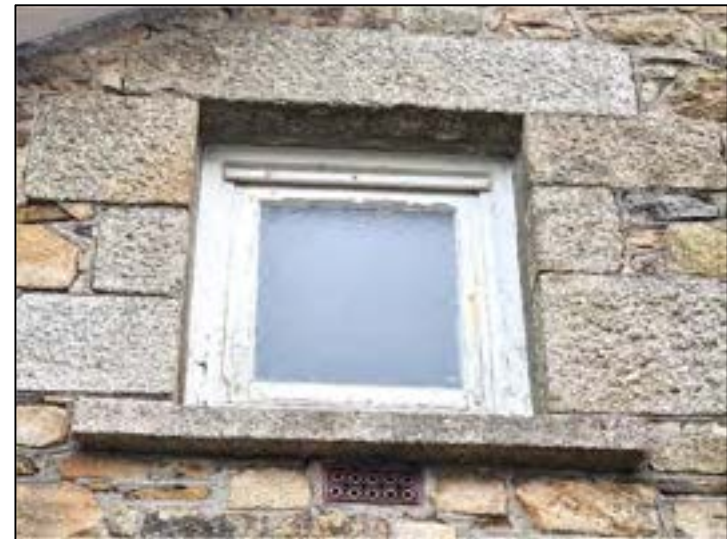
Comments: Painted finishes are tired with rust staining apparent. Ferrous fixings should be removed and replaced with non-ferrous fixings. We recommend that the putty is raked out and replaced. Priming and painting should be completed once the putty has cured. Given the limitations of the survey we were unable to fully inspect the bottom rail, jambs, stiles, and cill. To note: The window has been screwed shut, additional works will be required to make this window openable. Given the limitations of the survey we were unable to fully inspect the bottom rail, jambs, stiles and cill.

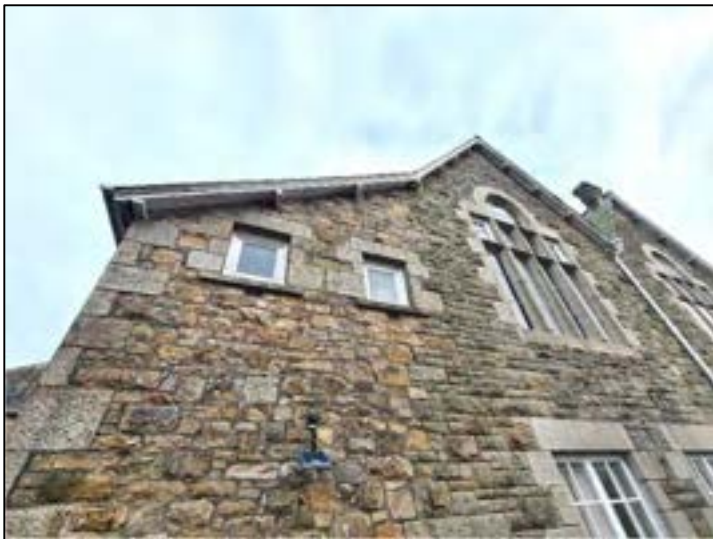
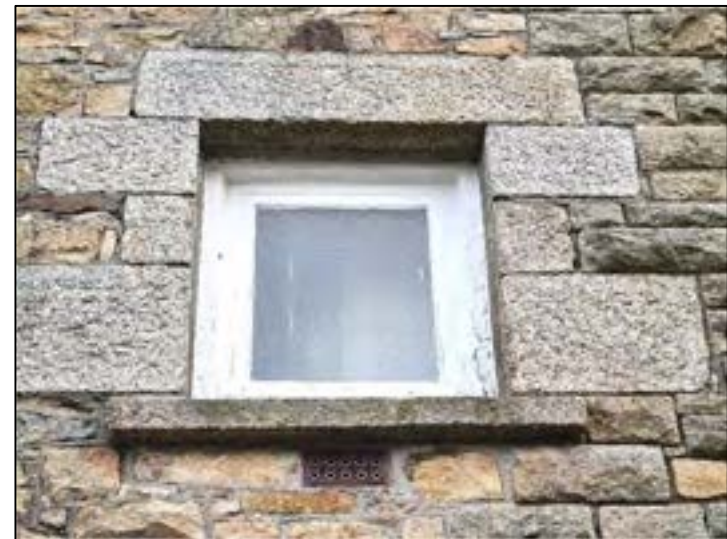
WINDOW NUMBER: BC – W70

Comments: Painted finishes are tired with rust staining apparent. Ferrous fixings should be removed and replaced with non-ferrous fixings. We recommend that the putty is raked out and replaced. Priming and painting should be completed once the putty has cured. Paint drips should be removed from the glazing. Given the limitations of the survey we were unable to fully inspect the bottom rail, jambs, stiles and cill.

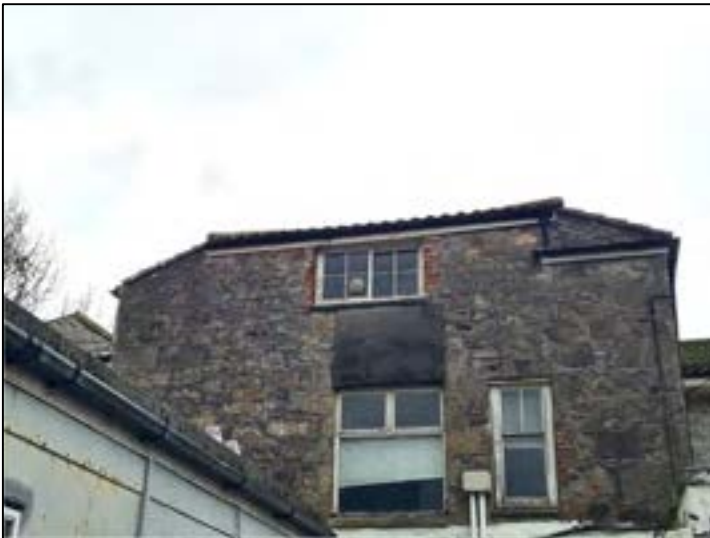
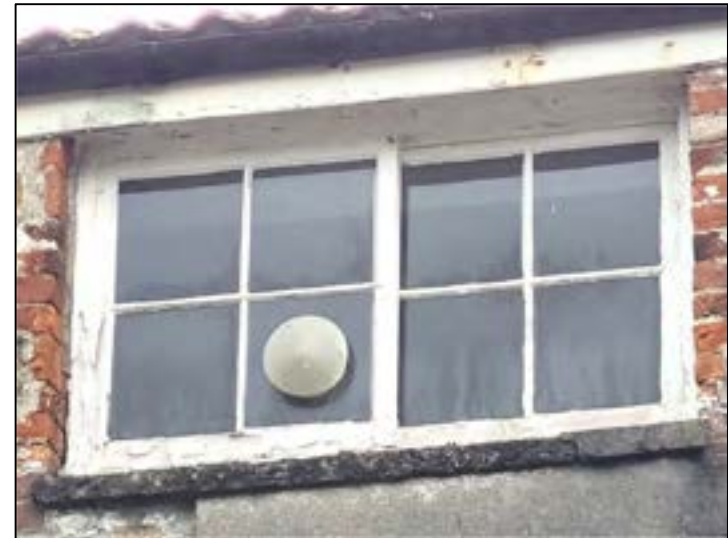
Comments: Rake out putty and replace broken pane. Sand down window and remove screws that are keeping opening section from sliding. Inspect sliding rail once openable. Apply resin/fill as required and allow to cure. Apply primer and top coats following remedial works. Given the extent of the works it is advisable to remove the window in its entirety.
