## Refurbishment Survey

Survey Reference Number: X-01078

Survey Date: 02 February 2018

38 Sally Port  
Isles of Scilly  
TR21 0JE

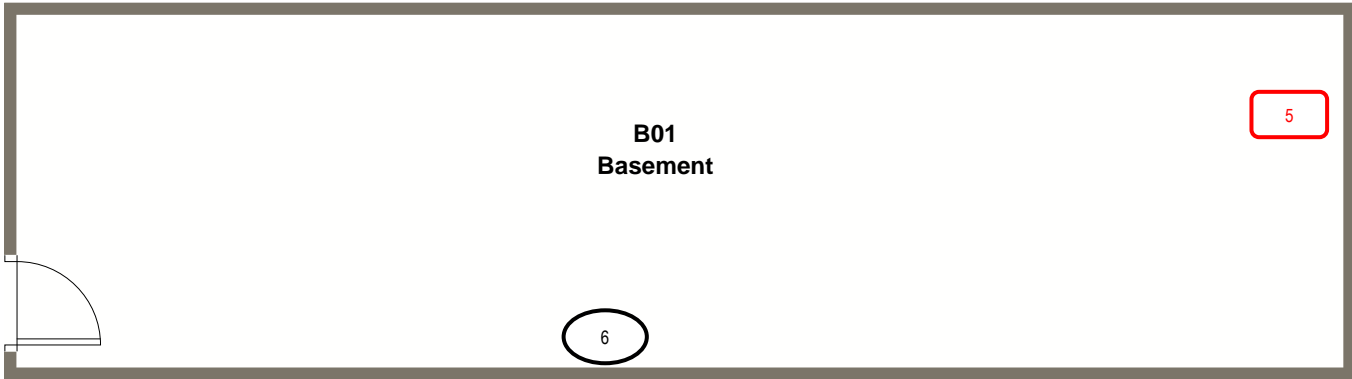
**B01  
Basement**

Sample No	No Sample Taken	Condition (B)	1	
Description	Cement Panel - Ceiling	Surface Treatment (C)	1	
Accessibility	Low	Asbestos Type (D)	3	
Risk Rating	Low	Material Score (A+B+C+D)	6	
Extent	1no.	Identification	PTCA	
Recommendation	Remove if affected by proposed refurbishment works – See section 5.2			
Comments	Visual inspection only to cement packer to concrete ceiling beneath old hearth due to damage limitations

Sample No	01078/CR/004	Condition (B)	N/A	
Description	Felt - Wall	Surface Treatment (C)	N/A	
Accessibility	Low	Asbestos Type (D)	N/A	
Risk Rating	N/A	Material Score (A+B+C+D)	N/A	
Extent	1lm	Identification	NAD	
Recommendation	No Action			
Comments	Felt in between brick work above switchgear

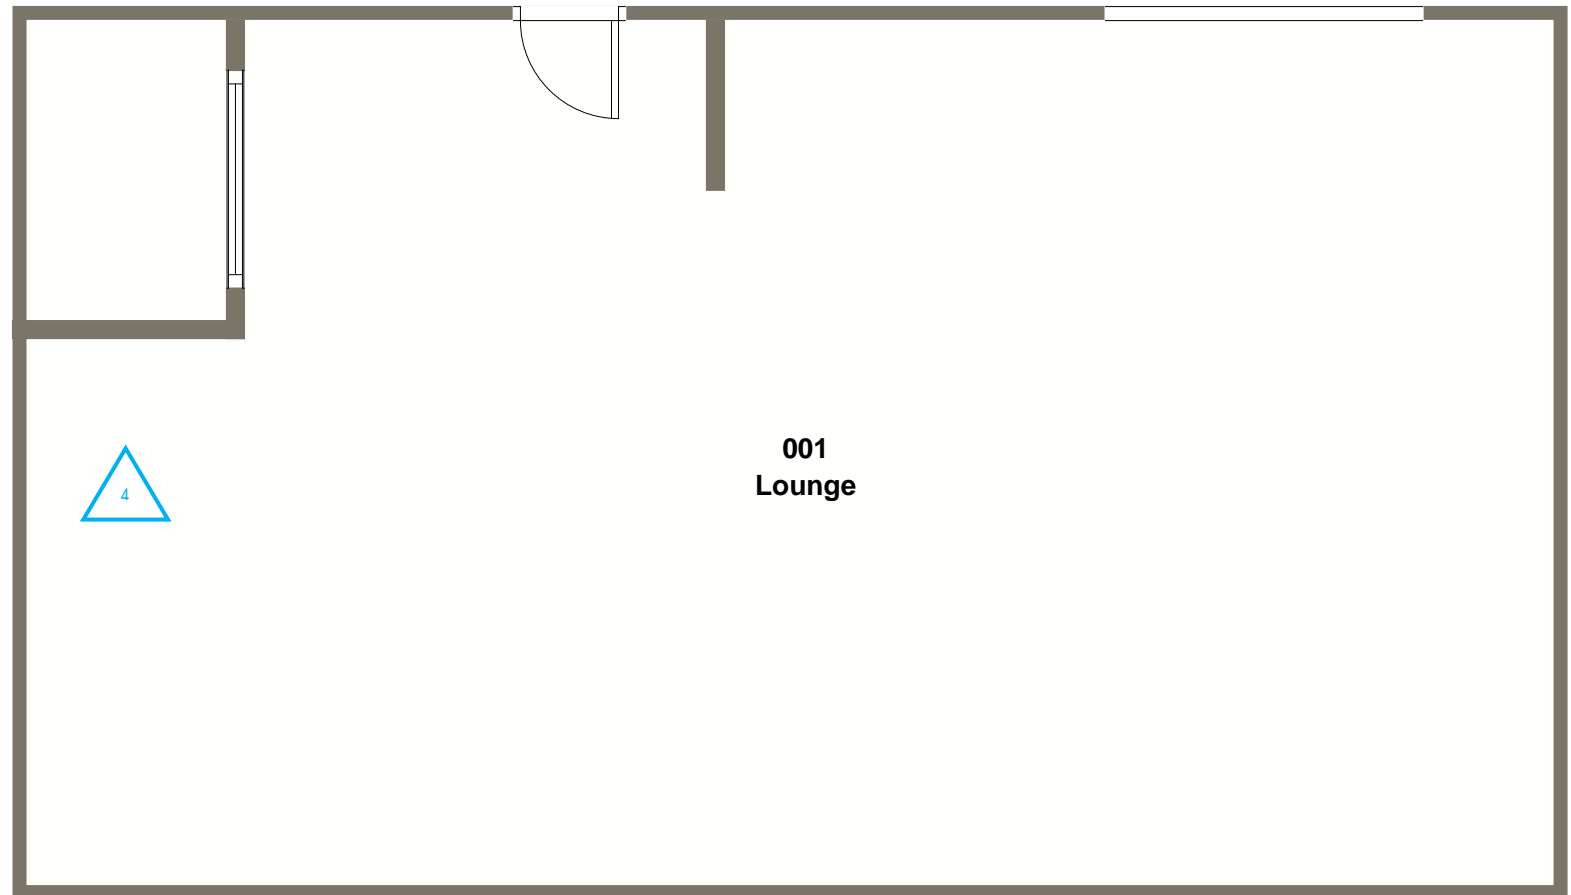
Site:	38 Sally Port Isles of Scilly TR21 0JE
Building:	1980's 3 storey block built mid-terrace house with a manmade tiled pitched roof.
Floor Level / Area:	Ground Floor
Ref No & Plan No:	X-01078 2 of 4

Reference	4	Product Type (A)	N/A
Sample No	No Sample Taken	Condition (B)	N/A
Description	No Access Gained - Plant & Equipment	Surface Treatment (C)	N/A
Accessibility	Low	Asbestos Type (D)	N/A
Risk Rating	Low	Material Score (A+B+C+D)	N/A
Extent	1no.	Identification	PTCA
Recommendation	Exercise Caution – See section 5.2		
Comments	Presumed to contain asbestos unless proven otherwise. No access within fireplace due to damage limitations, outside scope of works
