Simon Bastone Associates Ltd

**Structural Inspection Report
on
Various Structures
at
Goss Moor National Nature Reserve
For
Natural England
Part 1**

Reference R210348/SI/00

03 June 2021

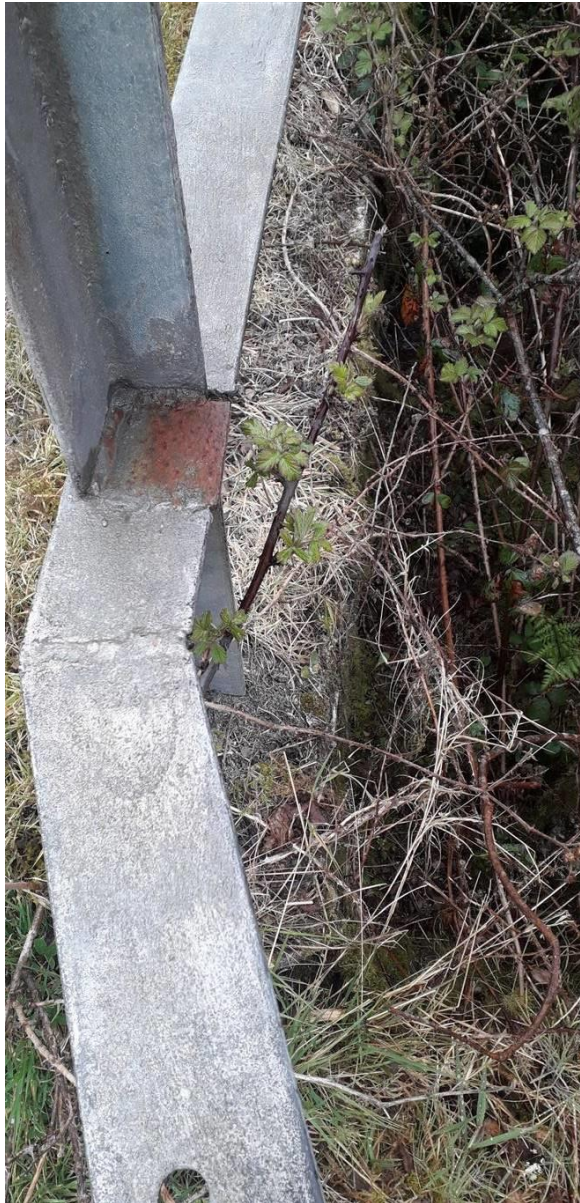
3.1.7

- 3.1.6 Some of the railings were rusty. The railings should be prepared and painted with a cold applied zinc rich paint system.

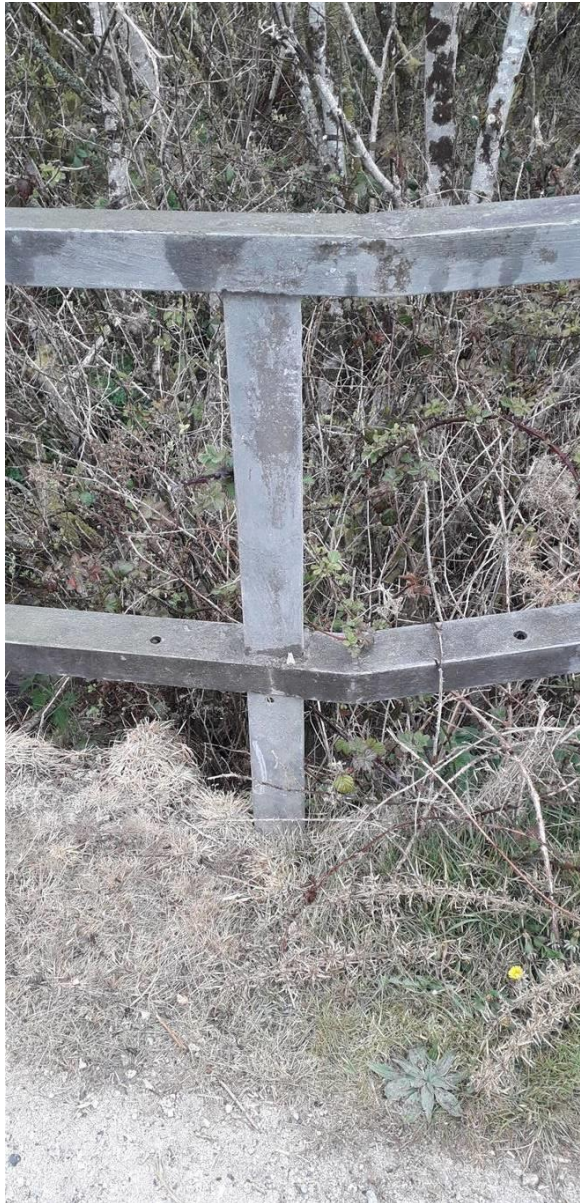
3.1.11

- 3.1.10 The Northwest baluster was loose. The fixings should be tightened or replaced.

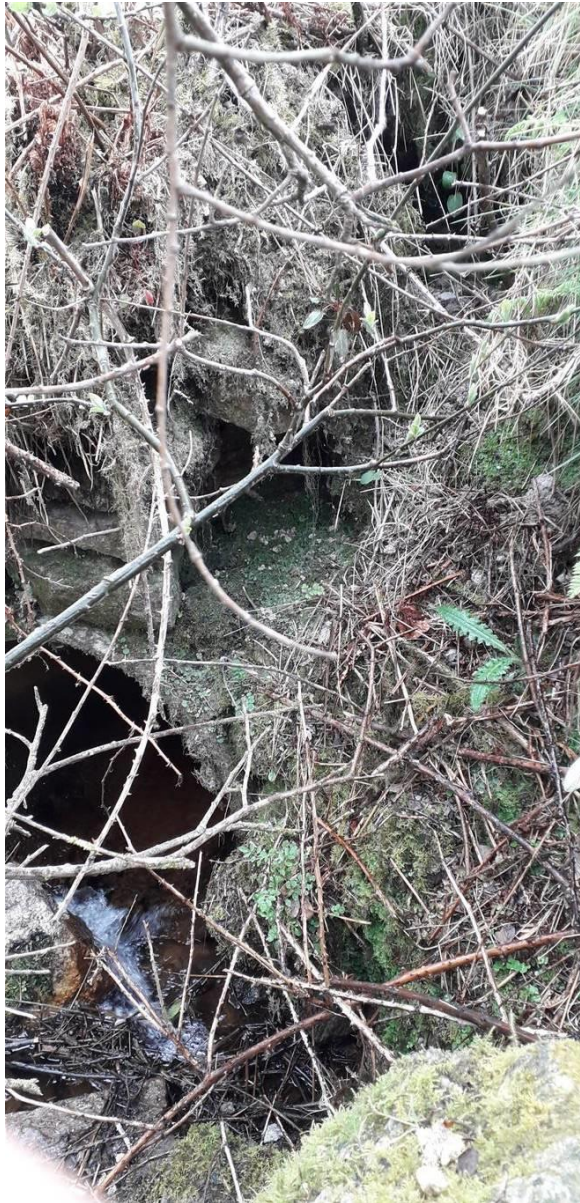
3.2.6

3.2.5 The North Headwall had partly collapsed. This should be rebuilt.

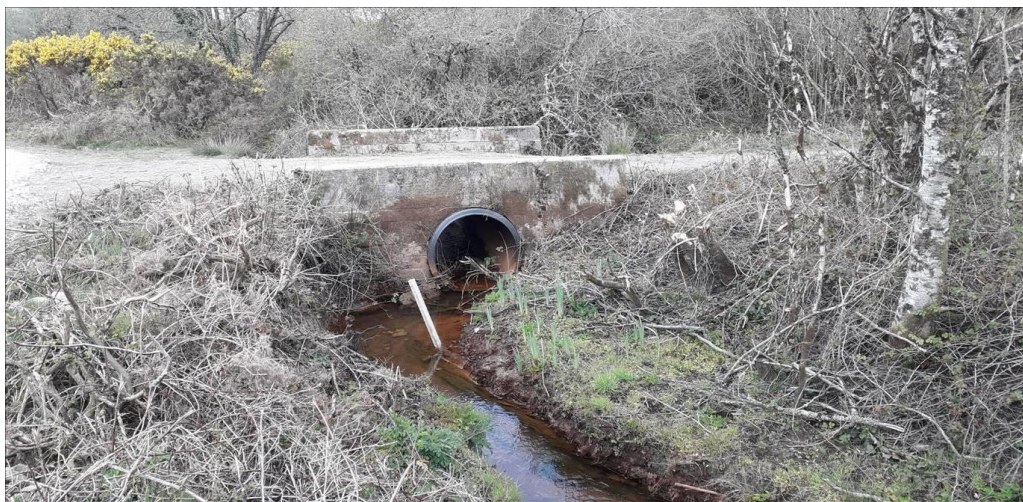
3.3.6

3.3.5 The South headwall had a severe crack up to 15 mm wide above the crown of the culvert. The headwall was leaning outwards by 40 mm. Scour has probably undermined the foundation of the headwall. The headwall should be rebuilt.

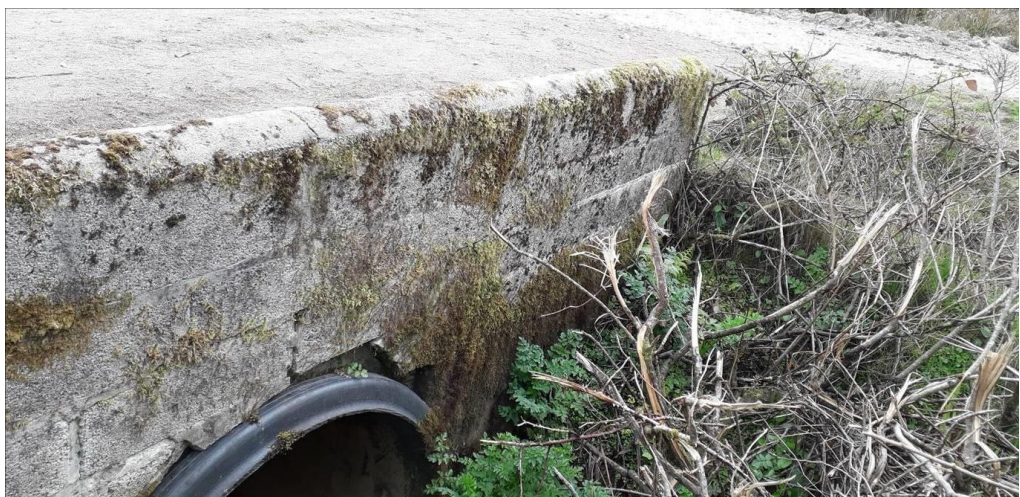
3.3.9

3.3.8 Slight cracking was noted on the North Headwall. This should be repaired.

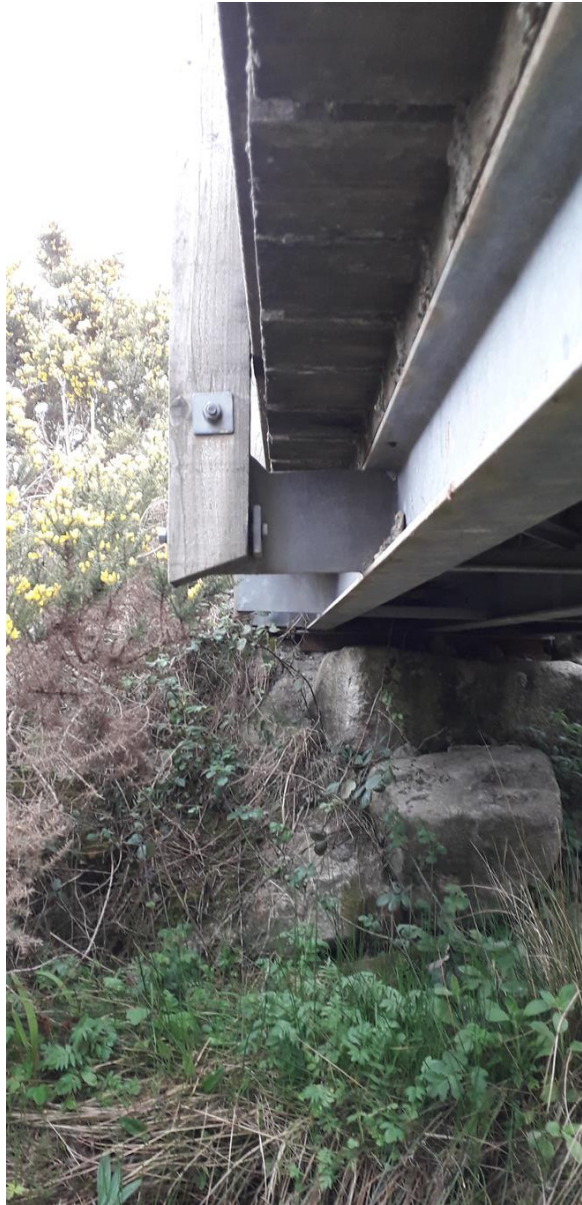
3.4.6

- 3.4.5 The handrails were loose. The nuts on most of the fixing bolts were not tight. Nuts should be replaced with galvanised nylock nuts and tightened to secure the handrails.

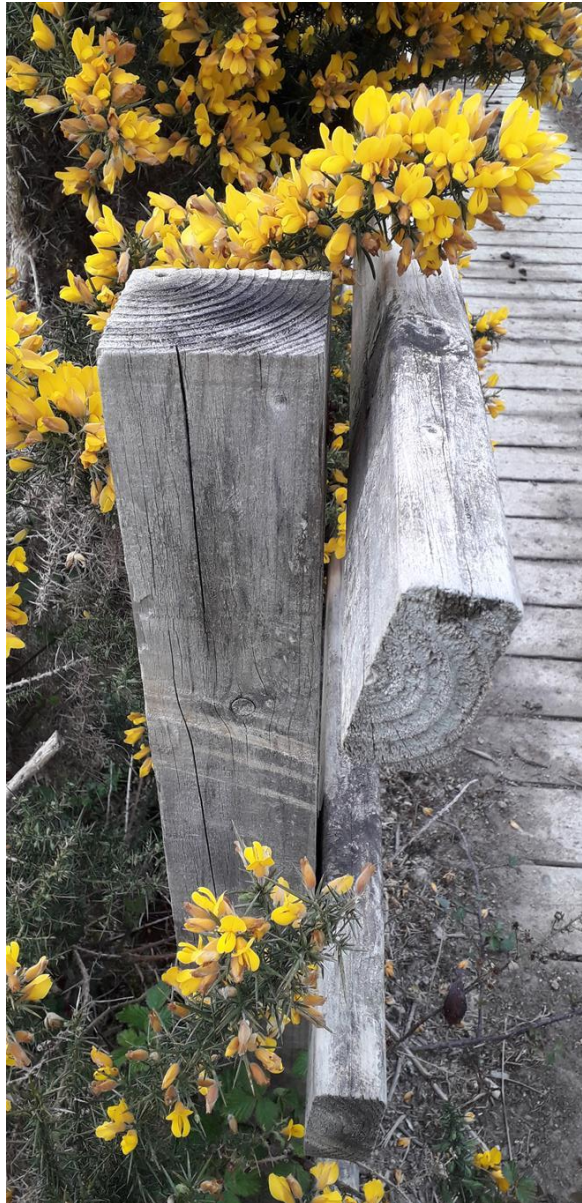
3.4.8

- 3.4.7 The handrail was twisted and screw fixings were rusty, with only one screw per fixing. Rusty screws should be replaced with stainless steel suitable for external exposure, and provide a minimum of two screws per fixing.

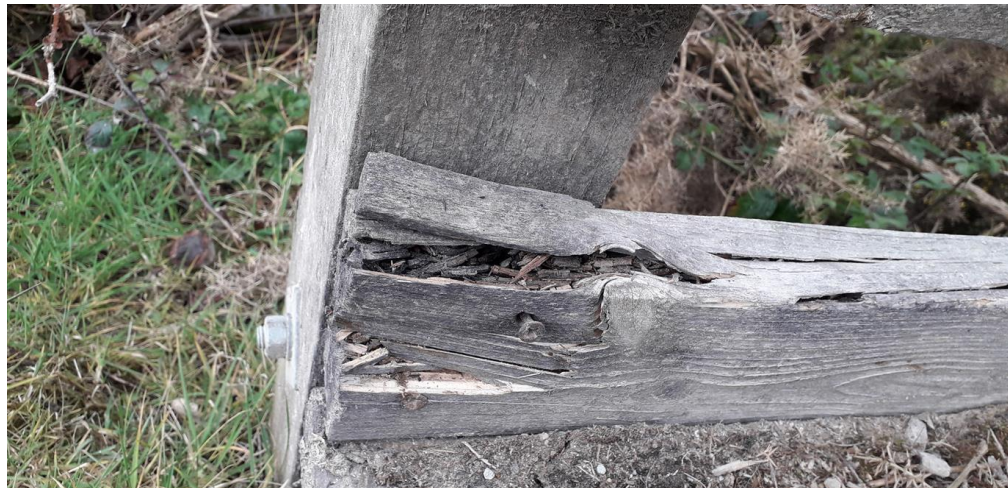
3.4.12

3.4.11 The kick board was rotten and should be replaced.

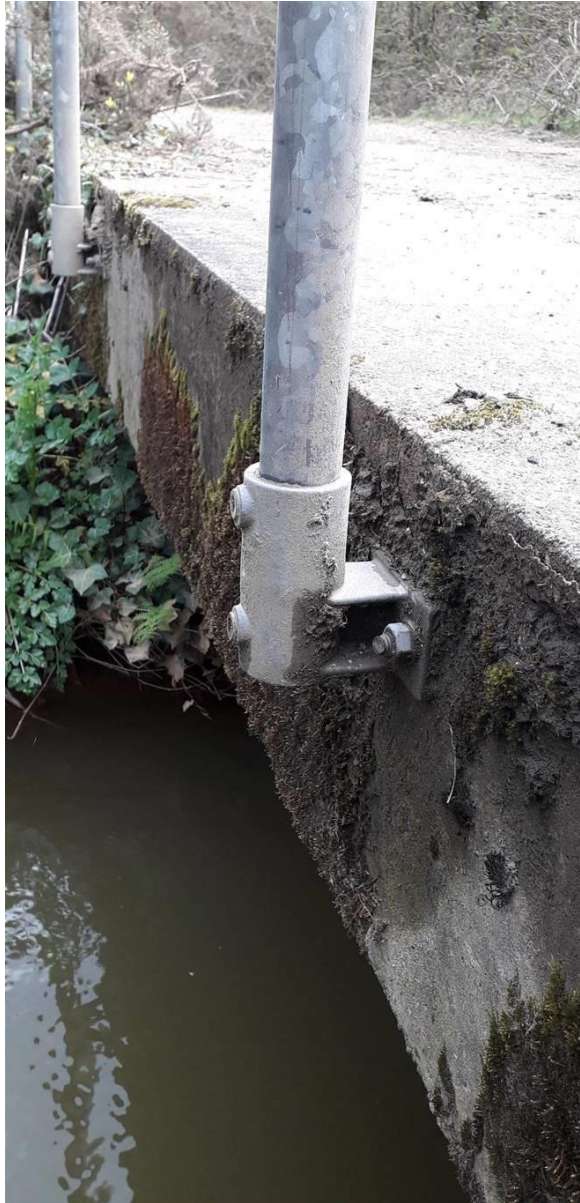
3.7.6

- 3.7.5 The handrail could be moved easily which indicates it lacks adequate strength to resist lateral loads. The two bolt fixing detail was suitable for bolting to steelwork rather than concrete. No other defects were noted.

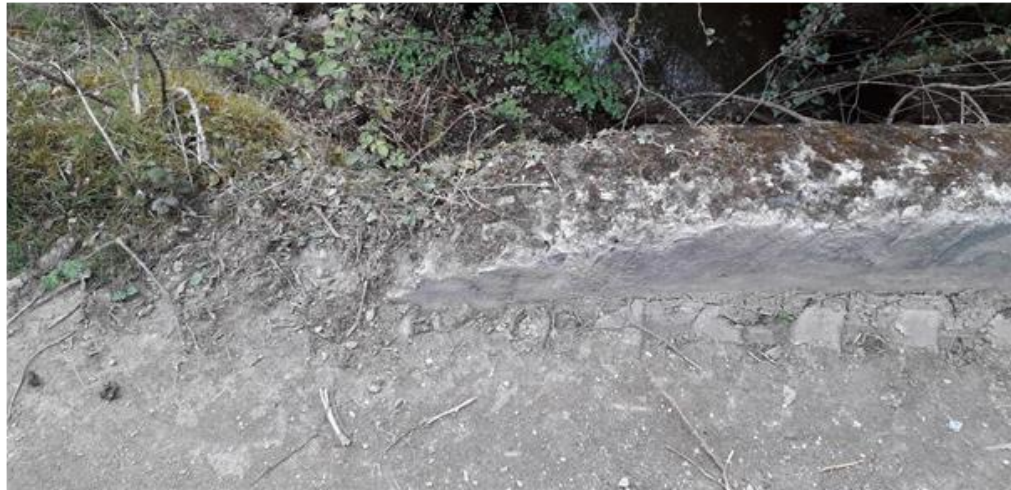
3.8.9

There was some damage to the parapets from farm vehicles. The worst damage was on the West side of the bridge. Damage should be repaired using concrete repair mortar.

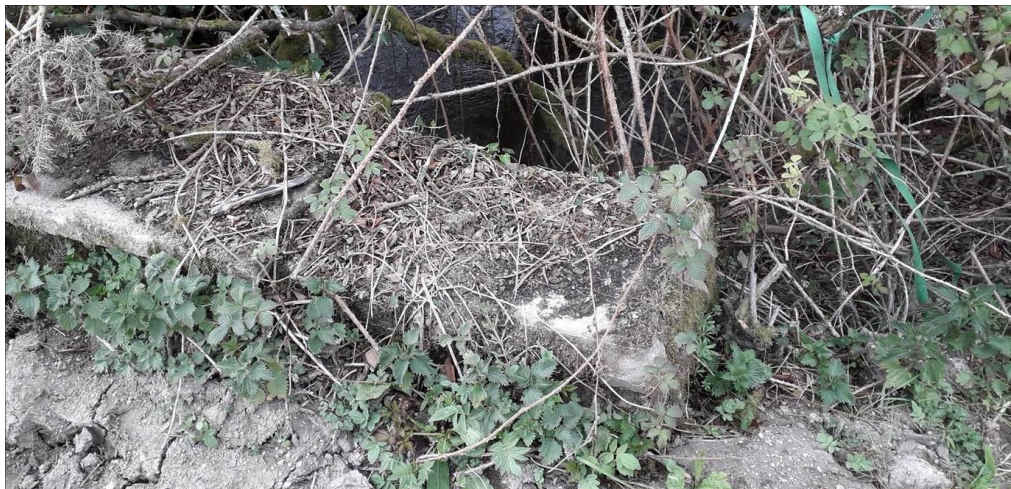
3.9.8

3.9.6 The copings had been damaged by farm vehicles. Copings should be set onto a strong mortar bed to protect the parapet masonry beneath.

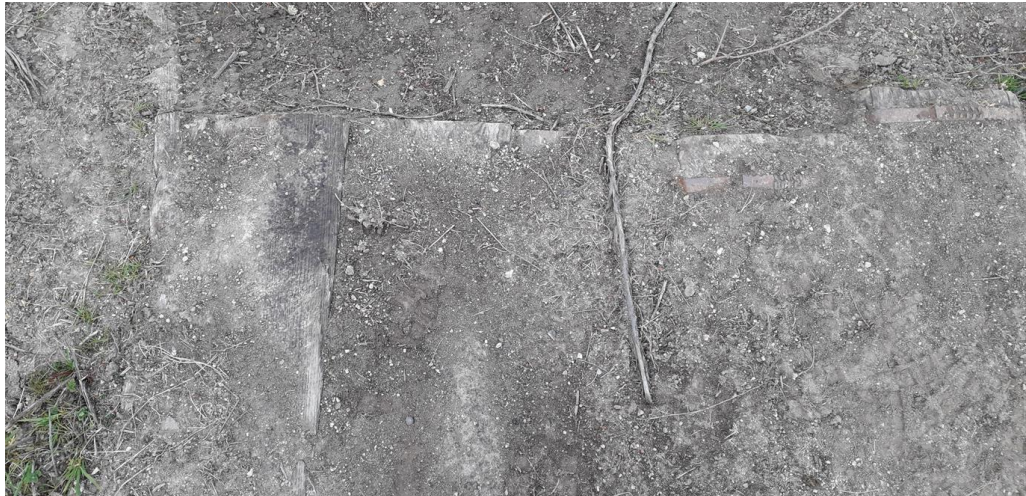
3.10.4

- 3.10.3 The deck was covered in mud and could not be inspected but where visible the timber appeared sound. The mud should be cleared and the sleepers inspected for rot.

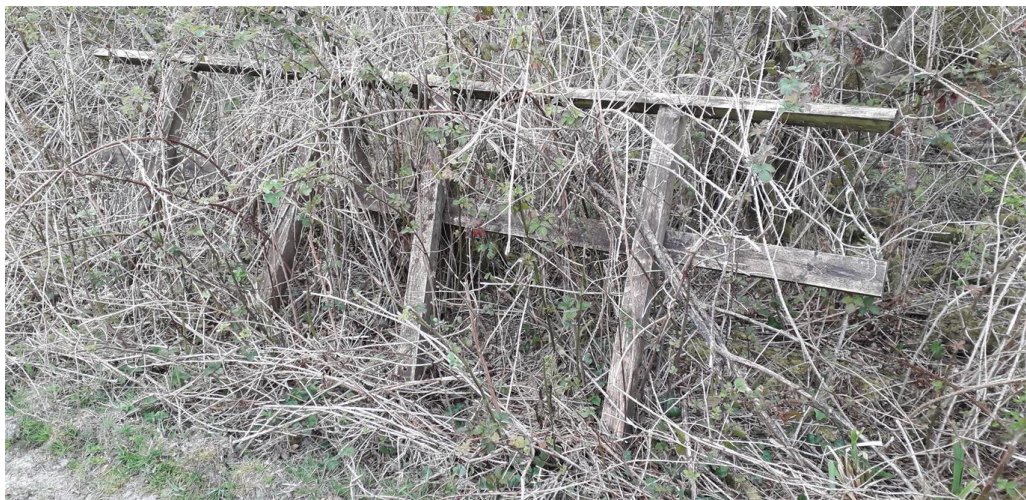
3.10.6

- 3.10.5 Both timber balustrades were in poor condition and should be replaced.

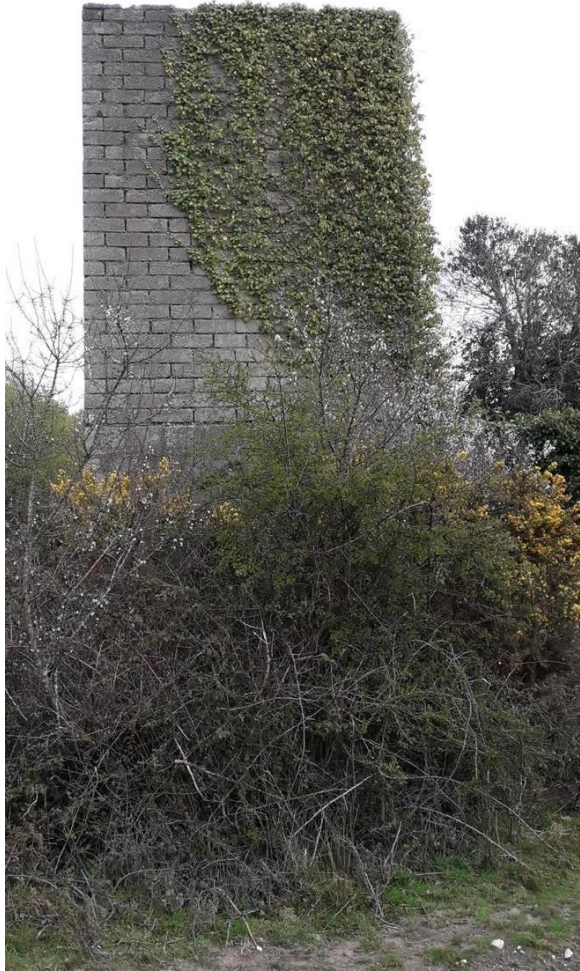
3.12.11

3.12.9 The upper parts of the silo walls had lost much of the pointing because of frost damage. Walls affected should be repointed.

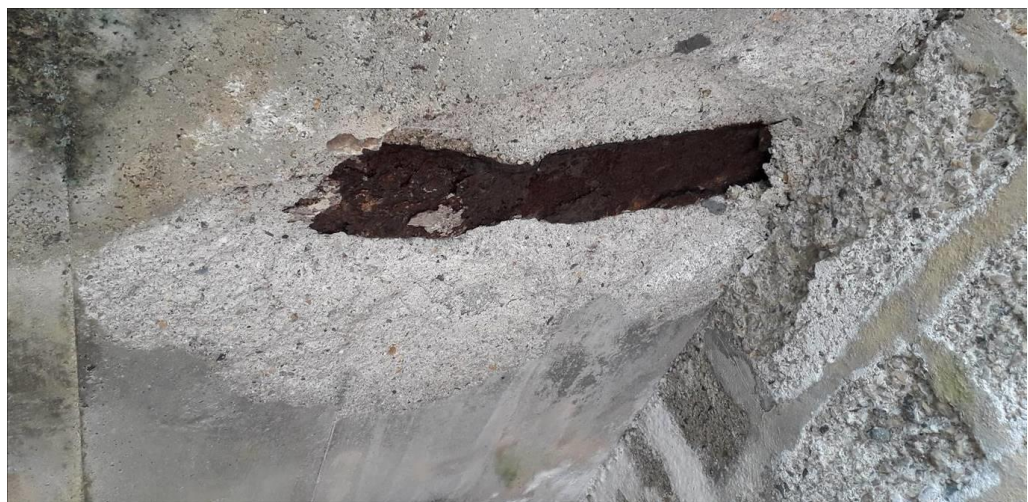
3.12.13

- 3.12.12 The floor within the silo was constructed of steelwork filler joists encased in concrete. This construction technique was used before reinforced concrete was invented. The steelwork was corroding and spalling the concrete cover on the underside of the slab. This concrete had dropped from the roof and is a potential hazard to the public. Concrete repairs could be undertaken, but the top side of the slab is probably much worse, and water is probably affecting the steelwork from the both the top and bottom. The best course of action is probably to monitor the corrosion and fence off the area as the slab deteriorates.

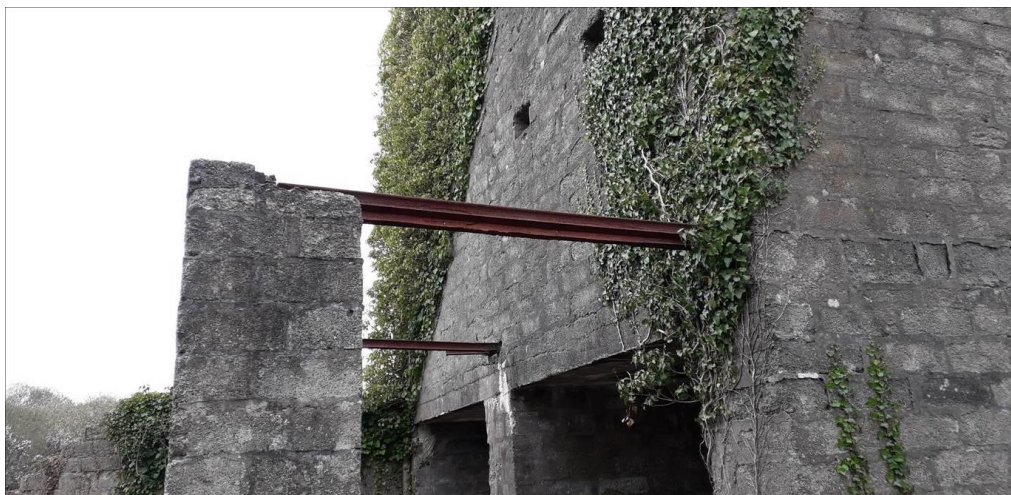
3.12.17

3.12.16 Many steelwork elements were noted embedded in the walls. The corrosion of these members will cause damage to the walls as the rust products expand. Where possible steelwork embedded into the walls should be removed and the walls made good.

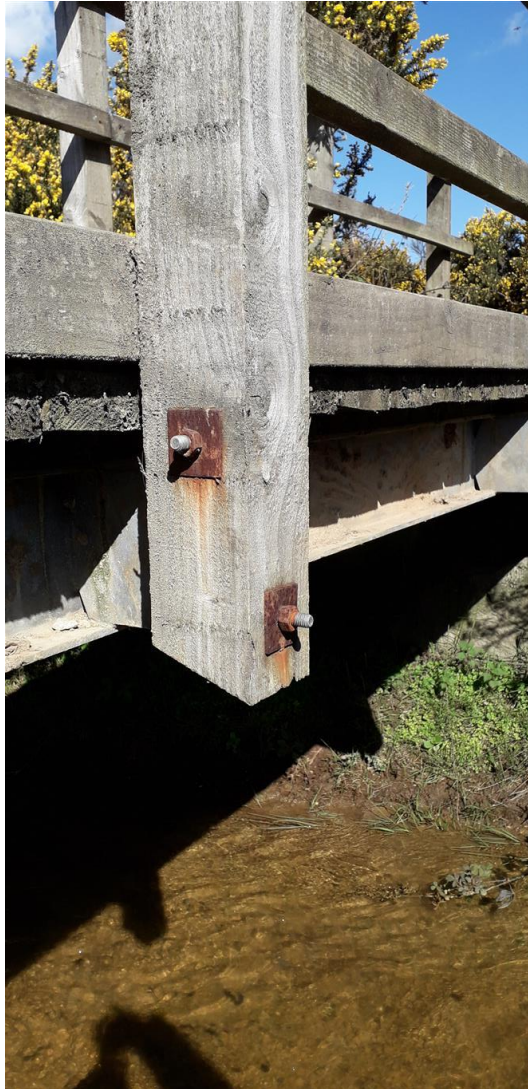
3.13.7

3.13.6 The handrails were loose. The nuts on most of the fixing bolts were not tight. Nuts and washers were rusty. Nuts and washers should be replaced with galvanised nylock nuts and washers and tightened to secure the handrails.

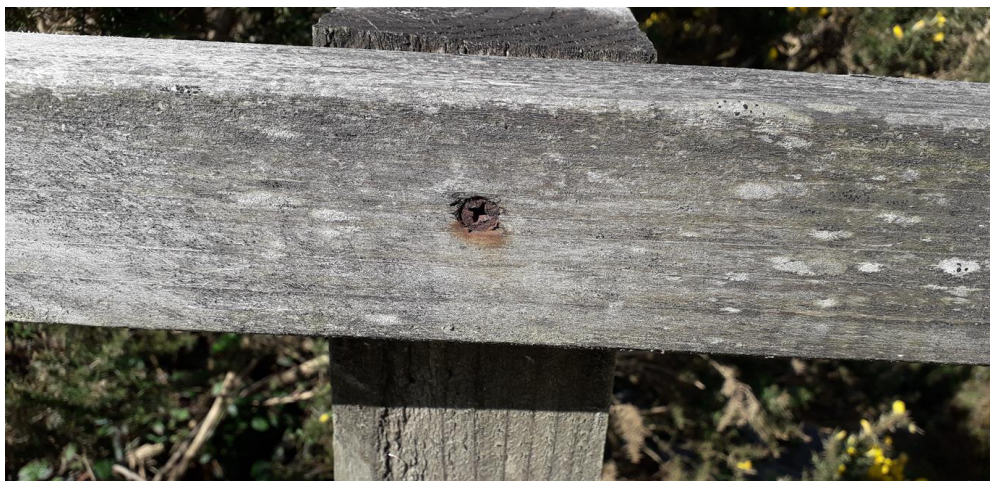
3.13.9

3.13.8 The handrail screw fixings were rusty, with only one screw per fixing. Rusty screws should be replaced with stainless steel suitable for external exposure, and provide a minimum of two screws per fixing.

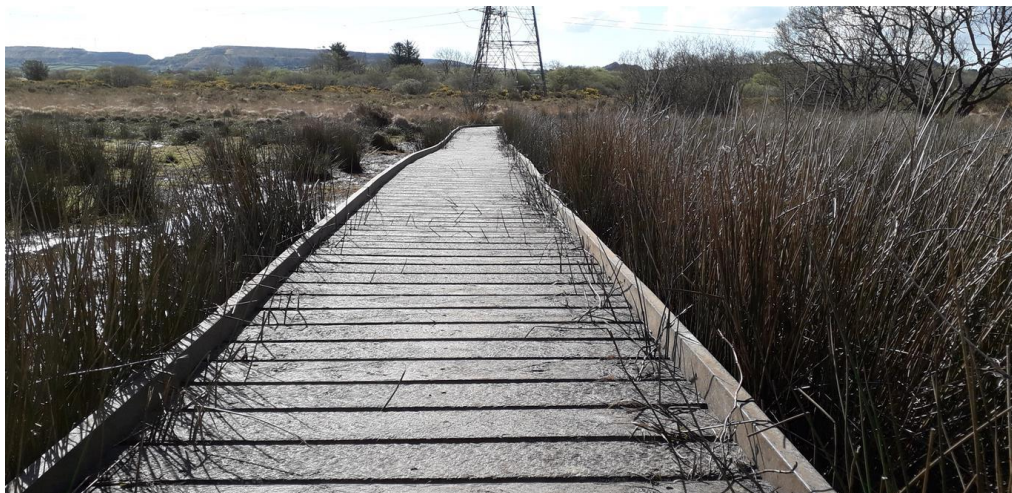
3.16.8

3.16.7 Some undulation was noted in the boardwalk which may indicate some settlement of the posts.

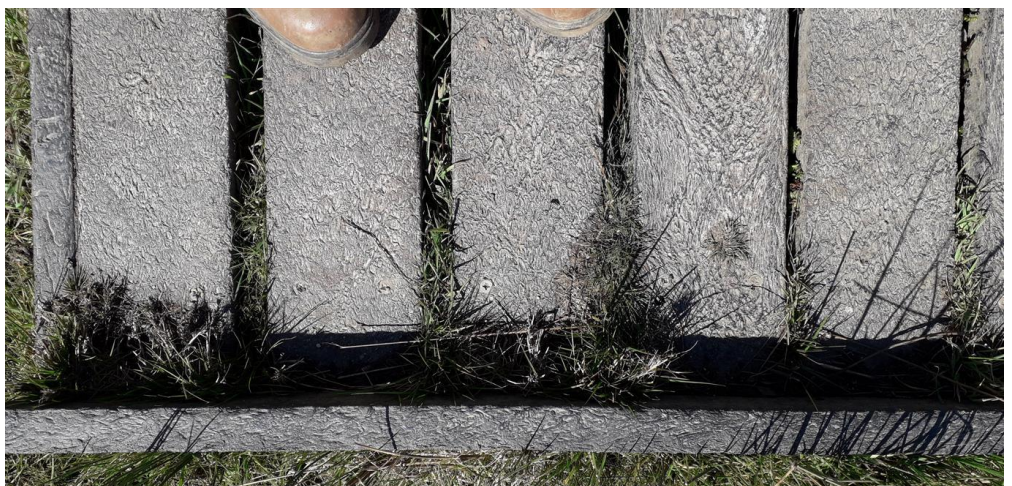
3.16.10

3.16.9 Some kick boards near the South end West side and North end West side were loose and require re-fixing.

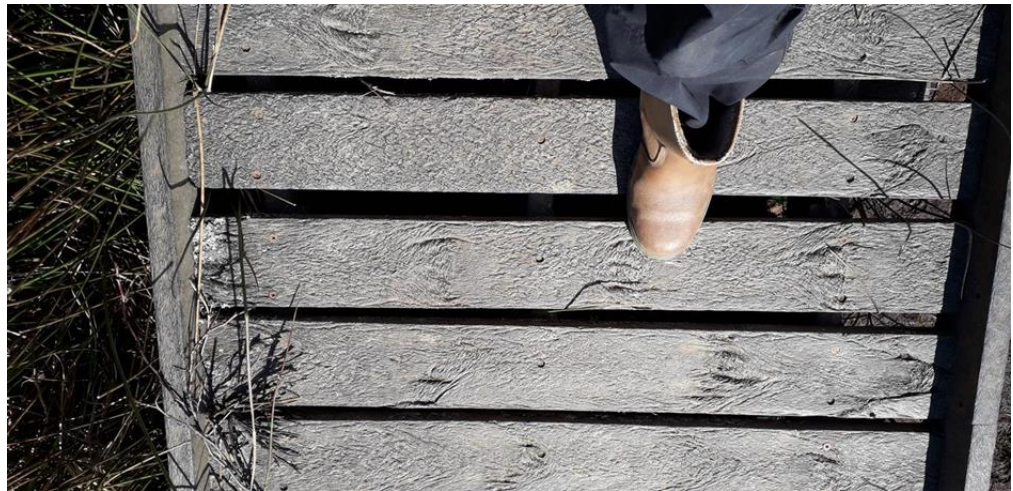
3.16.12

3.16.11 A board was loose close to the South end. The board should be re-fixed.

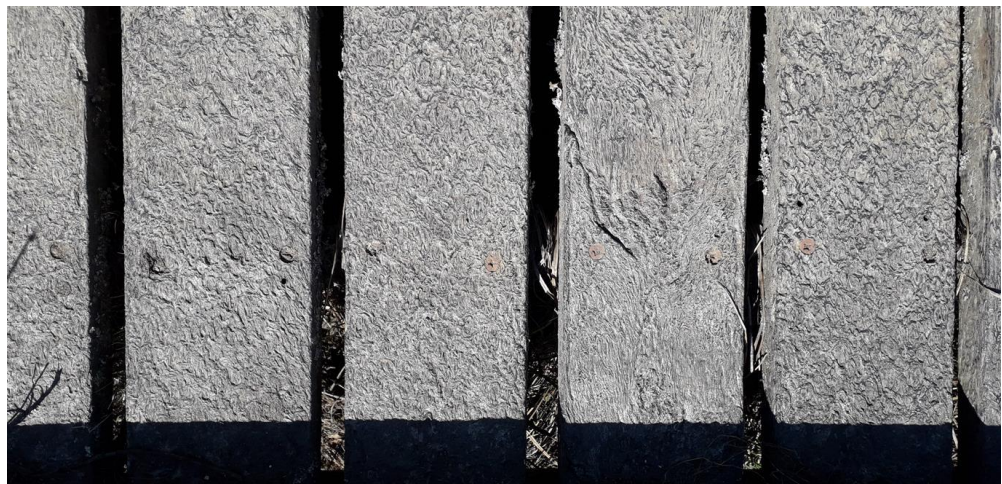
3.16.14

3.16.13 Fixings were rusting and should be replaced by stainless steel fixings.
