CBC Asbestos Re-Inspection Report Saxilby Boxing Club, Corby 22nd May 2020

Reference:				
Issue			Prepared by	Verified by
V1	May 20	JF

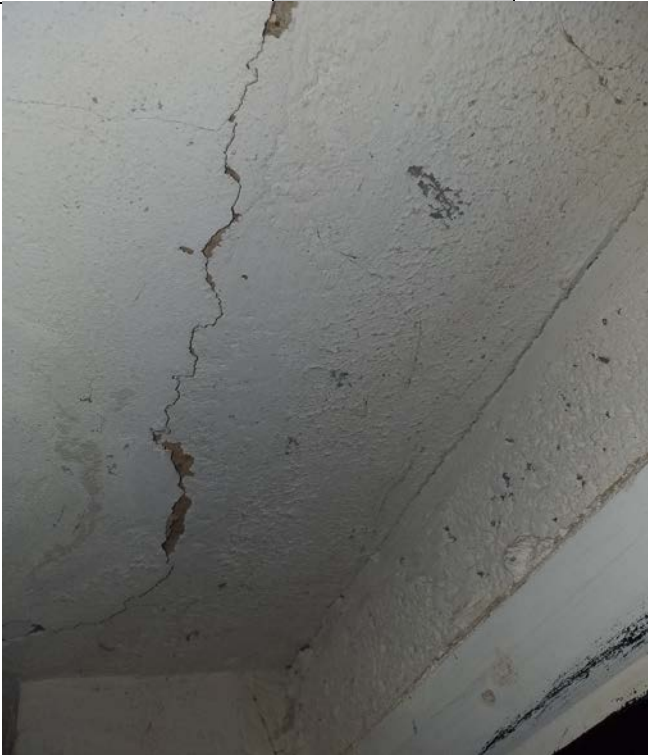
Photo Number	3	Reference number	220520RI03
Inspection / Sample	Inspection	Inspection Cross Reference / Visual I.D.	14/4/B/17/SG14

Notes	NADIS: No asbestos detected in sample

Building	Saxilby Boxing Club	Condition	Fair	1
Floor Level	Ground	Surface Treatment	Composite materials, reinforced plastics, resin, vinyl materials	0
Location	02 / Boiler Room	Material Friability	Low	1
Feature	Coating to ceiling	Asbestos Type	Strongly Presumed N.A.D.I.S	0
Material Type	Textured Coating			
Extent				
Recommendation	No action necessary	Assessment Score		0
		Assessment Band		E

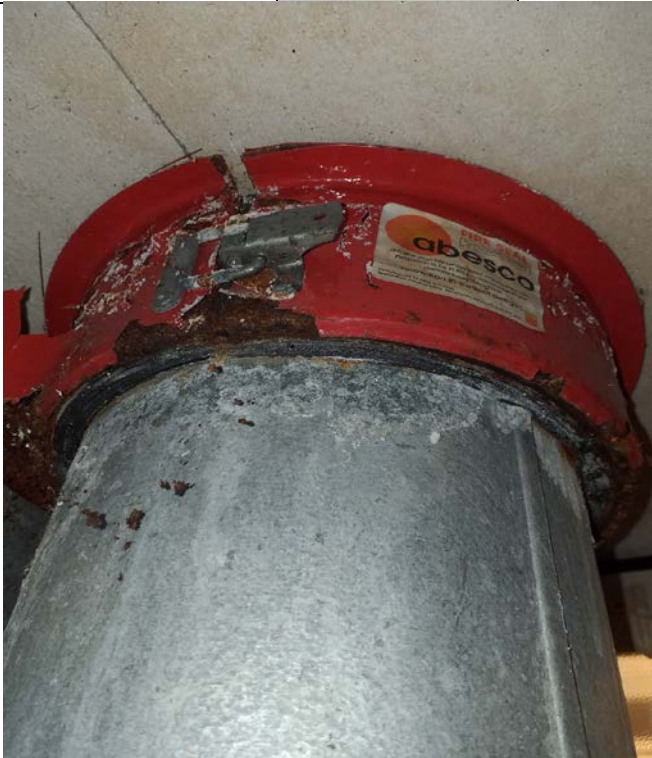
Photo Number	4	Reference number	220520RI04
Inspection / Sample	Inspection	Inspection Cross Reference / Visual I.D.	14/4/B/17/SG12

Notes	NADIS: No asbestos detected in sample

Building	Saxilby Boxing Club	Condition	Good	0
Floor Level	Ground	Surface Treatment	Composite materials, reinforced plastics, resin, vinyl materials	0
Location	02 / Boiler Room	Material Friability	Low	1
Feature	Gaskets to flue	Asbestos Type	Strongly Presumed N.A.D.I.S	0
Material Type	Bitumen			
Extent				
Recommendation	No action necessary	Assessment Score		0
		Assessment Band		E

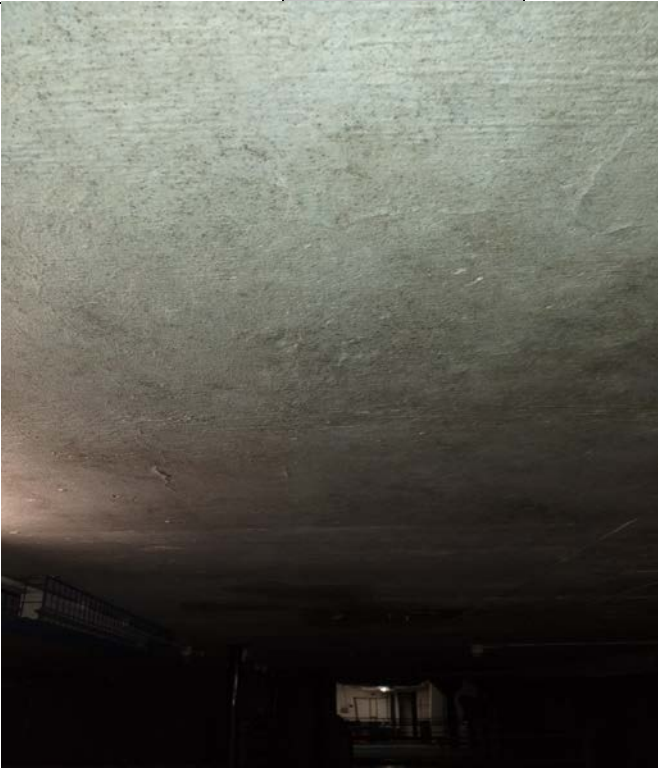
Photo Number	5	Reference number	220520RI05
Inspection / Sample	Inspection	Inspection Cross Reference / Visual I.D.	14/4/B/17/SG15

Notes	NADIS: No asbestos detected in sample

Building	Saxilby Boxing Club	Condition	Fair	1
Floor Level	Ground	Surface Treatment	Composite materials, reinforced plastics, resin, vinyl materials	0
Location	03 / Gym	Material Friability	Low	1
Feature	Coating to ceiling	Asbestos Type	Strongly Presumed N.A.D.I.S	0
Material Type	Textured Coating			
Extent				
Recommendation	No action necessary	Assessment Score		0
		Assessment Band		E

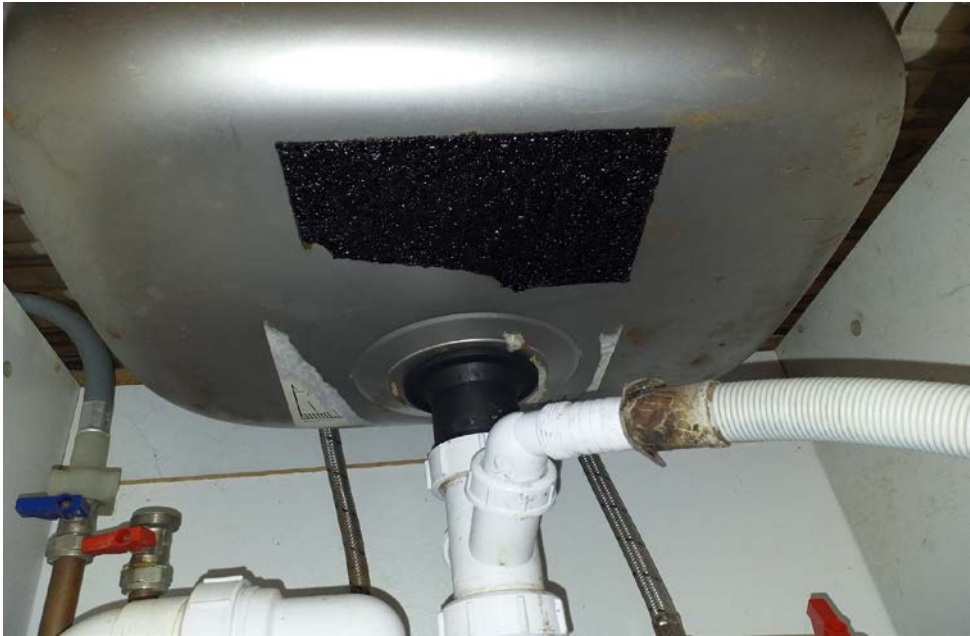
Photo Number	6	Reference number	220520RI06
Inspection / Sample	Inspection	Inspection Cross Reference / Visual I.D.	14/4/B/17/SG16

Notes	NADIS: No asbestos detected in sample

Building	Saxilby Boxing Club	Condition	Good	0
Floor Level	Ground	Surface Treatment	Composite materials, reinforced plastics, resin, vinyl materials	0
Location	04 / Kitchen	Material Friability	Low	1
Feature	Sink Pad	Asbestos Type	Strongly Presumed N.A.D.I.S	0
Material Type	Bitumen			
Extent				
Recommendation	No action necessary	Assessment Score		0
		Assessment Band		E

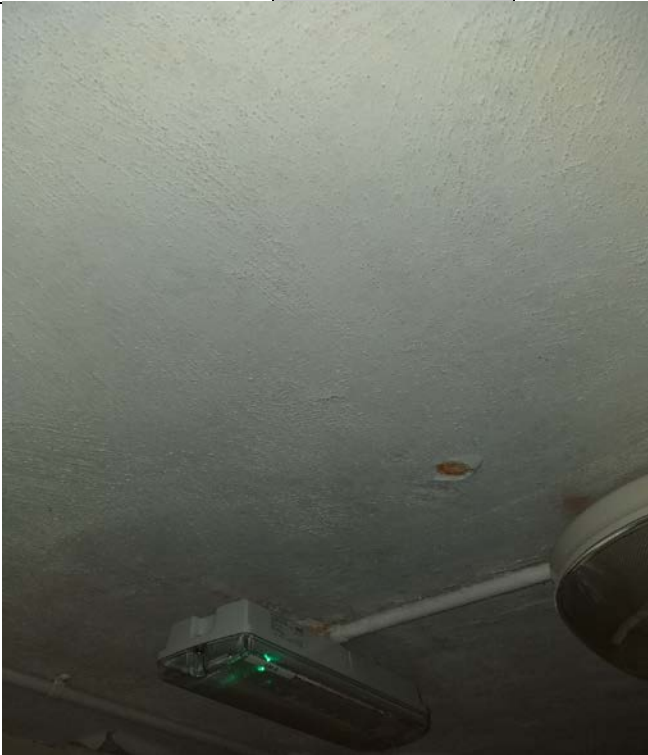
Photo Number	8	Reference number	220520RI08
Inspection / Sample	Inspection	Inspection Cross Reference / Visual I.D.	14/4/B/17/SG18

Notes	NADIS: No asbestos detected in sample

Building	Saxilby Boxing Club	Condition	Fair	1
Floor Level	Ground	Surface Treatment	Composite materials, reinforced plastics, resin, vinyl materials	0
Location	06 / Disabled Toilet	Material Friability	Low	1
Feature	Coating to ceiling	Asbestos Type	Strongly Presumed N.A.D.I.S	0
Material Type	Textured Coating			
Extent				
Recommendation	No action necessary	Assessment Score		0
		Assessment Band		E

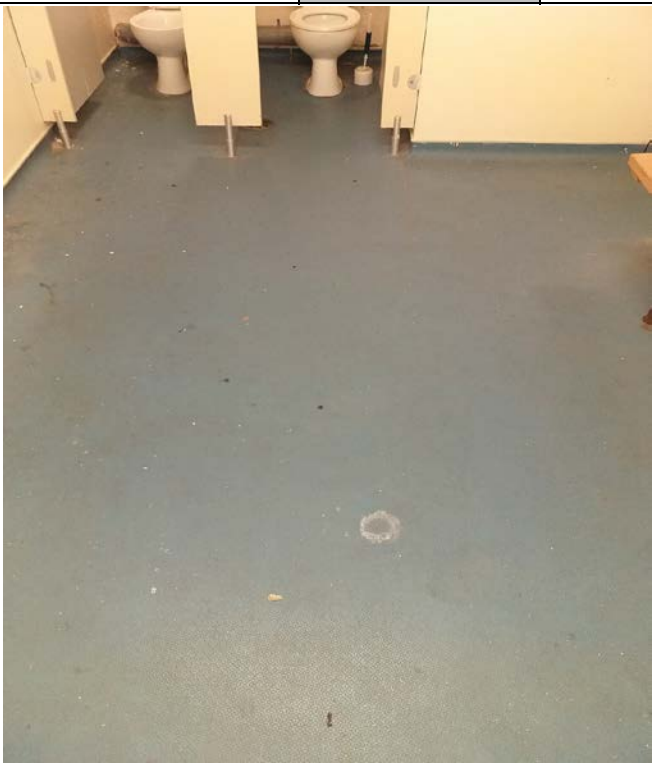
Photo Number	9	Reference number	220520RI09
Inspection / Sample	Inspection	Inspection Cross Reference / Visual I.D.	14/4/B/17/SG19

Notes	NADIS: No asbestos detected in sample

Building	Saxilby Boxing Club	Condition	Good	0
Floor Level	Ground	Surface Treatment	Composite materials, reinforced plastics, resin, vinyl materials	0
Location	07 / Changing room	Material Friability	Low	1
Feature	Vinyl floor covering	Asbestos Type	Strongly Presumed N.A.D.I.S	0
Material Type	Floor Tile / Covering			
Extent				
Recommendation	No action necessary	Assessment Score		0
		Assessment Band		E

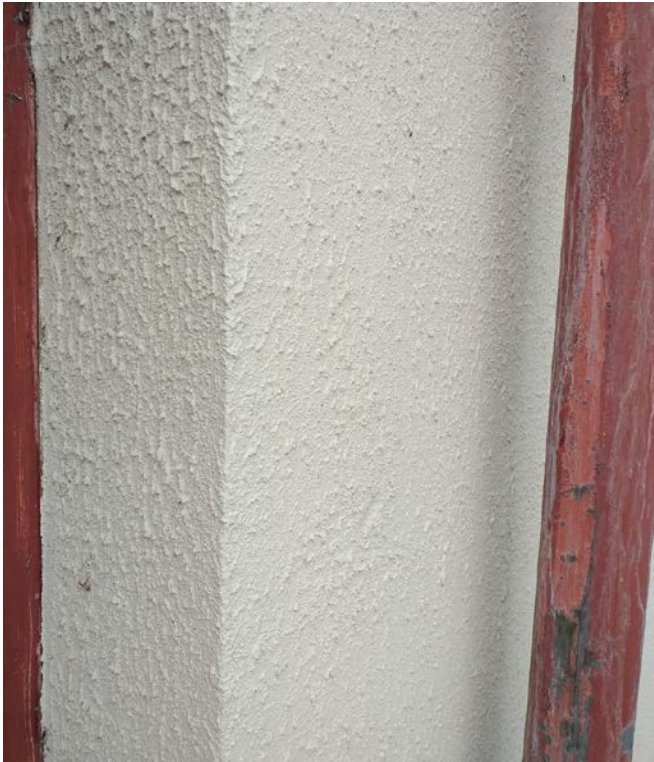
Photo Number	20	Reference number	220520RI20
Inspection / Sample	Inspection	Inspection Cross Reference / Visual I.D.	14/4/B/17/SG20

Notes	NADIS: No asbestos detected in sample

Building	Saxilby Boxing Club	Condition	Good	0
Floor Level	Ground	Surface Treatment	Composite materials, reinforced plastics, resin, vinyl materials	0
Location	20 / External	Material Friability	Low	1
Feature	Coating to wall	Asbestos Type	Strongly Presumed N.A.D.I.S	0
Material Type	Textured Coating			
Extent				
Recommendation	No action necessary	Assessment Score		0
		Assessment Band		E
