Hesbert Hall
Gisburn Forest
Skipton
North Yorkshire
BD234TA

Safer Asbestos Solutions Ltd Refurbishment Asbestos Survey

04th of August 2015

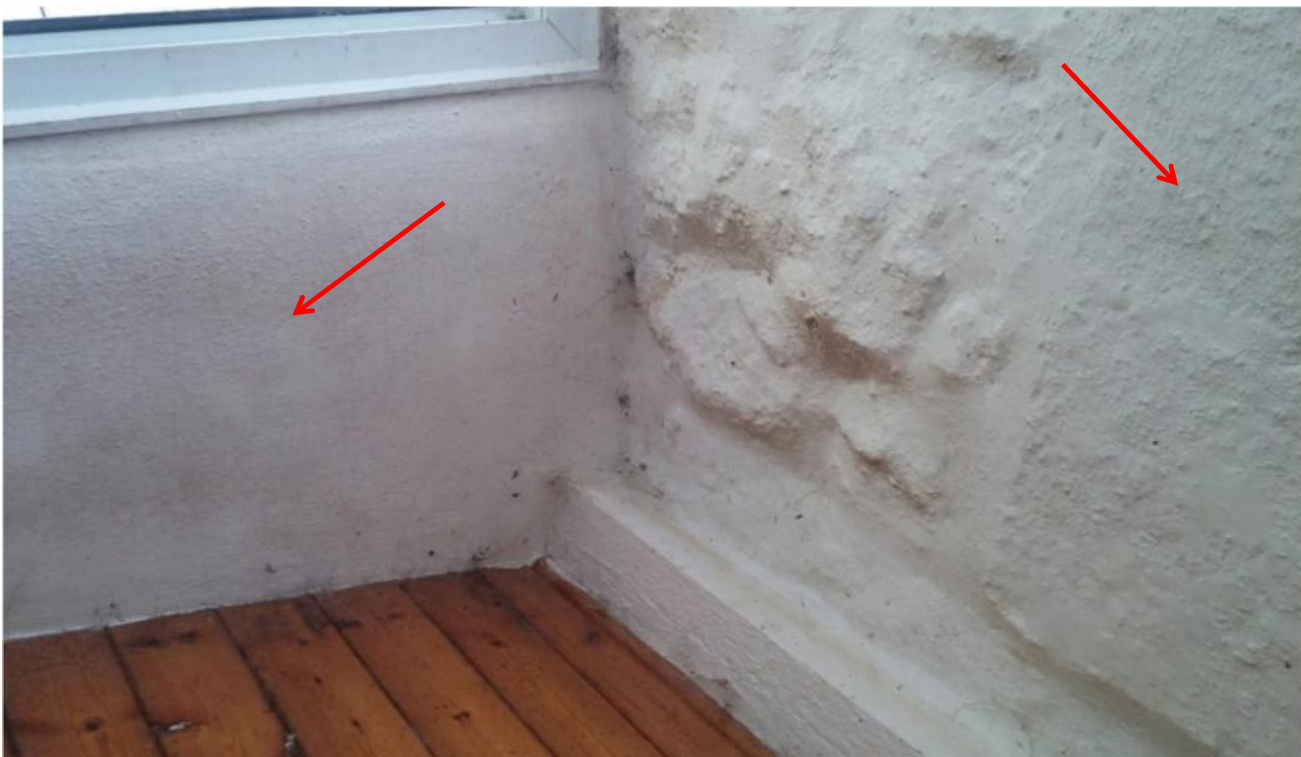
Photo Number	1	Reference number	040815TM-01
Inspection / Sample	Sample	Inspection Cross Reference / Visual I.D.	Not Applicable

Notes	Textured Coating To Porch

Building	Hesbert Hall	Condition	Poor	2
Floor Level	Ground	Surface Treatment	Composite materials containing asbestos: reinforced plastics, resins, vinyl tiles	0
Location	Area 01 - Porch	Material Friability	Low	1
Feature	Textured Coating	Asbestos Type	N.A.D.I.S	0
Material Type	Textured Coating	Accessibility	High	2
Extent	10 sq. m.	Position	Internal	1
Recommendation	No Asbestos Detected. No Further Action Required.		Assessment Score	0
			Assessment Band	E

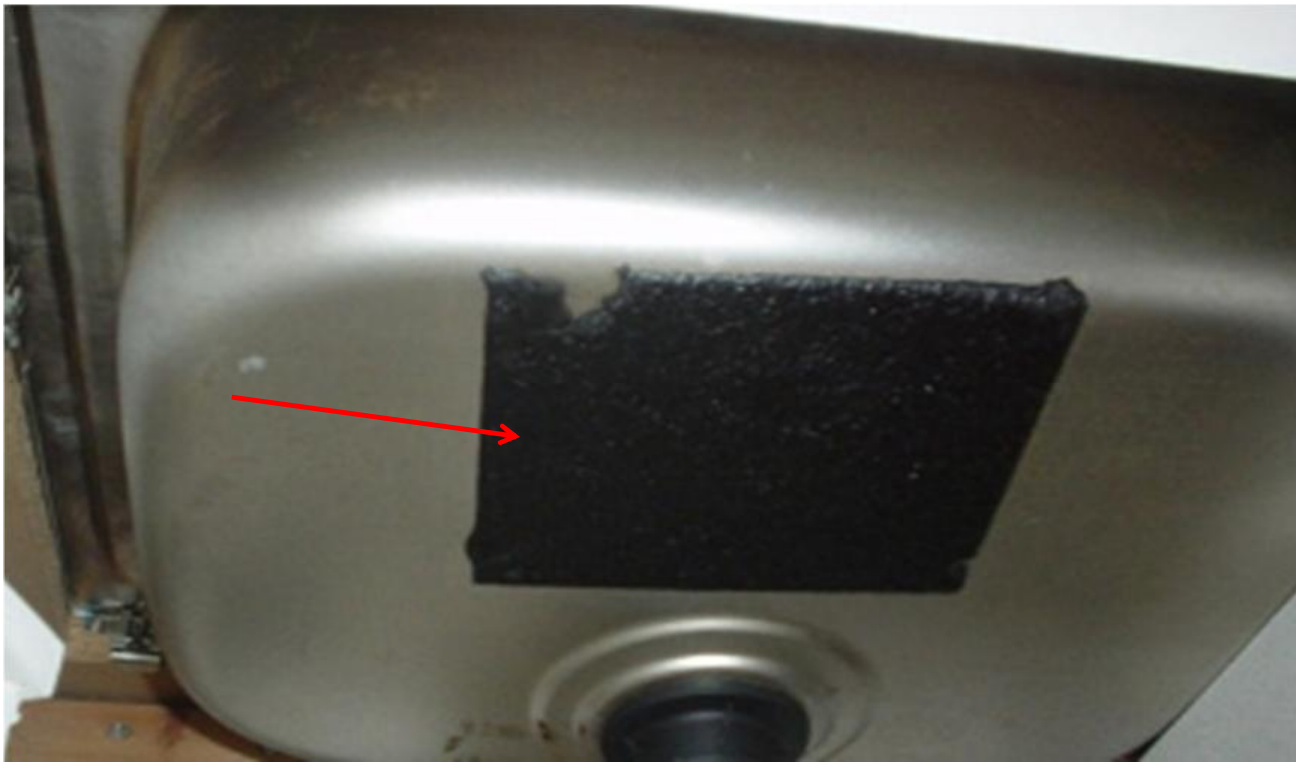
Photo Number	2	Reference number	040815TM-02
Inspection / Sample	Sample	Inspection Cross Reference / Visual I.D.	Not Applicable

Notes	Bitumen Sink Pad

Building	Hesbert Hall	Condition	Fair	1
Floor Level	Ground	Surface Treatment	Composite materials containing asbestos: reinforced plastics, resins, vinyl tiles	0
Location	Room 02 - Kitchen	Material Friability	Low	1
Feature	Sink Pad	Asbestos Type	N.A.D.I.S	0
Material Type	Bitumen	Accessibility	High	2
Extent	1 No.	Position	Internal	1
Recommendation	No Asbestos Detected. No Further Action Required.		Assessment Score	0
			Assessment Band	E

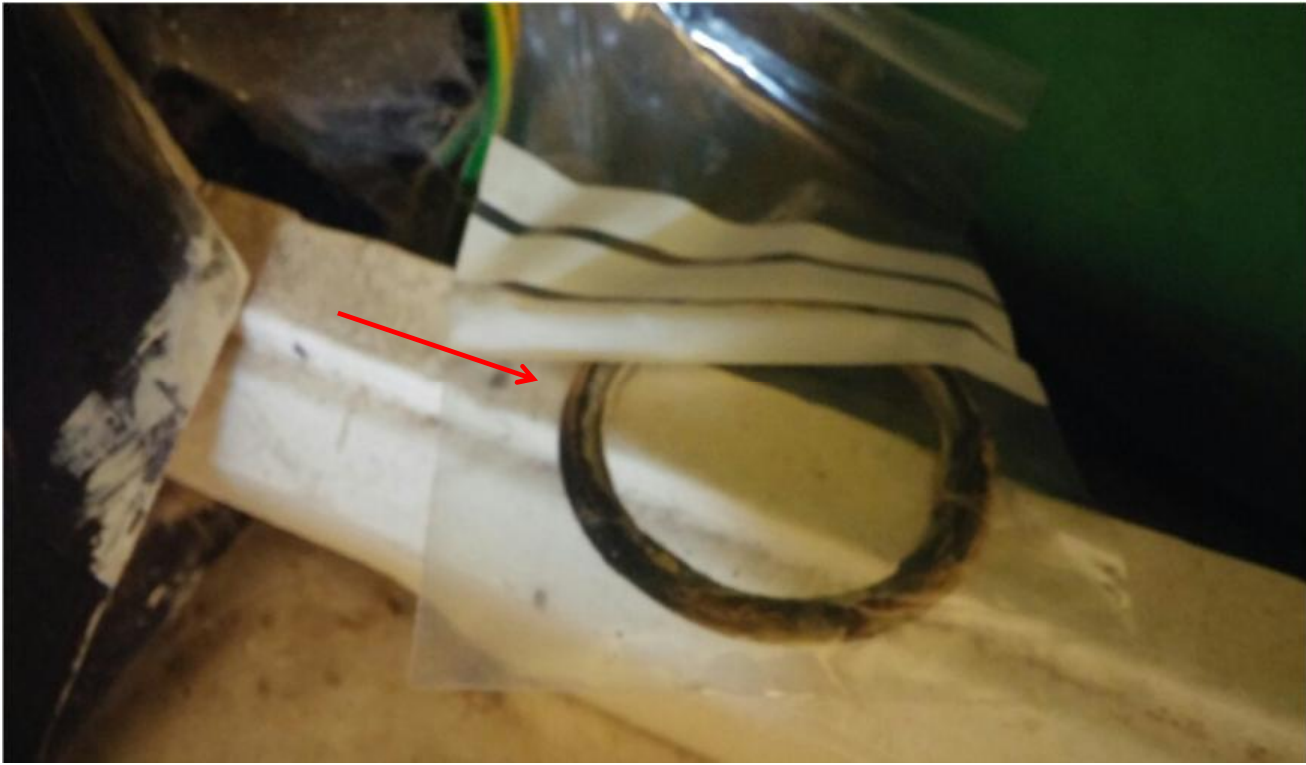
Photo Number	7	Reference number	040715TM-07
Inspection / Sample	Sample	Inspection Cross Reference / Visual I.D.	Not Applicable

Notes	Gasket To Boiler Pipe Work Within Boxing - REMOVED AS SAMPLE

Building	Hesbert Hall	Condition	Fair	1
Floor Level	1st floor	Surface Treatment	Composite materials containing asbestos: reinforced plastics, resins, vinyl tiles	0
Location	Room 102	Material Friability	Medium	2
Feature	Gasket	Asbestos Type	N.A.D.I.S	0
Material Type	Gasket / Seal	Accessibility	High	2
Extent	1 No.	Position	Internal	1
Recommendation	No Asbestos Detected. No Further Action Required.		Assessment Score	0
			Assessment Band	E

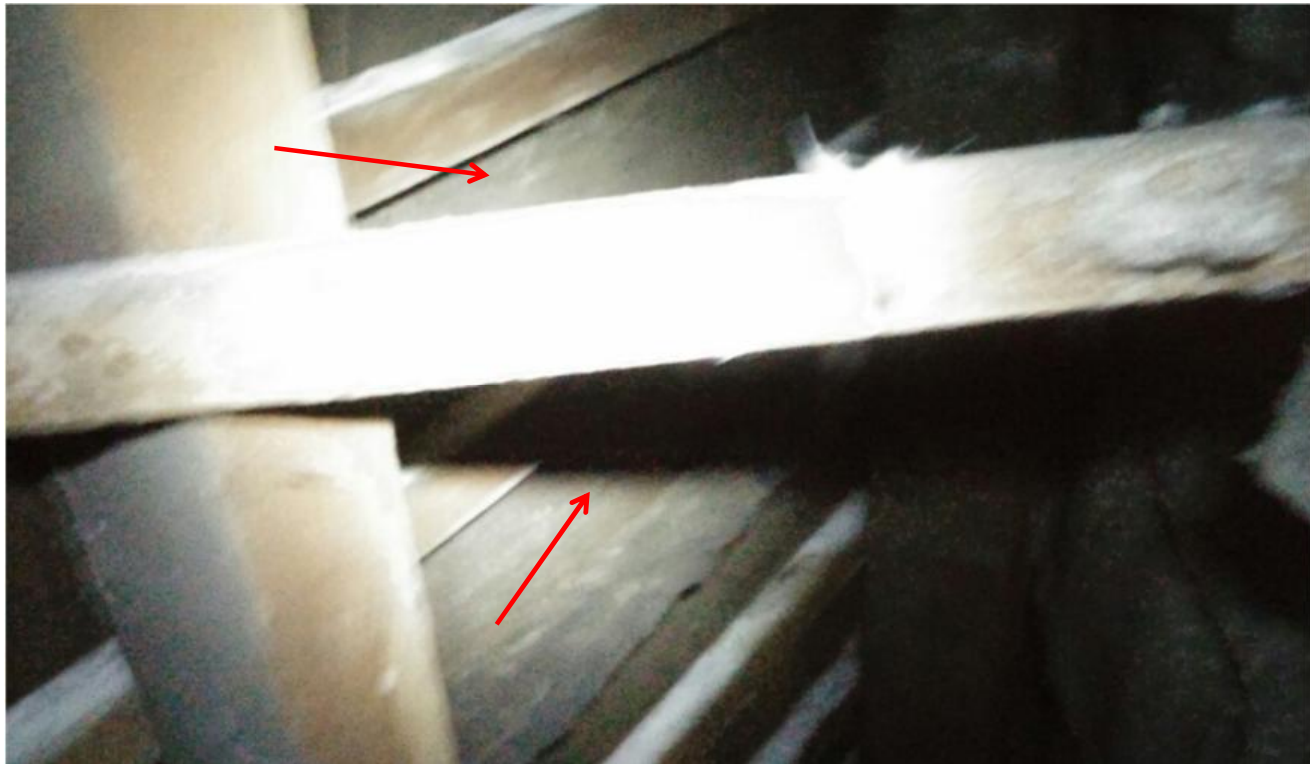
Photo Number	8	Reference number	040815TM-08
Inspection / Sample	Inspection	Inspection Cross Reference / Visual I.D.	Visual Identification

Asbestos Bitumen Sarkin Felt was presumed within the loft area due to limited access (please see plans for exact locations). The material was located in a good condition and was sealed. As such the material poses a very low risk to human health. It is recommended that the material inspected further as per CAR2012 prior to works commencing if likely to be disturbed.

Notes	Sarkin To Roof

Building	Hesbert Hall	Condition	Fair	1
Floor Level	Roof	Surface Treatment	Composite materials containing asbestos: reinforced plastics, resins, vinyl tiles	0
Location	Loft	Material Friability	Low	1
Feature	Sarkin	Asbestos Type	Presumed Chrysotile (White)	1
Material Type	Bitumen	Accessibility	Low	0
Extent	Throughout sq. m.	Position	Internal	1
Recommendation	Investigate Further Once Safe Access Can Be Arranged As Per CAR2012.	Assessment Score		4
		Assessment Band		D

Removal of Bitumen Sarkin Felt **does not necessitate** the use of a licensed asbestos removal contractor, and should be carried out in line with current asbestos legislation and guidance documents to ensure safe and appropriate working practice. An air-monitoring regime appropriate to the works undertaken should also be instigated to accompany any removal works. Key legislation and guidance that should be adhered to during the course of such works will include:
