Refurbishment Survey

Horsforth Town Council
3 The Green
Town Street Horsforth
LS18 4RH

Site Address	Building Designation	Building Description	Age of building
Horsforth Town Council 3 The Green Town Street Horsforth	Horsforth Town Council	Council Offices	1800s
General Building Construction Type <small>*Individual room construction can be found within Appendix 3 of this report</small>			
Mixed

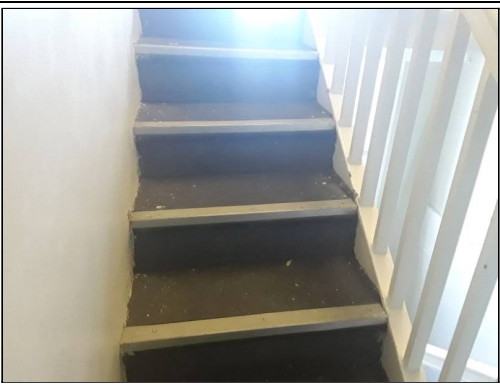
Survey Date:	Lead Surveyor	Survey Type	Floor	Analysis
	13 Oct 2022	Ant Green	Refurbishment Survey	2nd Floor	Chrysotile (1)
	Building	Room	Item	Quantity	
	Horsforth Town Council	Stairs/landing - 206	Grey stair nosings	18no.	
	Sample No (S,SP,P,As)	Product Type	Surface Treatment	Condition	Accessibility
	S MF001017	Reinforced Composite (1)	Completely Sealed (0)	Low Damage (1)	Routinely disturbed
Material Risk Score					
3					
Recommended action	Remove				
Surveyor comments	N/A

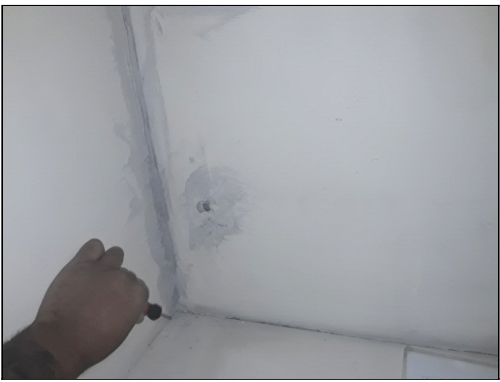
Building	Floor	Room	Item	Material	Risk assessment Score	Recommendations
Horsforth Town Council	1st	Cupboard 101	Cement panels lining ceiling and walls, with associated debris to shelf top	Asbestos Cement	MEDIUM (7)	Restrict access/remove

Survey Date:	Lead Surveyor	Survey Type	Floor	Analysis
	13 Oct 2022	Ant Green	Refurbishment Survey	1st Floor	Chrysotile (1)
	Building	Room	Item	Quantity	
	Horsforth Town Council	Cupboard - 101	Cement panels lining ceiling and walls, with associated debris to shelf top	2m	
	Sample No (S,SP,P,As)	Product Type	Surface Treatment	Condition	Accessibility
	S MF001019	Asbestos Cement (1)	Unsealed (2)	High Damage (3)	Routinely disturbed
	Material Risk Score				
7					
Recommended action	Restrict access/remove				
Surveyor comments	N/A

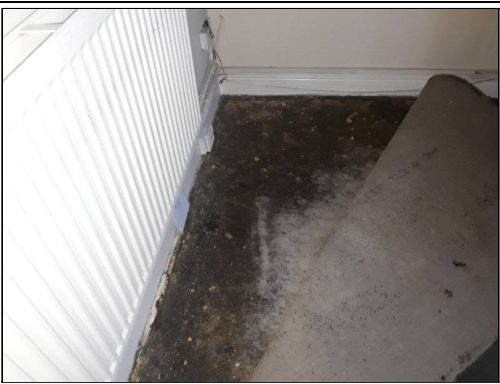
Survey Date:	Lead Surveyor	Survey Type	Floor	Analysis
	13 Oct 2022	Ant Green	Refurbishment Survey	Ground Floor	Chrysotile (1)
	Building	Room	Item	Quantity	
	Horsforth Town Council	Office - G01	Bitumen adhesive to floor beneath carpet	8m ²	
	Sample No (S,SP,P,As)	Product Type	Surface Treatment	Condition	Accessibility
	S MF001020	Reinforced Composite (1)	Completely Sealed (0)	Low Damage (1)	Routinely disturbed
	Material Risk Score				
3					
Recommended action	Remove				
Surveyor comments	N/A

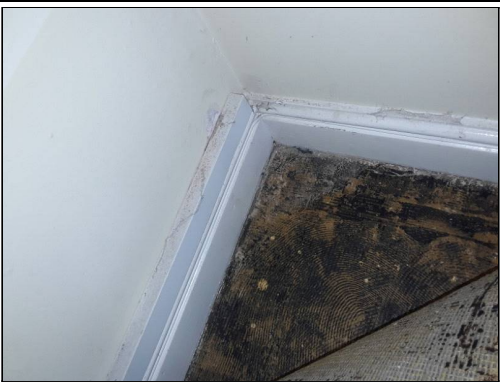
Survey Date:	Lead Surveyor	Survey Type	Floor	Analysis
	13 Oct 2022	Ant Green	Refurbishment Survey	Ground Floor	Chrysotile (1)
	Building	Room	Item	Quantity	
	Horsforth Town Council	Office - G02	Bitumen adhesive to floor beneath carpet	8m ²	
	Sample No (S,SP,P,As)	Product Type	Surface Treatment	Condition	Accessibility
	As MF001020	Reinforced Composite (1)	Completely Sealed (0)	Low Damage (1)	Routinely disturbed
	Material Risk Score				
3					
Recommended action	Remove				
Surveyor comments	N/A

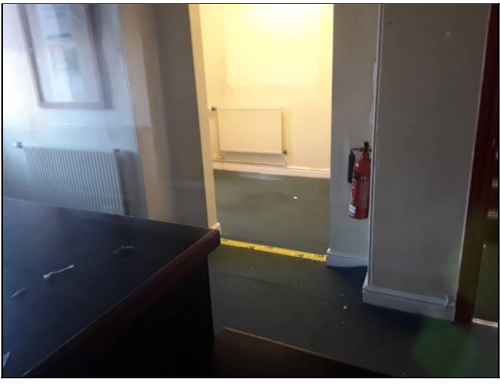
Survey Date:	Lead Surveyor	Survey Type	Floor	Analysis
	13 Oct 2022	Ant Green	Refurbishment Survey	Ground Floor	Chrysotile (1)
	Building	Room	Item	Quantity	
	Horsforth Town Council	Reception area - G03	Bitumen adhesive to floor beneath carpet	8m ²	
	Sample No (S,SP,P,As)	Product Type	Surface Treatment	Condition	Accessibility
	As MF001020	Reinforced Composite (1)	Completely Sealed (0)	Low Damage (1)	Routinely disturbed
	Material Risk Score				
3					
Recommended action	Remove				
Surveyor comments	N/A

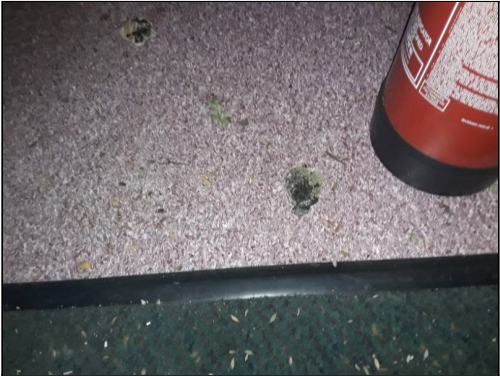
Survey Date:	Lead Surveyor	Survey Type	Floor	Analysis
	13 Oct 2022	Ant Green	Refurbishment Survey	Ground Floor	Chrysotile (1)
	Building	Room	Item	Quantity	
	Horsforth Town Council	Entrance Lobby - G05	Bitumen adhesive to floor beneath carpet and modern vinyl	8m ²	
	Sample No (S,SP,P,As)	Product Type	Surface Treatment	Condition	Accessibility
	As MF001020	Reinforced Composite (1)	Completely Sealed (0)	Low Damage (1)	Routinely disturbed
	Material Risk Score				
3					
Recommended action	Remove				
Surveyor comments	N/A

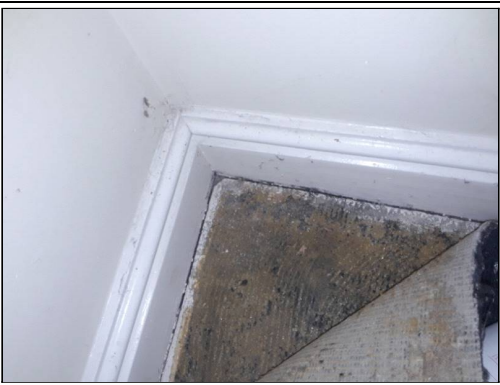
Survey Date:	Lead Surveyor	Survey Type	Floor	Analysis
	13 Oct 2022	Ant Green	Refurbishment Survey	Ground Floor	Chrysotile (1)
	Building	Room	Item	Quantity	
	Horsforth Town Council	Staff Room - G09	Bitumen adhesive to floor beneath carpet	15m ²	
	Sample No (S,SP,P,As)	Product Type	Surface Treatment	Condition	Accessibility
	As MF001020	Reinforced Composite (1)	Completely Sealed (0)	Low Damage (1)	Routinely disturbed
	Material Risk Score				
3					
Recommended action	Remove				
Surveyor comments	N/A

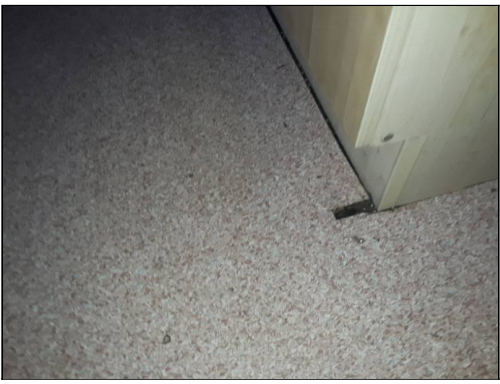
Survey Date:	Lead Surveyor	Survey Type	Floor	Analysis
	13 Oct 2022	Ant Green	Refurbishment Survey	Ground Floor	Chrysotile (1)
	Building	Room	Item	Quantity	
	Horsforth Town Council	Kitchen - G10	Bitumen adhesive to floor beneath carpet	9m ²	
	Sample No (S,SP,P,As)	Product Type	Surface Treatment	Condition	Accessibility
	As MF001020	Reinforced Composite (1)	Completely Sealed (0)	Low Damage (1)	Routinely disturbed
	Material Risk Score				
3					
Recommended action	Remove				
Surveyor comments	N/A

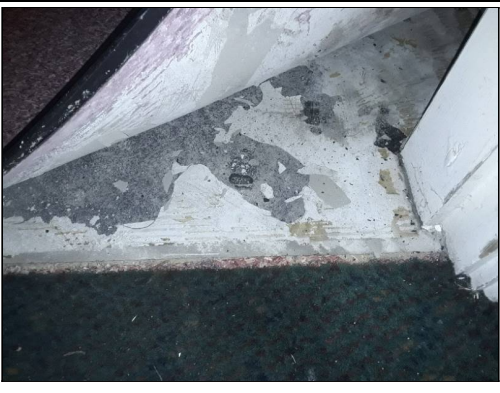
Survey Date:	Lead Surveyor	Survey Type	Floor	Analysis
	13 Oct 2022	Ant Green	Refurbishment Survey	Ground Floor	Chrysotile (1)
	Building	Room	Item	Quantity	
	Horsforth Town Council	Toilet - G11	Bitumen adhesive to floor beneath modern vinyl	2m ²	
	Sample No (S,SP,P,As)	Product Type	Surface Treatment	Condition	Accessibility
	As MF001020	Reinforced Composite (1)	Completely Sealed (0)	Low Damage (1)	Routinely disturbed
Material Risk Score					
3					
Recommended action	Remove				
Surveyor comments	N/A

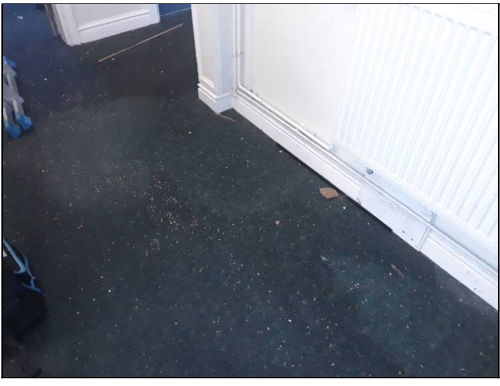
Survey Date:	Lead Surveyor	Survey Type	Floor	Analysis
	13 Oct 2022	Ant Green	Refurbishment Survey	Ground Floor	Chrysotile (1)
	Building	Room	Item	Quantity	
	Horsforth Town Council	Lobby - G12	Bitumen adhesive to floor beneath carpet	10m ²	
	Sample No (S,SP,P,As)	Product Type	Surface Treatment	Condition	Accessibility
	As MF001020	Reinforced Composite (1)	Completely Sealed (0)	Low Damage (1)	Routinely disturbed
Material Risk Score					
3					
Recommended action	Remove				
Surveyor comments	N/A

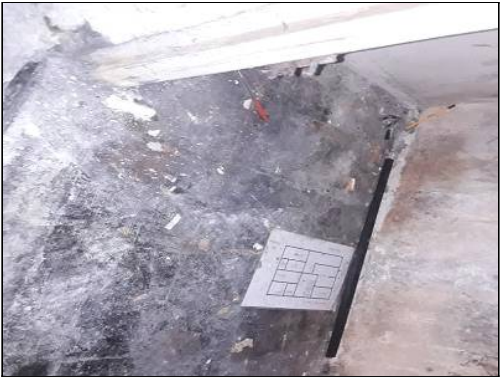
Horsforth Town Council	Z-Sub Level 1	Stairs/landing area - Z101 - Bitumen adhesive to landing area	As MF001020	Reinforced Composite	Low Damage	Completely Sealed	Chrysotile	1m ²	Routinely disturbed	3	Remove	N/A

Survey Date:	Lead Surveyor	Survey Type	Floor	Analysis
	13 Oct 2022	Ant Green	Refurbishment Survey	Z-Sub Level 1	Chrysotile (1)
	Building	Room	Item	Quantity	
	Horsforth Town Council	Stairs/landing area - Z101	Bitumen adhesive to landing area	1m ²	
	Sample No (S,SP,P,As)	Product Type	Surface Treatment	Condition	Accessibility
	As MF001020	Reinforced Composite (1)	Completely Sealed (0)	Low Damage (1)	Routinely disturbed
	Material Risk Score				
3					
Recommended action	Remove				
Surveyor comments	N/A
