Jewish Cemetery, Ponsharden

Proforma Condition and Repairs Schedule

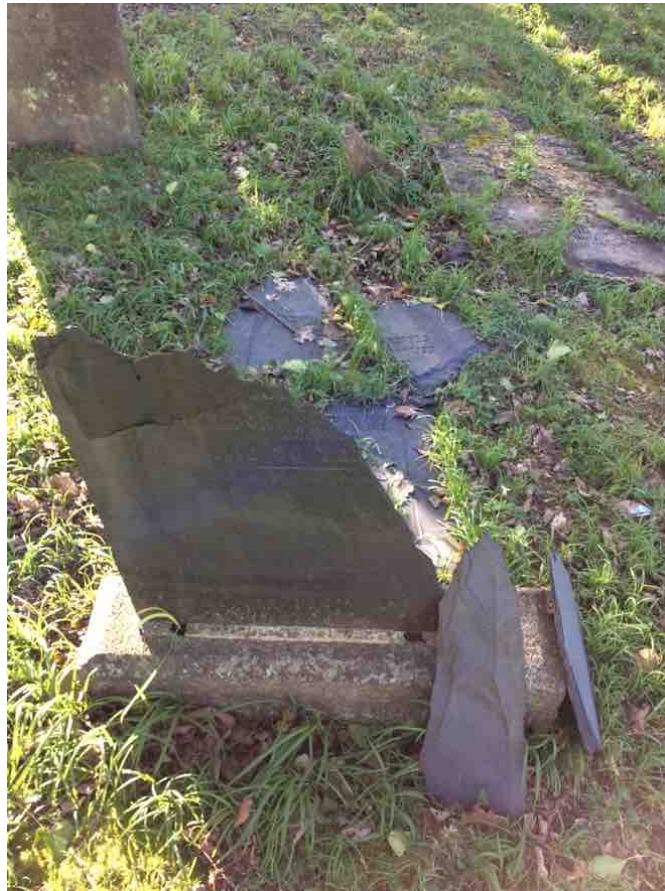
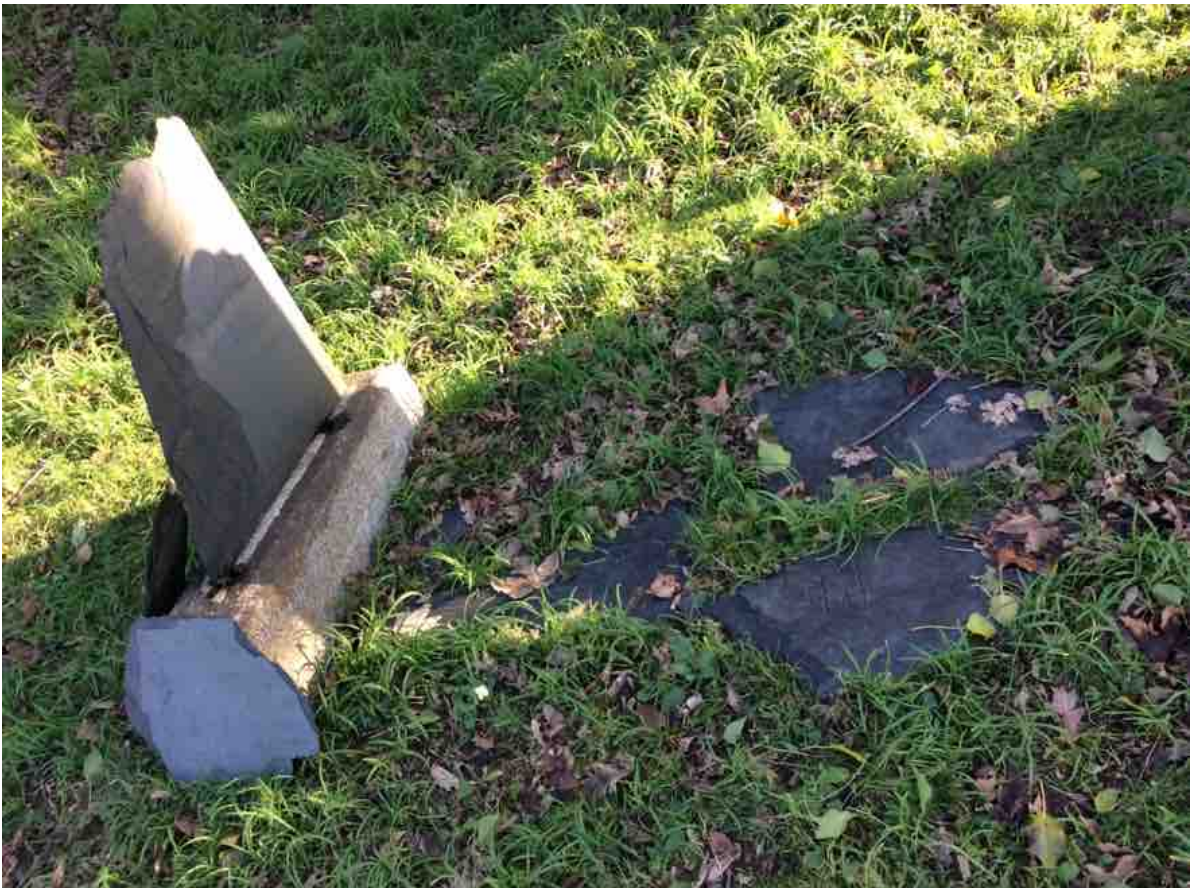
Types of deterioration:	Broken	Headstone broken into 4 main pieces, with some sections missing
Surface condition :	Organic growth	Some green staining
Condition of inscription :	Good

Condition of ironwork:	Corroded	Iron cramps fixing headstone to granite base?
------------------------	----------	---

General condition :	Poor	Heritage significance:	A
General comments:	Granite base has since been re-erected, with broken headstone attached (see photo). High risk of further loss.

Proposed repairs:	Clean off organic growth and dirt. Sink granite base into ground to original depth in original location. Pin surviving sections (4? no plus base) together to 25mm thick slate backing. Make good joints with mortar. Refix to granite base and re-erect headstone.
Schedule of Work clauses:	2.01 and 2.09a

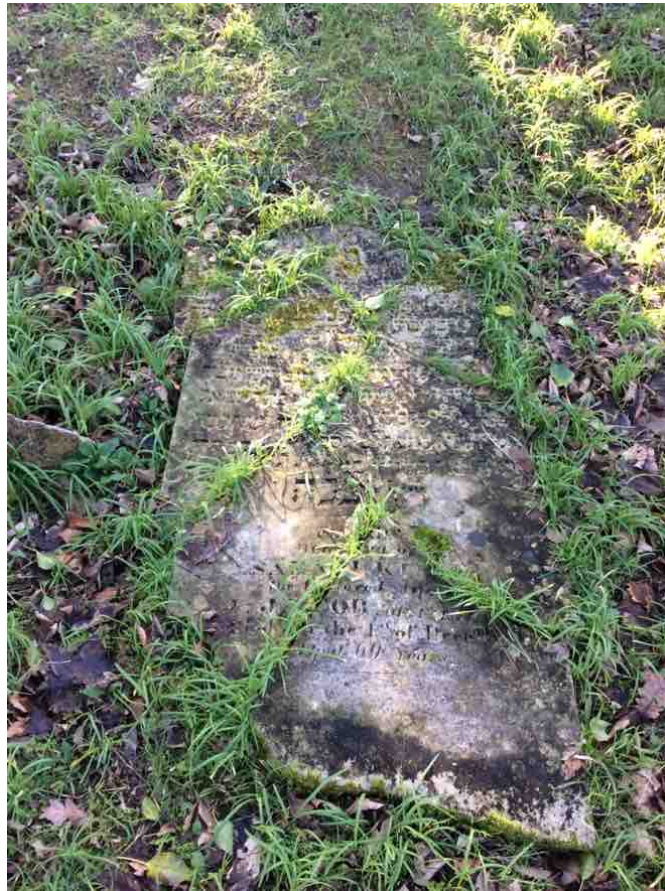
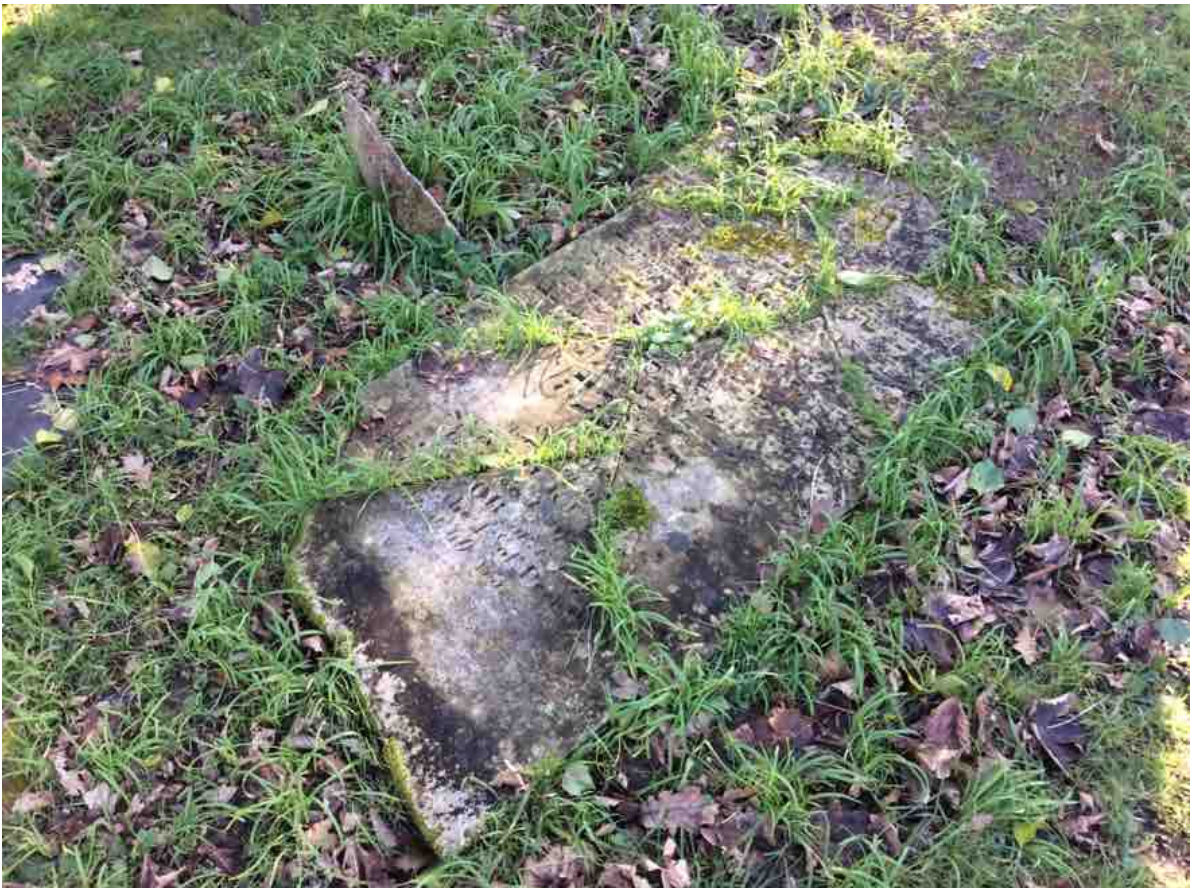
Types of deterioration:	<input type="text" value="Broken"/>	<input type="text" value="Headstone broken into nine main pieces plus fragment still in ground"/>
Surface condition :	<input type="text" value="Organic growth"/>	<input type="text"/>
Condition of inscription :	<input type="text" value="Good"/>	<input type="text" value="Most covered with moss"/>

General condition :	<input type="text" value="Poor"/>	Heritage significance:	<input type="text" value="C"/>
General comments:	<input type="text" value="High risk of further damage. Sandstone broken into several pieces, upright fragment giving true position"/>

Proposed repairs:	<input type="text" value="Clean off organic growth and dirt. Excavate base section. Pin broken sections (9 no plus base) together with stainless steel dowels, and pin to 25mm thick slate backing. Make good joints with mortar. Re-erect in original location."/>
-------------------	---

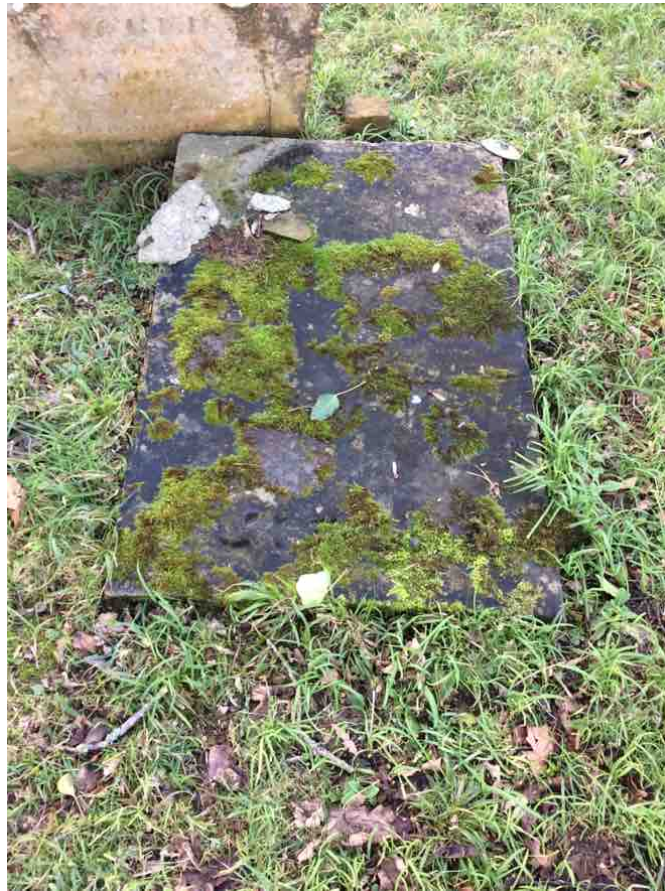
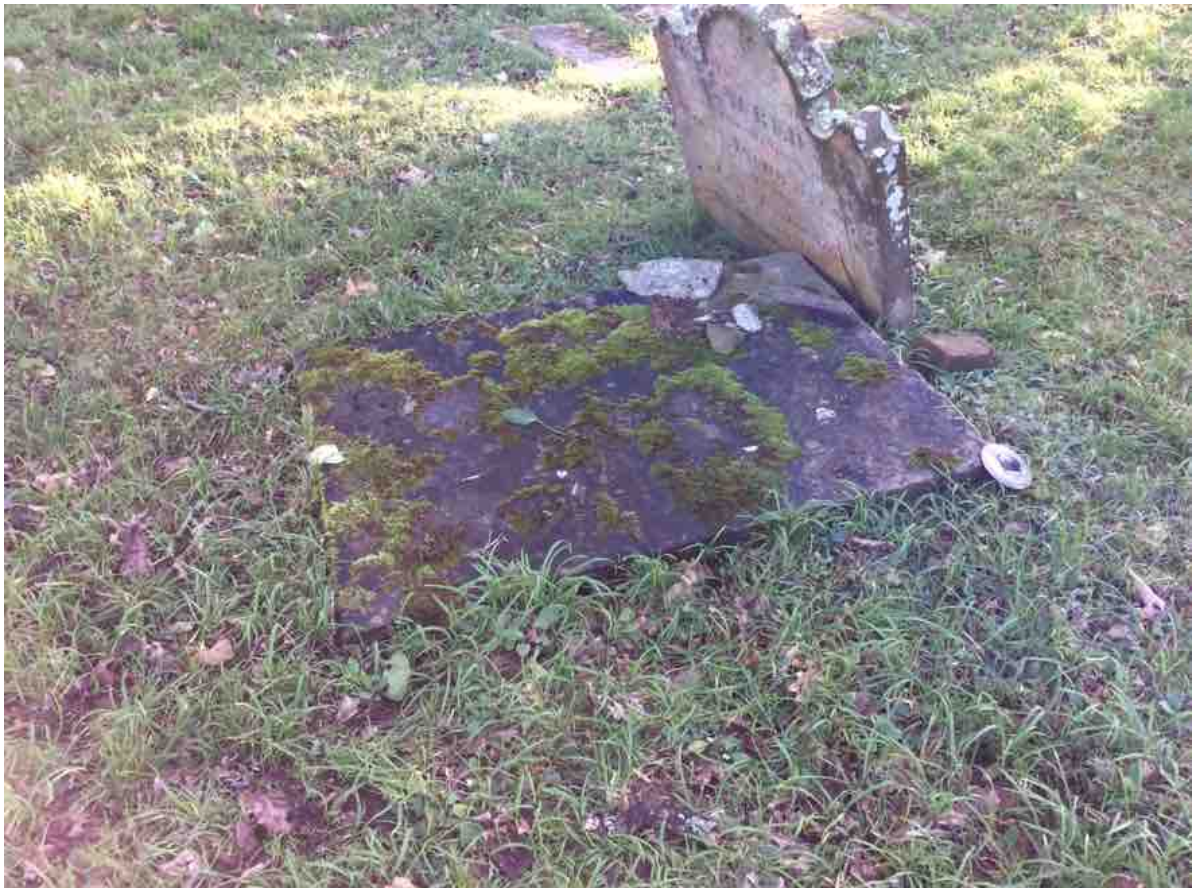
Types of deterioration:	Broken	Broken off at base, but complete
Surface condition :	Organic growth	Moss
Condition of inscription :	Other	Unreadable

General condition :	Fair	Heritage significance:	B
General comments:	Slate intact but lying face down, at risk of further damage if left in current location

Proposed repairs:	Clean off organic growth and dirt. Excavate base and pin base and top of headstone to 25mm thick slate backing. Make good joints with mortar. Re-erect in original location of existing base.
Schedule of Work clauses:	2.02 and 2.09a

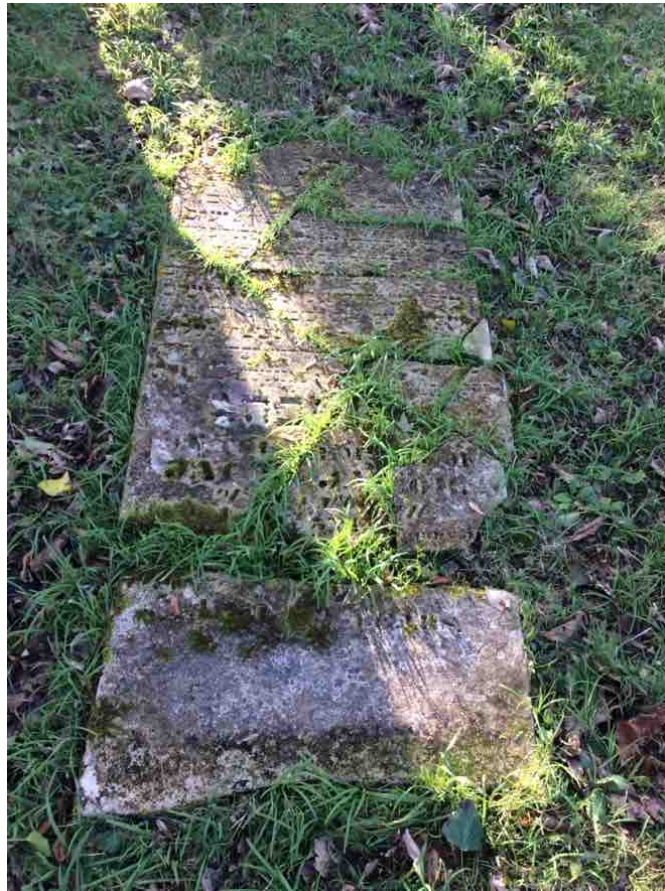
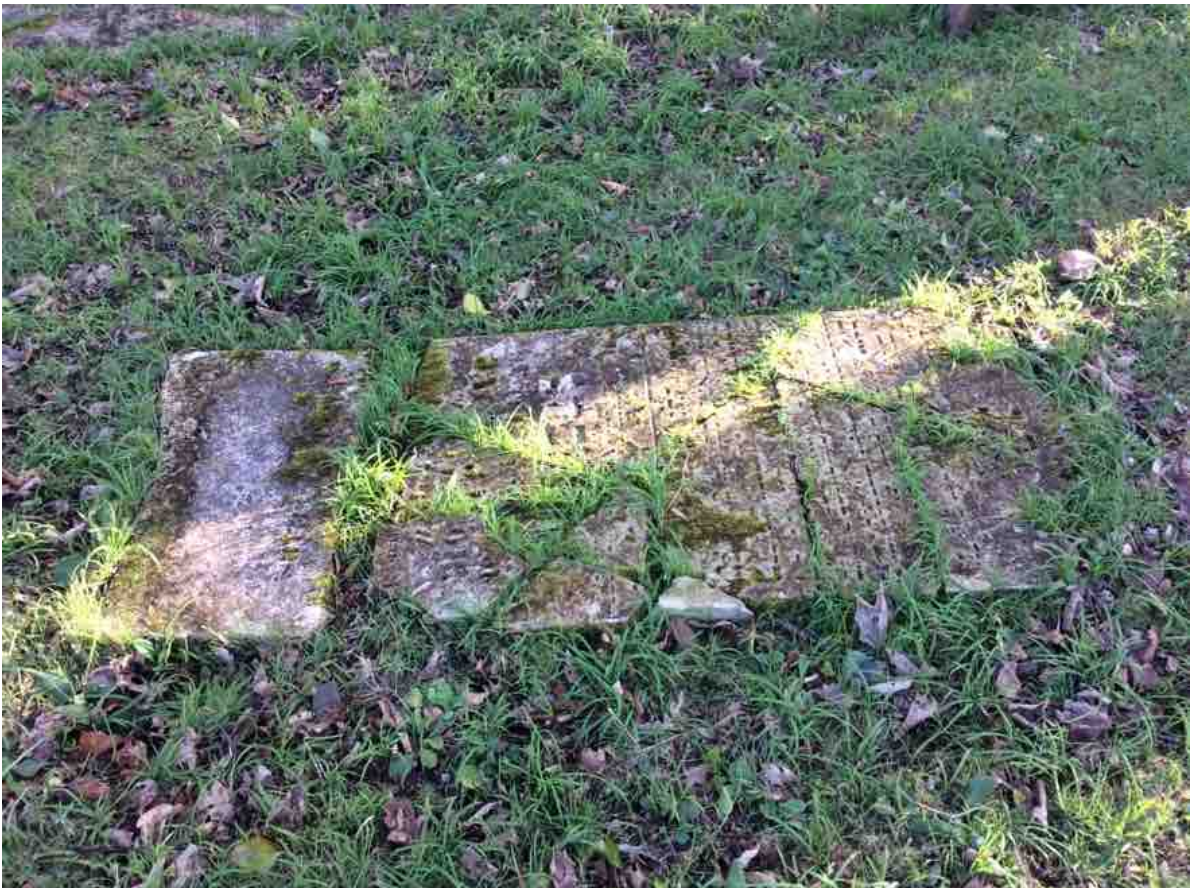
Types of deterioration:	<input type="text" value="Broken"/>	<input type="text" value="Headstone broken into 11 pieces"/>
Surface condition :	<input type="text" value="Organic growth"/>	<input type="text" value="and surface dirt"/>
Condition of inscription :	<input type="text" value="Other"/>	<input type="text" value="Growth and dirt covering parts of inscription"/>

General condition :	<input type="text" value="Poor"/>	Heritage significance:	<input type="text" value="C"/>
General comments:	<input type="text" value="Sandstone broken into several pieces. High risk of further damage"/>

Proposed repairs:	<input type="text" value="Clean off organic growth and dirt. Excavate base section. Pin broken sections (at least 11 no plus base) together with stainless steel dowels, and pin to 25mm thick slate backing. Make good joints with mortar. Re-erect in original location."/>
Schedule of Work clauses:	<input type="text" value="2.04 and 2.09a."/>

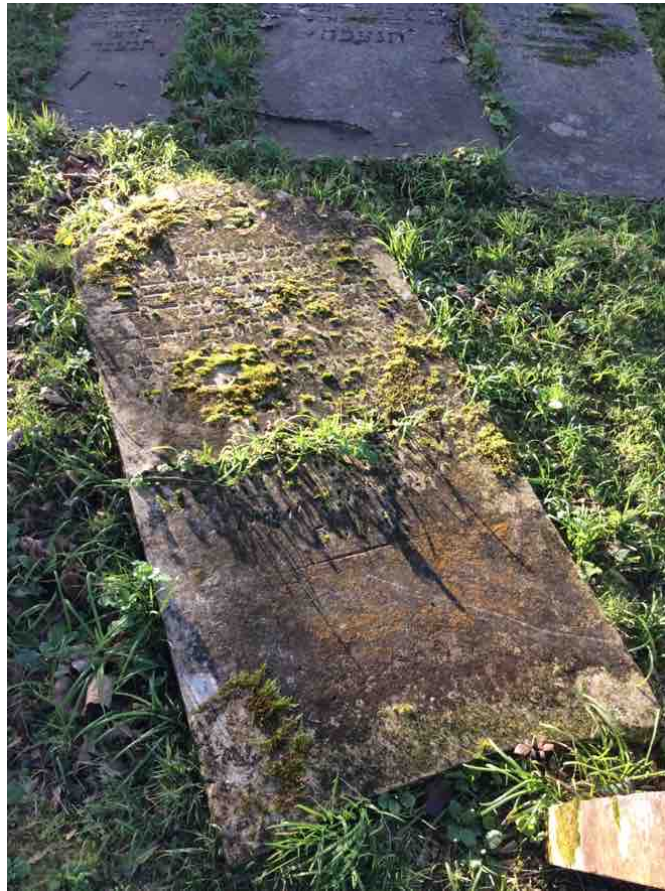
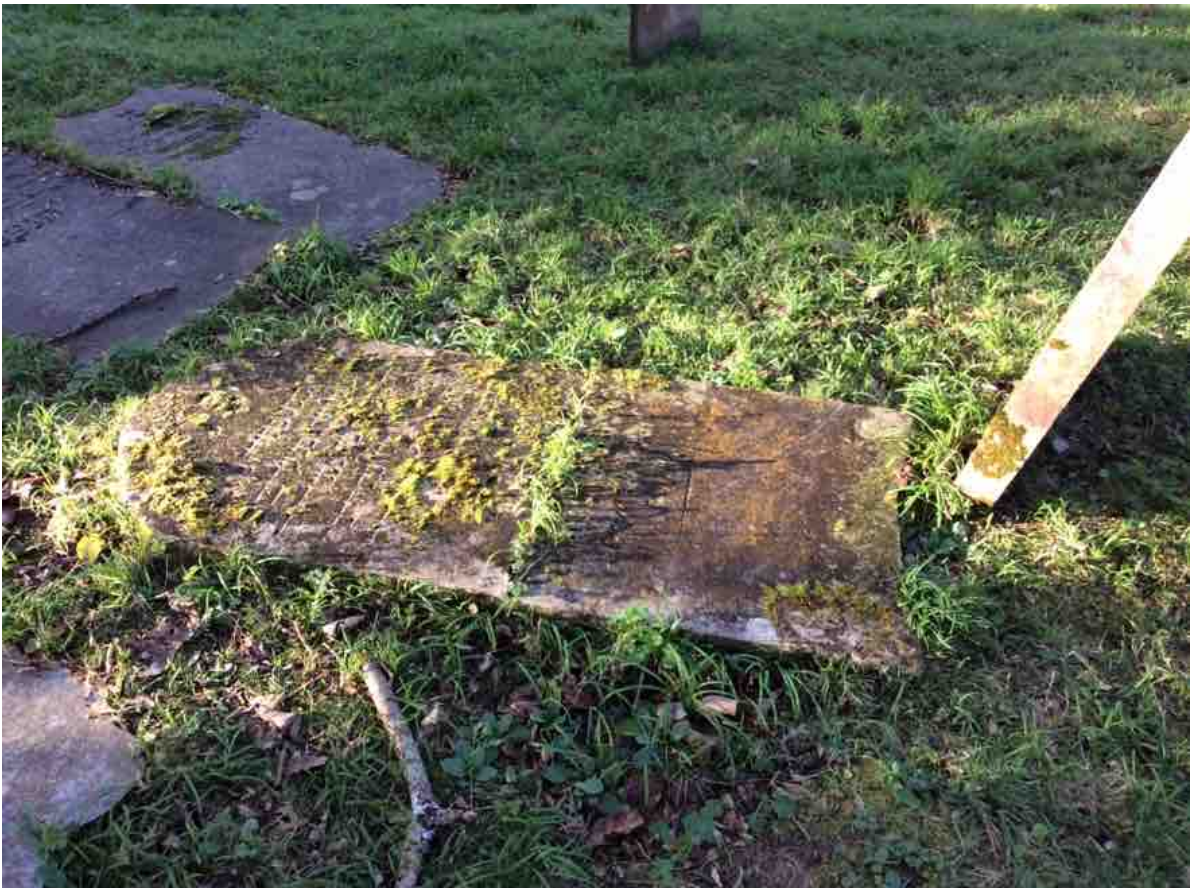
Types of deterioration:	<input type="text" value="Broken"/>	<input type="text" value="Headstone broken off at base?"/>
Surface condition :	<input type="text" value="Surface dirt"/>	<input type="text" value="De-colouration of sandstone"/>
Condition of inscription :	<input type="text" value="Good"/>	<input type="text" value="De-colouration over inscription"/>

General condition :	<input type="text" value="Poor"/>	Heritage significance:	<input type="text" value="B"/>
General comments:	<input type="text" value="Sandstone broken into two pieces. High risk of further damage"/>

Proposed repairs:	<input type="text" value="Clean off organic growth and dirt. Excavate base section. Pin broken sections together (2 no plus base) with stainless steel dowels, and pin to 25mm thick slate backing. Make good joints with mortar. Re-erect in original location."/>
-------------------	---

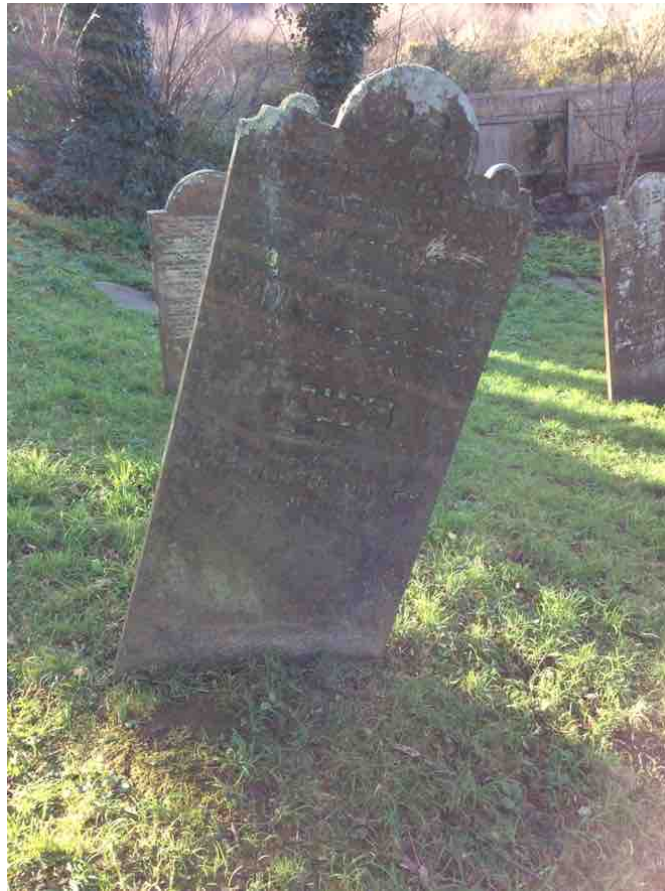
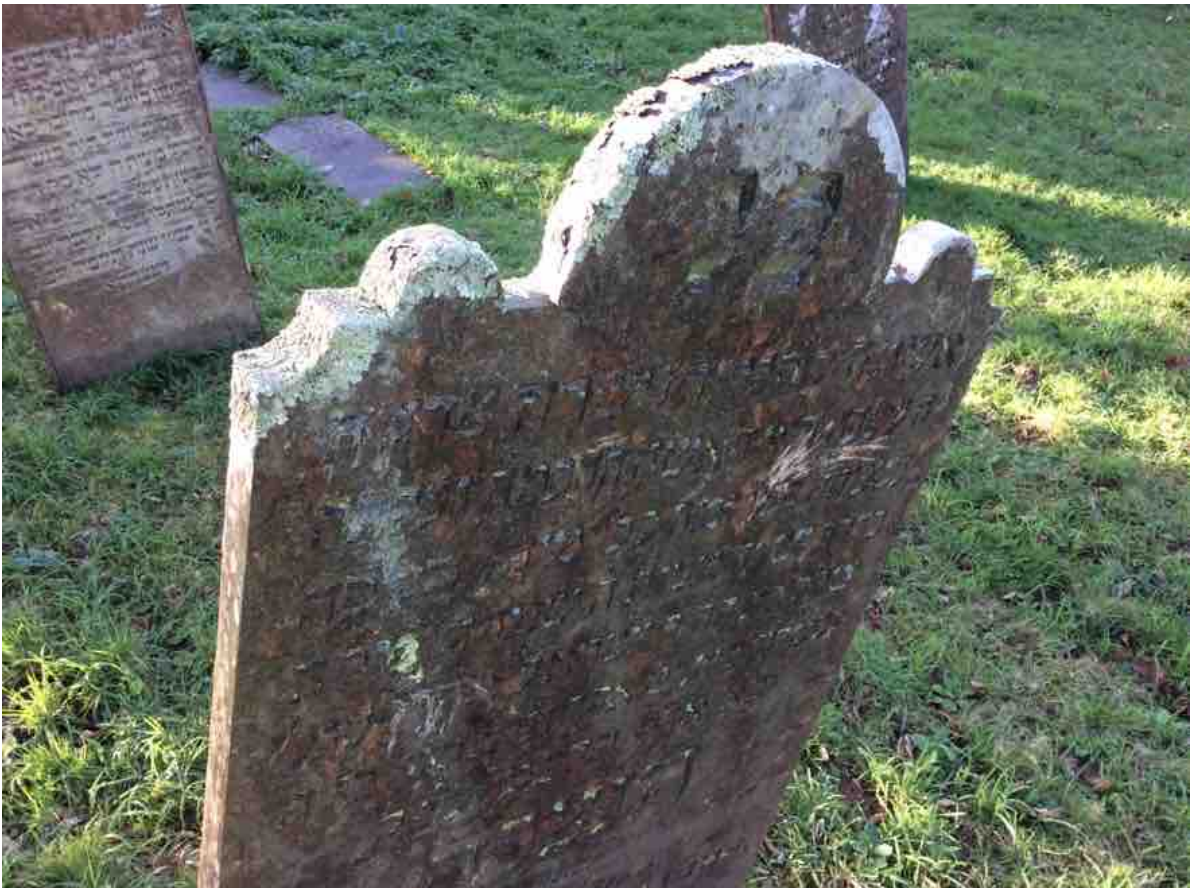
Types of deterioration:	<input type="text" value="Other"/>	<input type="text" value="Leaning headstone"/>
Surface condition :	<input type="text" value="Organic growth"/>	<input type="text" value="Lichen (see photo)"/>
Condition of inscription :	<input type="text" value="Other"/>	<input type="text" value="Some of inscription covered in lichen as above"/>

General condition :	<input type="text" value="Fair"/>	Heritage significance:	<input type="text" value="A"/>
General comments:	<input type="text" value="Sandstone with drastic lean, currently not unstable but may be advisable to deal with during any repair works to avoid need in the future"/>

Proposed repairs:	<input type="text" value="Carefully excavate headstone, and re-set vertically in the same location"/>
Schedule of Work clauses:	<input type="text" value="2.09a"/>

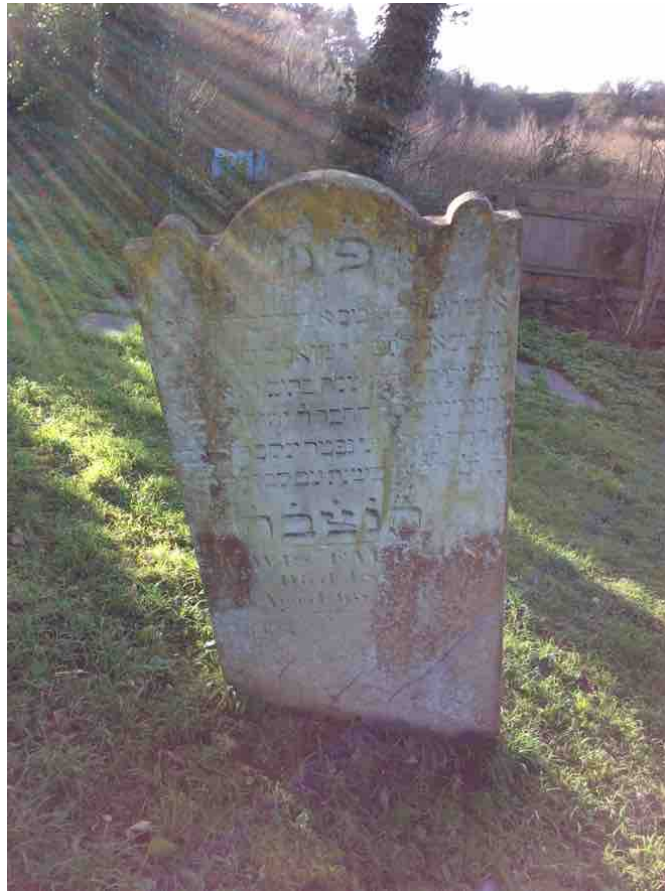
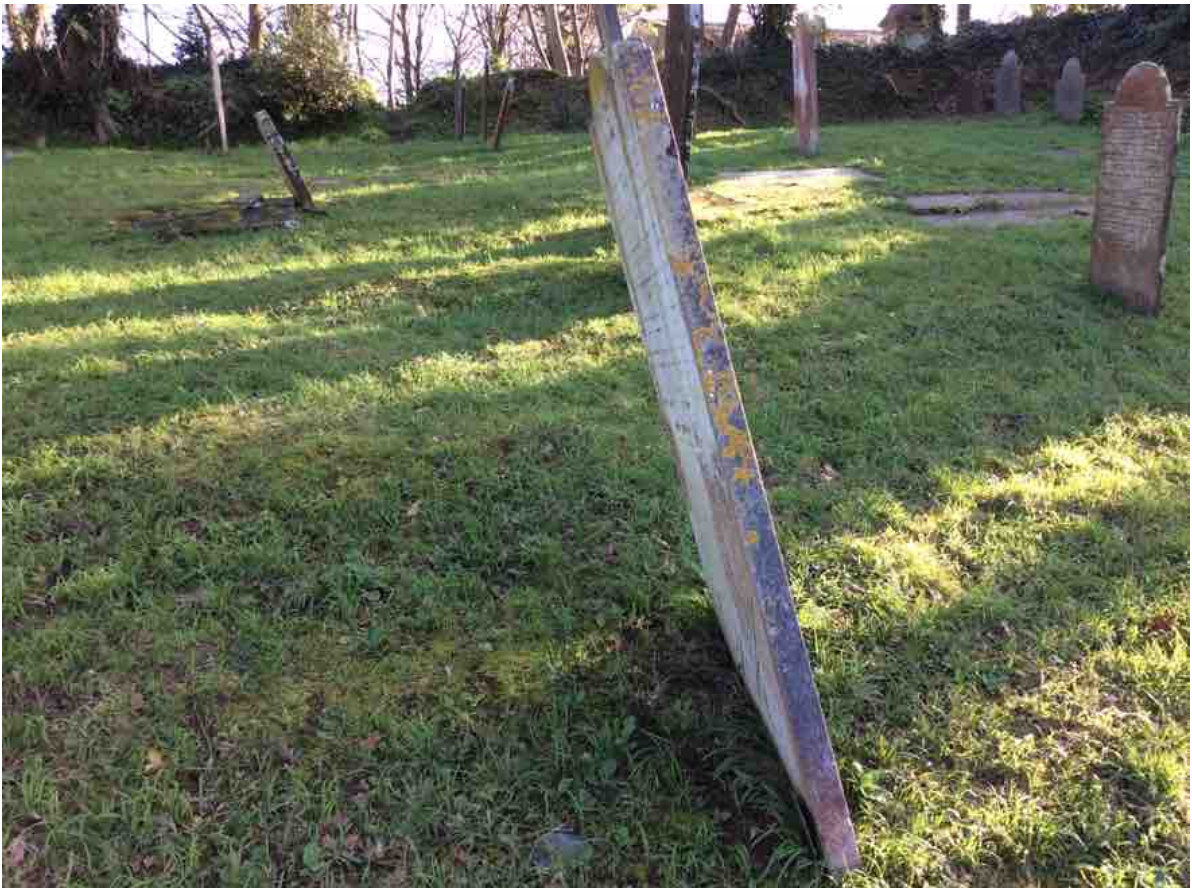
Types of deterioration:	<input type="text" value="Other"/>	<input type="text" value="Leaning headstone"/>
Surface condition :	<input type="text" value="Organic growth"/>	<input type="text" value="Lichen / tree deposit"/>
Condition of inscription :	<input type="text" value="Good"/>	<input type="text" value="Some of inscription covered with growth"/>

General condition :	<input type="text" value="Fair"/>	Heritage significance:	<input type="text" value="A"/>
General comments:	<input type="text" value="Drastic lean, currently not unstable but may be advisable to deal with during any repair works to avoid need in the future."/>

Proposed repairs:	<input type="text" value="Carefully excavate headstone, and re-set vertically in the same location"/>
Schedule of Work clauses:	<input type="text" value="2.09a"/>

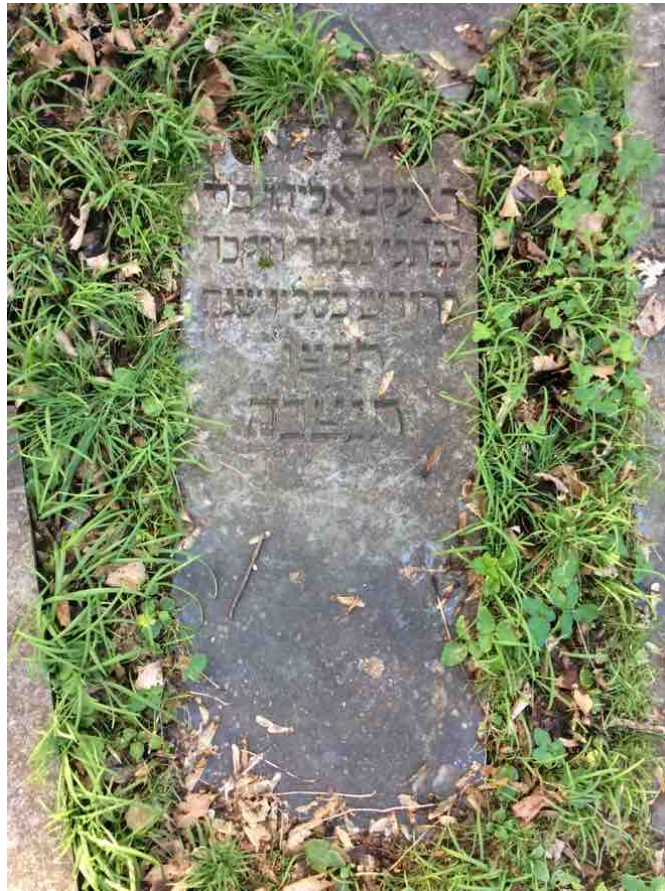
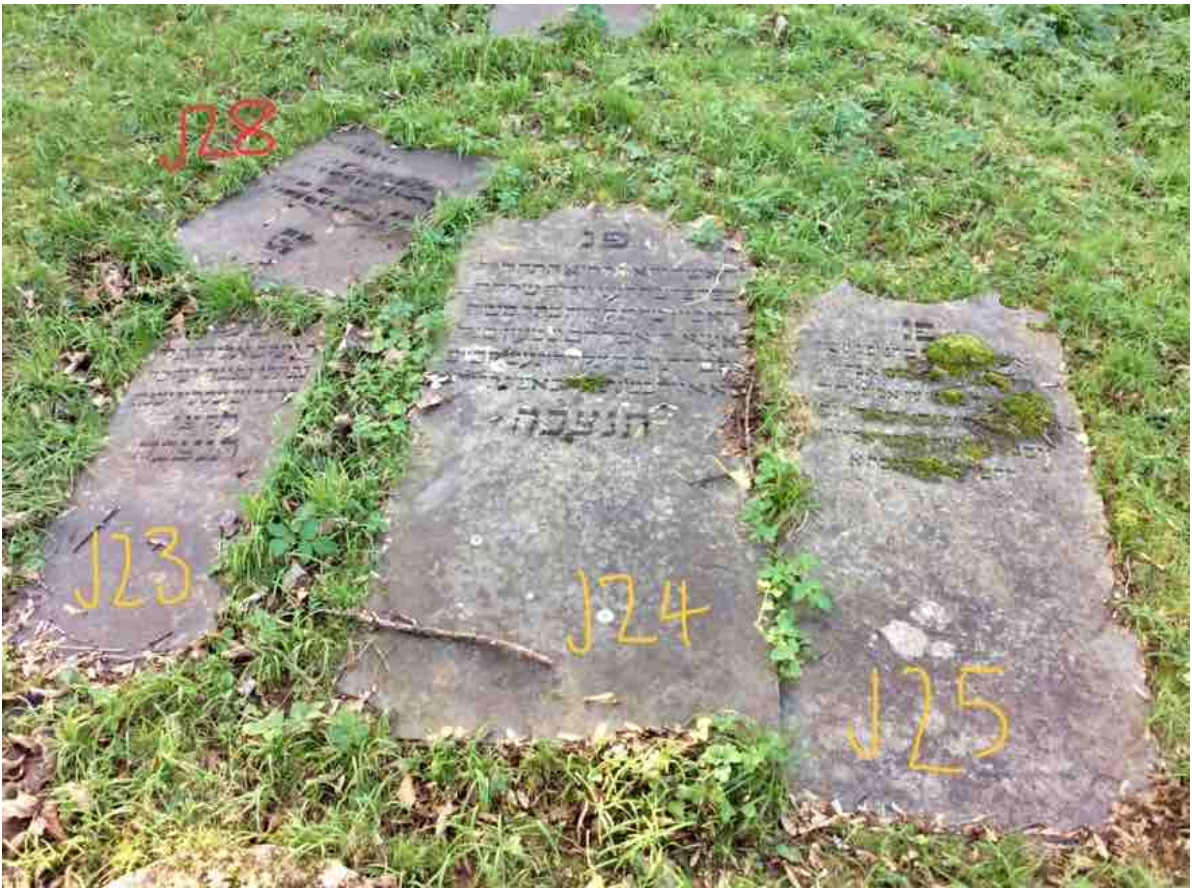
Types of deterioration:	Broken	Headstone broken off at base?
Surface condition :	Good	
Condition of inscription :	Good

General condition :	Good	Heritage significance:	B
General comments:	Good, slate lying on ground. Medium to high risk of further damage in current location.

Proposed repairs:	Clean off organic growth and dirt. Re-erect in original location.
-------------------	---

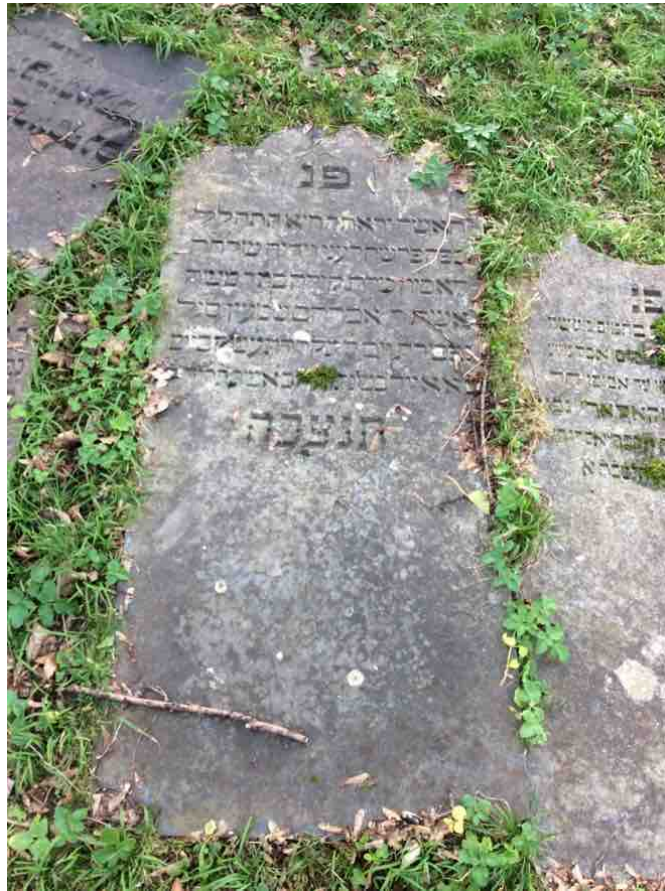
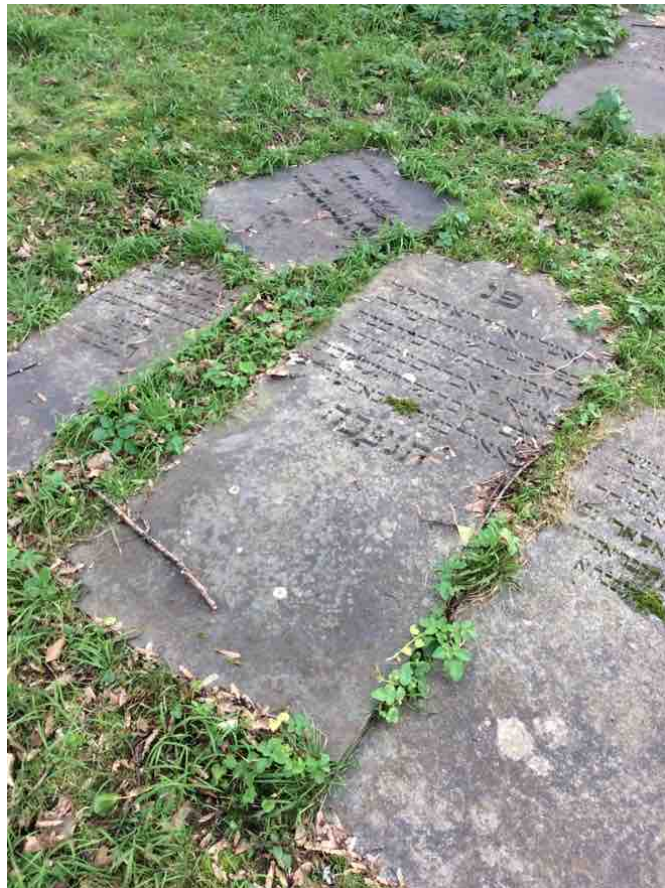
Types of deterioration:	Broken	Headstone broken off at base?
Surface condition :	Organic growth	Surface dirt / lichen
Condition of inscription :	Good	Some surface dirt over inscription

General condition :	Good	Heritage significance:	B
General comments:	Good, slate lying on ground. Medium to high risk of further damage

Proposed repairs:	Clean off organic growth and dirt. Re-erect in original location.
Schedule of Work clauses:	2.09a

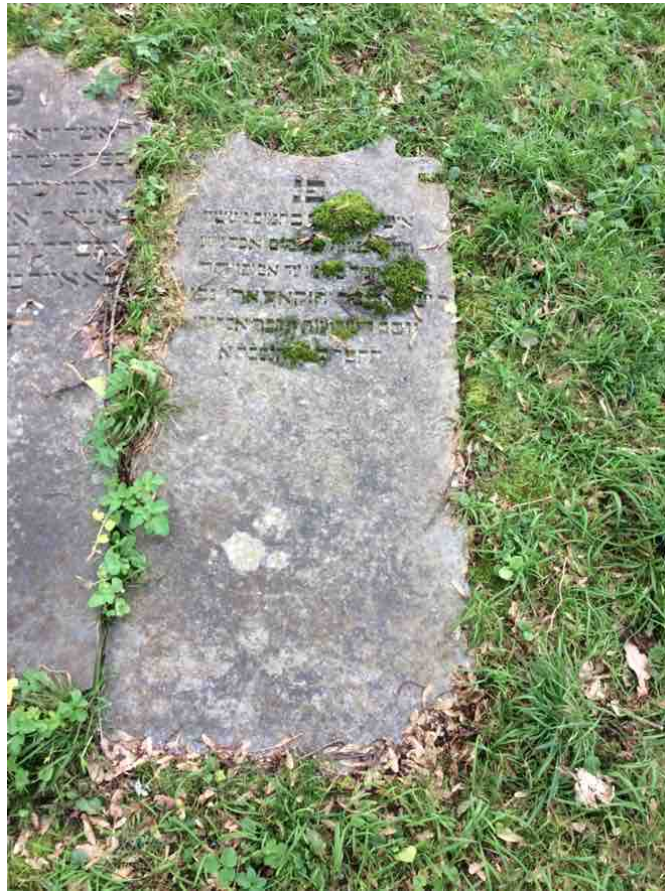
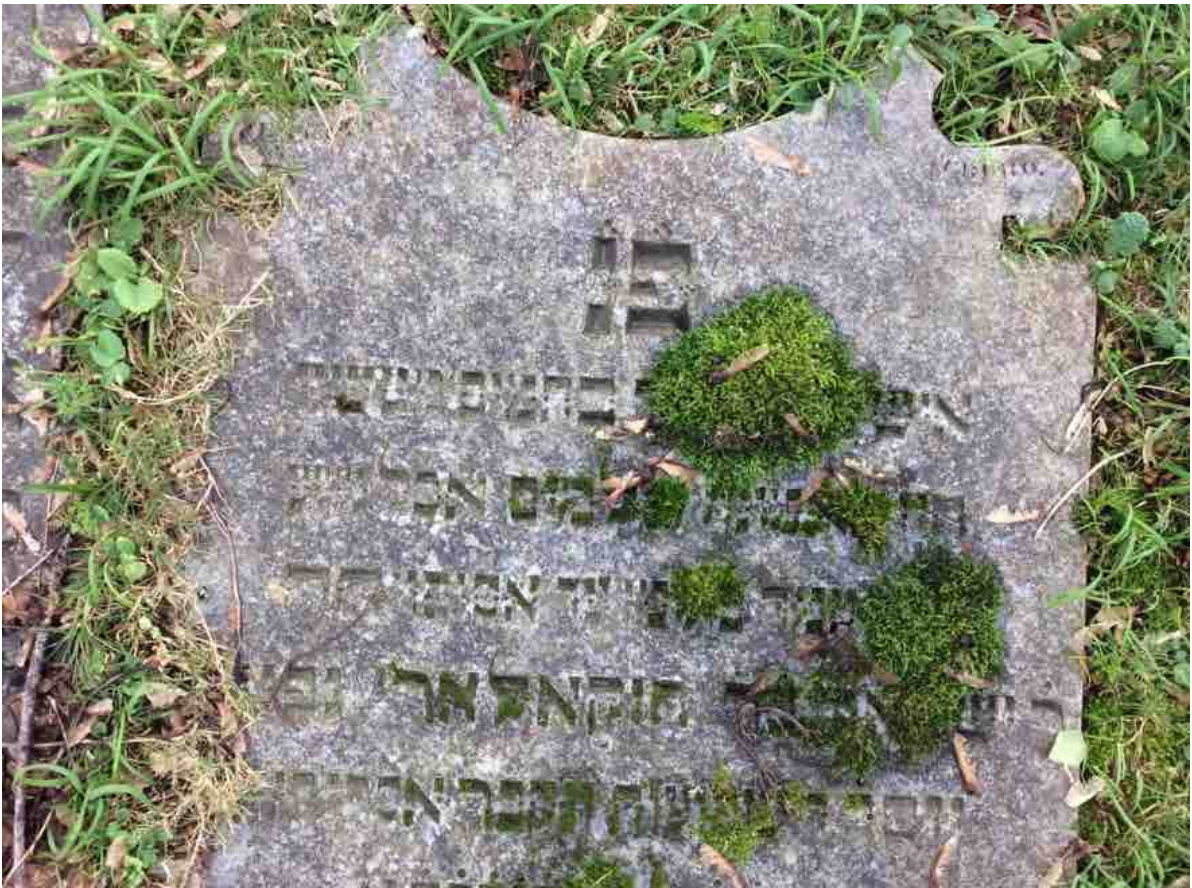
Types of deterioration:	Broken	Headstone broken off at base?
Surface condition :	Organic growth	Surface dirt / growth
Condition of inscription :	Good	Dirt covering some of inscription

General condition :	Good	Heritage significance:	B
General comments:	Good, slate lying on ground. Medium to high risk of further damage

Proposed repairs:	Clean off organic growth and dirt. Re-erect in original location.
Schedule of Work clauses:	2.09a

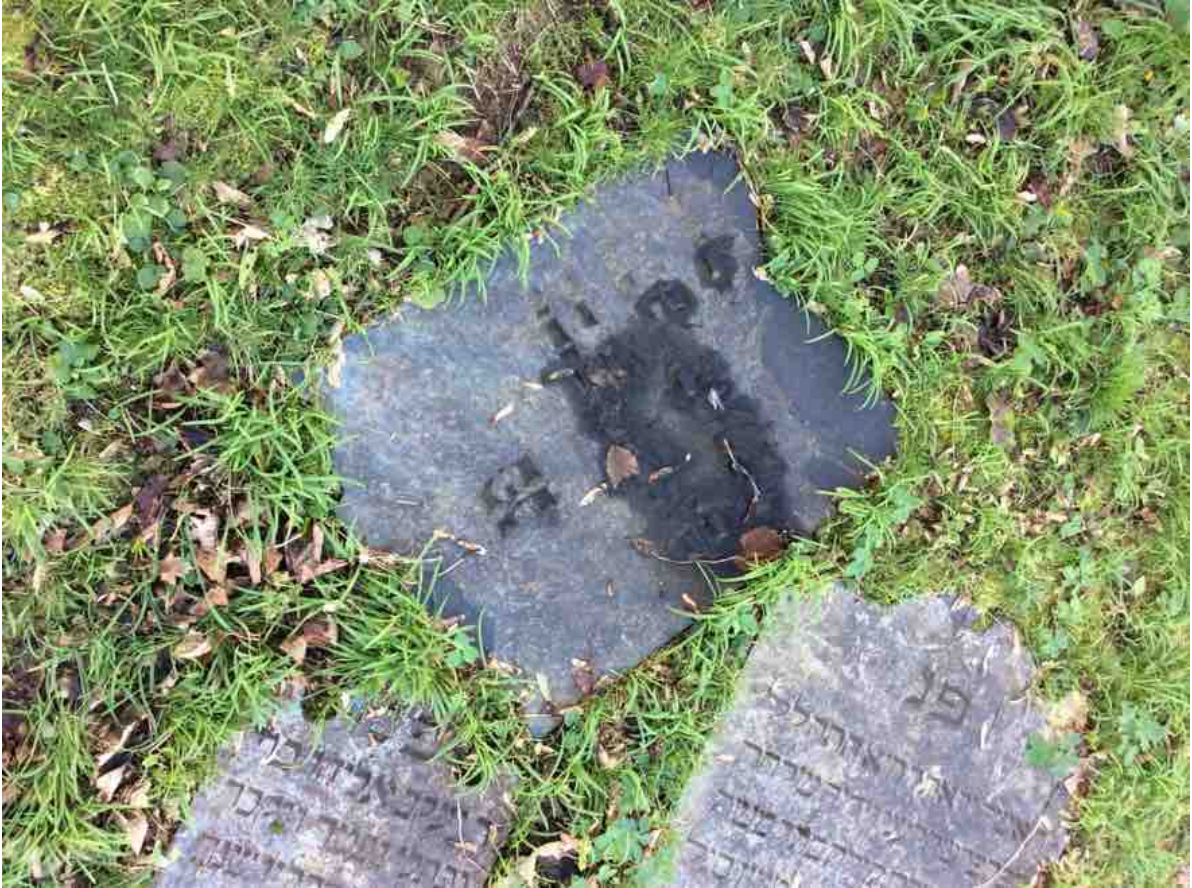
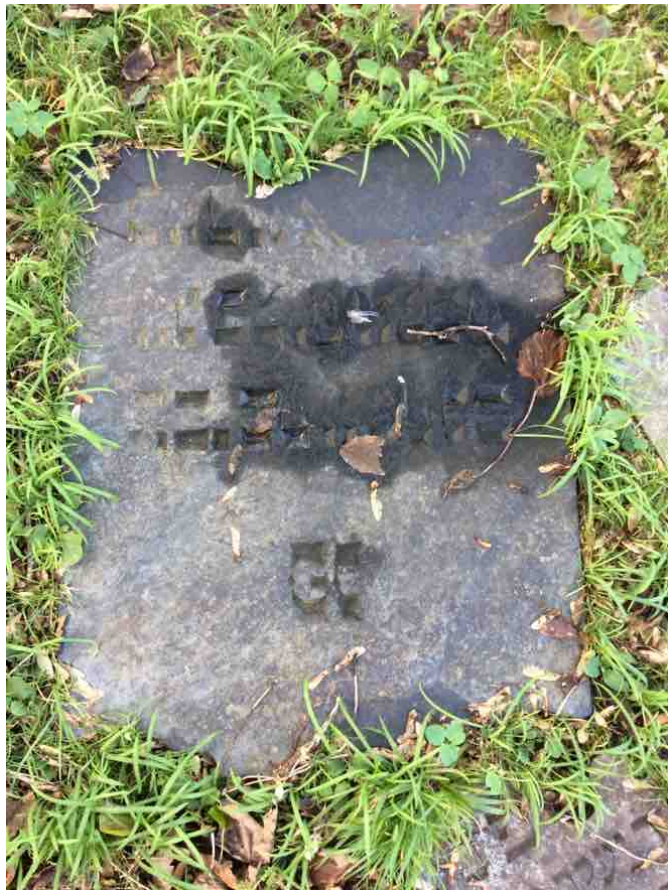
Types of deterioration:	<input type="text" value="Missing elements"/>	<input type="text"/>
Surface condition :	<input type="text" value="Good"/>	<input type="text"/>
Condition of inscription :	<input type="text" value="Good"/>	<input type="text"/>

General condition :	<input type="text" value="Poor"/>	Heritage significance:	<input type="text" value="C"/>
General comments:	<input type="text" value="Broken headstone laid flat, only one large piece apparent, not large enough to re-erect. Not included in CMP schedule of monuments to be repaired"/>

Proposed repairs:	<input type="text" value="Clean off organic growth and dirt. Allow to lay back down in current location at a slope on new limecrete bed. Add J30a if it established that this is part of J28."/>
Schedule of Work clauses:	<input type="text" value="2.09b"/>

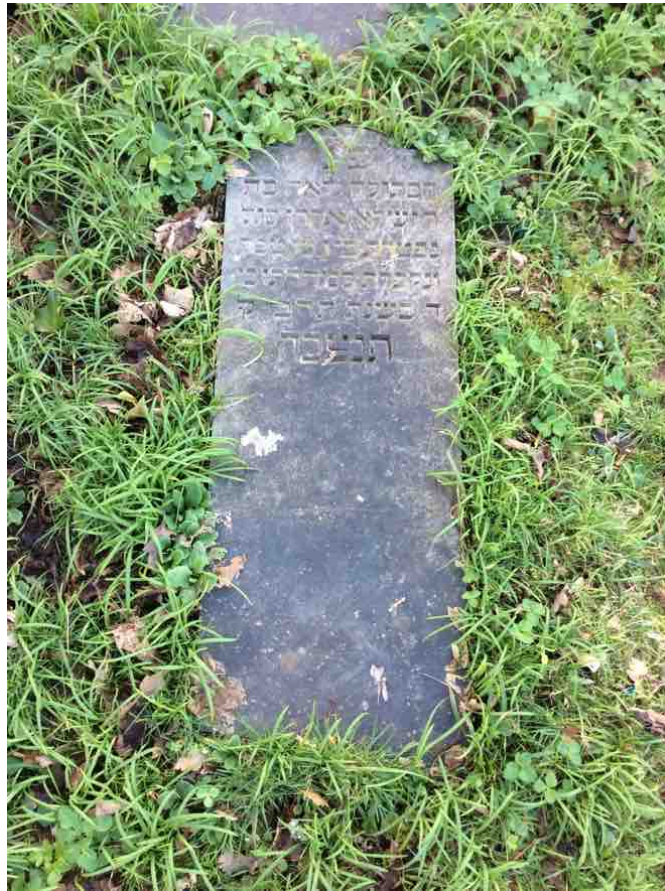
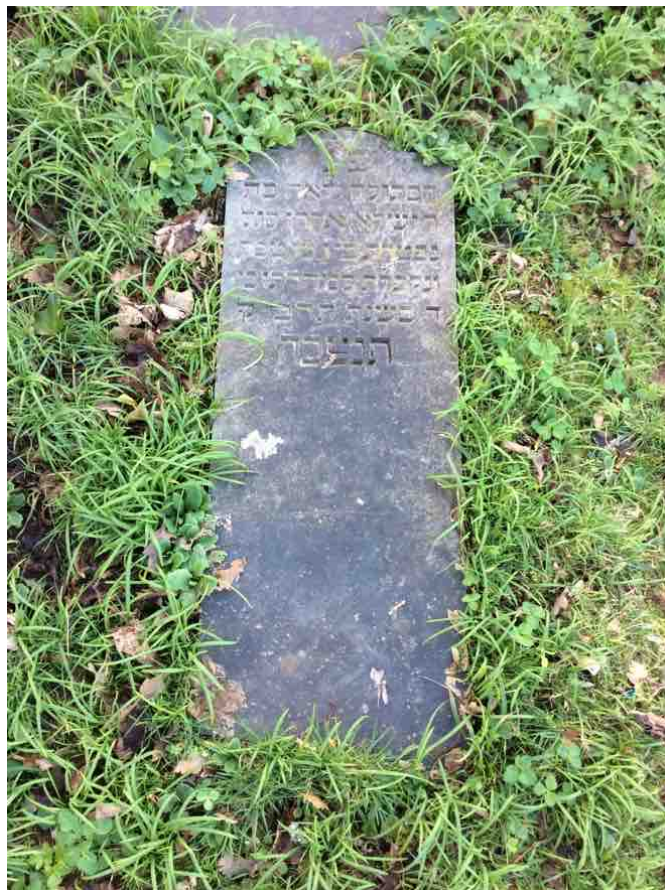
Types of deterioration:	<input type="text" value="Broken"/>	<input type="text" value="Headstone broken off at base"/>
Surface condition :	<input type="text" value="Good"/>	<input type="text"/>
Condition of inscription :	<input type="text" value="Good"/>	<input type="text" value="Some dirt in inscriptions"/>

General condition :	<input type="text" value="Poor"/>	Heritage significance:	<input type="text" value="B"/>
General comments:	<input type="text" value="Fair / poor - slate lying on ground, belongs to broken base J14"/>

Proposed repairs:	<input type="text" value="Clean off organic growth and dirt. Excavate base J14 and pin base and main section J29 to 25mm thick slate backing with stainless steel dowels. Make good joints with mortar. Re-erect at position J14."/>
Schedule of Work clauses:	<input type="text" value="2.01 and 2.09a"/>

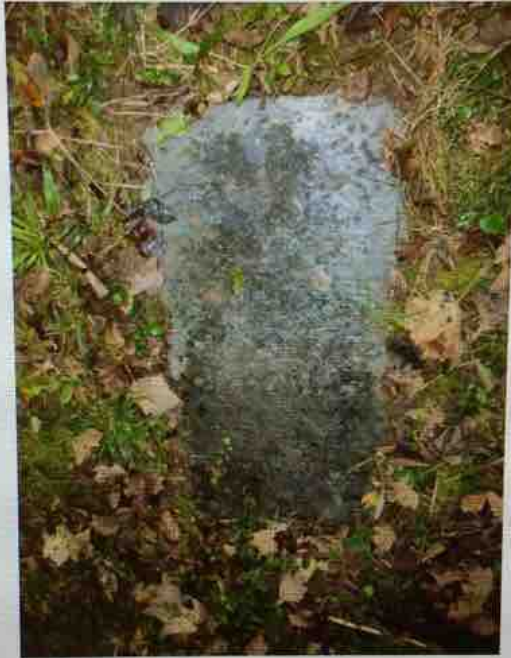
J30. NAME UNKNOWN

Slate, good condition, needs re-erecting.

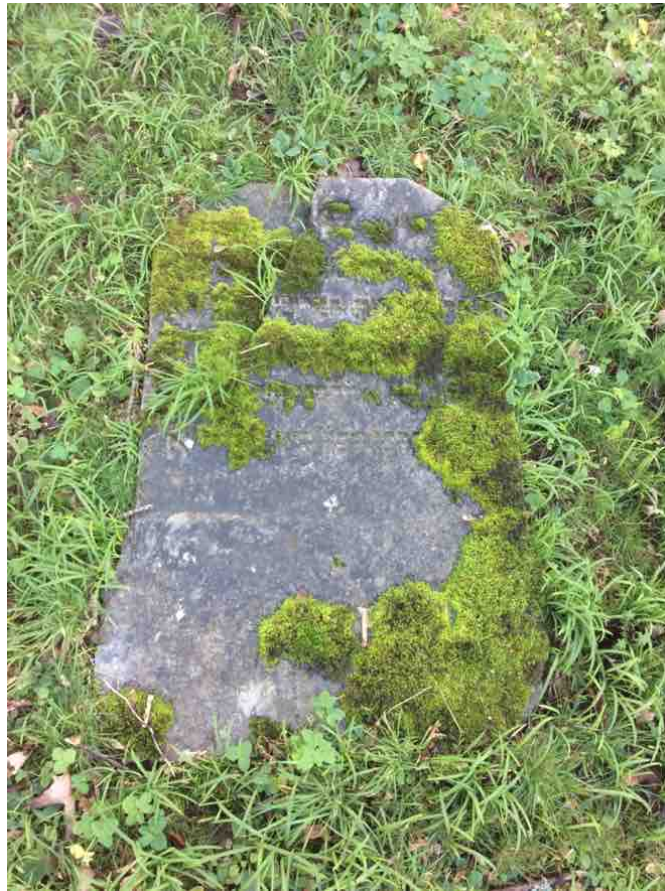
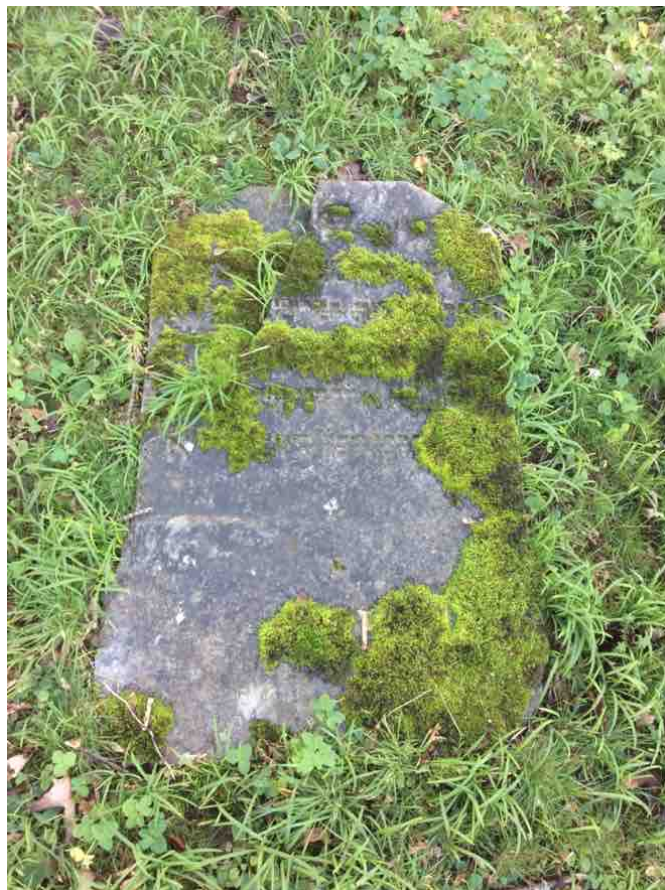
Types of deterioration:	Loose elements	Top corner of slate headstone broken
Surface condition :	Organic growth	Surface dirt / moss growth
Condition of inscription :	Other	Moss and other growths over most of inscription

General condition :	Poor	Heritage significance:	B
General comments:	Fair/Poor, slate lying on ground, top corner broken. Medium to high risk of further damage

Proposed repairs:	Clean off organic growth and dirt. Excavate base. Pin broken sections (2 no plus base) to 25mm thick slate backing with stainless steel dowels. Make good joints with mortar. Re-erect in original location.
Schedule of Work clauses:	2.01 and 2.09a
