Jewish Cemetery, Ponsharden

Proforma Condition and Repairs Schedule

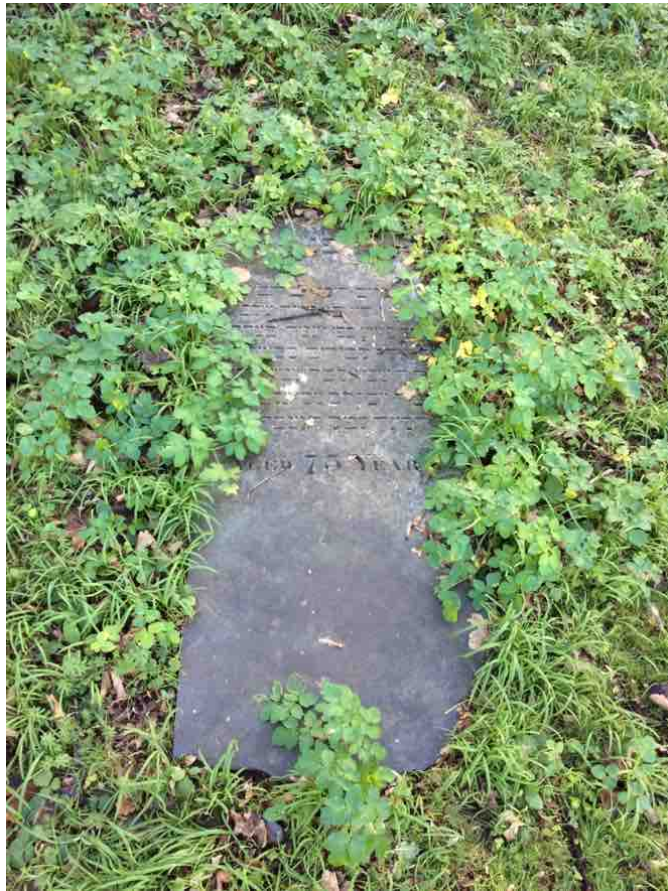
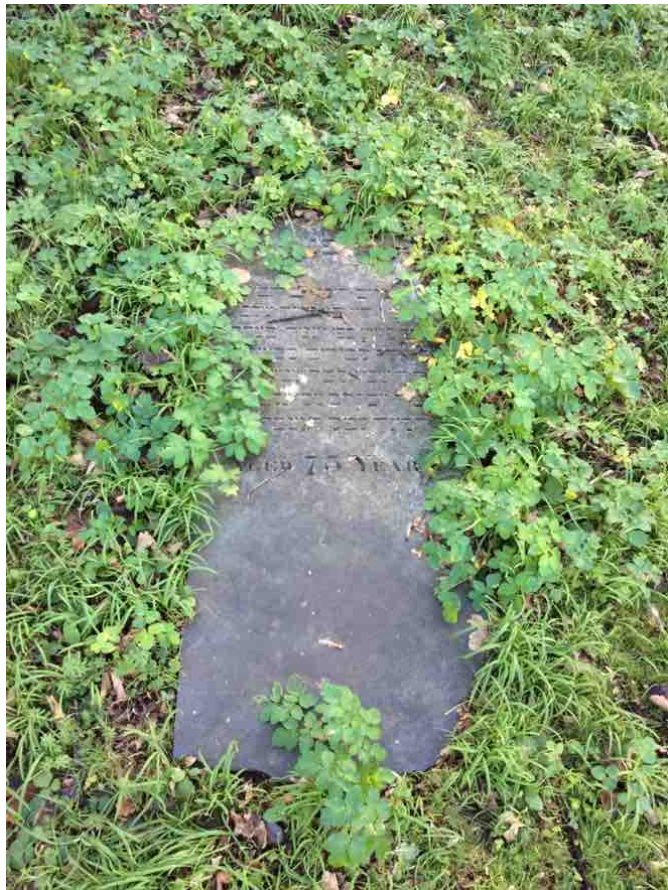
Types of deterioration:	Broken	Headstone broken off at base?
Surface condition :	Surface dirt	
Condition of inscription :	Good

General condition :	Good	Heritage significance:	B
General comments:	Slate lying on ground, but in good condition. Medium to high risk of further damage

Proposed repairs:	Clean off organic growth and dirt. Re-erect in original location.
-------------------	---

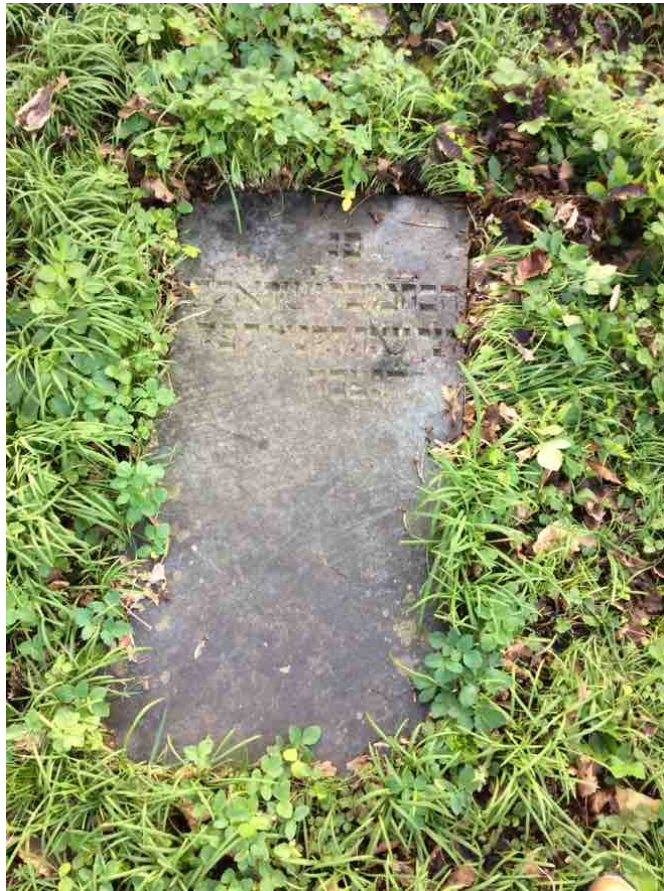
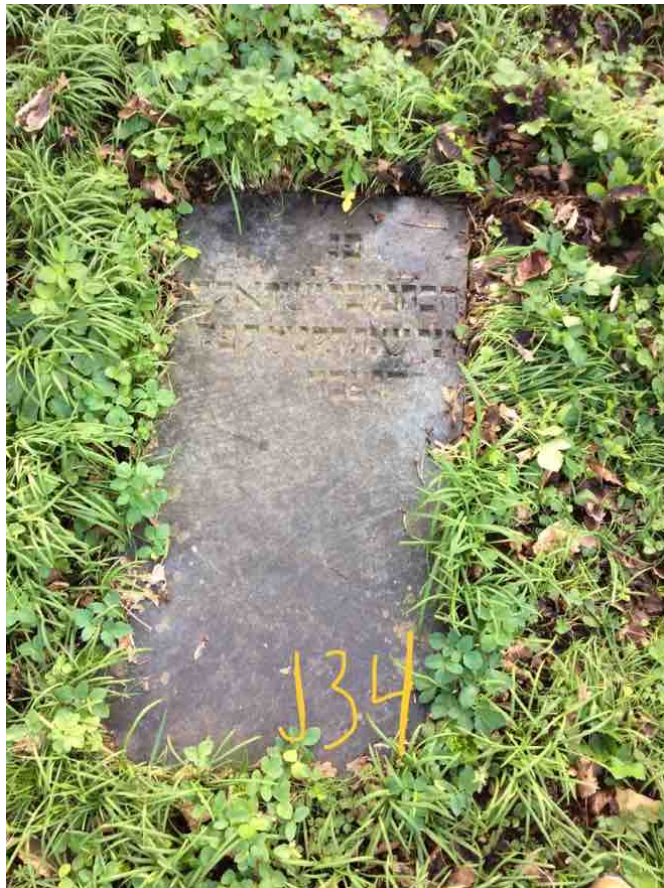
Types of deterioration:	Broken	Headstone broken off at base?
Surface condition :	Organic growth	Surface dirt
Condition of inscription :	Good

General condition :	Fair	Heritage significance:	B
General comments:	Slate lying on ground but in good condition. Medium to high risk of further damage

Proposed repairs:	Clean off organic growth and dirt. Allow to lay back down in current location at a slope on new limecrete bed. Headstone will be re-erected if original location can be established.
Schedule of Work clauses:	2.09b

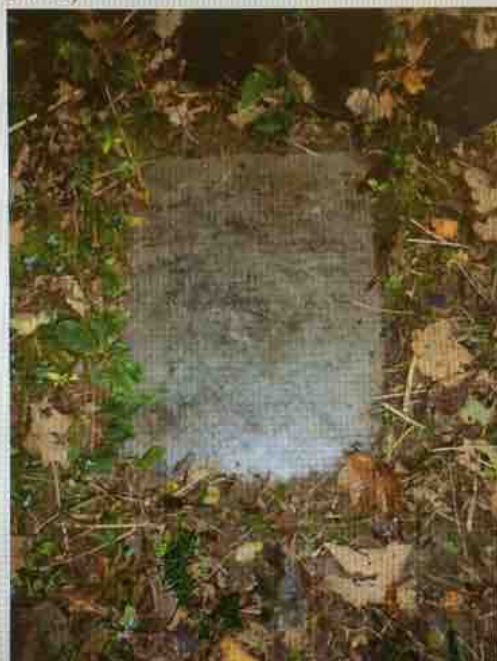
J30A. PHOEBE MOSES, d. 1804 (Feigle daughter of Moses, d. 5565)
(Recently uncovered, beneath J41)

Slate, very good condition, should be re-erected.

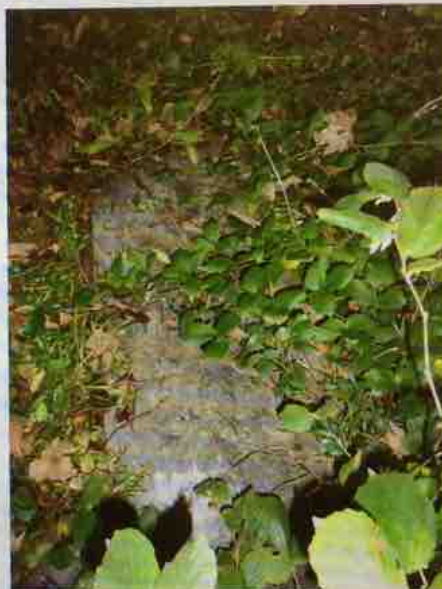
J42. NAME UNKNOWN

Slate, good condition, needs re-erecting.
