Additional Photos (25/10/2023)

ROOF VOIDS

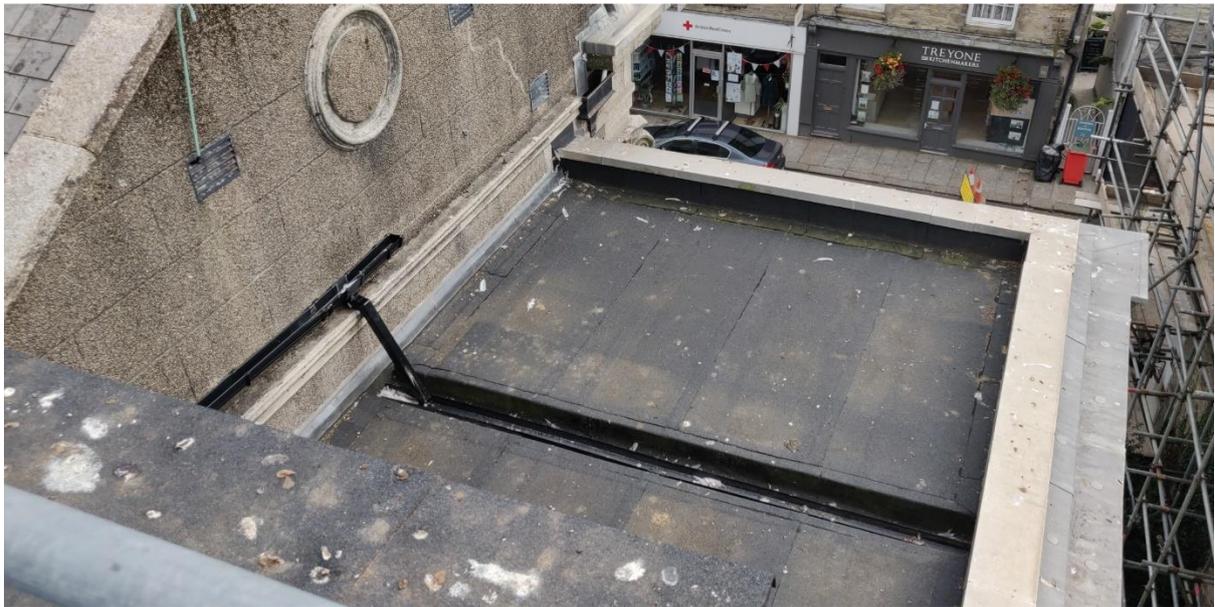
The white outlet seems inadequate so the lead trough will overflow. Same detail on the other end of this main roof (Appendix 2 DSC00107).
