Tender Addendum 1- Tender Reference: HCAP16065

Site Address- Tamar Building, Stratton Business Park, Bude, EX23 8LY

**SAMPLING OF FUME CUPBOARD EXTRACT SYSTEM DUCTS – TAMAR BUILDING, BUDE**

## Sampling of Fume Cupboard Extract System Ducts

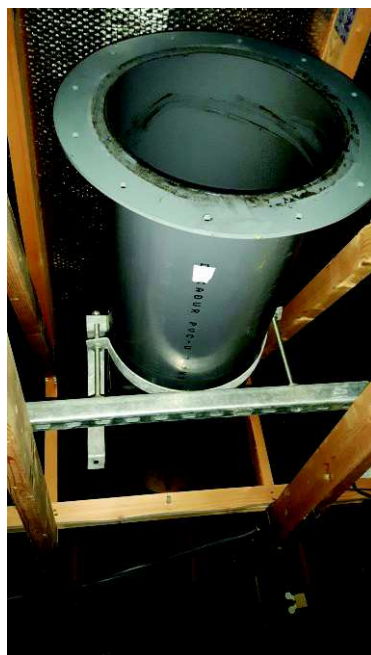
**Fig 3:** Example of large extract system duct within roof of Tamar Building.

- 3.3 Inspection revealed evidence of some residual contamination within the interior surface of the ducts and the fume cabinets. However it is not known how long the ducts and fume cupboards have been in the present state and as such this may have an accumulation of dust from activities which have taken place in the Tamar Building since the laboratory ceased operation.

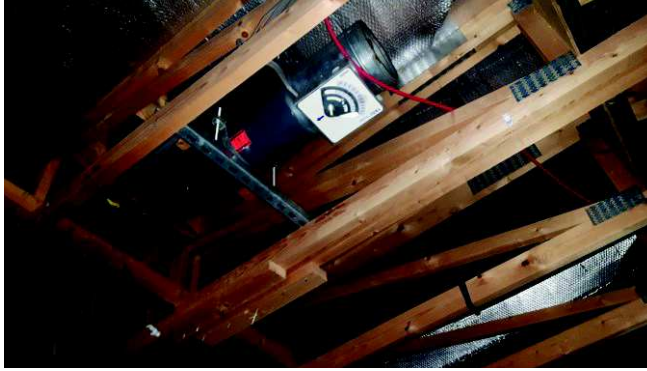
**Fig 4:** Example of small duct extract system within roof of the Tamar Building.

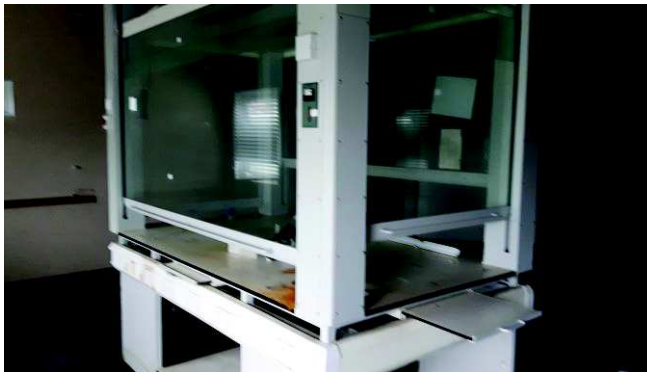
**Fig 5:** Large fume cupboard within Tamar Building laboratory

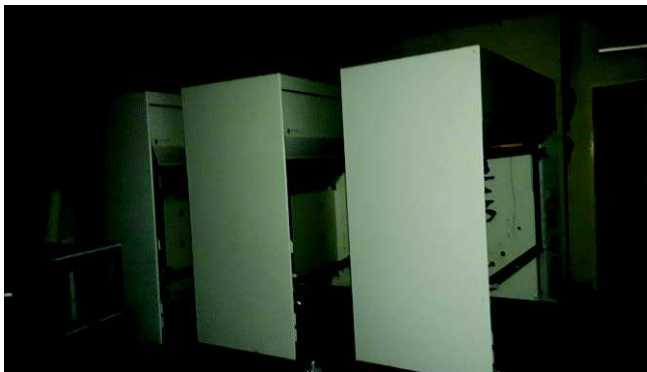
**Fig 6:** Small fume cupboards stored within the laboratory room of Tamar House.

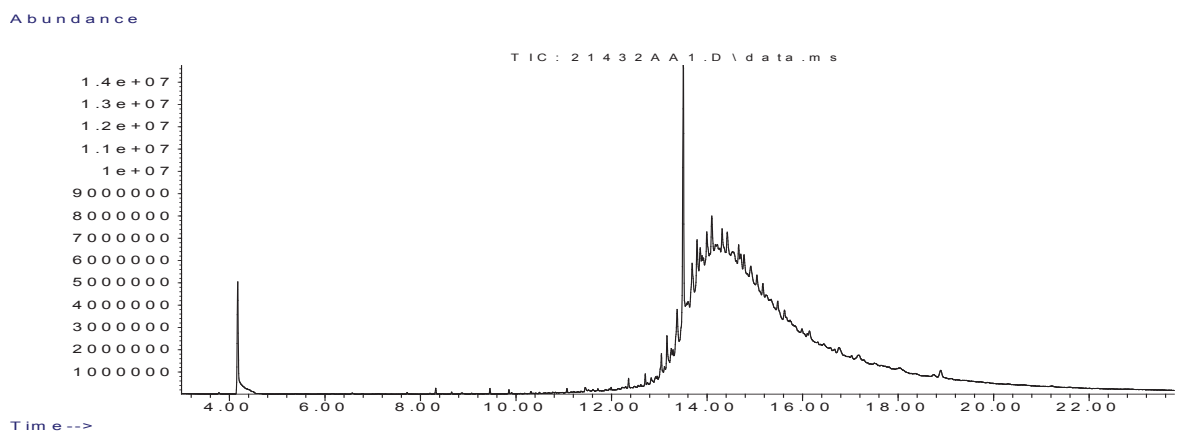
**Figure 7.** TIC obtained from solvent extract of sample PN-026105/1

Solvent extract and GC/MS analysis of the sample found it to contain Butylated hydroxytoluene (11 $\mu$ g), Phthalates (682 $\mu$ g) and a hydrocarbon mineral oil with trace levels of silicones (40000 $\mu$ g). Quantified figures stated are an estimate based of the response of the compound against the response of the internal standard (Octane). The Total Ion Chromatograph (TIC) is shown in figure 7.

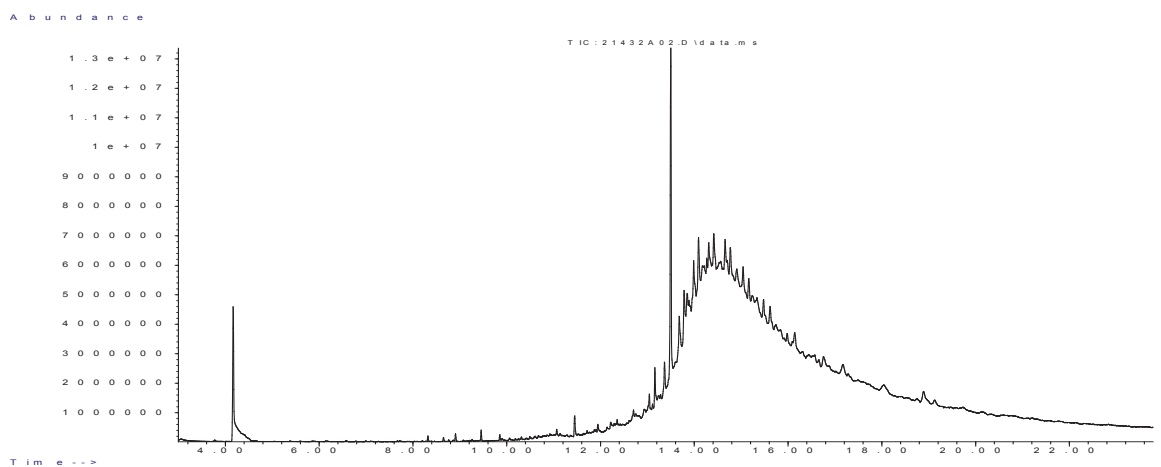
**Figure 8.** TIC obtained from solvent extract of sample PN-026105/2

Solvent extract and GC/MS analysis of the sample found it to contain 2,4,7,9-Tetramethyl-5-decyn-4, 7-diol (1.2 $\mu$ g), Butylated hydroxytoluene (1.7 $\mu$ g), Phthalates (65 $\mu$ g) and a hydrocarbon mineral oil with trace levels of silicones (18000 $\mu$ g). Quantified figures stated are an estimate based of the response of the compound against the response of the internal standard (Octane). The Total Ion Chromatograph (TIC) is shown in figure 8.

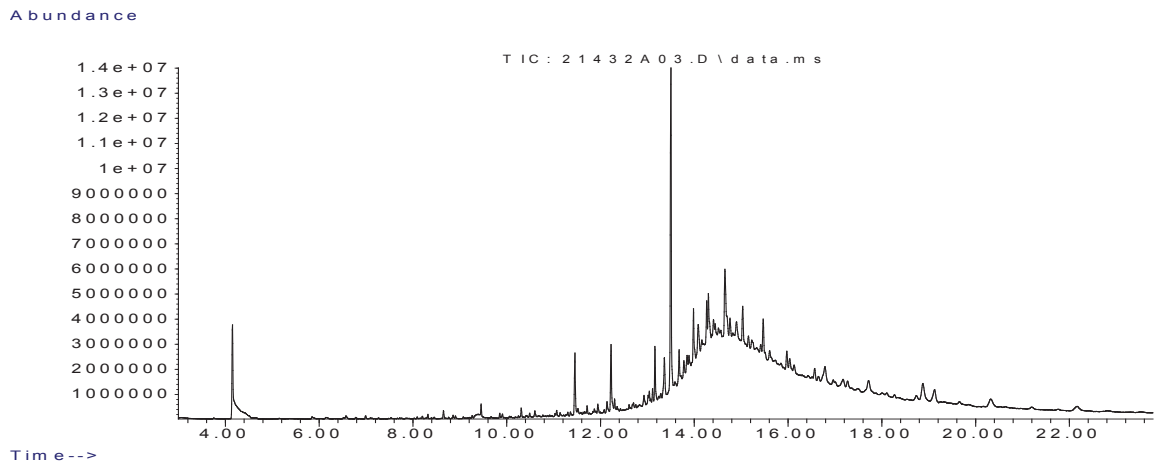
**Figure 9.** TIC obtained from solvent extract of sample PN-026105/3

Solvent extract and GC/MS analysis of the sample found it to contain Butylated hydroxytoluene (2.6µg), C<sub>16</sub>-C<sub>18</sub> Fatty acids (42µg), Phthalates (78µg) and a hydrocarbon mineral oil containing hydrocarbon waxes and trace levels of silicones (2200µg). Quantified figures stated are an estimate based of the response of the compound against the response of the internal standard (Octane). The Total Ion Chromatograph (TIC) is shown in figure 9.

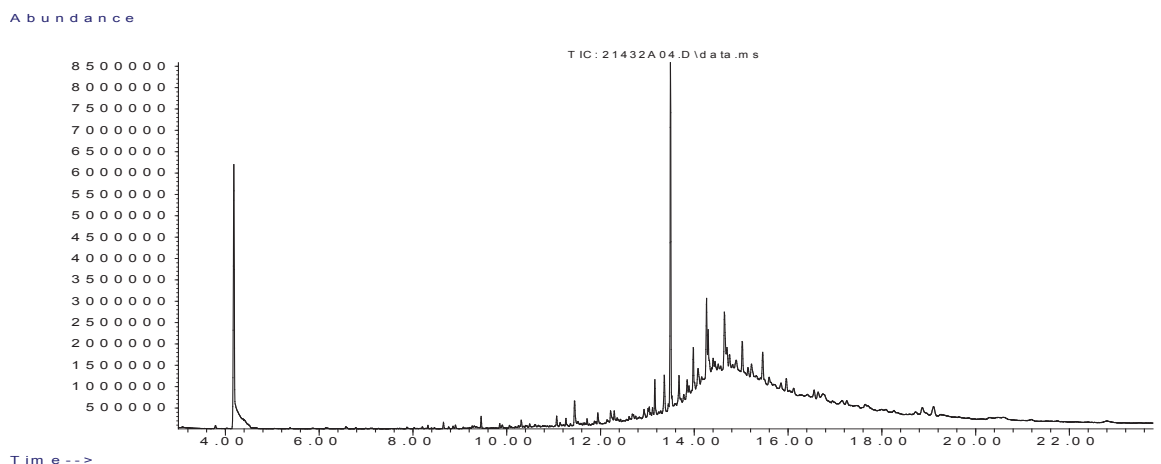
**Figure 10.** TIC obtained from solvent extract of sample PN-026105/4

Solvent extract and GC/MS analysis of the sample found it to contain Butylated hydroxytoluene (1.1µg), Fatty acids (3.3µg), Phthalates (36µg) and a hydrocarbon mineral oil containing hydrocarbon waxes and trace levels of silicones (900µg). Quantified figures stated are an estimate based of the response of the compound against the response of the internal standard (Octane). The Total Ion Chromatograph (TIC) is shown in figure 10.

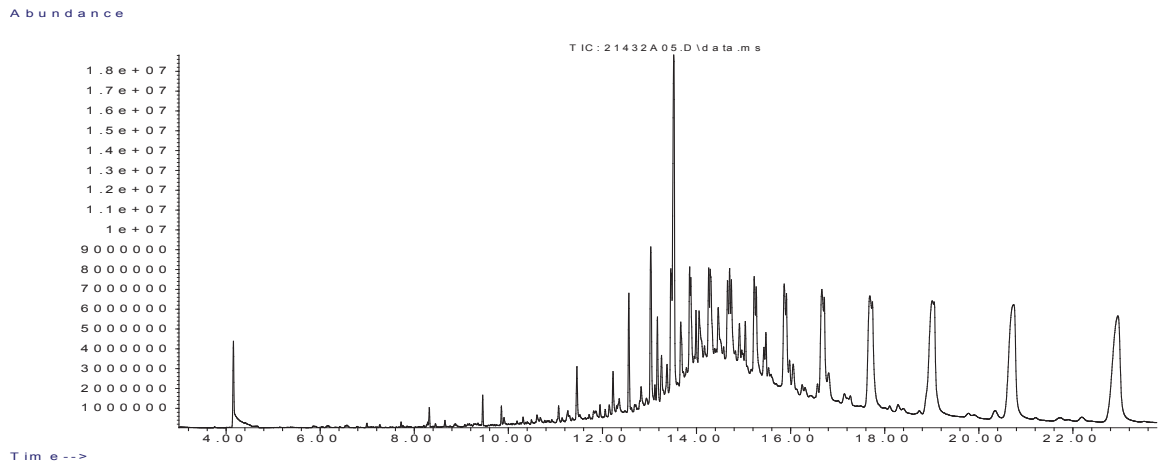
**Figure 11.** TIC obtained from solvent extract of sample PN-026105/5

Solvent extract and GC/MS analysis of the sample found it to contain Butylated hydroxytoluene (6.8µg), C<sub>16</sub>-C<sub>18</sub> Fatty acids (65µg), Phthalates (160µg) and a silicone oil (5200µg). Quantified figures stated are an estimate based of the response of the compound against the response of the internal standard (Octane). The Total Ion Chromatograph (TIC) is shown in figure 11.

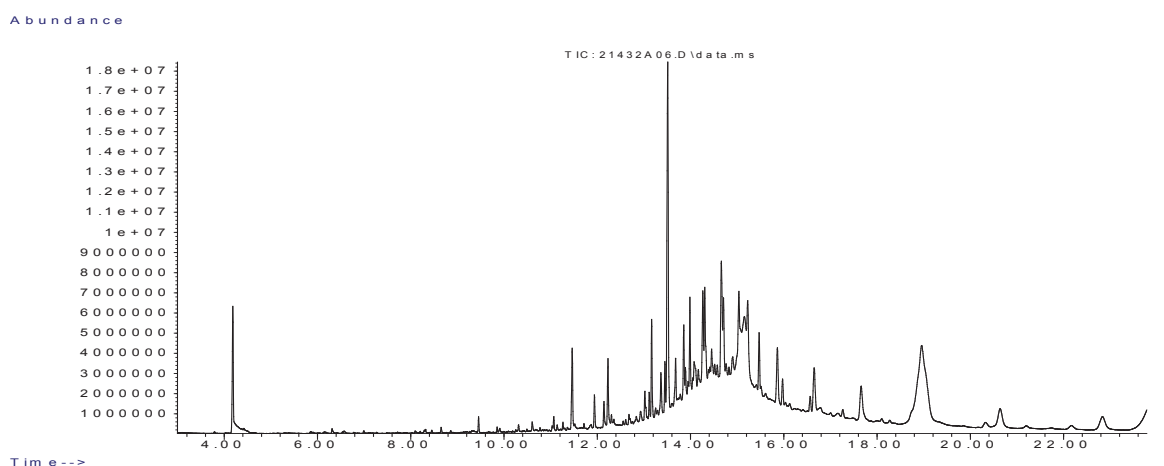
**Figure 12.** TIC obtained from solvent extract of sample PN-026105/6)

Solvent extract and GC/MS analysis of the sample found it to contain Butylated hydroxytoluene (3.1µg), C<sub>16</sub>-C<sub>18</sub> Fatty acids (66µg), Phthalates (120µg) and a silicone oil containing hydrocarbon waxes (2300µg). Quantified figures stated are an estimate based of the response of the compound against the response of the internal standard (Octane). The Total Ion Chromatograph (TIC) is shown in figure 12.

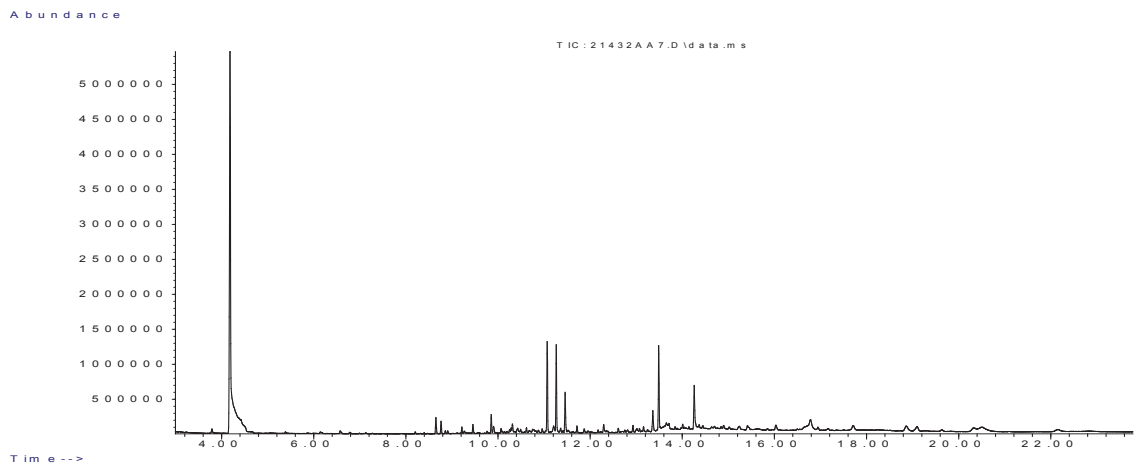
**Figure 13.** TIC obtained from solvent extract of sample PN-026105/7

Solvent extract and GC/MS analysis of the sample found it to contain Phthalates (20 $\mu$ g) and lesser amounts of Butylated hydroxytoluene (0.6 $\mu$ g) and Fatty acids (1.9 $\mu$ g). Quantified figures stated are an estimate based of the response of the compound against the response of the internal standard (Octane). The Total Ion Chromatograph (TIC) is shown in figure 13.

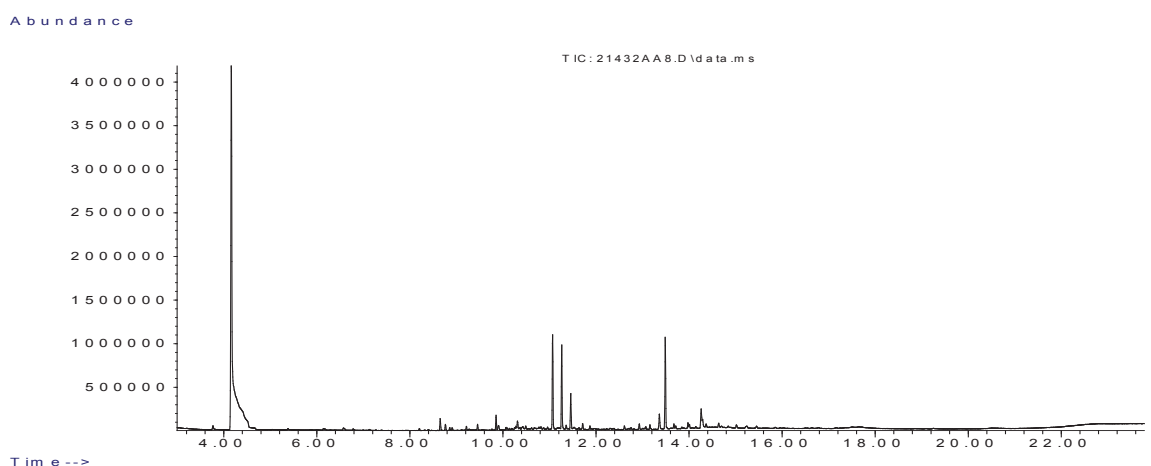
**Figure 14.** TIC obtained from solvent extract of sample PN-026105/8

Solvent extract and GC/MS analysis of the sample found it to contain Phthalates (18 $\mu$ g) and lesser amounts of 2,4,7,9-tetramethyl-5-decyn-4, 7-diol (0.1 $\mu$ g) and Butylated hydroxytoluene (0.3 $\mu$ g). Quantified figures stated are an estimate based of the response of the compound against the response of the internal standard (Octane). The Total Ion Chromatograph (TIC) is shown in figure 14.

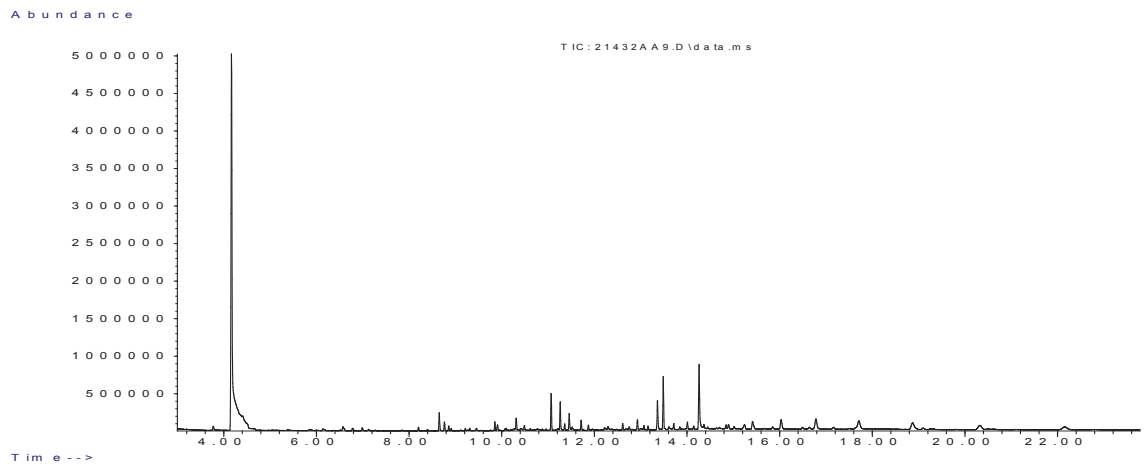
**Figure 15.** TIC obtained from solvent extract of sample PN-026105/9

Solvent extract and GC/MS analysis of the sample found it to contain a mixture of Phthalates (10 $\mu$ g) and Fatty acids (2.1 $\mu$ g). Quantified figures stated are an estimate based of the response of the compound against the response of the internal standard (Octane). The Total Ion Chromatograph (TIC) is shown in figure 15.
