# Coronation Lake, Helston.

## Investigation of site

Project No: 63684

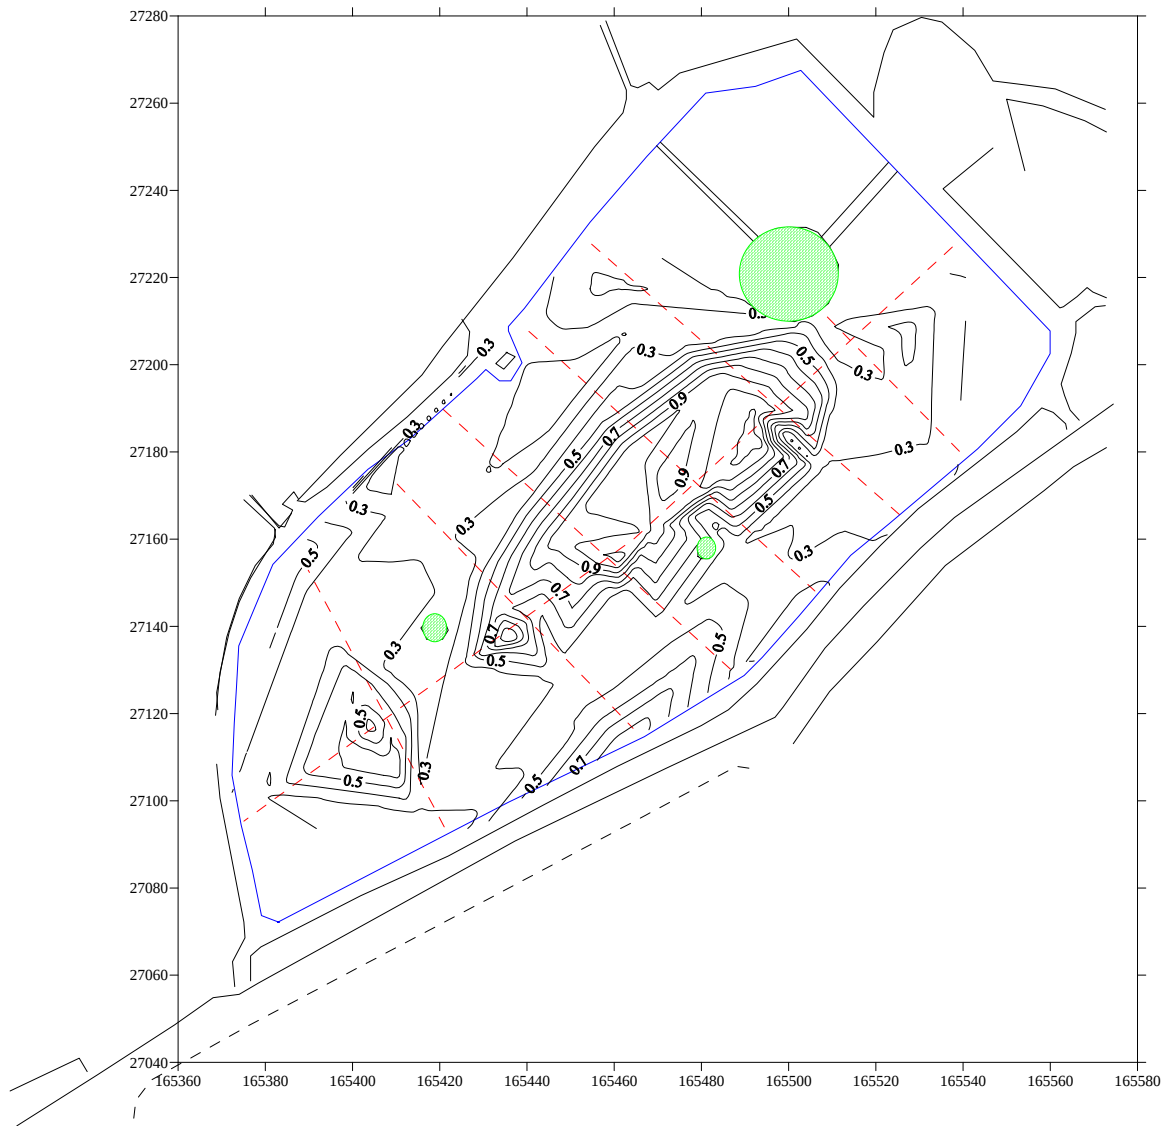
**contour map showing thickness of silt**

The report indicates that the volume of silt totals approximately 6400m<sup>3</sup> and that it varies in depth between 0.1m and 1.4m deep.

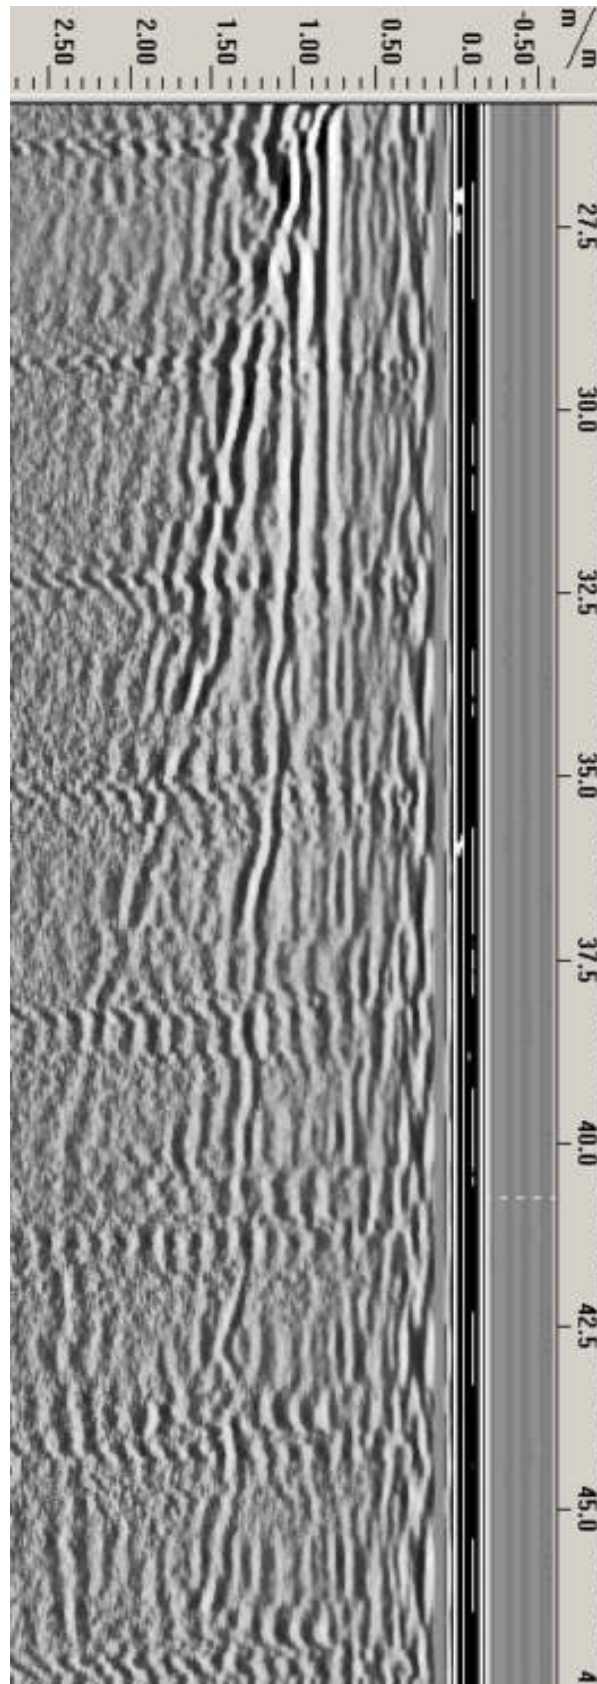
**Profile D NW/SE**

The above profile shows 2 distinct horizons the deeper on being picked as the clay liner and the other as top of the silt. Figures along the top are distance in meters.

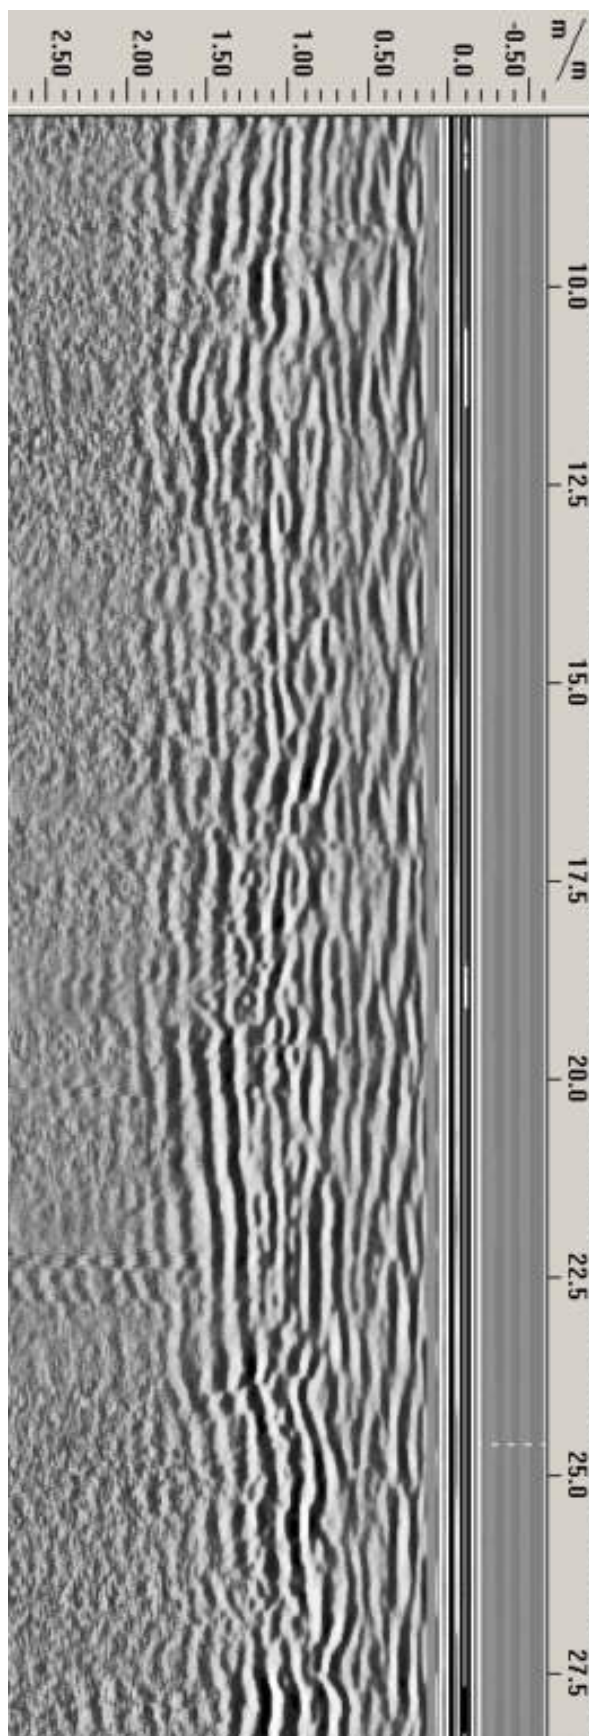
**Profile A SE/NW**

The above profile is across the shallower SW end of the lake. Again 2 distinct horizons can be seen but much closer together.

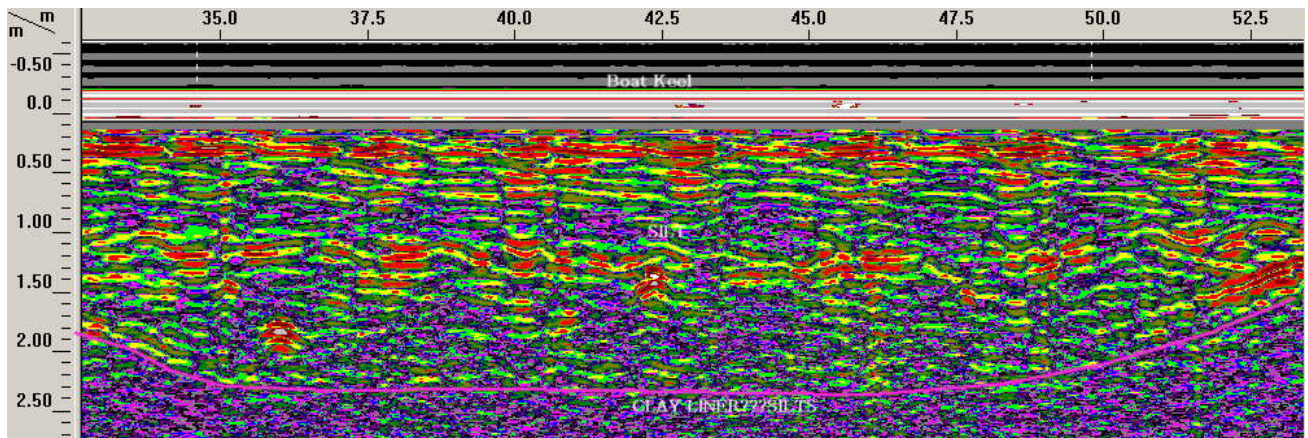
Central area of profile E

In the centre of the lake where the water is deepest the clay liner horizon can just be seen. It is possible that it is weak and damaged blending into the geology beneath, a possible area of leakage.

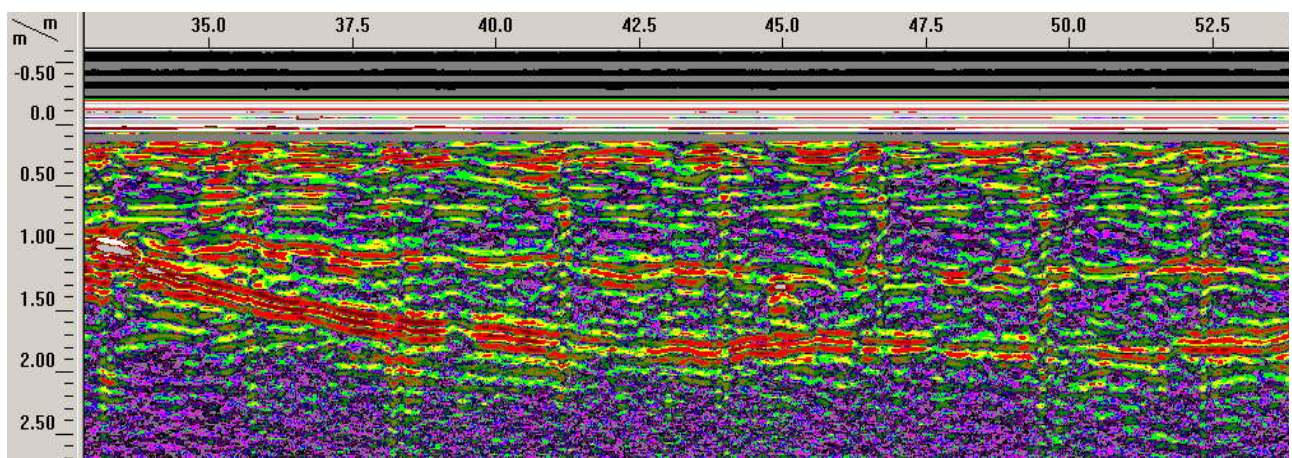
Central area profile B

Above profile shows good section of clay liner in centre of lake.

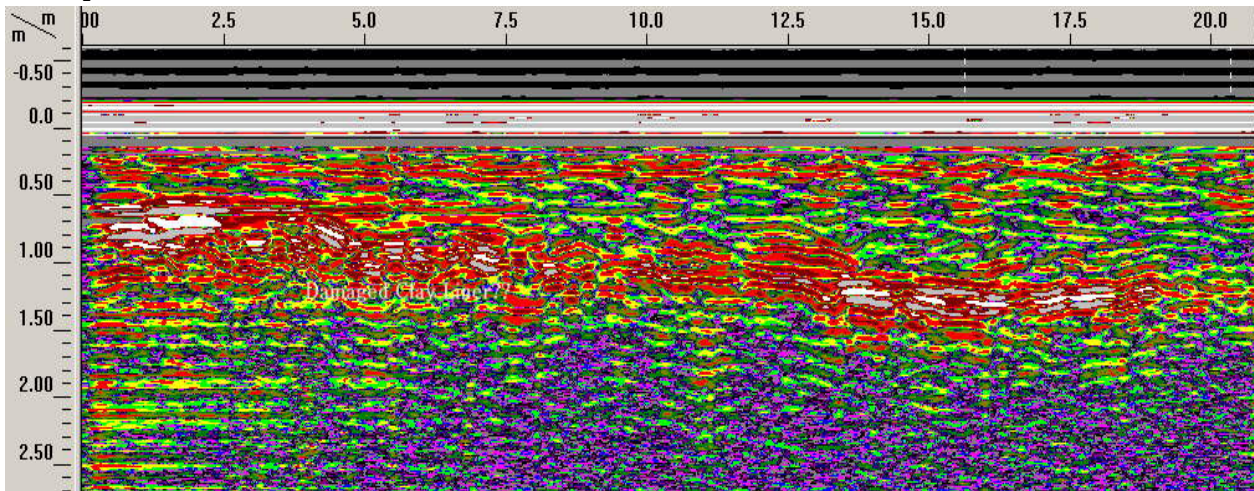
NW end of Profile D

In some of the shallower areas the Liner is clearly seen but appears fractured and damaged. The profile below shows a disjointed and broken horizon to the NW of the profile.

It would appear that there are two possible faults in the clay liner. The first in the deeper part of the lake where it is difficult to distinguish the liner from the geology beneath. The second is that in some of the shallower areas where the liner can be seen but appears to be broken. This is seen on two of the profiles shown above.

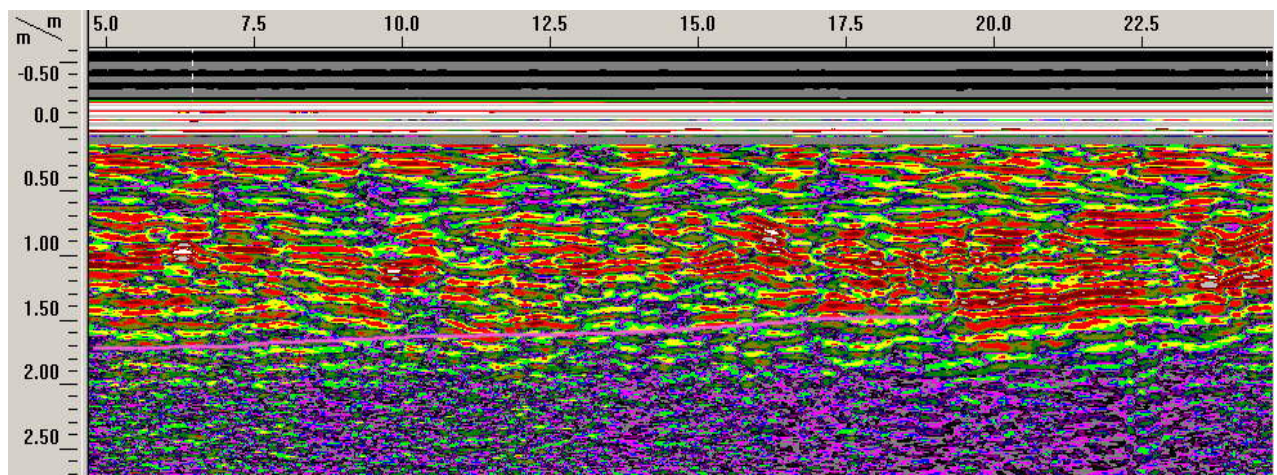
SE end of Profile A

Profile A below shows a very weak horizon, where the clay and silt are difficult to distinguish between.
