BUILDING SURVEY REPORT FOR:

OLD BOLSOVER TOWN COUNCIL

BOLSOVER ASSEMBY HALL COMMUNITY CENTRE,

HILL TOP, BOLSOVER, S44 6NG.

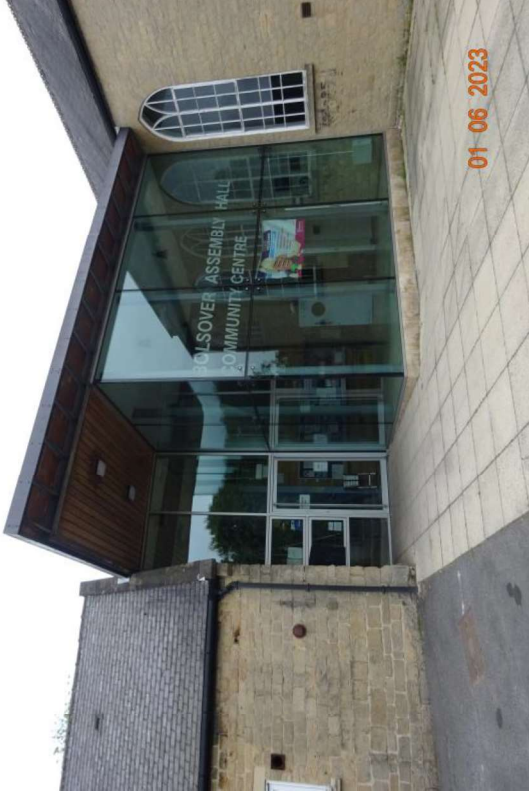
17

There are full height glazed walls to the front elevation of the main entrance to the community centre with dwarf walls below floor level, finished with stone cladding which is cracked in places. (Photograph 17).

In my opinion the defective stone cladding should be replaced to prevent premature failure and to prevent the ingress of moisture into the building in this location.

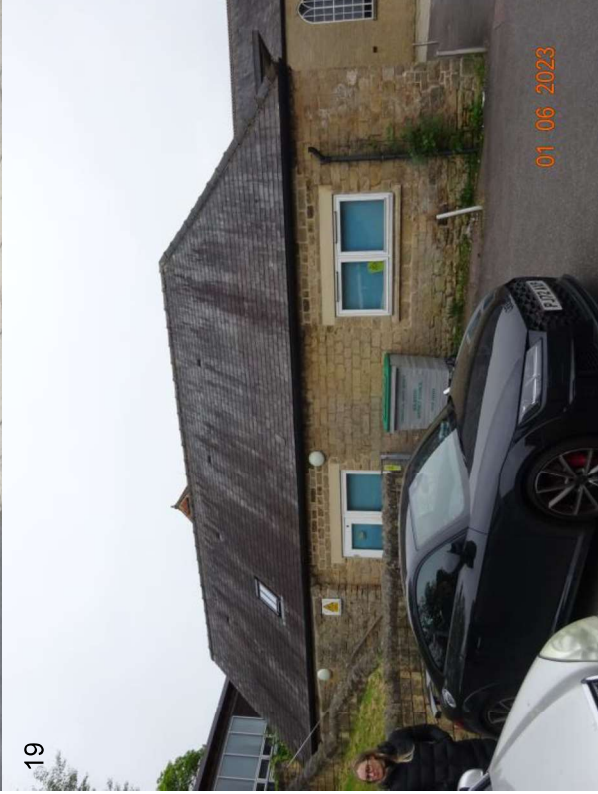
19

There is poor pointing at low-level to the left-hand elevation of the nursery building which would benefit from being re-pointed using a suitable mortar mix in a suitable style. There is a crack in the pointing to the brickwork in proximity of the redundant rainwater pipe to this elevation. (Photograph 19).

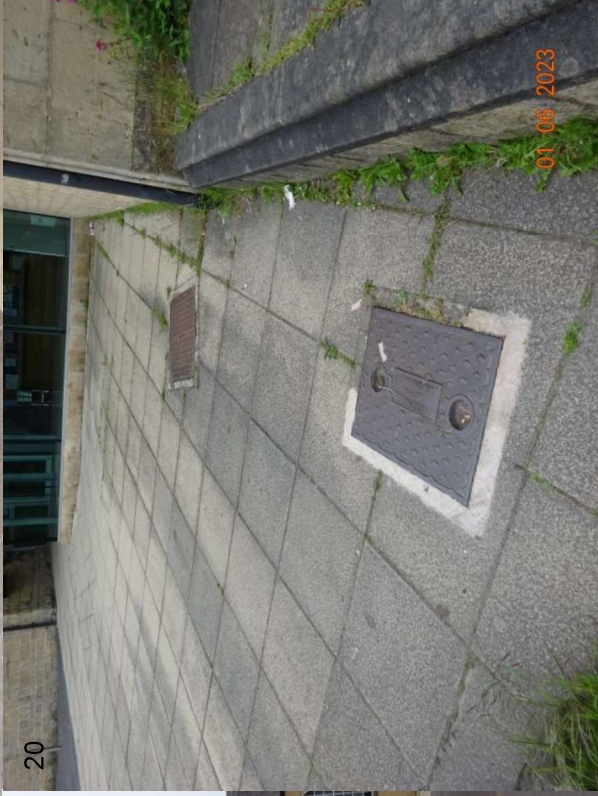
20

There are two cast-iron inspection chamber covers located in the pressed concrete paving which are defective and have missing lifting eyes. The inspection chamber covers were not raised for survey purposes at the time of the survey and the condition of the underground drainage cannot be commented upon in this report. (Photograph 20).
