Asbestos Management Survey Report for The Pavillion, Englefield Rd, Theale

8 August 2013

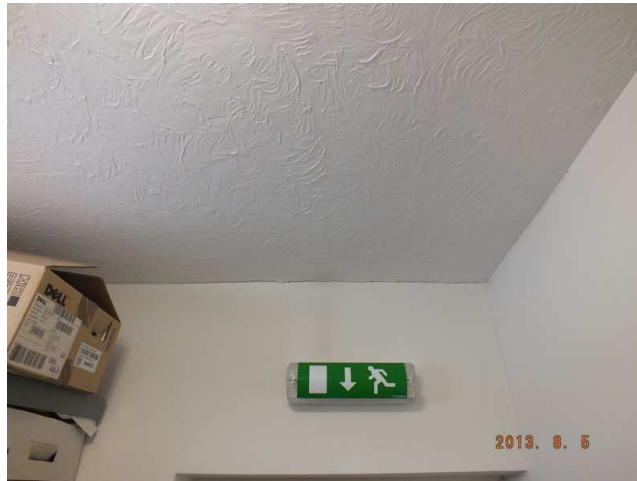
Figure 3 S001 Textured Coating

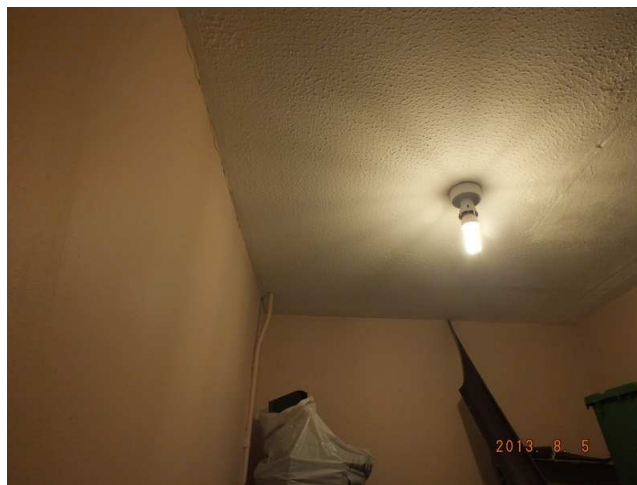
Fig 4 S002 Textured Coating

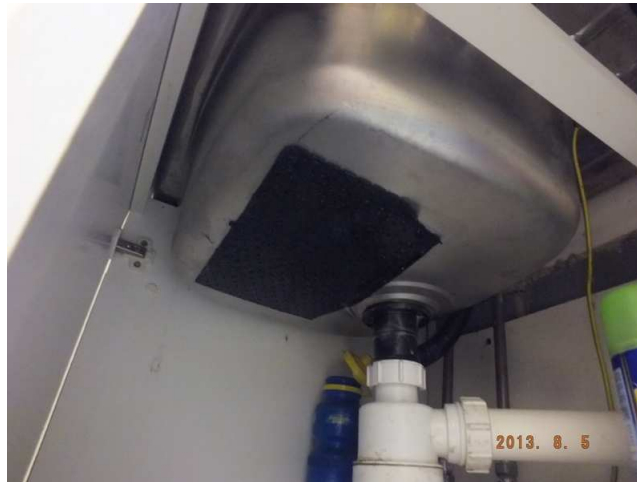
Fig 5 S003 Under Sink Damper

The under sink damper to the stainless sink in the central kitchen area has been shown to contain Chrysotile. There is very low risk of fibre release, and this should be managed in situ.

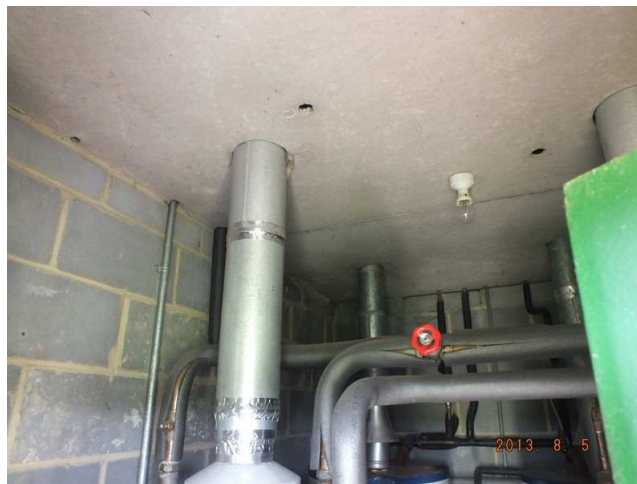
Fig 6 S004 Ceiling Board

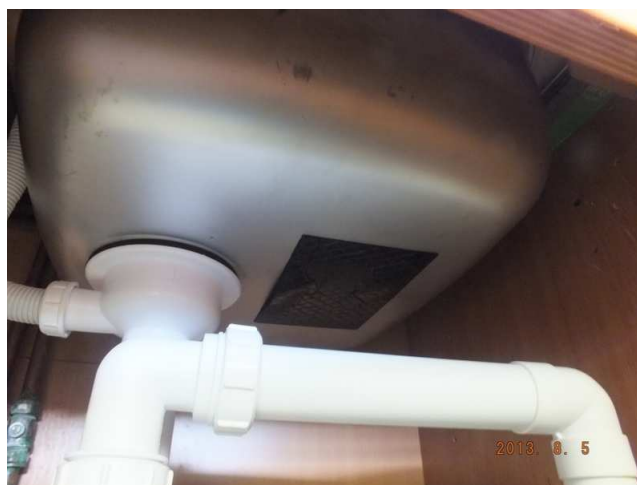
Fig 7 S005 Under Sink Damper

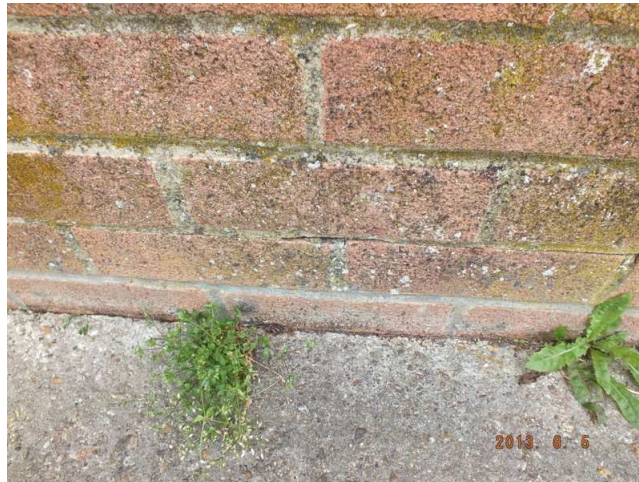
Fig 8 S006 DPC

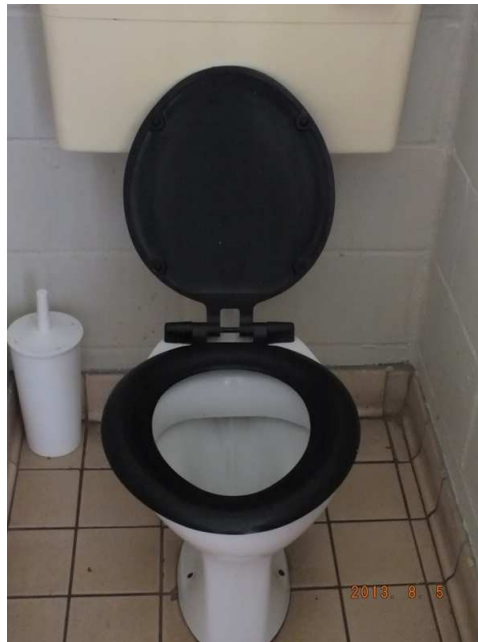
Fig 9 P001 WC Seat - Gents

The Toilet seat in the Gents WC should be presumed to contain asbestos as is it of a construction known to contain asbestos. It cannot be sampled non-destructively. Should it be replaced it should be treated as asbestos waste and disposed of accordingly.
