LEGIONELLA RISK ASSESSMENT

CUSTOMER : NATURAL ENVIRONMENTAL RESEARCH COUNCIL

SITE : BRITISH GEOLOGICAL SURVEY, KEYWORTH

DATE : 20 MARCH 2017

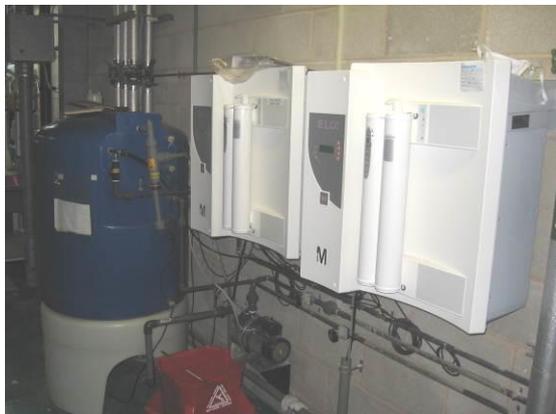
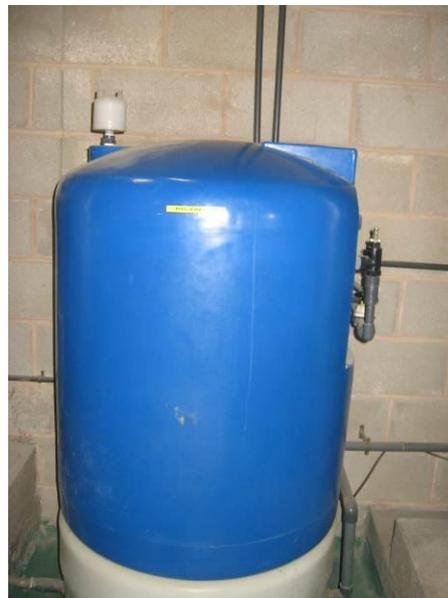
The reverse osmosis process will filter out any bacteria present within the mains water. RO water system temperatures are usually >20°C, owing to the way the water is recirculated, and it generally reaches the ambient room temperature.

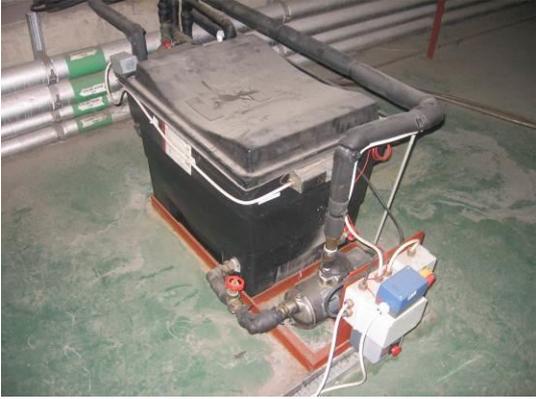
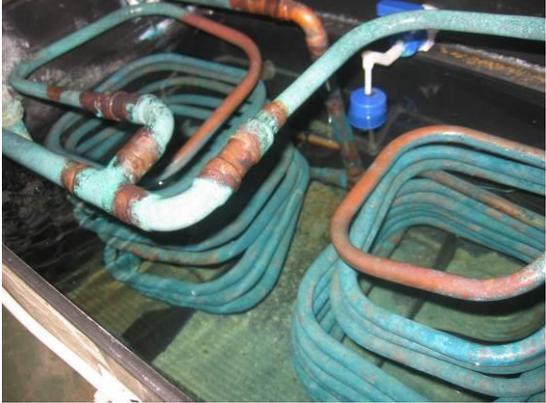
| <p>The tanks and vessels are recirculating and supplying water <20°C which is not conducive to bacteria growth. The supplies to these tanks are flushed weekly.</p> | | |

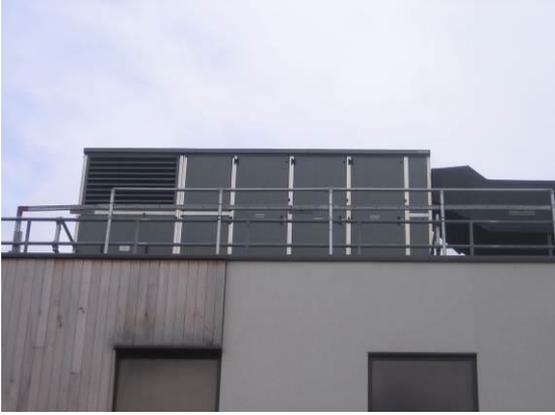
| <p style="text-align: center;">AHU (EIGL 3)</p> | | |

| <p>Water condensing from the cooled air at the cooling coils within the air handling units may create conditions suitable for bacteria to grow. The cooling coils and drainage trays of these units could support bacteria growth and should be regularly inspected and maintained in a clean condition.</p> | | |

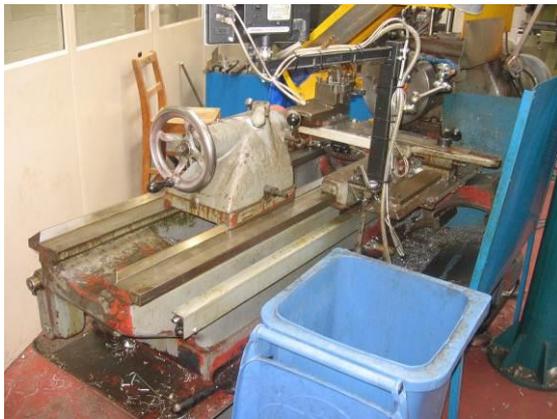
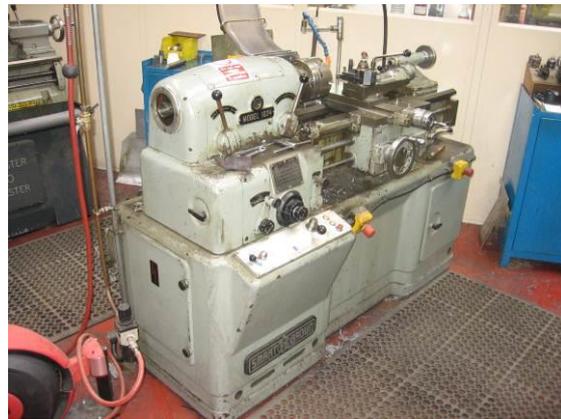
The cutting lubricants can support legionella and other bacteria which can cause respiratory disease. Lubricants should contain a biocide and systems should be cleaned regularly every six months.

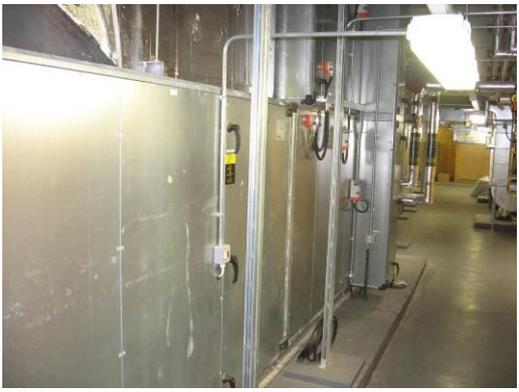
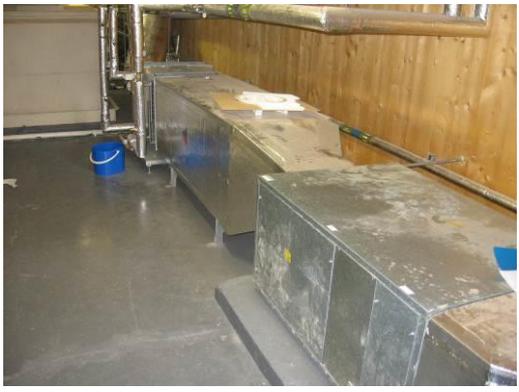
| <p>Water condensing from the cooled air at the cooling coils within the air handling units may create conditions suitable for bacteria to grow. The cooling coils and drainage trays of these units could support bacteria growth and should be regularly inspected and maintained in a clean condition.</p> | | |

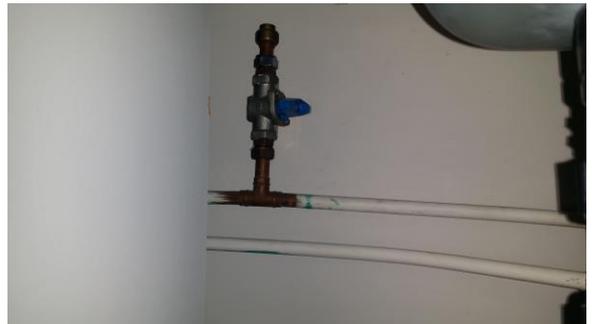
SMALL DEADLEG EIGL 1, LAB U032

There may be some stagnant conditions present in the deadlegs of pipework found within the system. (see Recommendations, section 6 and photos.
