# Electrical Services Report

Public Toilet Block – Warminster Road, Westbury, BA13 3PE

Prepared for: Information and Refurbishment Recommendations

Date: Tuesday 30<sup>th</sup> September 2025

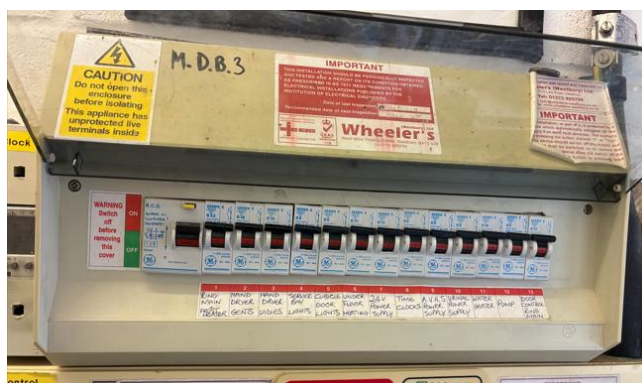
Ref 1.

The next inspection date was March 2015, which is now over ten years overdue. A full Electrical Installation Condition Report (EICR) is strongly recommended as soon as possible as it represents a compliance failure, Periodic Inspections are required under BS7671, Part 6. (Photo(s) Ref 1)

The Distribution Board is plastic and does not comply with the current requirement for non-combustible (metal clad) consumer units as outlined in regulation 421.1.201. (Photo(s) Ref 1)

The current setup includes RCD protection, however, if a single circuit develops a fault, it will trip the entire board. We recommend upgrading to RCBO protection on individual circuits to improve safety and minimise disruption. (Photo(s) Ref 1)

In accordance with BS 7671 (IET Wiring Regulations), several compliance issues were identified: The Distribution Board requires an EICR immediately, as inspection is overdue by more than 10 years.

The Distribution Board is plastic and does not comply with the current requirement for non-combustible (metal clad) consumer units as outlined in regulation 421.1.201.

RCD/RCBO protection must be reviewed and upgraded to provide individual circuit protection, in line with Chapter 41 of BS 7671.

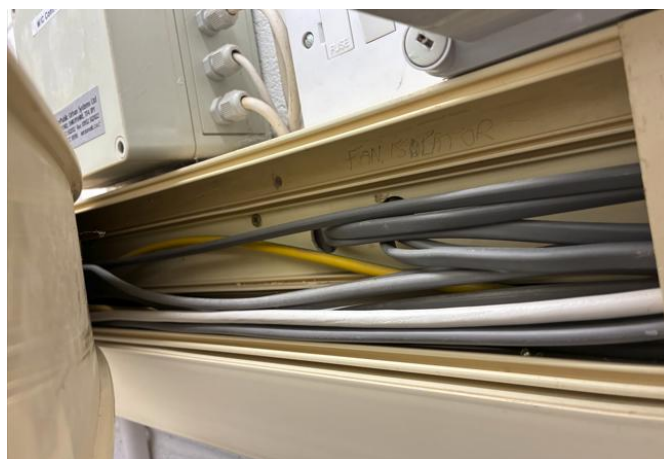
Ref 2.

Containment is mainly plastic trunking and plastic conduit, which have degraded over time and offers limited fire resistance. Modern Standards recommend the use of metallic containment in public access buildings to prevent premature collapse in a fire (Regulation 521.10.202). (Photo(s) Ref 2)

Installed cabling is standard PVC, not low smoke and fume (LSF) cable. Given this is a public building, LSF cabling is strongly recommended to reduce smoke and toxic emissions in the event of a fire, helping maintain visibility and safety. (Photo(s) Ref 2)

Use of PVC cables in a public building does not comply with best practice. LSF (Low Smoke and Fume) cabling is strongly advised (Regulation 422.2.1).

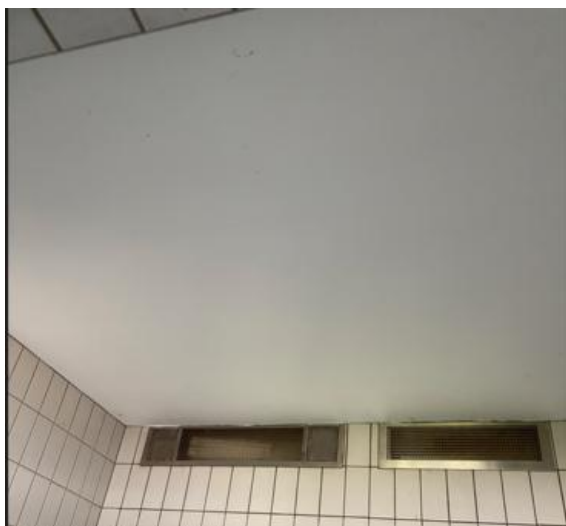
Ref 4.

No fire detection systems are installed, while the toilet block may be considered a low risk environment for fire, a fire risk assessment should determine whether heat or smoke detection is required, particularly in service areas where electrical equipment is concentrated. At a minimum, installation of a standalone heat detector in the service area where cleaners' products and the electrical intake area should be considered. (Photo(s) Ref 4)

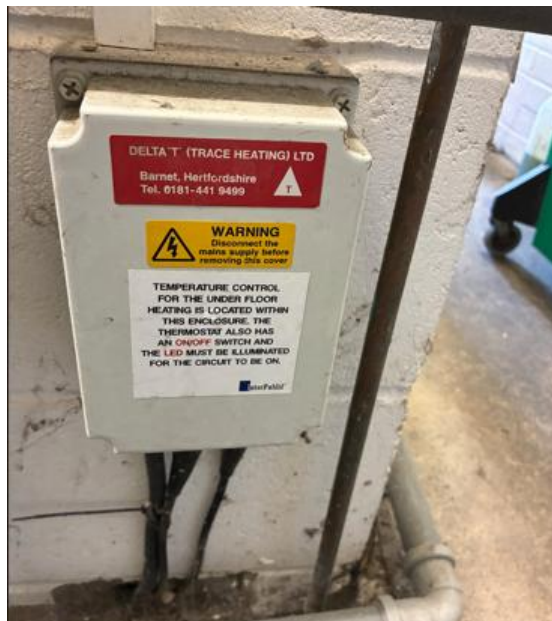
Ref 5.

Underfloor heating is present but not tested during the survey, electrical heating systems require suitable RCD which are in place under Regulation 701.753. The age and condition of the system should be reviewed and tested. (Photo(s) Ref 5)
