Our Ref: 02C300227

14 February 2023

**KINGS MEADOW HOUSE, KING'S MEADOW ROAD, READING  
DEFECT LETTER REPORT**

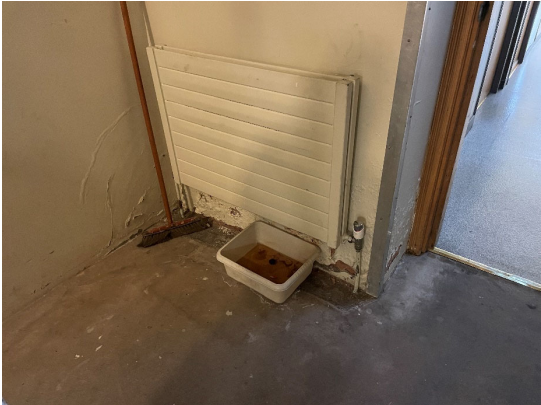
- 1) Damp staining to the bottom of the west wing stairwell. We were informed that the damp is at its worst during spells of heavy rain. The staining is located around the base of a riser. Original construction plans held on site record the presence of 100mm rainwater downpipe within the riser that serves the main roof. It was not possible to see in the riser as pressed steel radiators have been installed across the riser's access hatches.

Given that the damp staining to the west wing stairwell is at the bottom of a riser that accommodates a rainwater down pipe, the most likely cause is a leaking joint or crack to the pipe, possibly exacerbated if the pipe is partially blocked causing water to back up beyond the location of the defect. Alternatively, it is possible that the waterproofing has split between the roof and the outlet and water in running down the outside of the pipe.

Photo No	Photograph Description	Photograph
4.	Damp damage to the west wing stairwell at Ground Floor level.

There are initial investigations that can be undertaken into the suspected downpipe leak before you commit to the expensive and disruptive removal of the radiators blocking the access hatches. We first recommend removing the section of inverted roofing around the rooftop drainage outlet to check the integrity of the waterproofing in this area, and ensure that the outlet is still firmly fixed in position.

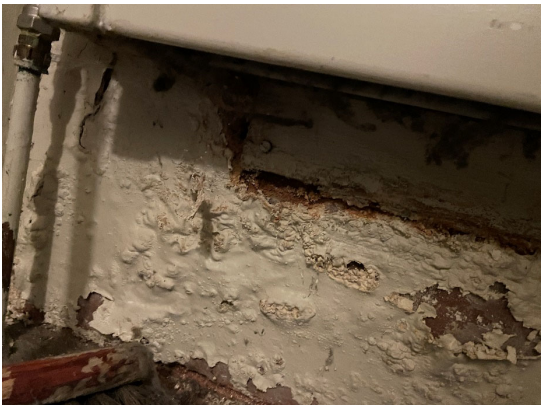
5.	Riser access hatch with radiator over.

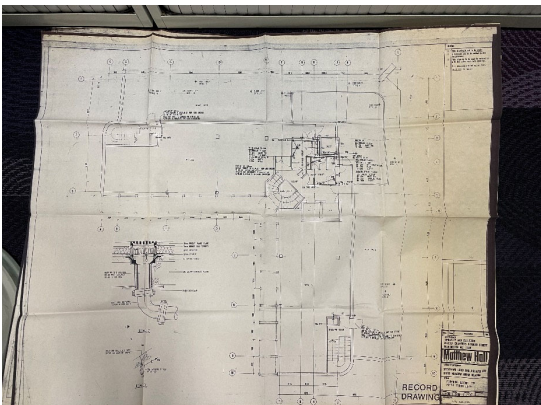
However, the original construction drawings suggest that the downpipe is underslung under the roof slab for a distance of about 2.2m before it enters the riser. We would expect that any water running on the outside of the pipework would be shed where brackets hold the underslung pipe before it enters the riser.

6.	Original construction drawing details that the riser to the west wing stairwell riser includes a 100mm rainwater downpipe, and detail of rooftop outlet.

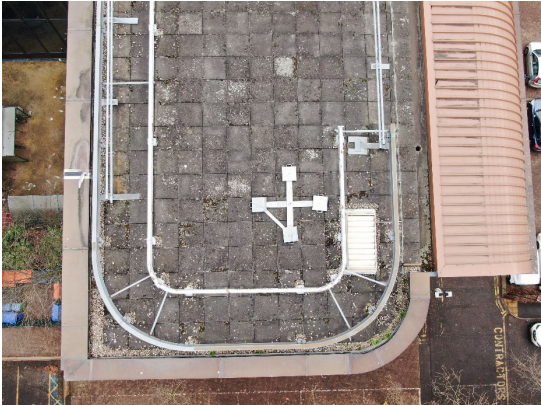
Photo No	Photograph Description	Photograph
7.	West wing – roof top drainage outlet leading to the internal downpipe situated to the centre right of the picture.

A specialist drainage CCTV survey company may be able to check the integrity of the downpipe by using a push CCTV camera, sent down into the pipe from the rooftop outlet. If the defect is in a difficult to access location it may be possible to effect a repair using a downpipe relining system inserted from above.

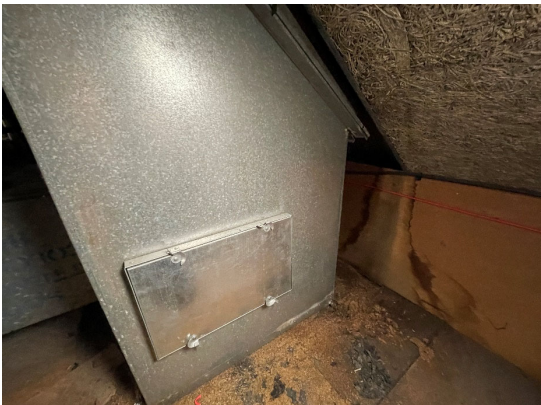
- 4) Within the rooftop plant room we were shown water staining to woodwool slabs behind the angled cladding and adjacent to a ventilation grille in the cladding.

8.	Rooftop plantroom duct and grille, with water staining evident to the right of the duct.

The mastic seals to the cladding and grille should be renewed, and it may also be necessary to dismantle the cladding around the grille to confirm the issue and fully remedy it.

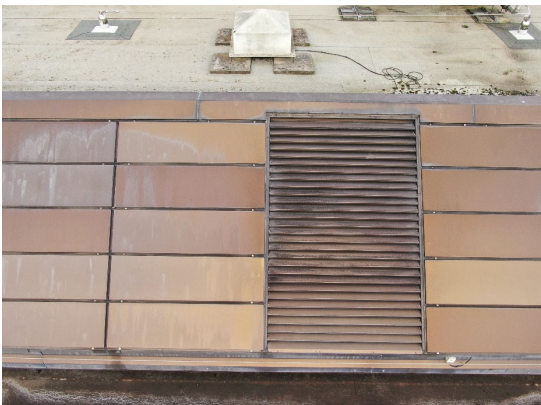
The drone survey did not definitively identify a defect around the ventilation grille that would be the source of the water ingress. However, some of the mastic seals to the cladding and grille look aged and shrunk. The cause of the water ingress to this location could also be hidden behind the grille and/or cladding and further investigations are required.

9.	South facing grille to the roof top plant roof. Mastic seals, particularly to the top of the grille and the top line of cladding panels are aged and split.

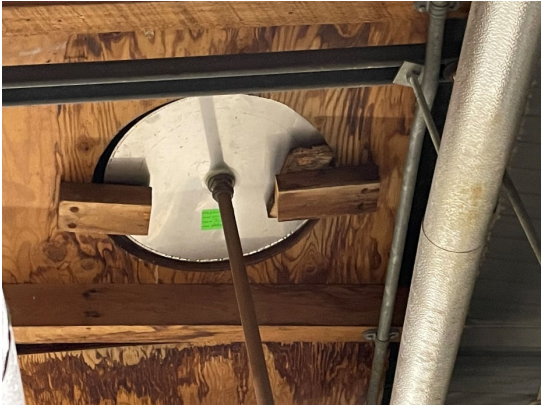
- 5) Within the main plant room we were shown water staining to the south east corner of the room. The staining is in the vicinity of a blocked off penetration through the roof deck relating to a flue, now removed. However, it was reported that water ingress also occurs to the plant room away from this

We also noted that while the redundant flue penetration has been infilled, the flue to the exterior of the cladding remains. This may be a weak point, where water is entering the plantroom.

Photo No	Photograph Description	Photograph
10.	Infilled redundant flue penetration to the south west corner of the main plant room at 5 <sup>th</sup> floor level. Water staining is evident around the penetration.

Consideration should also be given to removing the flue above the redundant flue penetration and ensuring the former penetration is fully waterproofed.

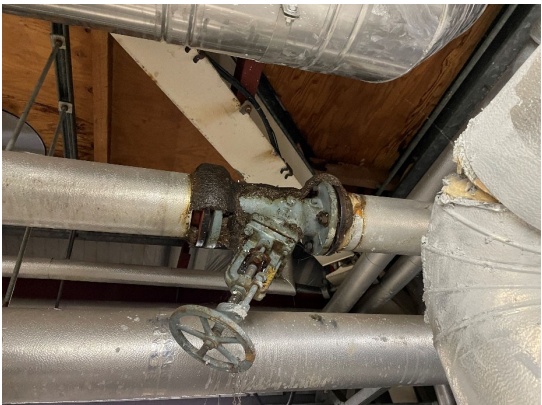
11.	Water staining also evident in other locations in the south east corner of the plant room.

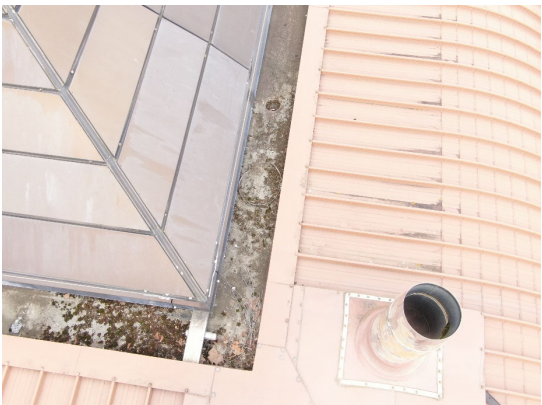
The leak into the main 5<sup>th</sup> Floor plant room may be associated with the gutter than runs between the main roof and the curved cladding. The gutter lining does not appear to have any significant defects, but there are debris present which may be obstructing water flow, possibly leading to the gutter and drainage points being overwhelmed in heavy downpours of rain.

12.	Some debris to the gutter between the main roof and the curved cladding over the main plant room.

The gutter above the curved cladding should be cleared and the gutter overhauled. It may be worth relining the gutter to extend its life expectancy. The loose and missing foam profile fillers to the curved cladding should be replaced and secured, and any joint sealant checked and replaced where necessary.

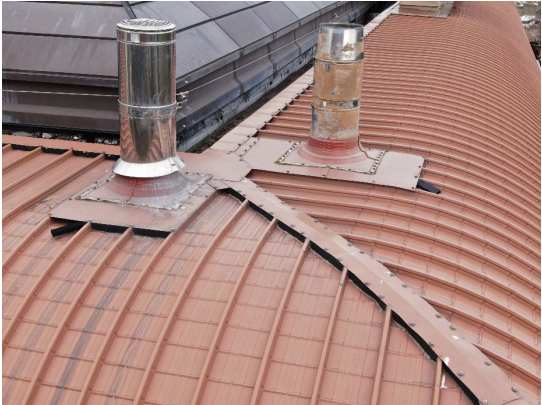
We noted that many of the foam profile fillers to the joints in the curved cladding are loose and some are missing. This may also be a possible route for the water ingress.

Photo No	Photograph Description	Photograph
13.	Redundant flue (to the right) through the curved cladding, the penetration for which has been infilled internally. Note loose foam profile fillers.

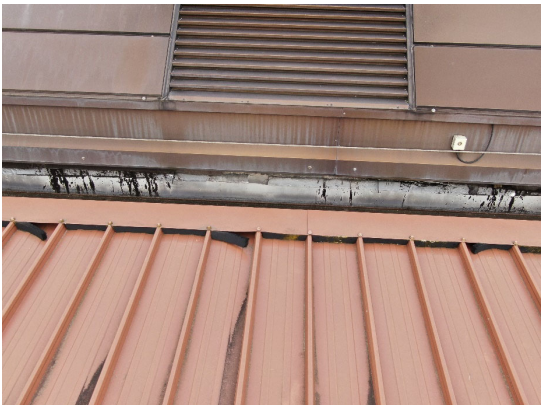
14.	Loose foam profile fillers.

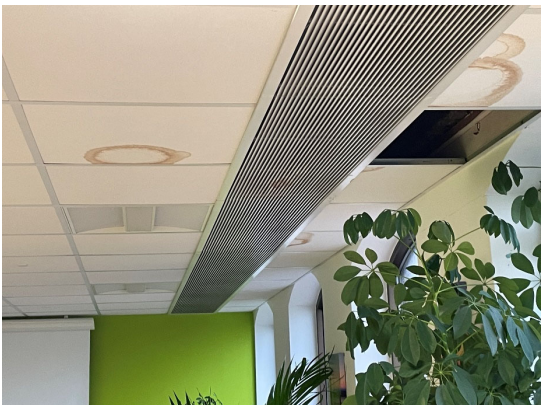
- 2) Lines of damp stained mineral fibre ceiling tiles in the canteen at 4<sup>th</sup> Floor level. The worst staining was along the east elevation towards the south east corner of the building. However, other more minor damp patches were noted along the south elevation. Other damp stained tiles were noted further into the floor plate, but we were informed that this may be the result of leaks from the boiler in the plant rooms above.

15.	Water staining to the ceiling tiles in the 4 <sup>th</sup> Floor canteen.

One of the main drawbacks of inverted roof systems is that it can be difficult to identify the route of water leaks without intrusive investigations. We therefore recommend that sections of the inverted roof ballast and insulation are lifted, and the condition of the waterproofing laying is examined, particularly where buddleia bushes are growing. We also recommend that the exposed roof membrane is tested by specialists using a system such as earth leakage leak detection as any breaches in the waterproof layer may be small and hard to identify via a visual inspection alone.

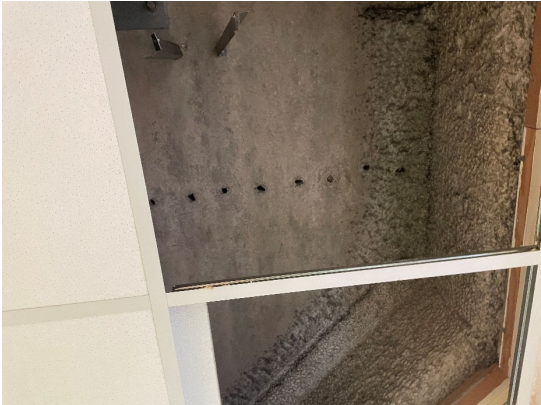
The source of the water ingress into the 5<sup>th</sup> and 4<sup>th</sup> Floor offices may not necessarily be located above where the internal staining is present. Water will often track along a concrete floor slab until it finds a path through the slab. Where ceiling tiles have been removed towards the south east corner of the 4<sup>th</sup> Floor we noted a row of holes in this area, which may be providing a path for the water to come through in to the ceiling void in this area. As such, there is a range of possible pathways where water may be entering the building.

Photo No	Photograph Description	Photograph
16.	Holes to roof slab to the south east corner of the 4 <sup>th</sup> floor. Water staining has occurred beneath the holes.

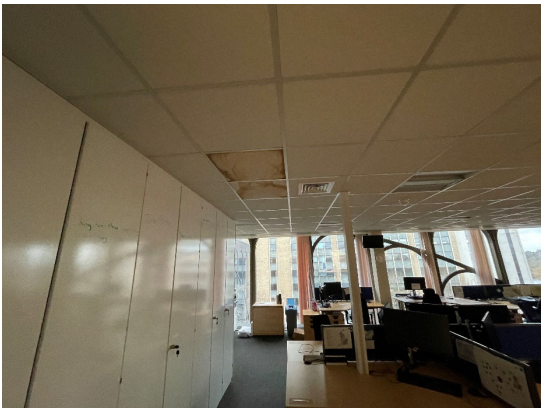
- 3) To the north wing office at 5<sup>th</sup> Floor level there is damp staining to the ceiling close to the north west corner where the two wings meet.

17.	Water staining to the ceiling of the north wing at 5 <sup>th</sup> floor level.

For the main roof, where access is easier and edge protection is in place, you could adopt a trial and error approach, exposing sections of the roof membrane and undertaking patch repairs until the water ingress to the 5<sup>th</sup> Floor office stops. For the parapet roofs, however, it is likely that scaffold will be required for safe access and to protect pedestrians below. The cost of this would make a trial and error approach unfeasible and so the whole section of inverted roof should be stripped off.

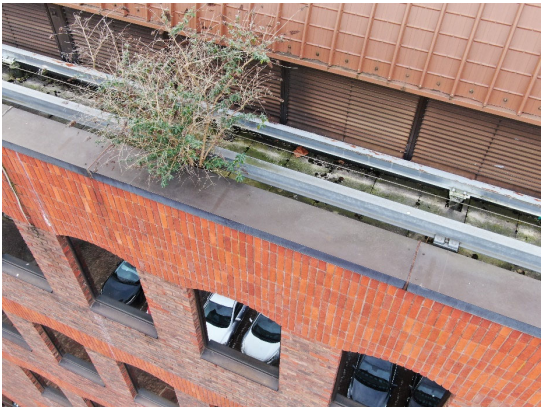
We noted buddleia bushes growing in the ballast of the east parapet inverted roof, and their roots may have damaged the waterproofing. While we were informed that the leaks predate the growth of the bushes, the buddleia may be exacerbating the issue, or may lead to further issues in the future.

18.	Buddleia bush growing in the ballast of the parapet roof over the 4 <sup>th</sup> Floor.

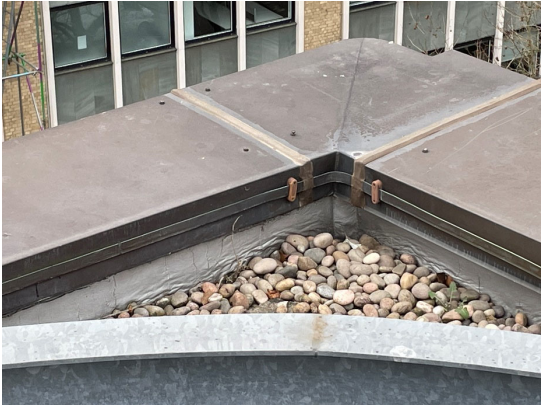
Other roof issues were noted which may be causing water ingress. We identified that the asphalt upstands to perimeter walls and to the roof top plant room are slumped and cracked. We also noted that the asphalt upstands to the cleaning cradle supports are also slumped and cracked. The slumping and cracking may have breached the asphalt waterproofing layer, allowing water to percolate through to the interior.

Photo No	Photograph Description	Photograph
19.	Slumped asphalt upstand to the main roof.

We have allowed for repairs to defective asphalt upstands as well as a provisional sum for general repairs to the membranes. As the window washing cradles have been out of

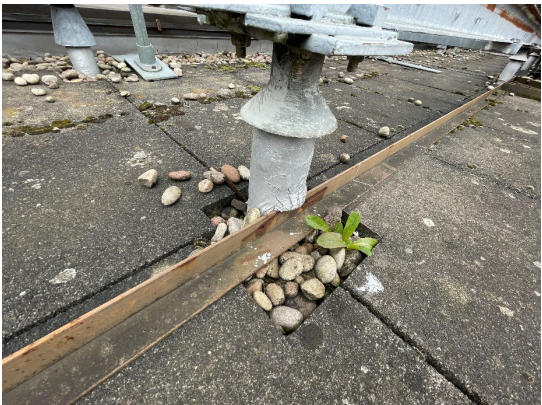
20.	Damaged asphalt upstand to a window washing cradle's rail support.

use for some time consideration should be given to removing the systems entirely to remove an ongoing maintenance liability.

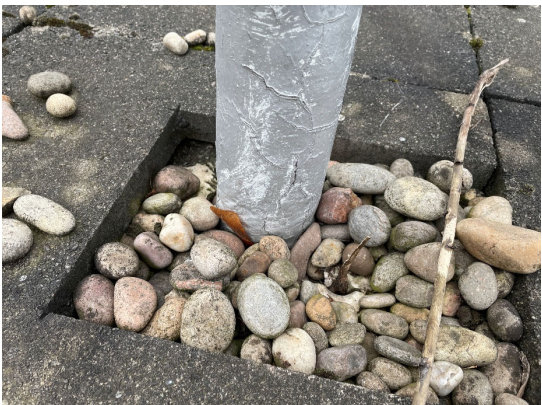
21.	Cracked asphalt upstand to a window washing cradle's rail support.

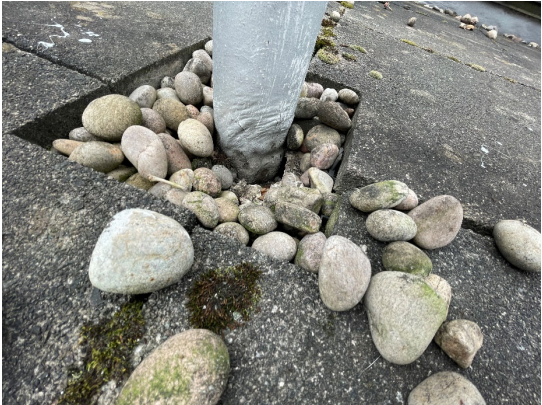
Photo No	Photograph Description	Photograph
22.	Slumped and cracked asphalt upstand to a window washing cradle's rail support.

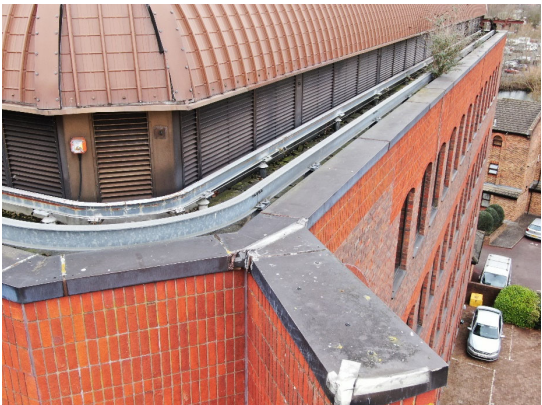
The steel sheet parapet wall cappings above the 4<sup>th</sup> Floor to the south and east elevations are also in poor condition, with mastic seals that have shrunk and are split. We also noted that the cappings to the south west corner have been inappropriately repaired using zinc foil back “flashband” type tape.

23.	Damaged parapet wall capping inappropriately repaired with tape.

The steel sheet parapet wall cappings should be also repaired/ replaced, as necessary.
