the play inspection company

Annual Inspection

Central Swindon North Parish Council

Inglesham Road

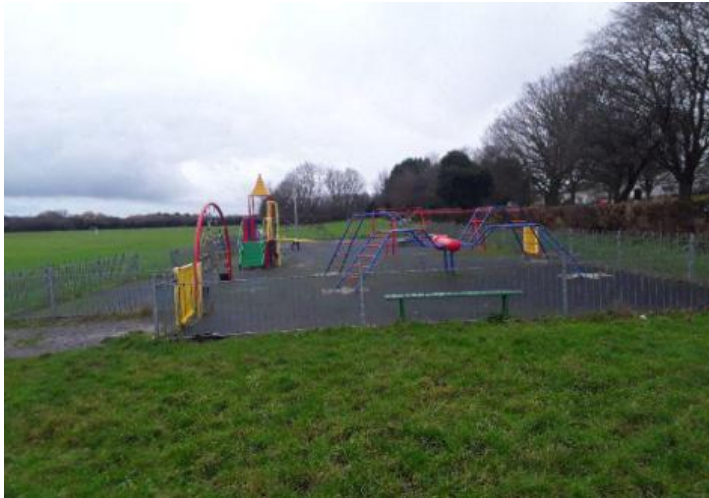
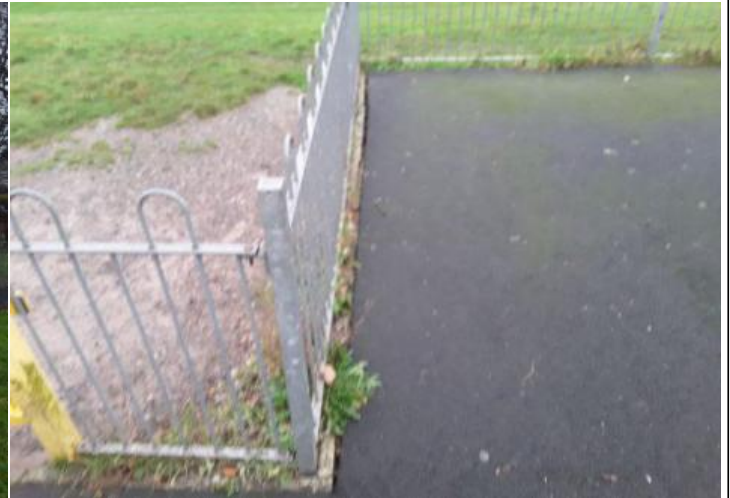
Risk Level: L - Low Risk
Surface: Mixed Surface

Finding: There are significant gaps (over 30mm) between the surface and the edging or between the joints in the surface; these are large enough for a small foot to enter

Action: Repair surfacing

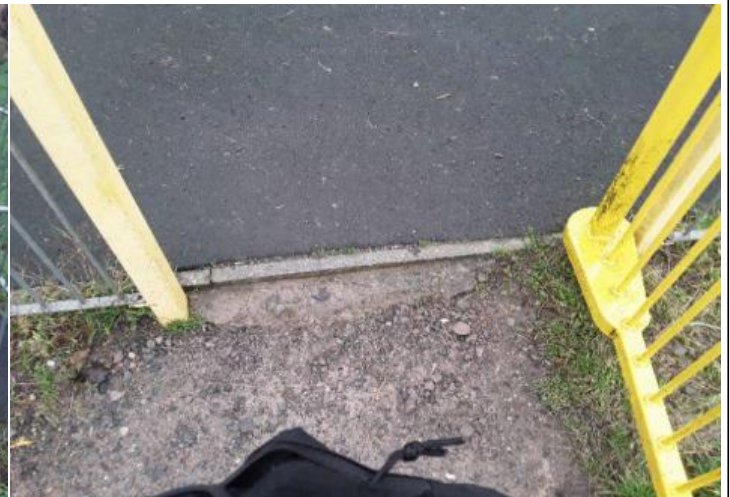
Risk Level: L - Low Risk
Surface: Grass

Finding: The area under the gate has eroded leaving uneven areas, or the concrete foundations exposed, resulting in trip hazards at the entrance/exit to the playground

Action: Reinstate to level with surrounding surfaces

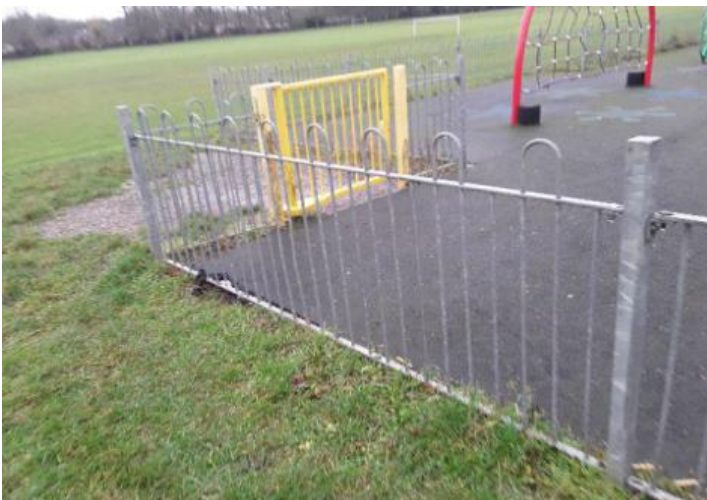
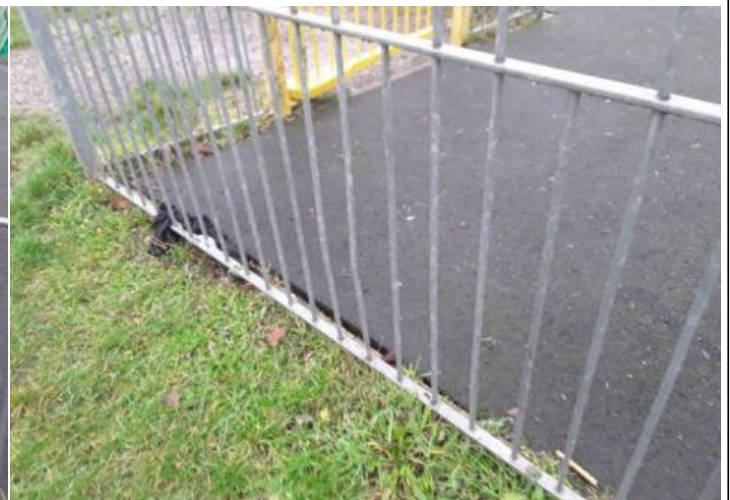
Risk Level: L - Low Risk
Surface: Grass

Finding: There is some damage to the fence sections

Action: Monitor for any further deterioration and repair as required

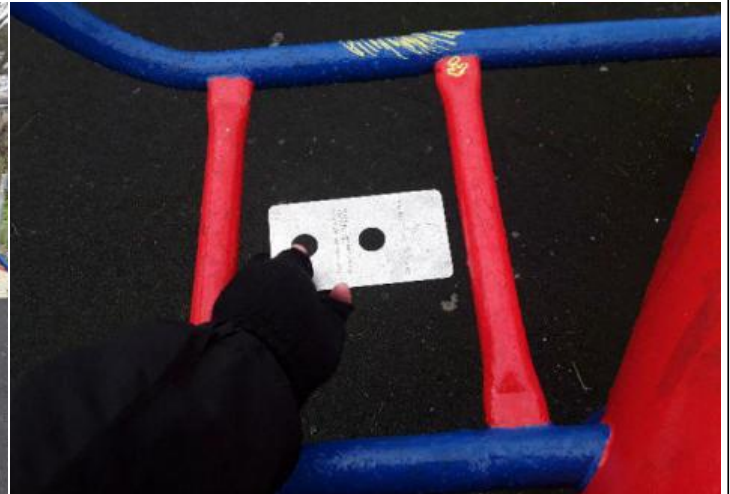
Risk Level: V - Very Low Risk
Surface: Wet Pour

Finding: The item fails to meet the requirements of BS EN 1176 Part 1 4.2.7.2 for head and neck entrapment in the frame

Action: Monitor - No remedial work recommended

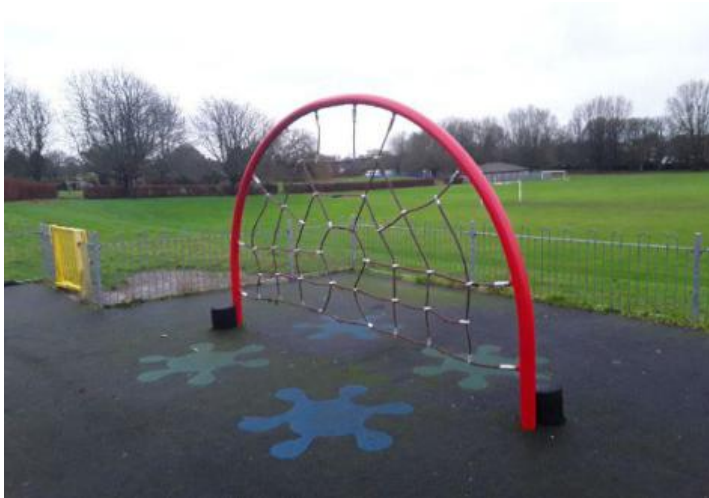
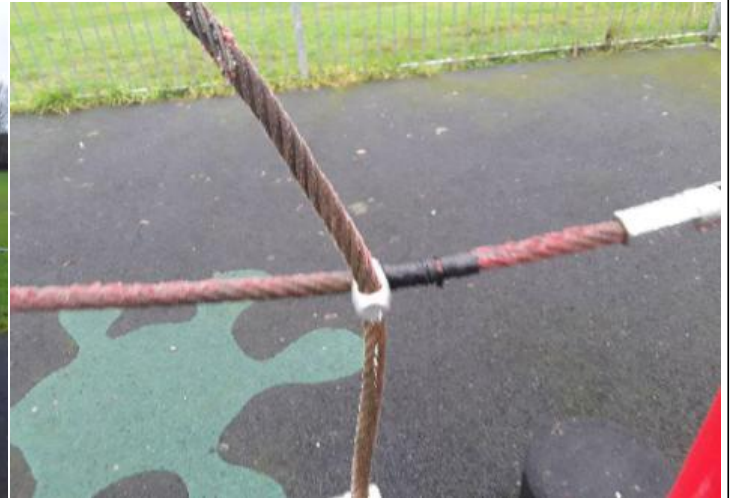
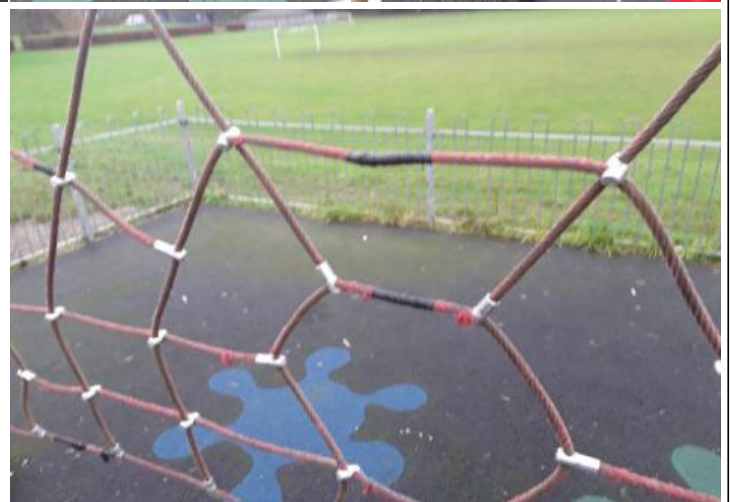
Risk Level: N - Risk Assessment not Undertaken
Surface: Wet Pour

Finding: The ropes on this item have been taped and we are unable to fully assess the condition of the rope, ensure no wire strands are broken beneath the tape

Action: Repair or replace as required

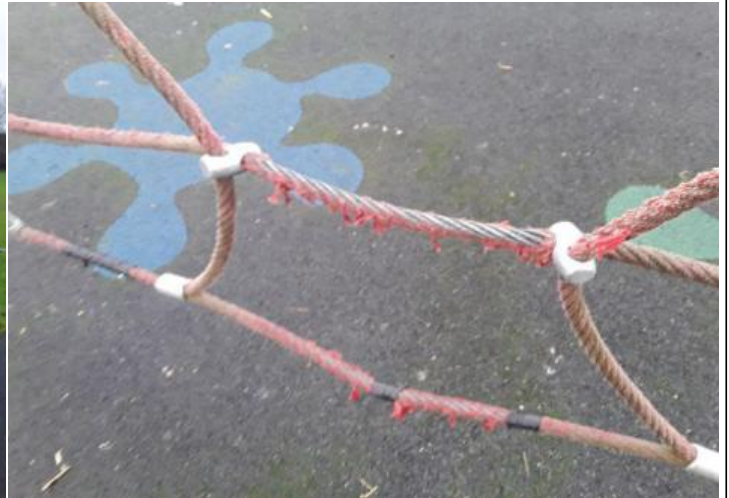
Risk Level: L - Low Risk
Surface: Wet Pour

Finding: The ropes/nets are worn/damaged in places

Action: Monitor for any further deterioration and repair or replace as required

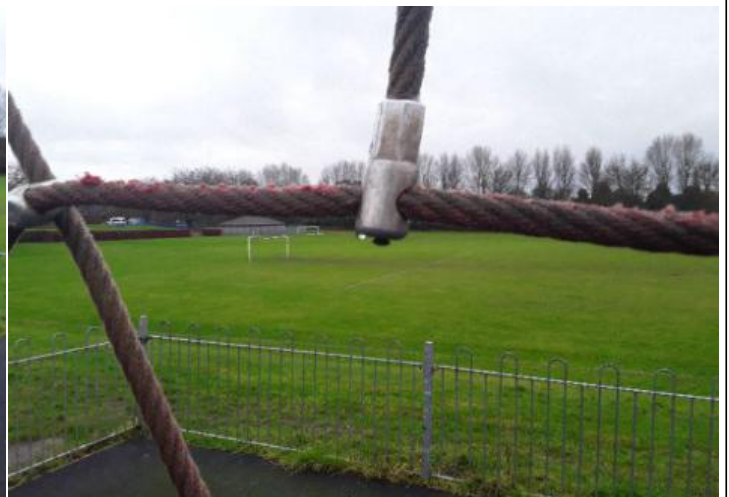
Risk Level: L - Low Risk
Surface: Wet Pour

Finding: A number of fixing(s) have worked loose

Action: Secure all loose fixings

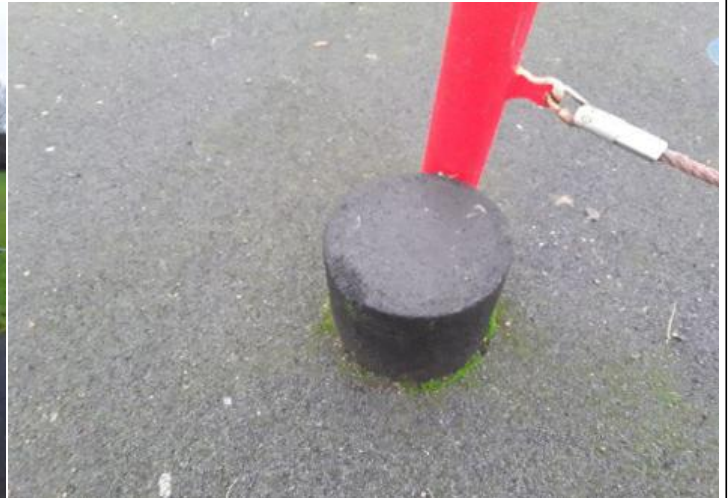
Risk Level: L - Low Risk
Surface: Wet Pour

Finding: The rubber stepping posts have some minor damage

Action: Monitor for any further deterioration and replace as required

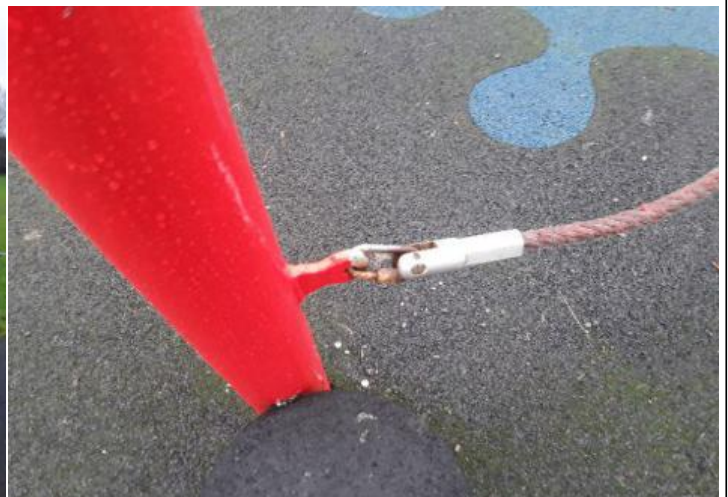
Risk Level: L - Low Risk
Surface: Wet Pour

Finding: There is some wear to the shackles.

Action: Monitor for any further deterioration and replace when 40% worn

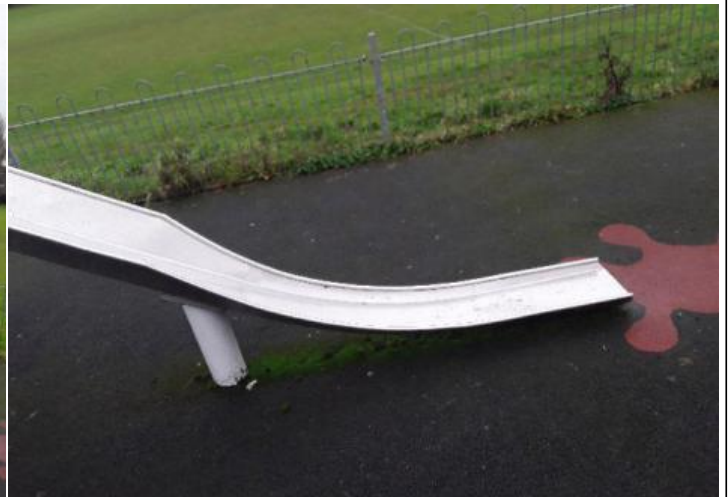
Risk Level: V - Very Low Risk
Surface: Wet Pour

Finding: There are a number of dents in the slide surface

Action: Monitor for any further deterioration and repair as required

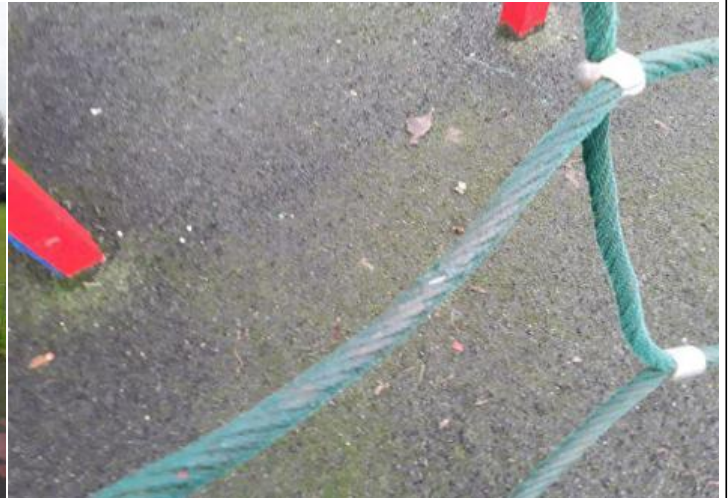
Risk Level: L - Low Risk
Surface: Wet Pour

Finding: The ropes/nets are worn/damaged in places

Action: Monitor for any further deterioration and repair or replace as required

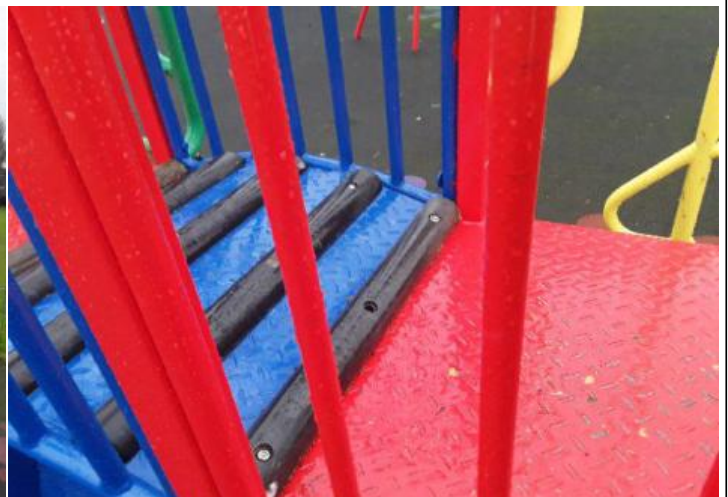
Risk Level: L - Low Risk
Surface: Wet Pour

Finding: There is or are fixings missing on the item

Action: Replace all missing fixings

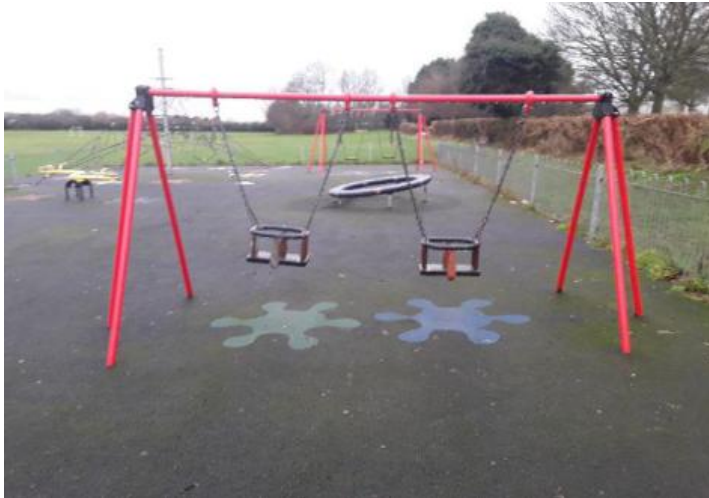
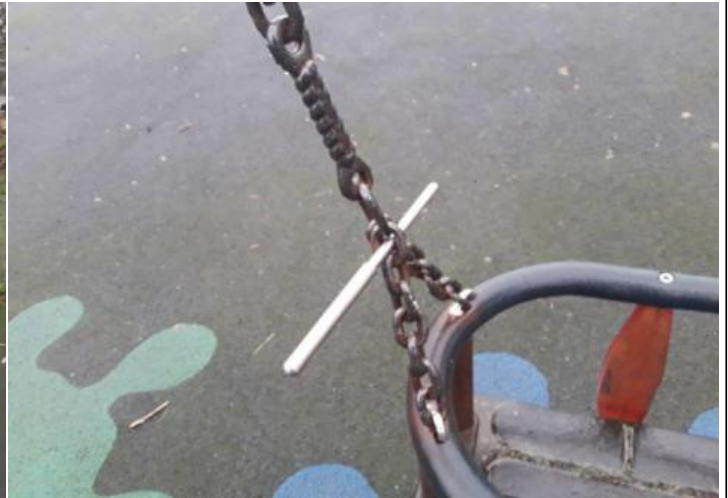
Risk Level: V - Very Low Risk
Surface: Wet Pour

Finding: The connecting links are in excess of 8.6mm and less than 12mm and fail the requirements of BS EN 1176 Part 1; clause 4.2.13, Chains

Action: Monitor - No remedial work recommended

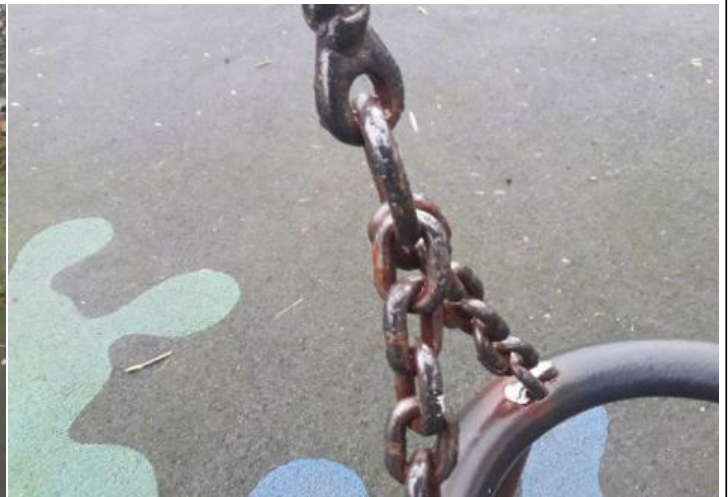
Risk Level: L - Low Risk
Surface: Wet Pour

Finding: There is some notable evidence of chain wear

Action: Monitor for any further deterioration and replace when 40% worn

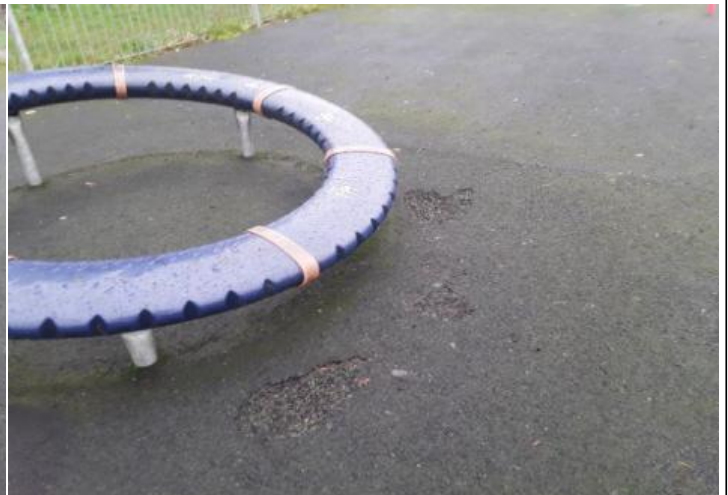
Risk Level: L - Low Risk
Surface: Wet Pour

Finding: There is moderate damage to the surface

Action: Repair the damaged areas of surfacing

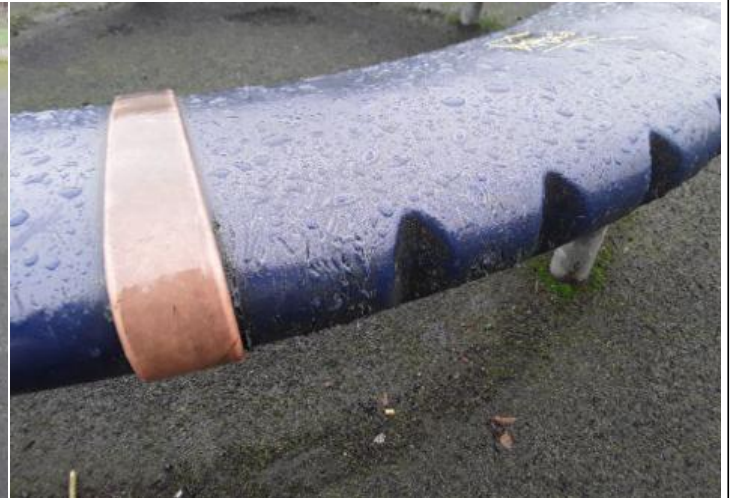
Risk Level: L - Low Risk
Surface: Wet Pour

Finding: The plastic body has been damaged

Action: Monitor for any further deterioration and replace as required

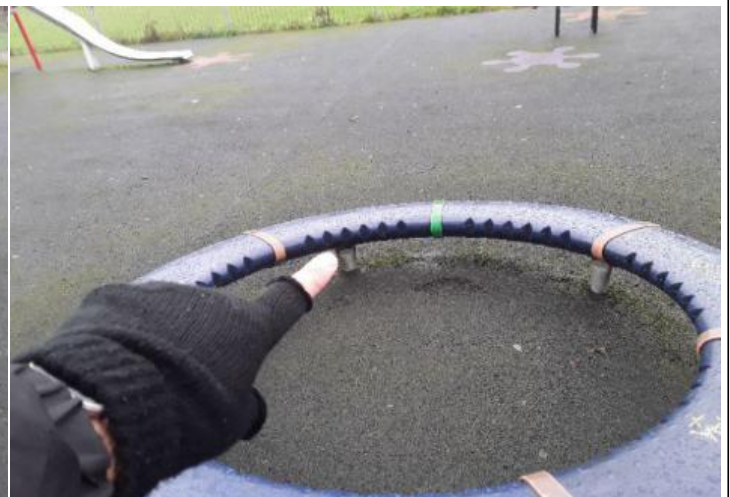
Risk Level: V - Very Low Risk
Surface: Wet Pour

Finding: There is/are bolt cap covers missing or damaged on the item

Action: Replace missing or damaged bolt cap covers

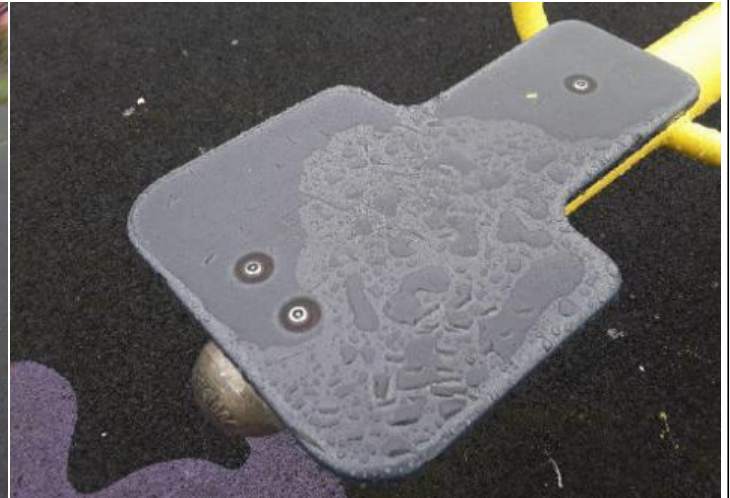
Risk Level: L - Low Risk
Surface: Wet Pour

Finding: There is some minor damage to the seat

Action: Monitor for any further deterioration and replace as required

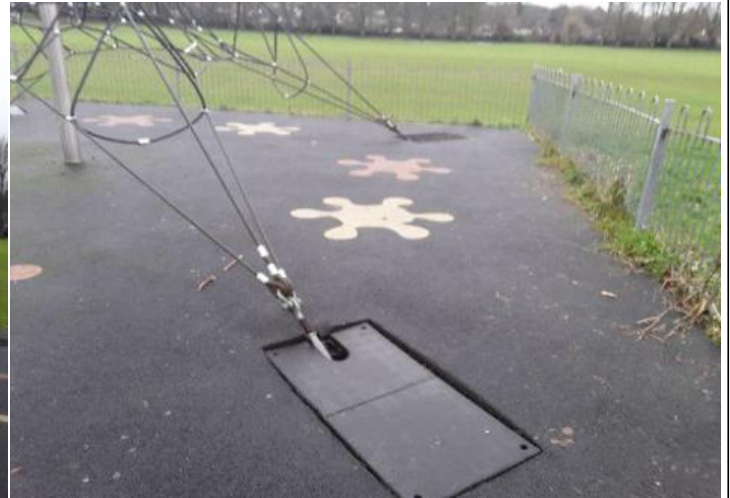
Risk Level: L - Low Risk
Surface: Wet Pour

Finding: There are trip hazards present

Action: Reinstate surrounding surfaces to level to remove the trip points

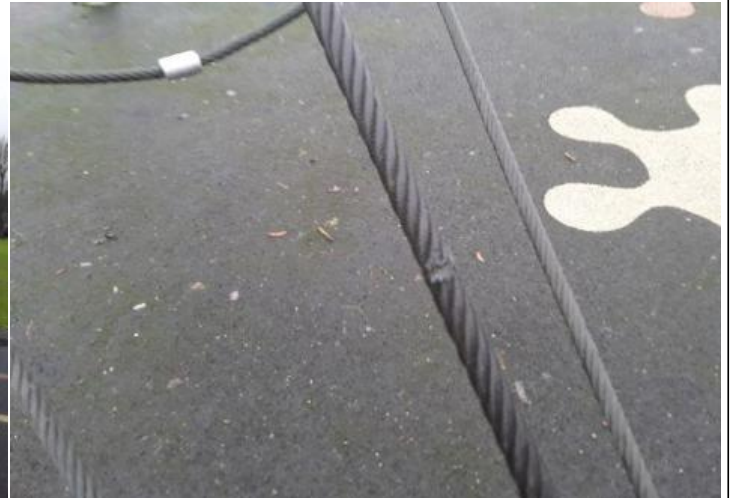
Risk Level: L - Low Risk
Surface: Wet Pour

Finding: The ropes/nets are worn/damaged in places

Action: Monitor for any further deterioration and repair or replace as required

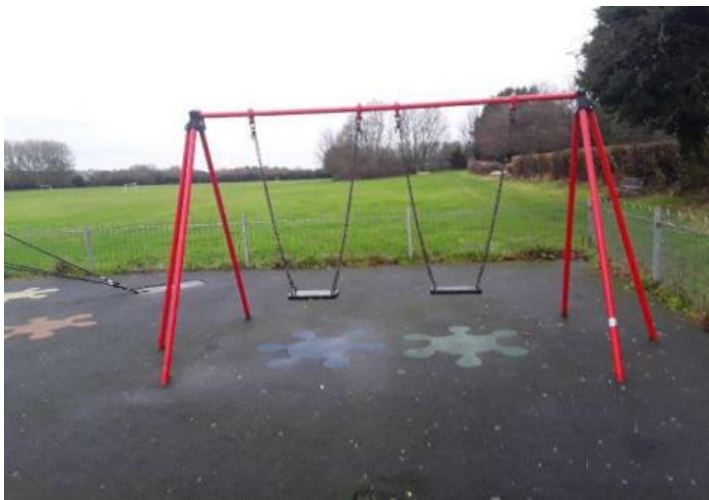
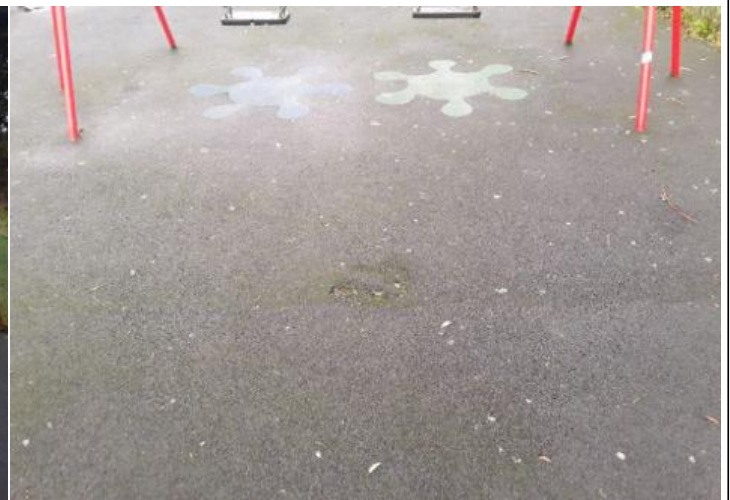
Risk Level: L - Low Risk
Surface: Wet Pour

Finding: There is moderate damage to the surface

Action: Repair the damaged areas of surfacing

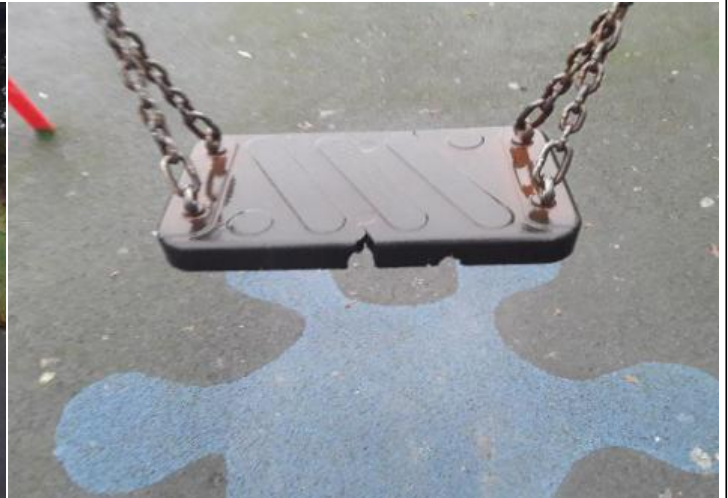
Risk Level: L - Low Risk
Surface: Wet Pour

Finding: The seat has minor damage or wear

Action: Monitor for any further deterioration and replace as required

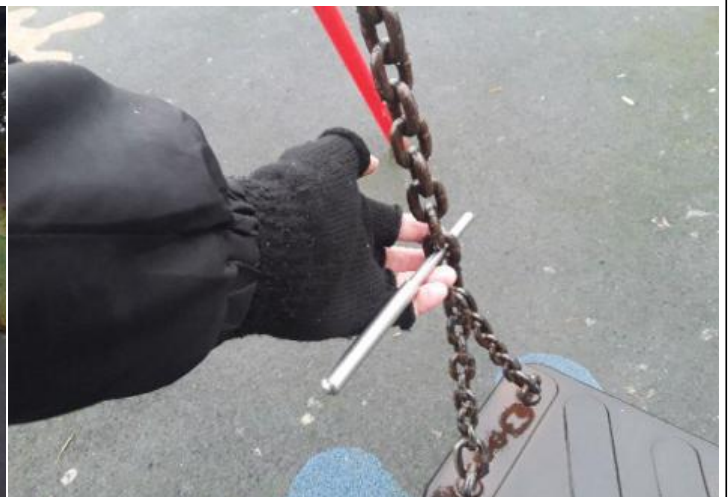
Risk Level: V - Very Low Risk
Surface: Wet Pour

Finding: The connecting links are in excess of 8.6mm and less than 12mm and fail the requirements of BS EN 1176 Part 1; clause 4.2.13, Chains

Action: Monitor - No remedial work recommended

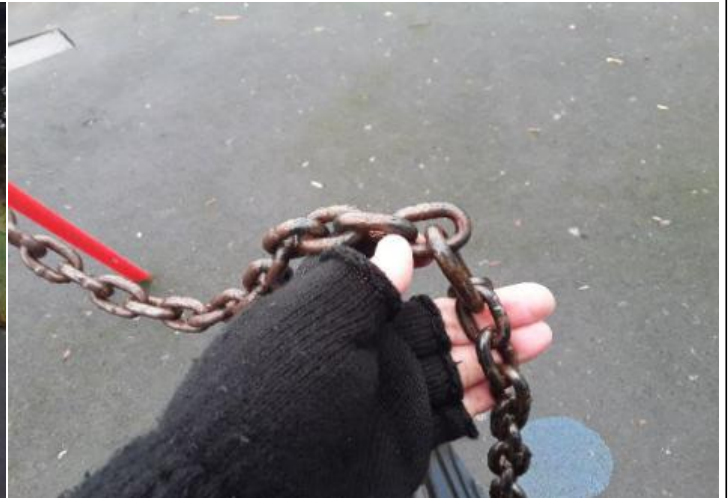
Risk Level: L - Low Risk
Surface: Wet Pour

Finding: There is some notable evidence of chain wear

Action: Monitor for any further deterioration and replace when 40% worn

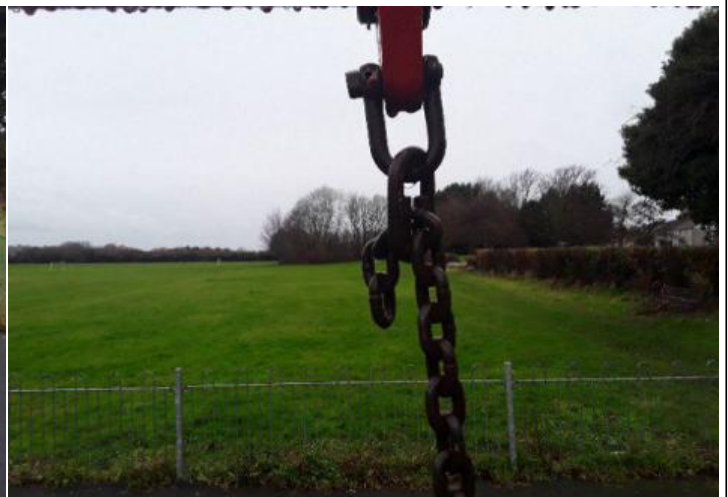
Risk Level: L - Low Risk
Surface: Wet Pour

Finding: There is some wear to the shackles.

Action: Monitor for any further deterioration and replace when 40% worn

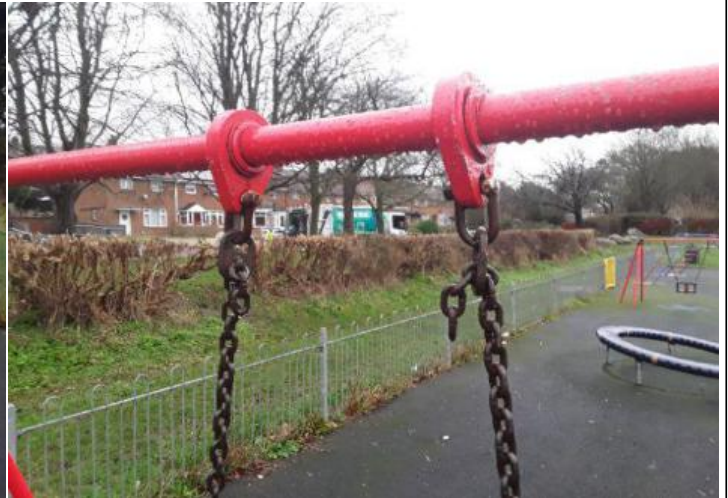
Risk Level: L - Low Risk
Surface: Wet Pour

Finding: The bushes are worn or missing

Action: Replace worn or missing bushes

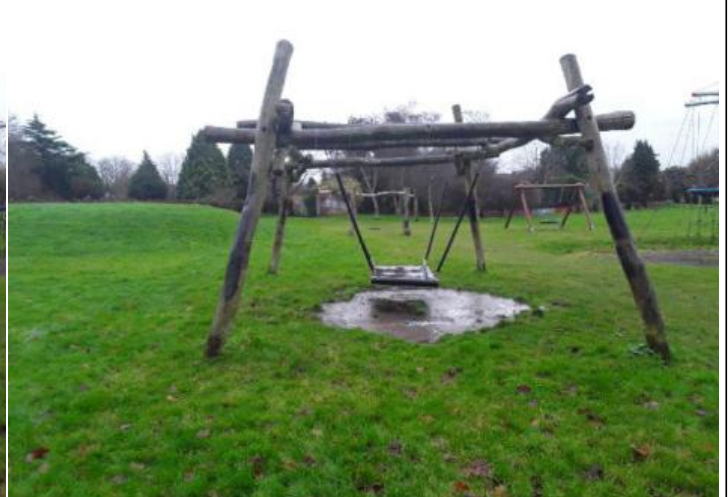
Risk Level: N - Risk Assessment not Undertaken
Surface: Grass Matrix Tiles

Finding: The fixings or components for this item were in excess of 2.5m above the standing surface and could not be fully accessed by the inspector. We have completed a visual inspection of the fixings from ground level but a maintenance inspection should be undertaken to assess the condition, security and wear of the components at intervals in accordance with the manufacturers recommendations.

Action: Inspect in accordance with the manufacturers recommendations

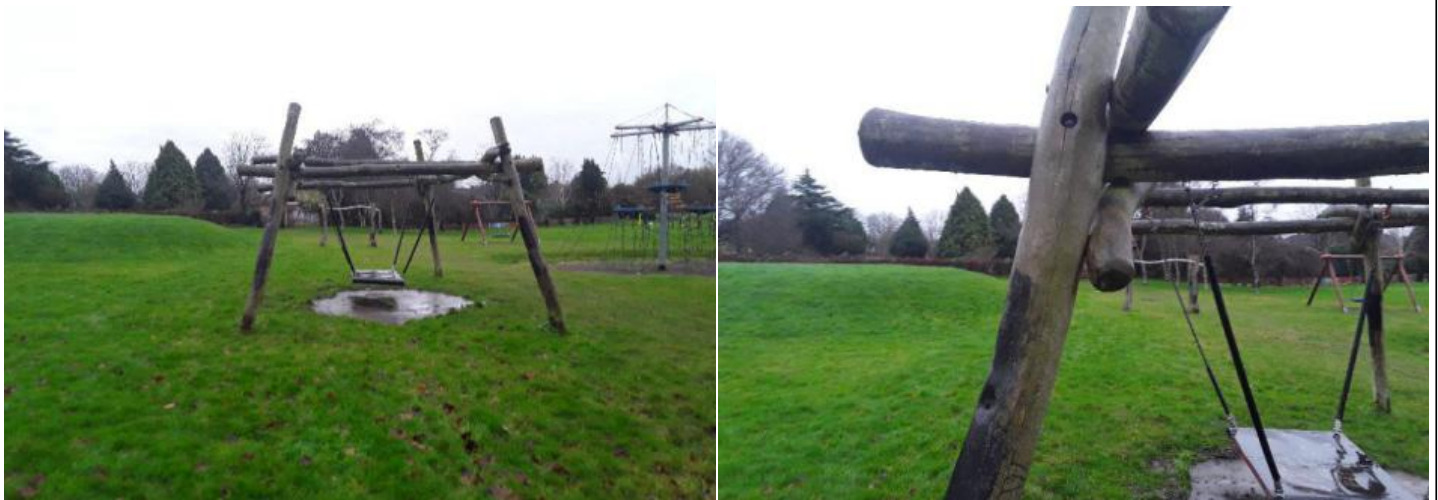
Risk Level: V - Very Low Risk
Surface: Grass Matrix Tiles

Finding: There is/are bolt cap covers missing or damaged on the item

Action: Replace missing or damaged bolt cap covers

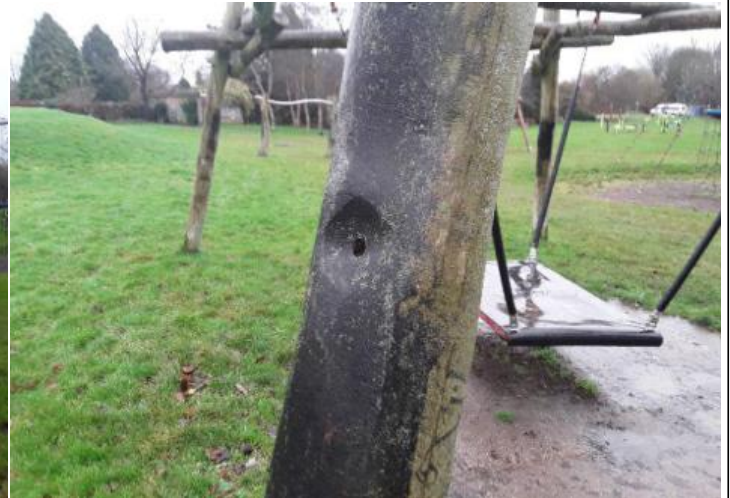
Risk Level: V - Very Low Risk
Surface: Grass Matrix Tiles

Finding: There is/are inserts missing

Action: Replace missing inserts

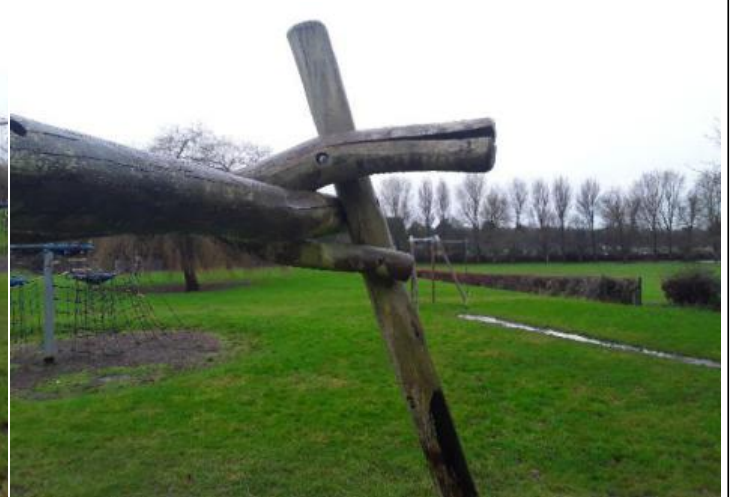
Risk Level: L - Low Risk
Surface: Grass Matrix Tiles

Finding: There are splits running through the timber that cross through or near fixing points and may cause instability in the future

Action: Monitor stability of fixings

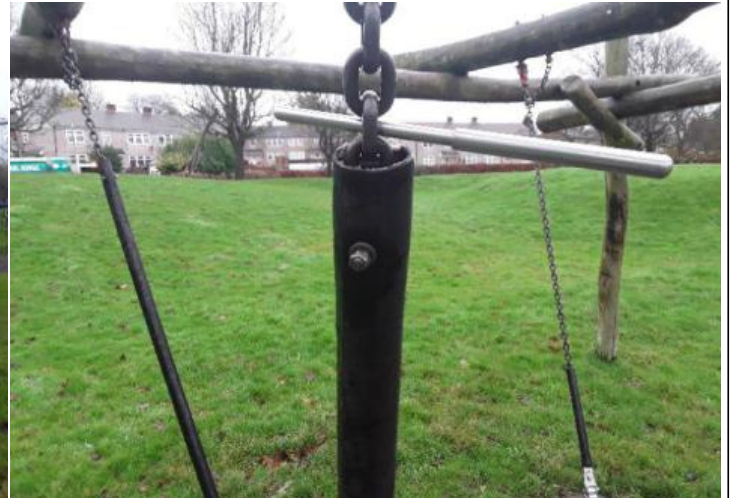
Risk Level: V - Very Low Risk
Surface: Grass Matrix Tiles

Finding: The connecting links are in excess of 8.6mm and less than 12mm and fail the requirements of BS EN 1176 Part 1; clause 4.2.13, Chains

Action: Monitor - No remedial work recommended

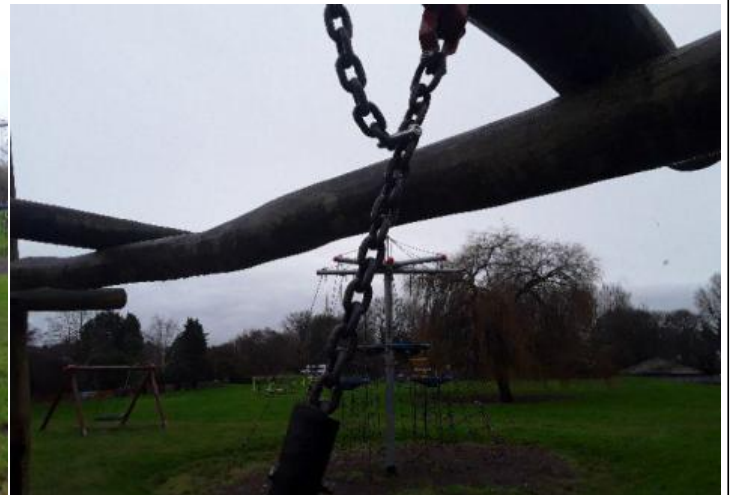
Risk Level: L - Low Risk
Surface: Grass Matrix Tiles

Finding: There is some notable evidence of chain wear

Action: Monitor for any further deterioration and replace when 40% worn

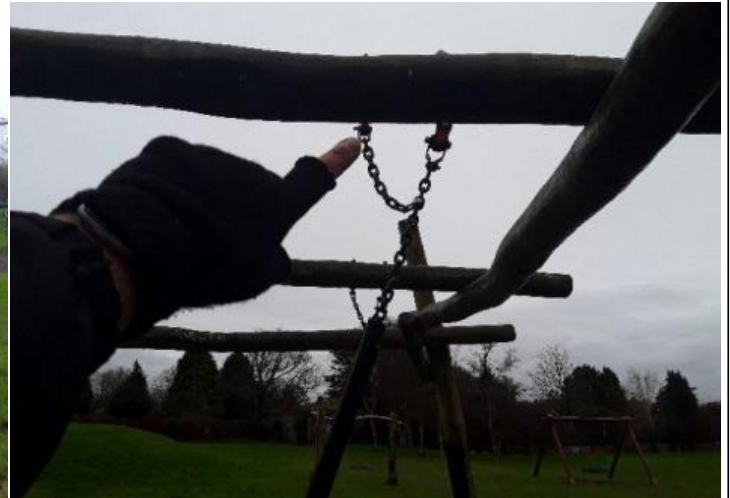
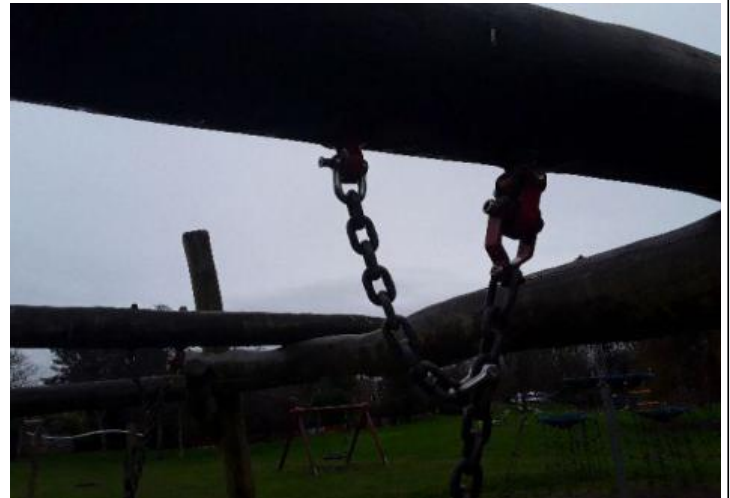
Risk Level: L - Low Risk
Surface: Grass Matrix Tiles

Finding: A number of secondary safety fixing(s) have worked loose

Action: Secure all loose fixings

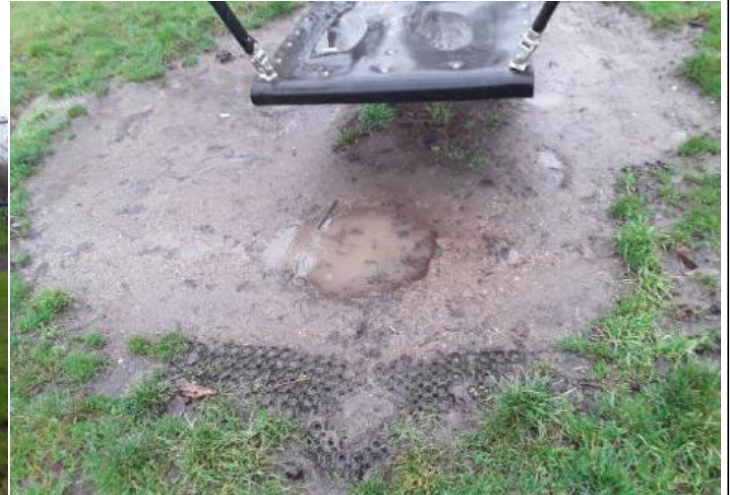
Risk Level: M - Moderate Risk
Surface: Grass Matrix Tiles

Finding: The surfacing is severely damaged or missing

Action: Repair damaged areas of surfacing

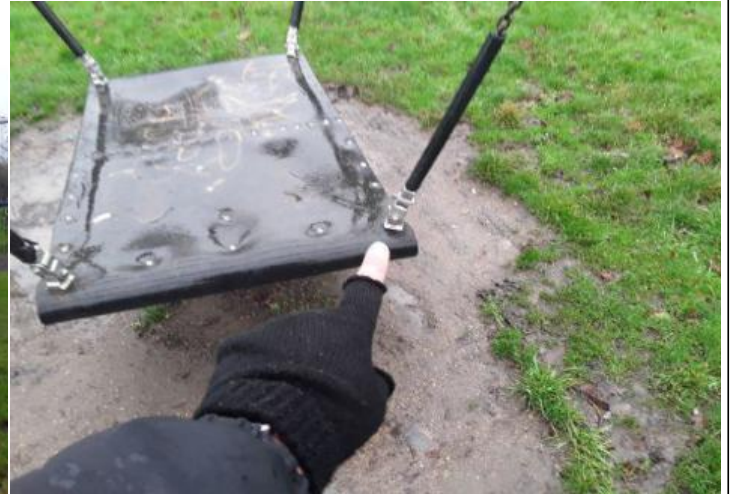
Risk Level: L - Low Risk
Surface: Grass Matrix Tiles

Finding: A number of seat connector fixing(s) have worked loose

Action: Secure all loose fixings

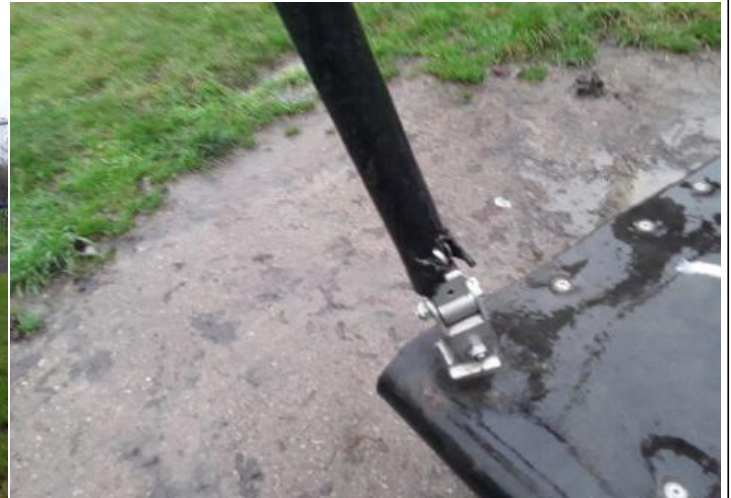
Risk Level: L - Low Risk
Surface: Grass Matrix Tiles

Finding: The seat suspension cover has been damaged

Action: Monitor for any further deterioration and replace as required

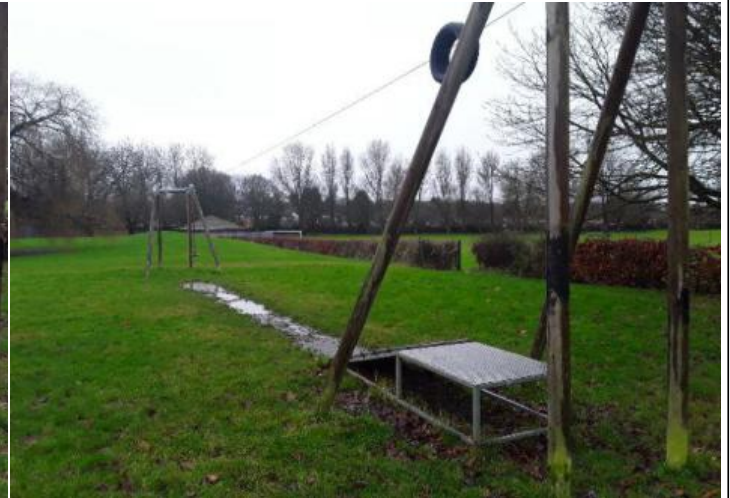
Risk Level: N - Risk Assessment not Undertaken
Surface: Grass Matrix Tiles

Finding: We have completed a visual inspection of the suspension links, cable and fixing points from ground level, however it is not possible to fully inspect these areas without either hiring equipment to gain access or removing the cable and suspension and inspecting at ground level. We recommend that the main cable and fixing security is thoroughly inspected at least in accordance with the manufacturers recommendations to check for wear, damage, security or internal rusting; this will help to ensure the continued safe use of the equipment

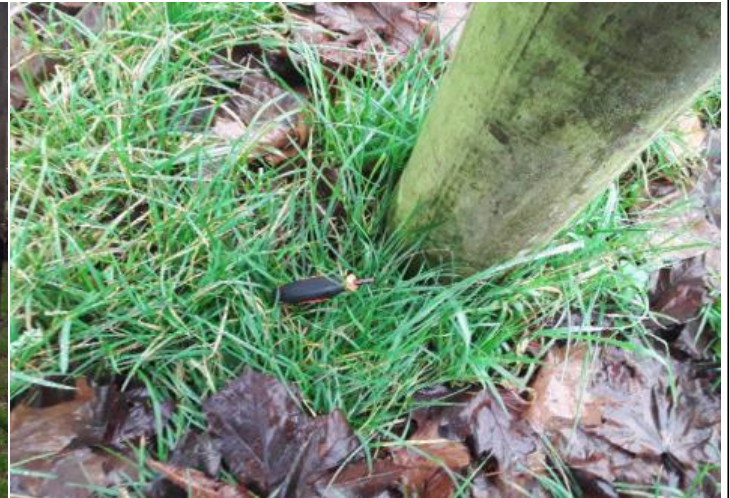
Risk Level: L - Low Risk
Surface: Grass Matrix Tiles

Finding: There is some evidence of rot in the timber posts

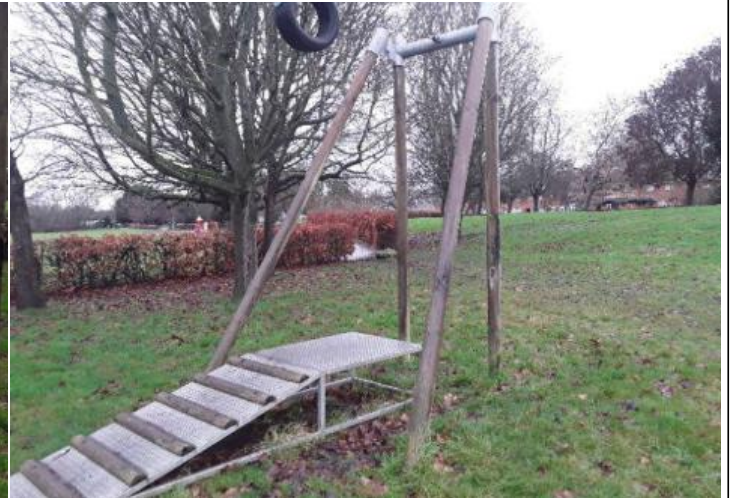
Risk Level: L - Low Risk
Surface: Grass Matrix Tiles

Finding: The item is slightly loose in its foundations

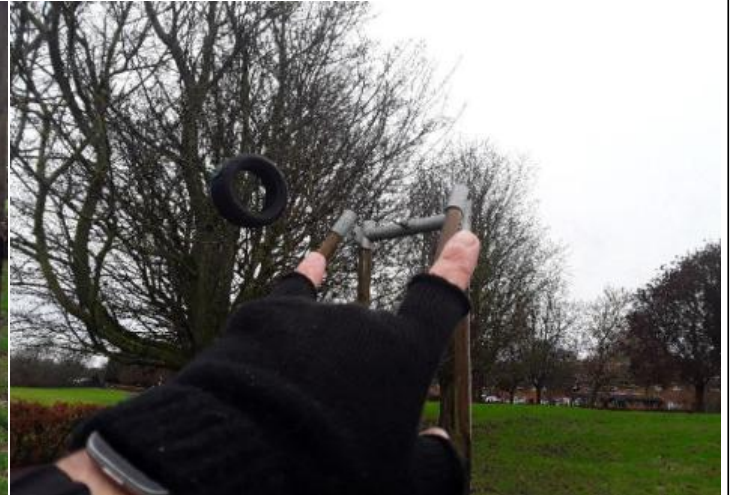
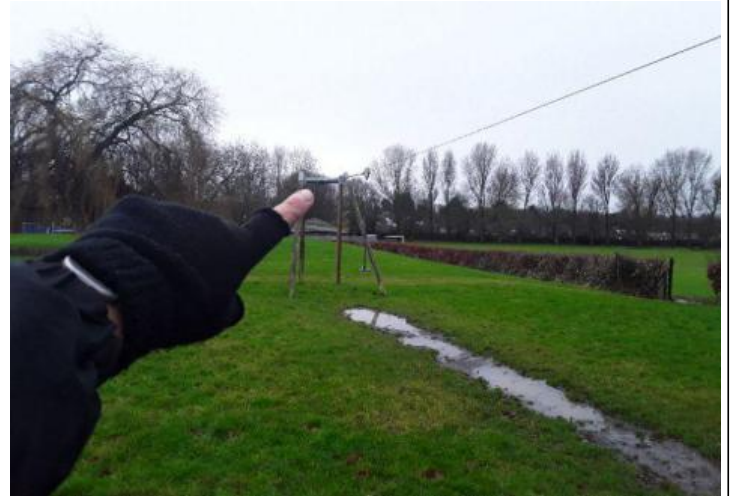
Risk Level: M - Moderate Risk
Surface: Grass Matrix Tiles

Finding: There is or are fixings missing on the steel brackets at both ends making the item unsafe

Action: Replace all missing fixings

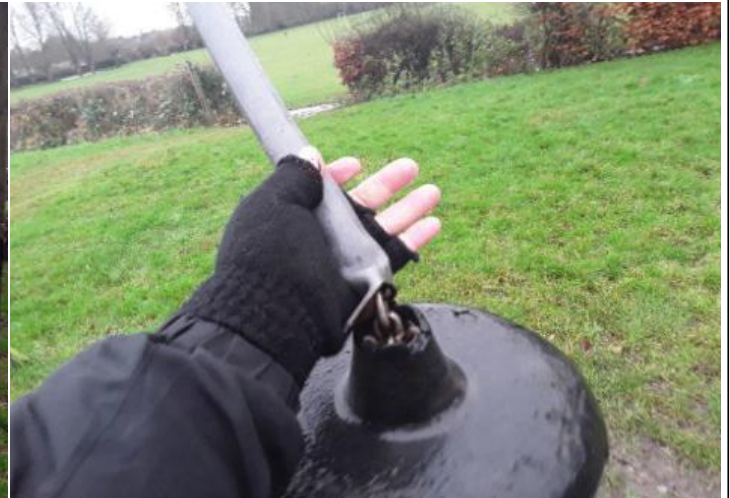
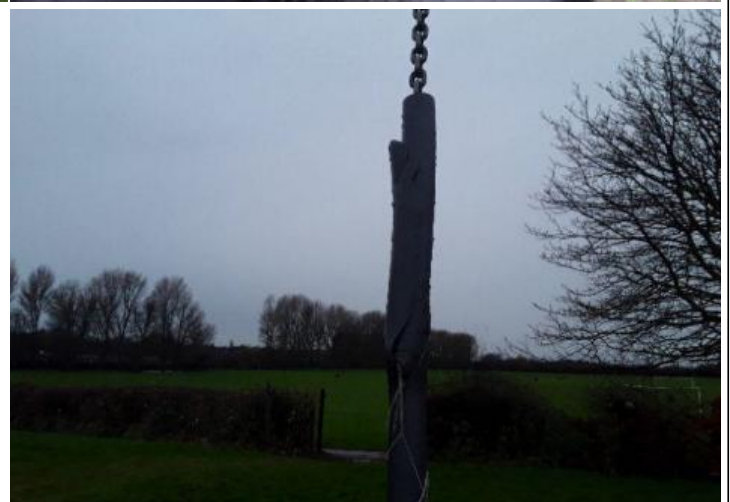
Risk Level: L - Low Risk
Surface: Grass Matrix Tiles

Finding: The suspension cover has been damaged

Action: Replace

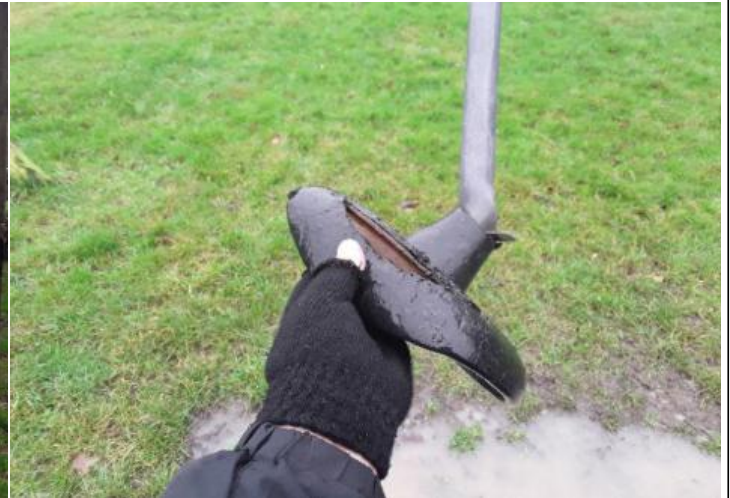
Risk Level: L - Low Risk
Surface: Grass Matrix Tiles

Finding: The seat has been severely damaged

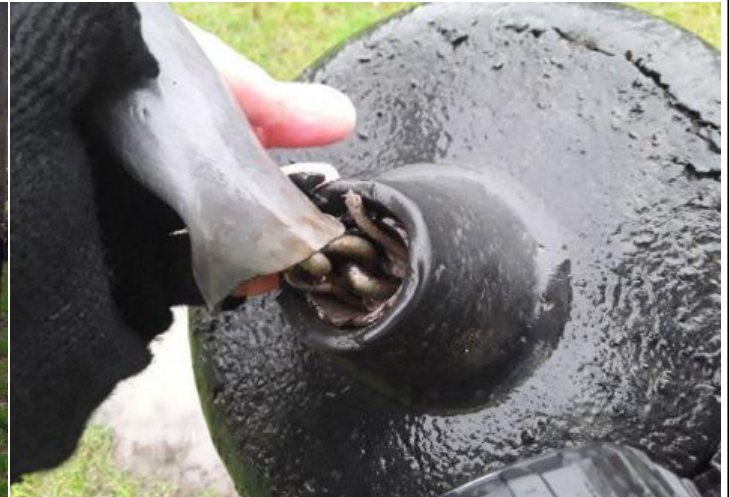
Risk Level: L - Low Risk
Surface: Grass Matrix Tiles

Finding: There is some notable evidence of chain wear

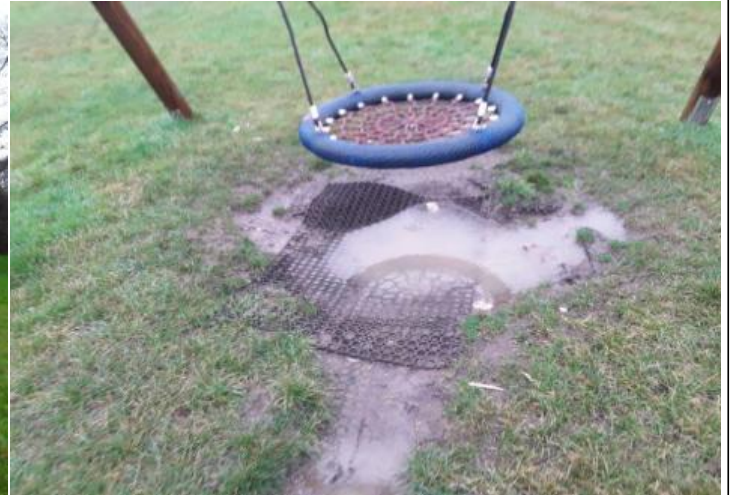
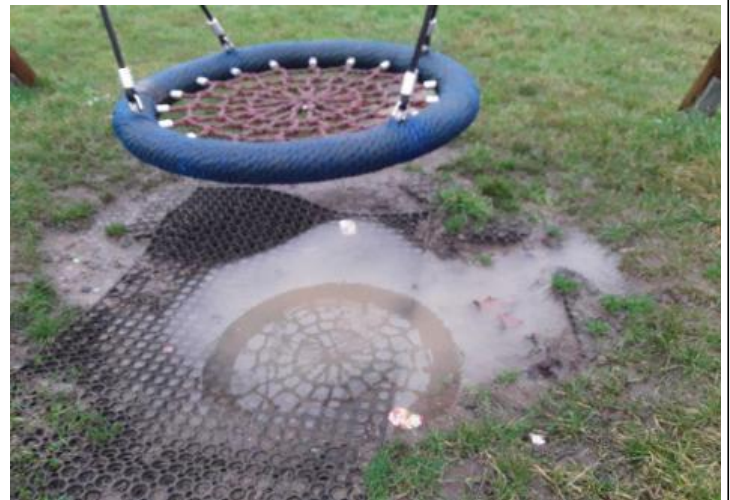
Risk Level: M - Moderate Risk
Surface: Grass Matrix Tiles

Finding: The surfacing is severely damaged or missing in places

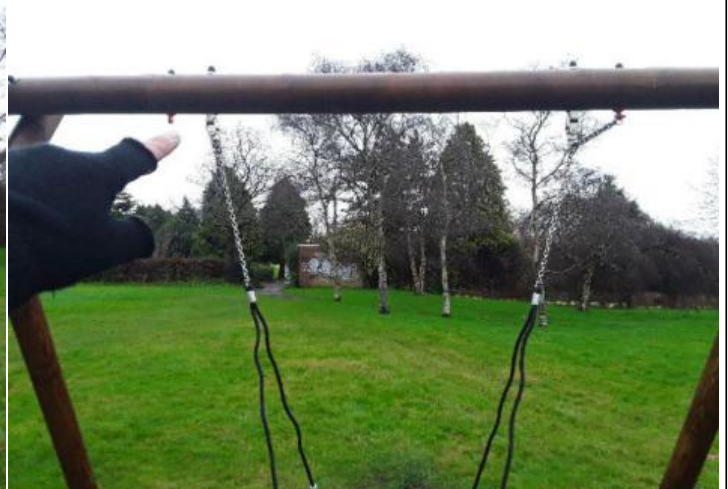
Risk Level: L - Low Risk
Surface: Grass Matrix Tiles

Finding: There is or are fixings missing on the secondary safety

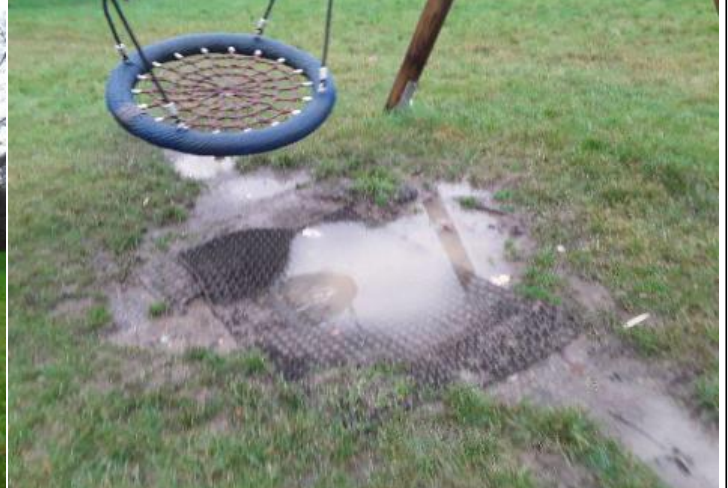
Risk Level: L - Low Risk
Surface: Grass Matrix Tiles

Finding: The surface has subsided in some areas
