the play inspection company

Annual Inspection

Central Swindon North Parish Council

Inglesham Road

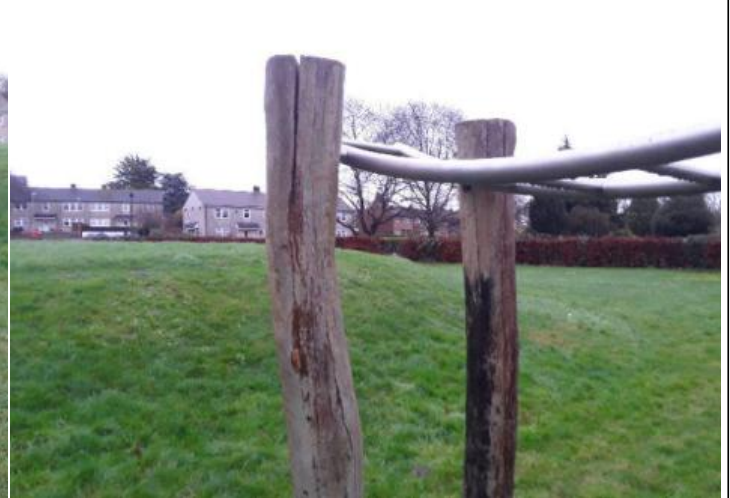
Risk Level: L - Low Risk
Surface: Grass Matrix Tiles

Finding: The timber has a number of splits/shakes or air cracks and this may affect the stability or allow water ingress which will accelerate the rotting process

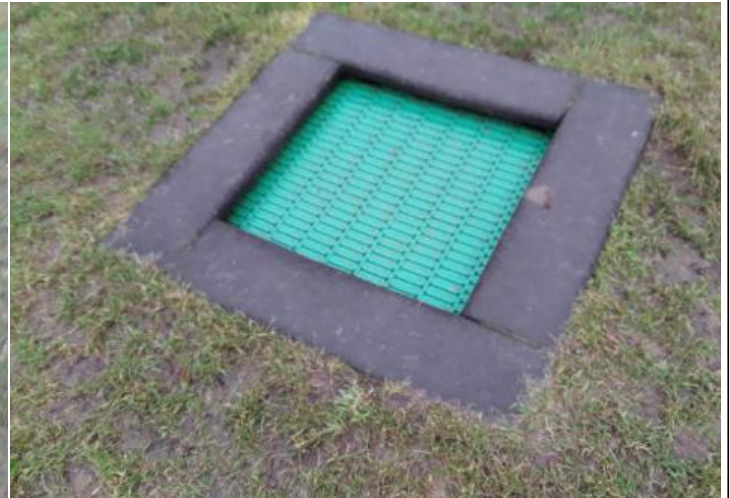
Risk Level: L - Low Risk
Surface: Grass Matrix Tiles

Finding: On site visits it is not possible to test the ground clearance of the Bouncing Facility bed as specified in BS EN 1176; ensure that the clearance between the Bouncing Facility Bed and the ground underneath is in accordance with the manufacturers recommendations (It was not possible recorded the nominal depth at time of inspection due to the design of the bed).

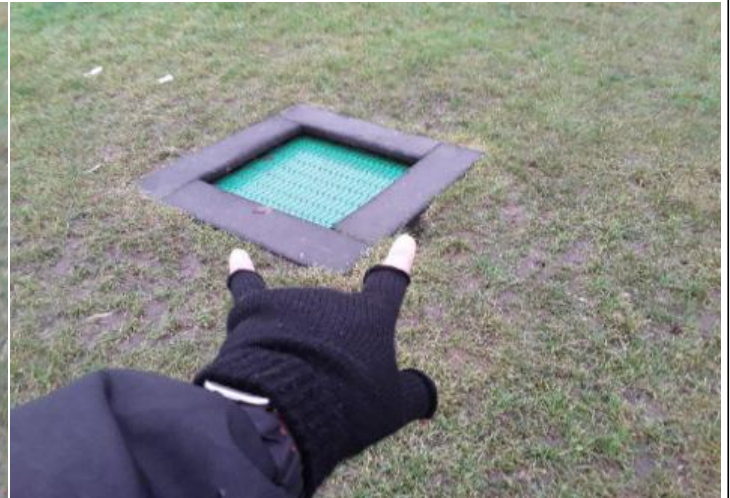
Risk Level: L - Low Risk
Surface: Grass Matrix Tiles

Finding: There are trip hazards at the edges of the surface **Action:** Reinstate surrounding surface levels to remove the trip points

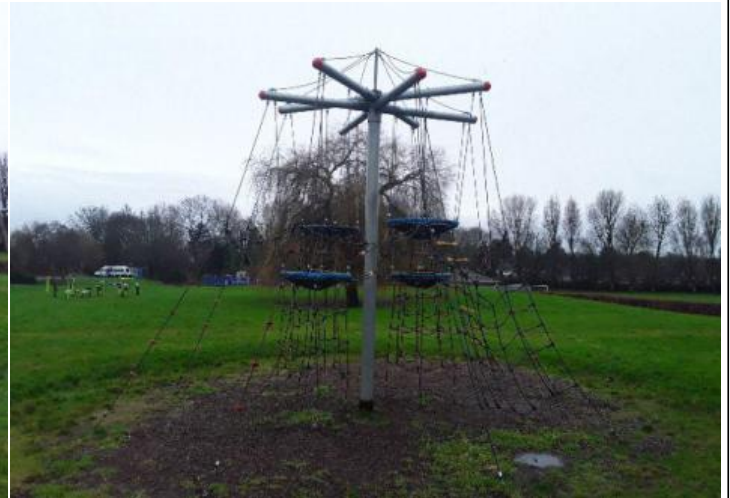
Risk Level: N - Risk Assessment not Undertaken
Surface: Woodchip

Finding: The fixings or components for this item were in excess of 2.5m above the standing surface and could not be fully accessed by the inspector. We have completed a visual inspection of the fixings from ground level but a maintenance inspection should be undertaken to assess the condition, security and wear of the components at intervals in accordance with the manufacturers recommendations.

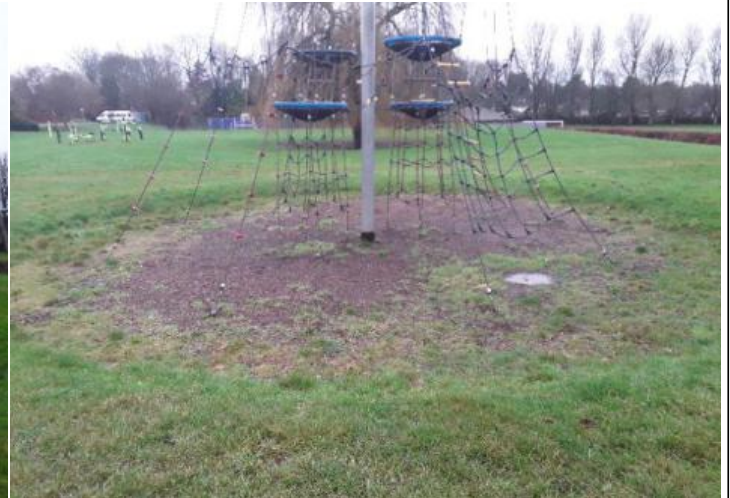
Risk Level: L - Low Risk
Surface: Woodchip

Finding: The depth of the loose fill surfacing is lower than the recommended depth specified in BS EN 1176 for a fall height over 2.0m. A minimum depth of 400mm is recommended (including an extra 100mm to allow for compaction and displacement as per BS EN 1176 Part 1 - Table 4)

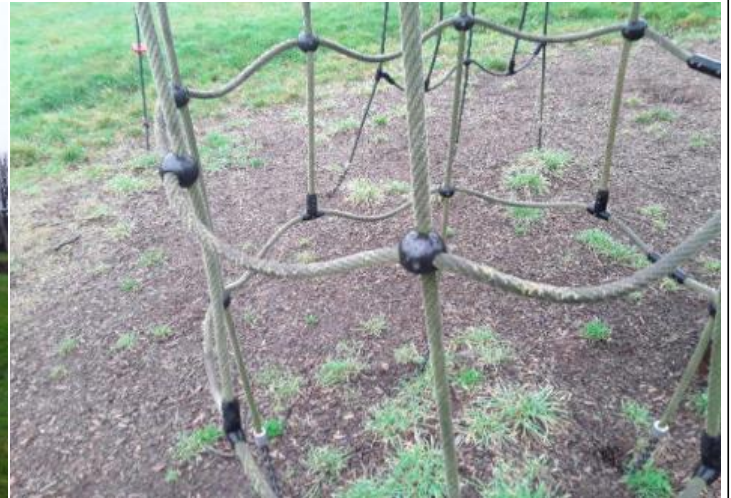
Risk Level: L - Low Risk
Surface: Woodchip

Finding: The ropes/nets are worn/damaged in places

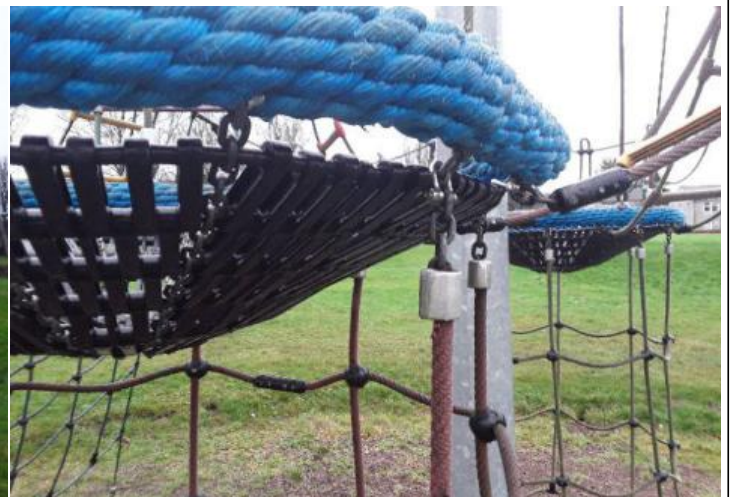
Risk Level: L - Low Risk
Surface: Woodchip

Finding: There is some notable evidence of chain and shackle wear

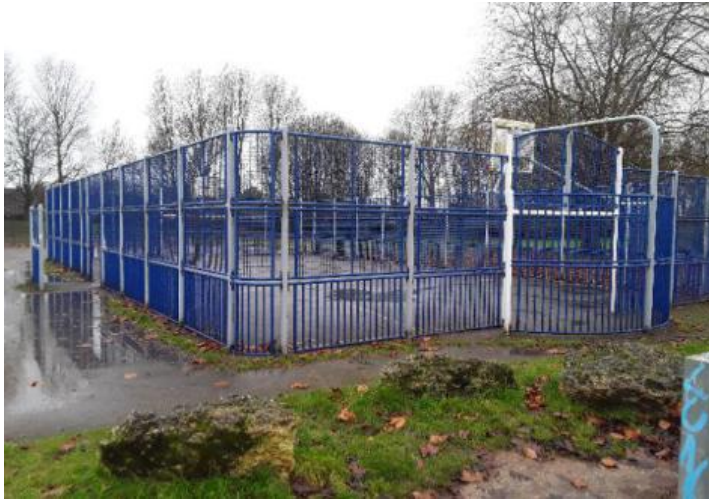
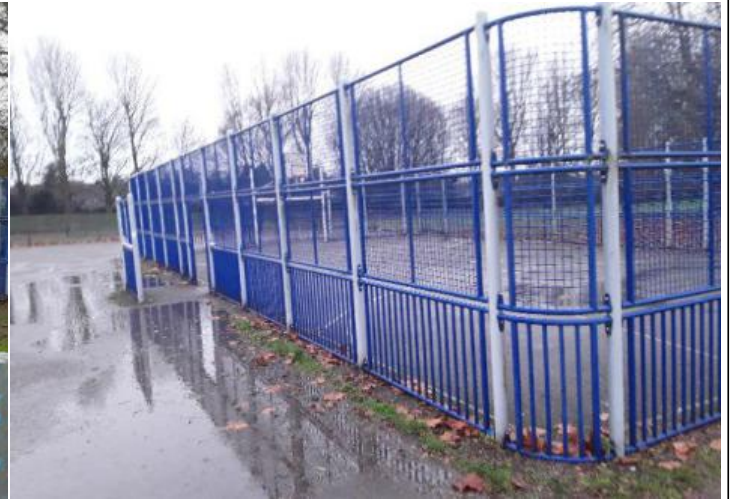
Risk Level: V - Very Low Risk
Surface: Bitmac

Finding: A clearly visible facility sign should be provided in a prominent position with the wording as detailed BS EN 15312- the equipment is not intended for children less than 3 years old- the warning - Do not climb on the framework or nets- the warning - Do not hang on the ring (if provided)- the warning - Do not wear rings or other jewellery- name and telephone number of the administrator- number to call in case of accident

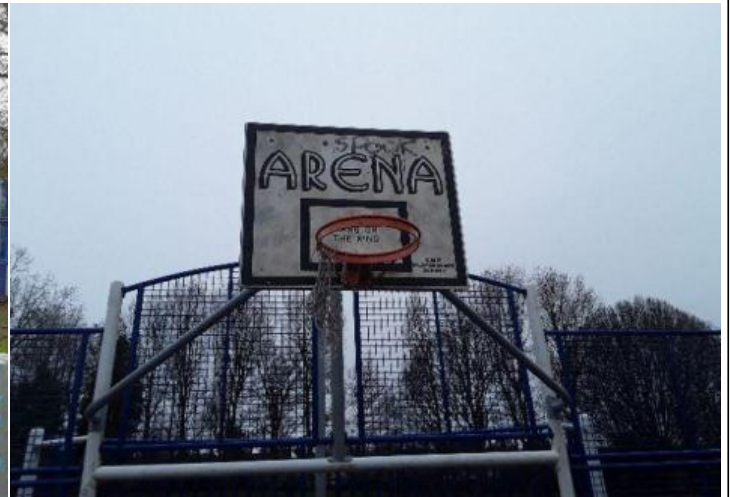
Item: Multi Use Games Area - Multi Use Games Area (MUGA)
Manufacturer: S M P (Playgrounds Ltd)
Risk Level: M - Moderate Risk
Surface: Bitmac

Finding: The hoop netting has been severely damaged
Action: Replace

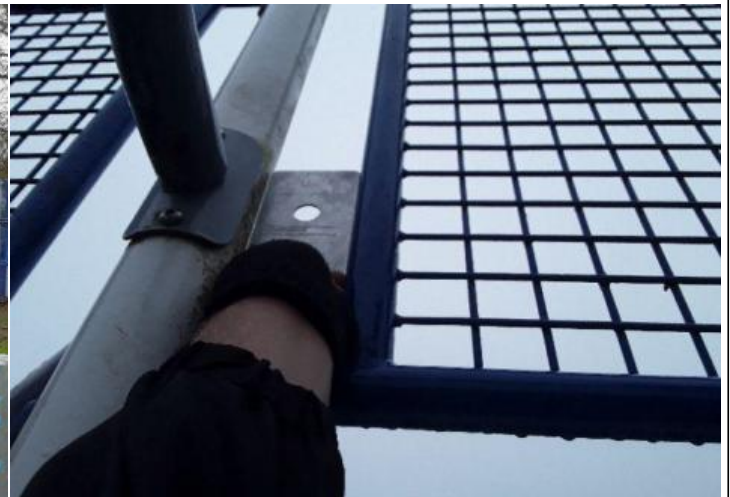
Item: Multi Use Games Area - Multi Use Games Area (MUGA)
Manufacturer: S M P (Playgrounds Ltd)
Risk Level: V - Very Low Risk
Surface: Bitmac

Finding: The item fails to meet the requirements of BS EN 15312 4.4.2.1 head and neck entrapment in the frame
Action: Monitor - No remedial work recommended

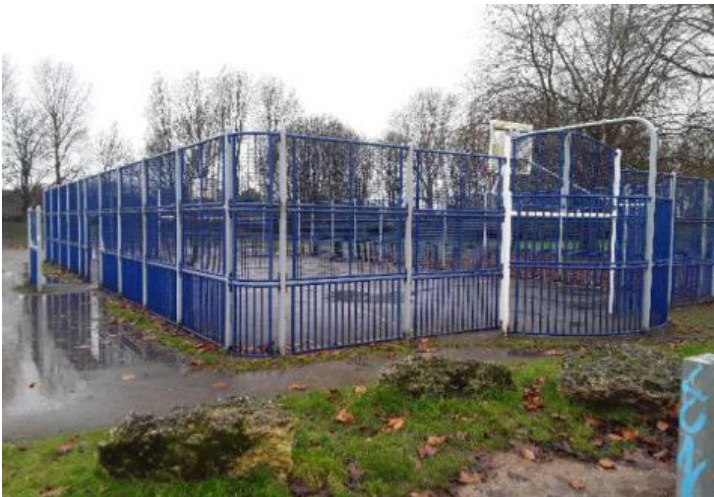
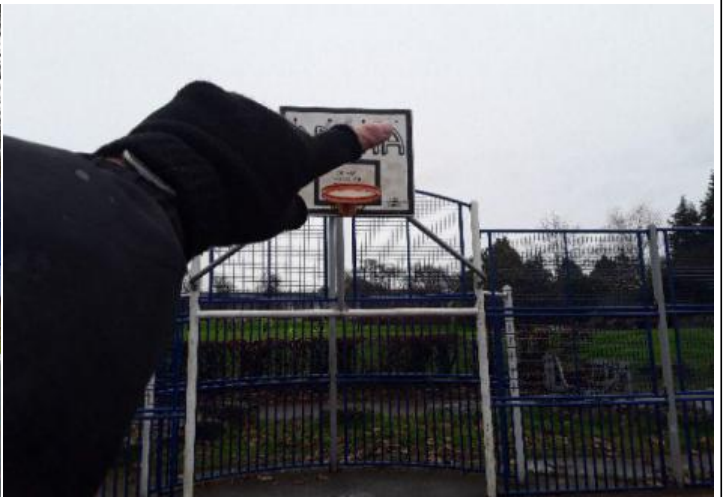
Item: Multi Use Games Area - Multi Use Games Area (MUGA)
Manufacturer: S M P (Playgrounds Ltd)
Risk Level: L - Low Risk
Surface: Bitmac

Finding: There is or are fixings missing on the backboard
