**TOWER REPAIR WORKS**

## HORNCastle CEMETERY CHAPEL

Project No. 6013

**CHAPEL SPIRE, BOSTON ROAD CEMETERY, HORNCastle**

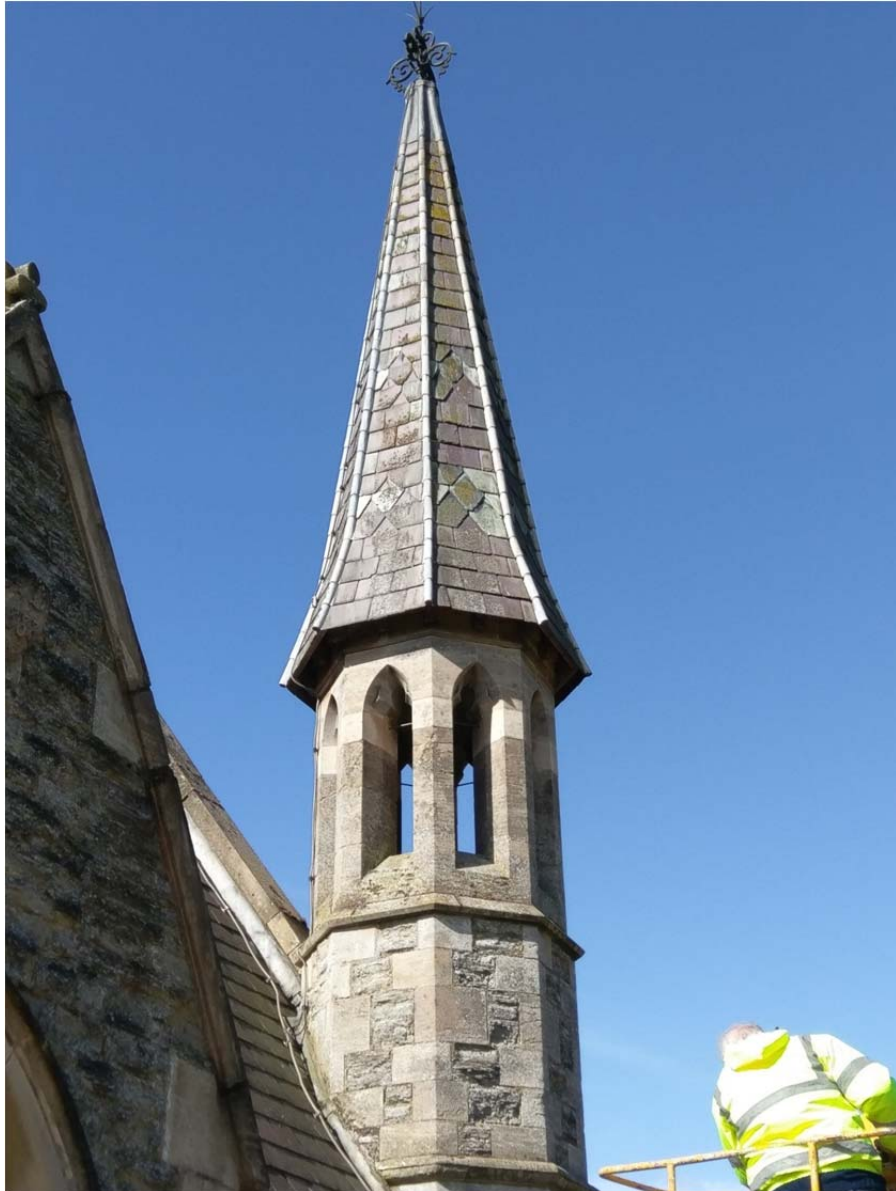
The Chapel is a late Victorian freestanding single storey structure and is Grade II listed. On the northwest corner of the Chapel stands an octagonal tower (*Photo 1*) of coursed masonry construction surmounted with a large capstone, anchored by a large central tie bar (*Photo 2*). This capstone forms the plinth upon which are seated eight dressed stone columns supporting the eaves level band of stonework (*Photo 3*) which, in turn, supports a timber wallplate and the timber spire structure above.

**P1 – General view from Northeast**

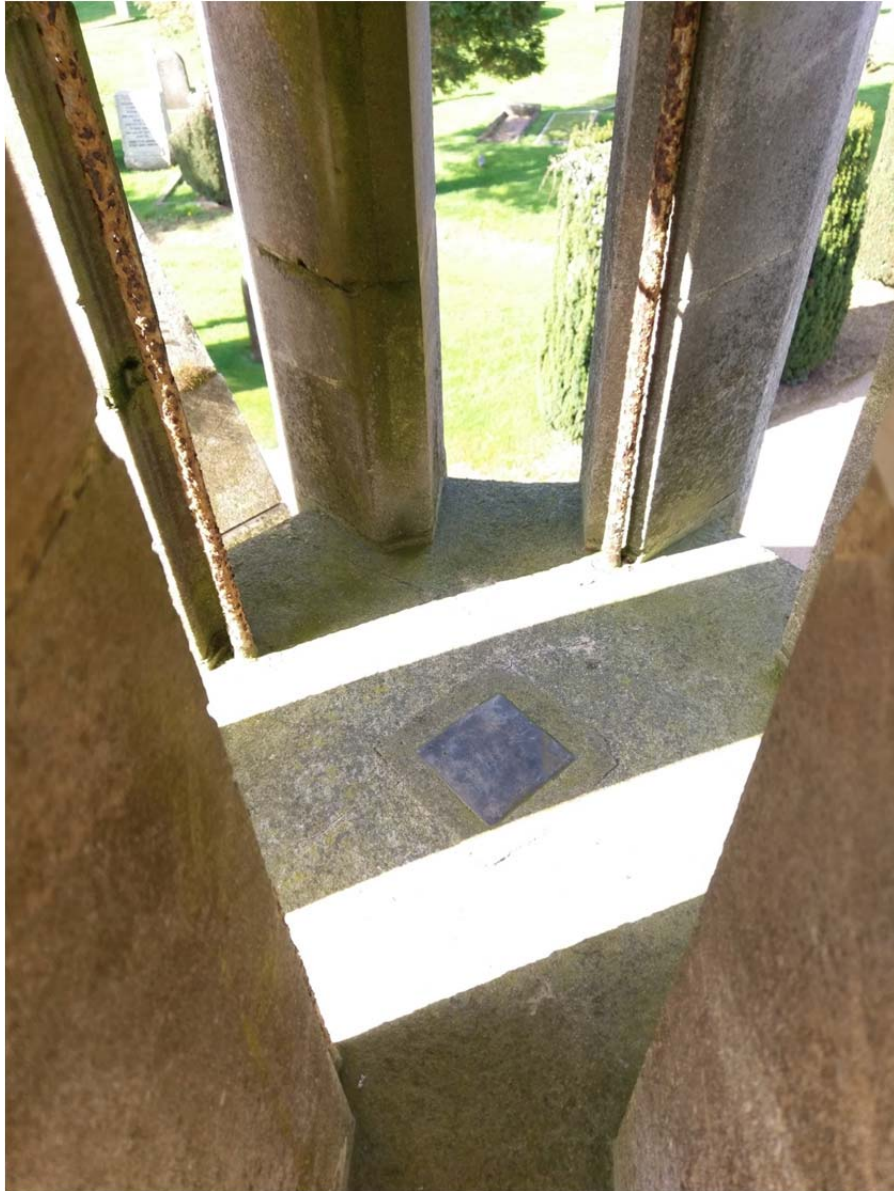
At each of the four positions where the wallplate tie beams meet the wallplates, tie bars extend from the wallplate tie beams down to the plinth/capstone. It is not known whether these tie bars are wrought iron or steel, however they are corroded but this does not appear to have affected their structural cross section significantly.

**P2 – Plinth / cap stone with central tie bar**

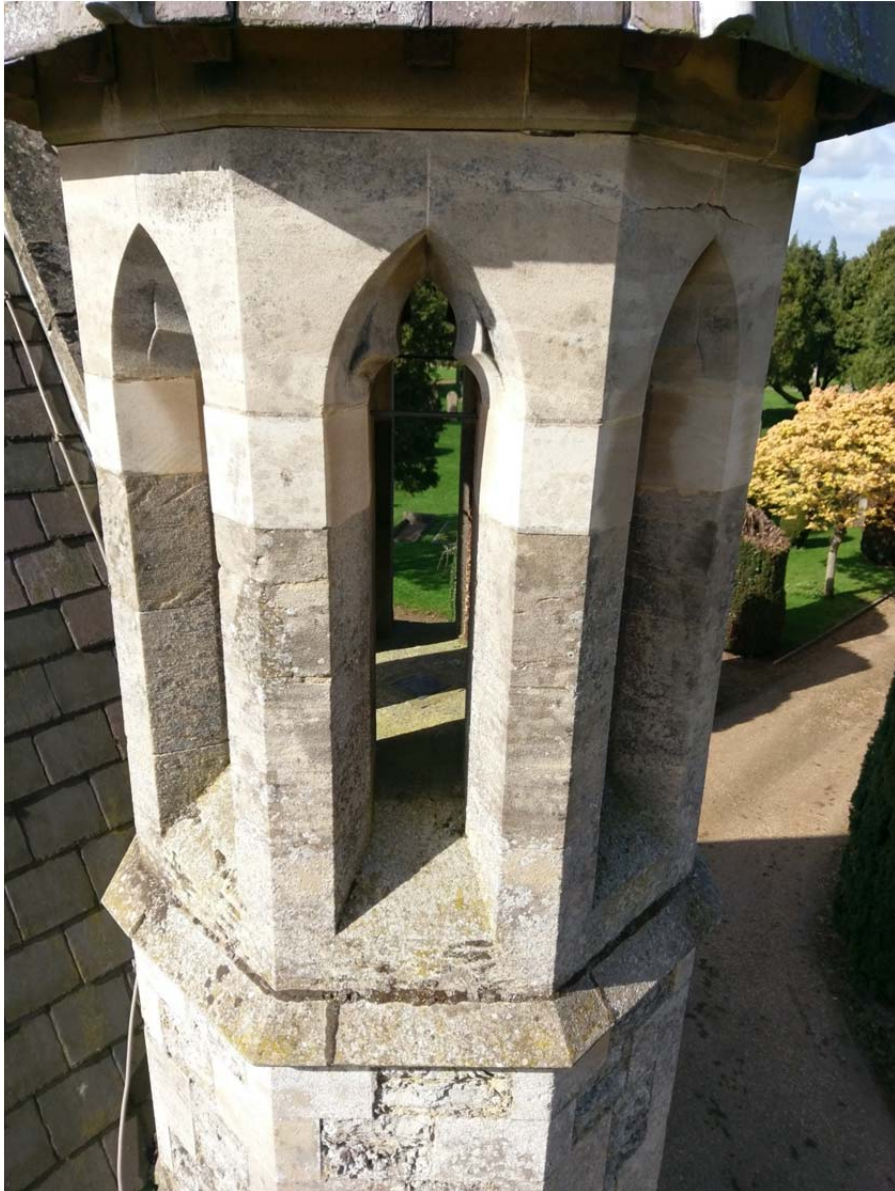
**P3 – Dressed stone columns**

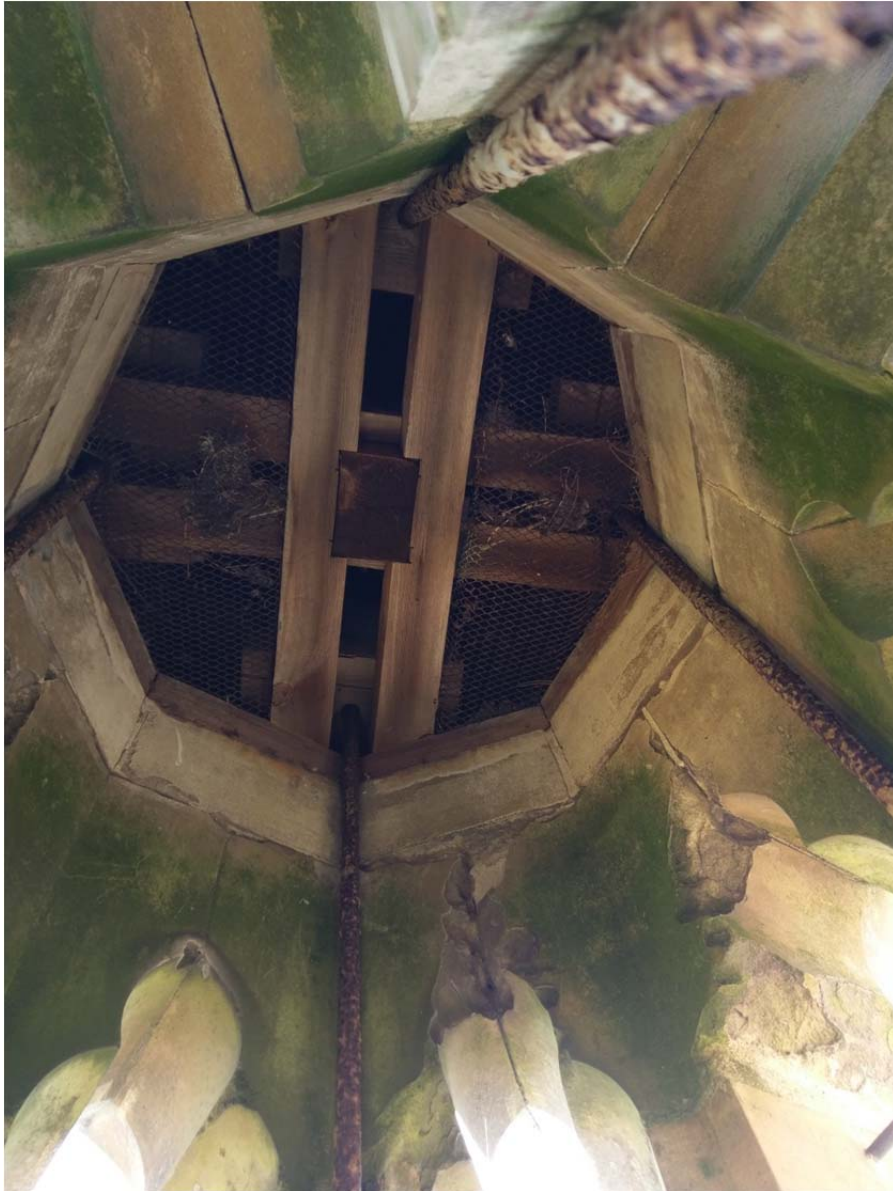
The roof structure appears to be generally in good condition where visible. There were some slightly misaligned wallplate joints and rafter birds-mouths which were not flushly aligned with the stonework, however this is quite likely to be misalignment at the time of reconstruction rather than a sign of any movement of the roof. The roof is well tied down and in good alignment generally with no signs of recent movement.

P4 – Internal view of roof structure (north at bottom of picture)

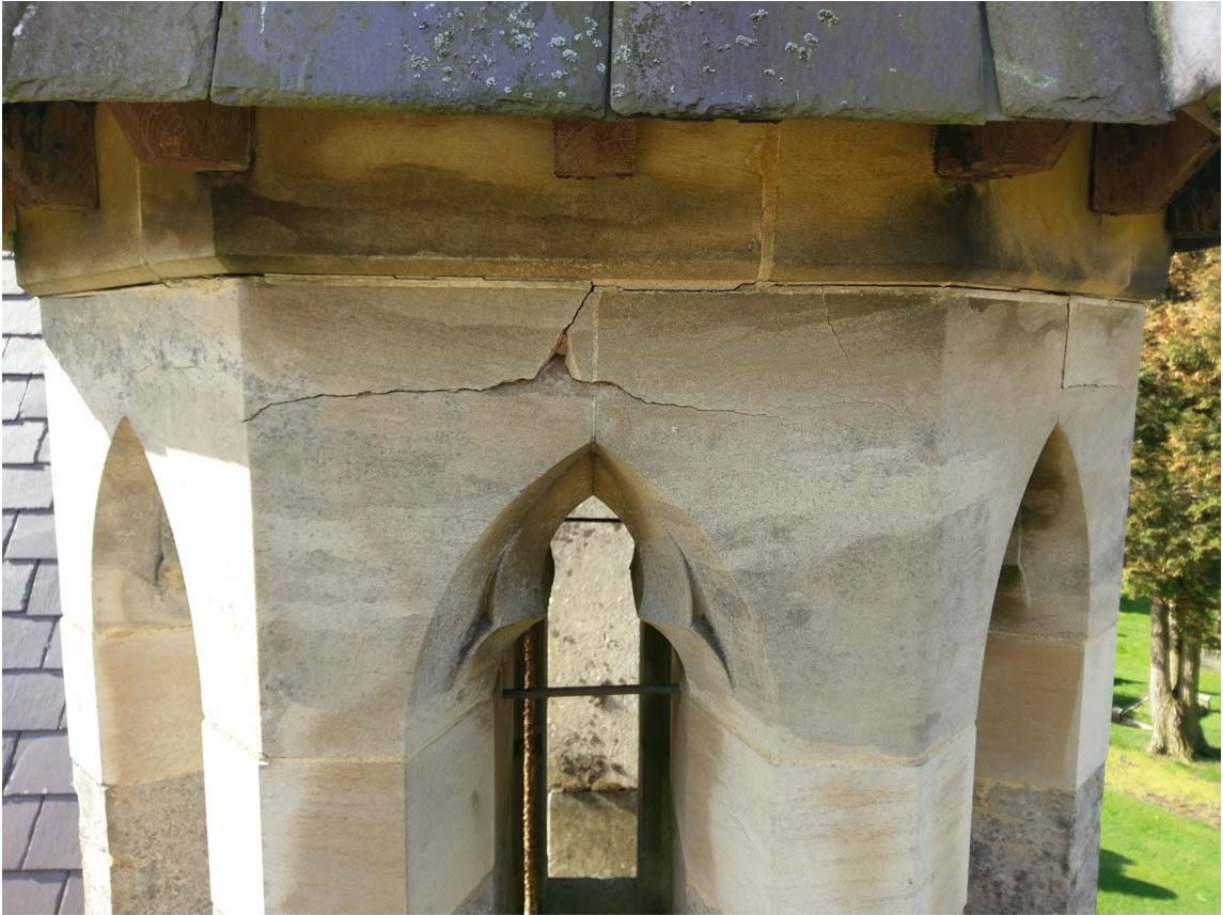
A horizontal crack occurs in the bed joint immediately above the arched openings below the corbelled stonework. This horizontal crack extends almost completely around the circumference of the tower and exhibits vertical displacement of approximately 2-3mm fairly uniformly around the tower.

Immediately below the same bed joint, the perpend joint between adjacent column sections (at the head of the arched openings) exhibits spalling of the outer face of the stonework or cracking indicating the early signs of spalling to all sides of the tower.

To the north elevation (*Photo 5*), some of the spalled stonework fragments were loose and were removed for safety reasons. To the southwest corner, some of the small infill stones between the rafter above the corbel course were loose and one of these stones was removed as a safety precaution (*Photo 6*).

Whilst a lack of access internally prevented us from definitively ascertaining the cause of the cracking, it is very likely that the cause of the cracking is expansion of corroding embedded metalwork. It is likely that wrought iron or steel cramps are present between the adjacent stones of the top of the arched openings. The expansion of the corroding metalwork is causing the upper stonework to lift away from the lower stonework, creating the gap observed in the bed joint.

It is likely that the same piece of corroding metalwork is also causing the outer face of the stonework to spall. Left unaltered, the metalwork will continue to corrode and expand, causing further damage to the stonework and eventually threatening the stability of the spire.

**P5 – Horizontal cracked bed joint and spalling face (north elevation)**

It is recommended that the corroding metalwork is removed and replaced with new stainless steel or phosphor bronze as appropriate and provide indented stone repairs to the worst affected areas of spalling. Less severe spalling may be glued in place using a suitable compound.

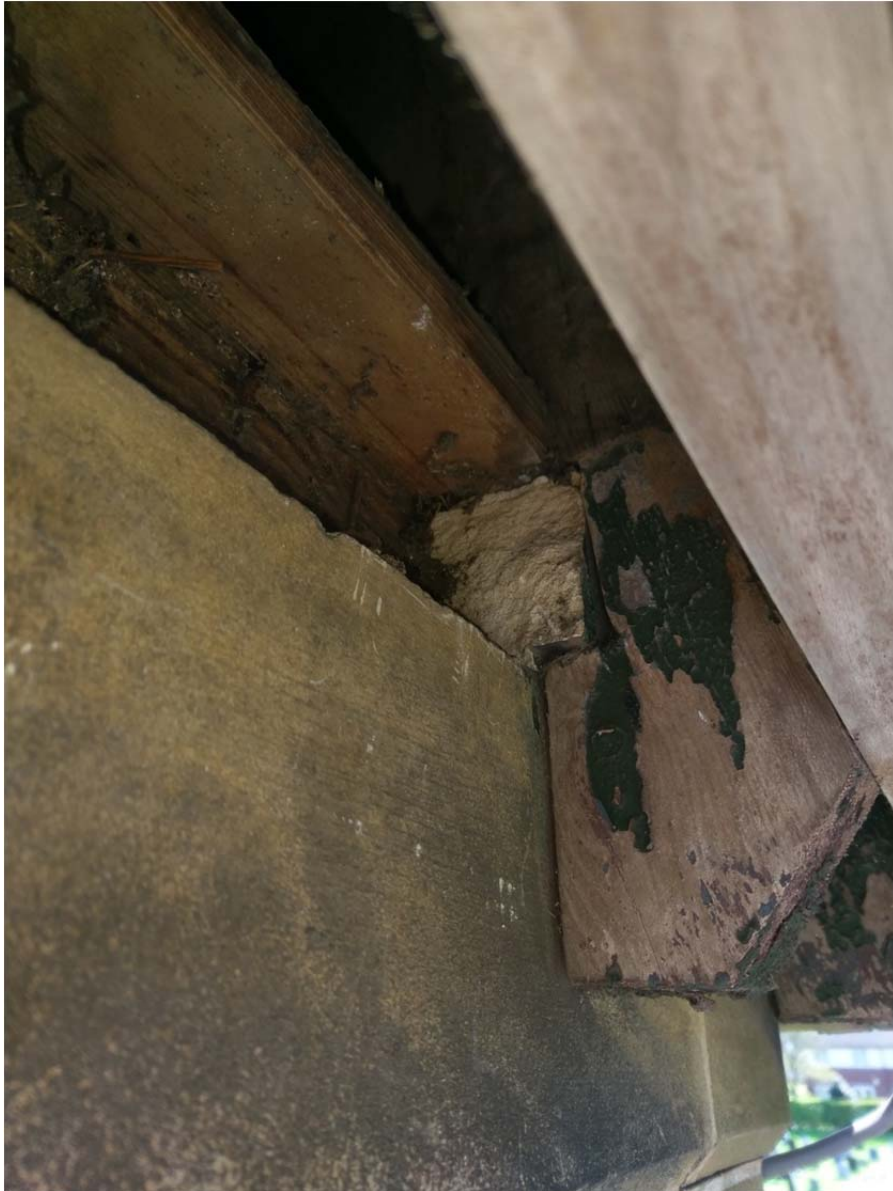
**P6 – Loose corbel stone removed from southwest elevation**

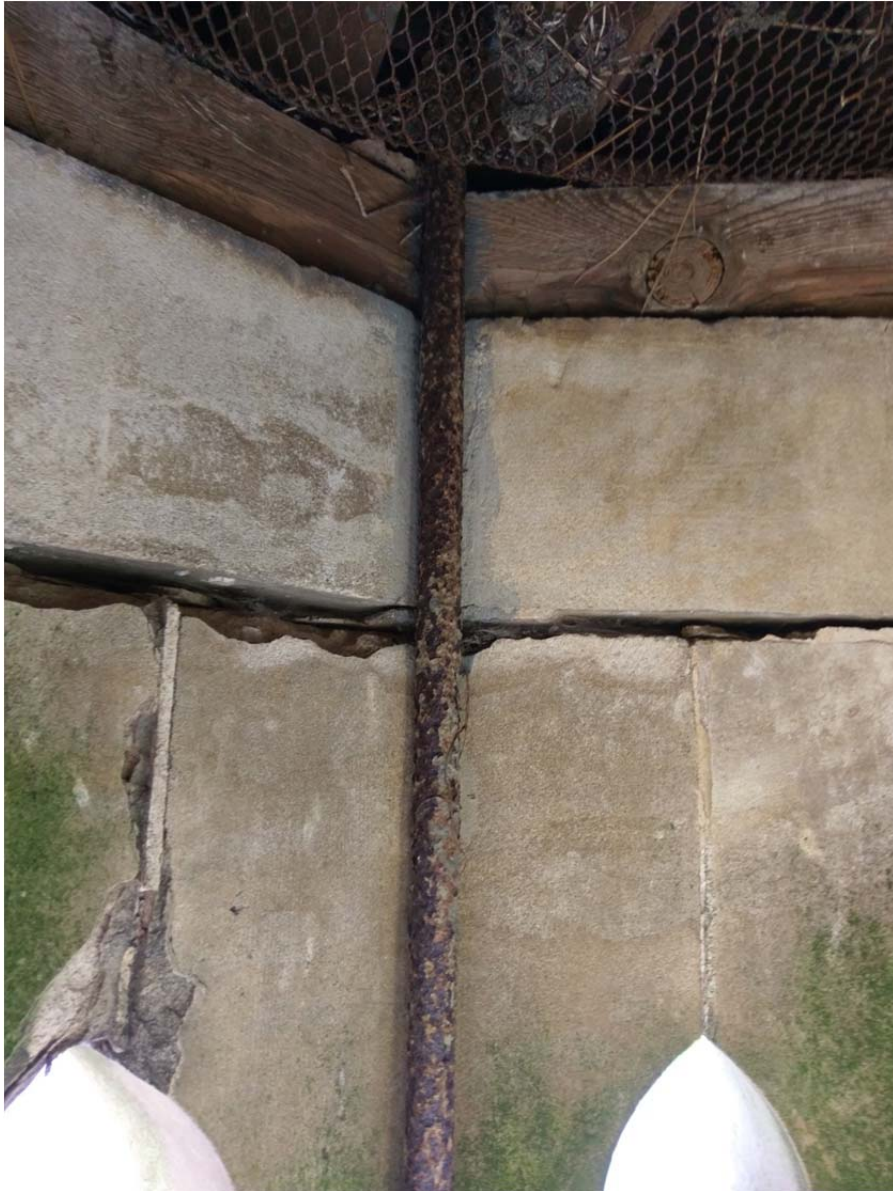
Internal viewing of the tower is difficult, as between the columns is only 180mm. Nevertheless, it could be clearly seen that the same bed joint which exhibited vertical displacement externally had the same movement internally (*Photo 7*). There also appeared to be more degradation of the bed joint mortar internally than externally.

**P7 – Horizontal bed joint cracking**

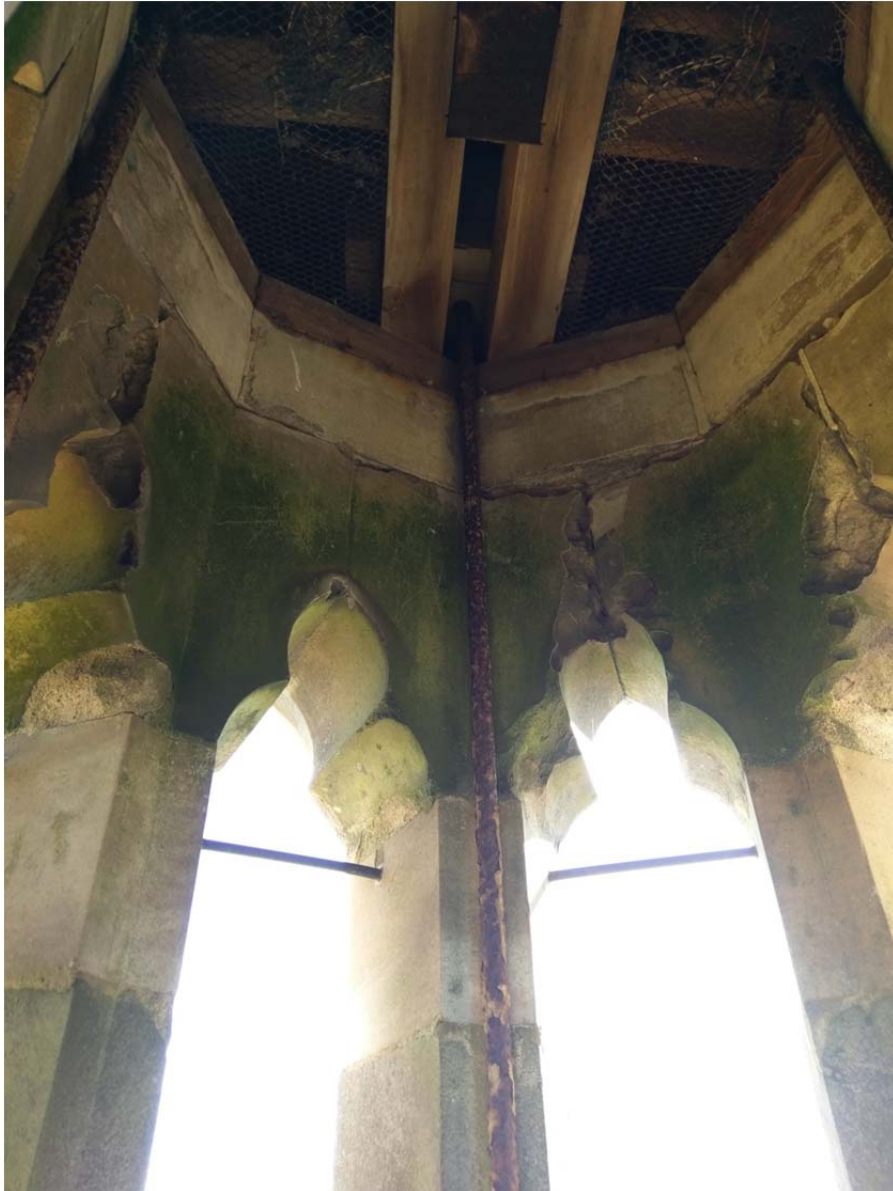
To the northeast corner, there was also some significant stonework erosion around the mortar bed joints and perpend joints (*Photo 8*). This does not appear to be recent or ongoing, and is quite likely due to the cement pointing internally which was reportedly present prior to the lightning strike in 1993. The current mortar all appears to be lime-based.

**P8 – Eroded stonework internally**
