Our Ref: **J414/D01**

10<sup>th</sup> February 2022

**RE: Bat Inspection Survey, Brown Law, Redford, County Durham, DL13 3NL**

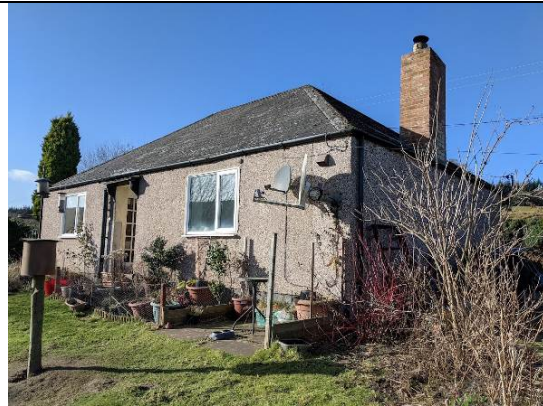
Photograph 2: South-eastern elevation

The external elevations of the property are rendered concrete blockwork throughout, providing little or no potential for roosting bats. The render is mostly intact which eliminates any cracks or crevices that bats might occupy. There is a small patch where damp has caused delamination of the render from the main fabric of the house, but there were no gaps or crevices beneath this area.

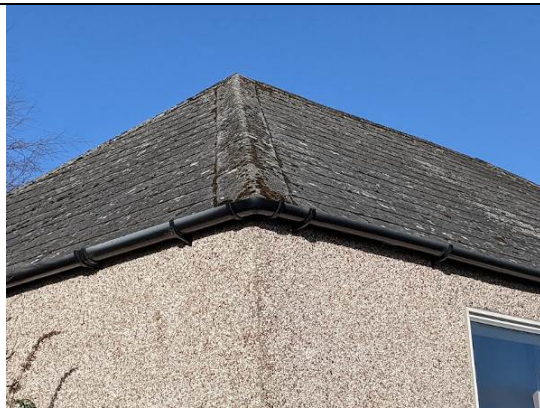
Photograph 3: Southern roof detail

The roof is covered with thin ceramic tiles that mimic slates. These are all closely fitted and offer no gaps or crevices between them. Moss can also often be found in the gaps between the tiles, effectively sealing them from the outside. The roof is arranged in a hipped style, which provides a short main ridge and four angled hip ridges. All ridges are covered with ceramic ridge tiles which are close-fitting and sealed with mortar in all instances.

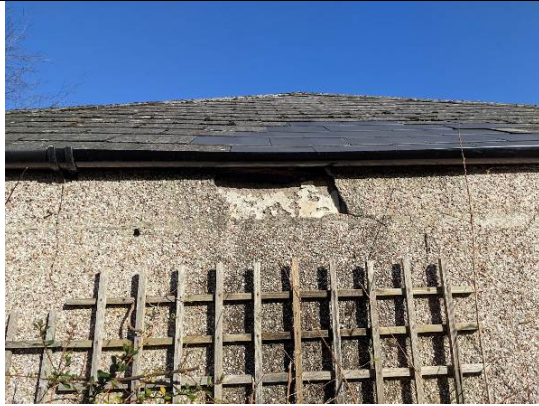
Photograph 7: Damaged render

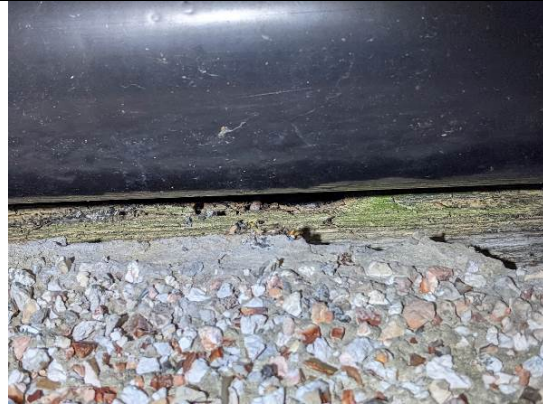
through the roof itself. On occasion, light could be seen from the eaves of the roof where a small gap can be found between the roof and the wall-top below. This gap appears to be too small for bats in most places, but has been widened in some locations by mice, which have found access to the roof void.

Photograph 8: Eaves under gutter, showing mouse damage

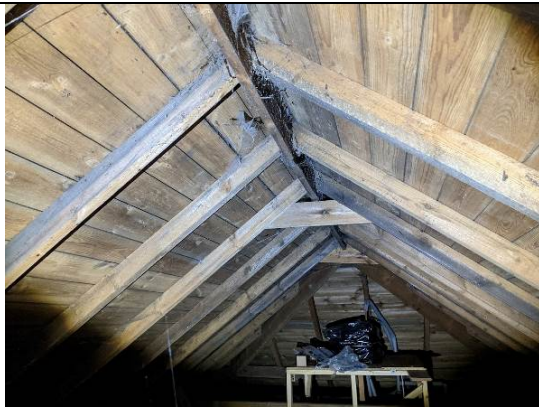
Photograph 9: Roof void

Internally, there is a single roof void over the entire house. The roof is backed with timber sarking boards, which are all intact and close-fitted, thus eliminating any external ingress

Mouse droppings were found throughout the roof void, with several mouse nests being found within the ceiling insulation. No bat droppings were found however, which indicates that no bats have been roosting within the roof void. In addition to this, the void featured numerous cobwebs, most notably accumulating at the ridge level of the void. This is a location where open roosting bats (such as brown long-eared bats) would naturally roost, if they were present. However, the presence of the cobwebs strongly indicates the absence of such bat species.

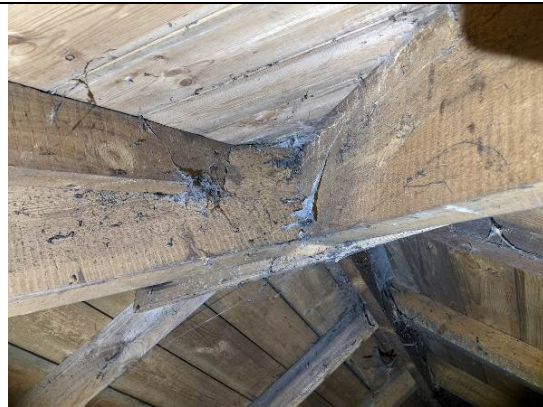
Photograph 10: Ridge apex showing cobwebs

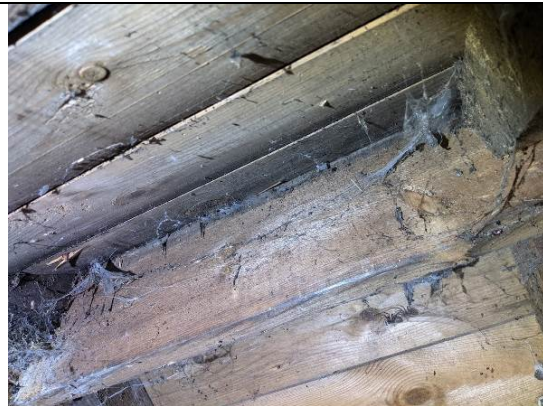
Photograph 12: Ridge showing cobwebs

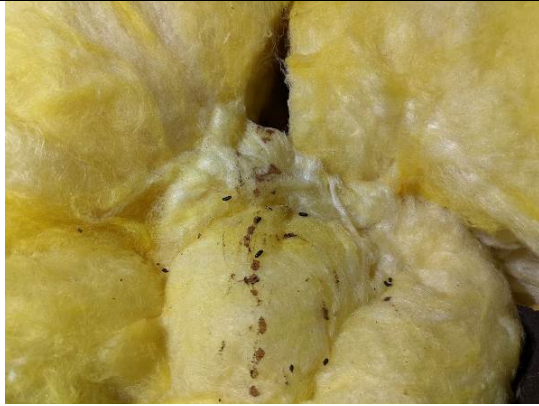
Photograph 11: Mouse nest

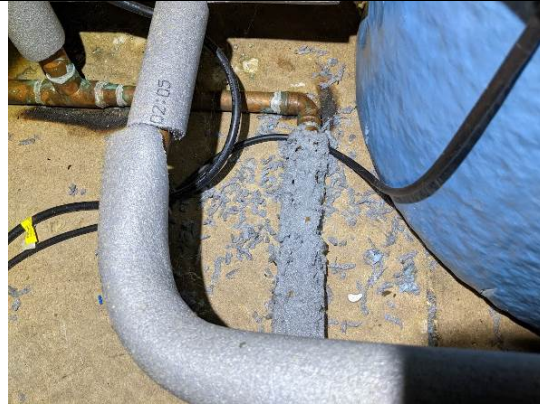
Photograph 12: Pipe lagging chewed by mice
