ASBESTOS MANAGEMENT PLAN

Grosvenor House, George Street

Reference Number	Version Number	Date Issued	Review Date	Summary of Amendments	Policy Author
ASB002	1	16/05/18	15/05/21	Initial Issue	M. Warburton

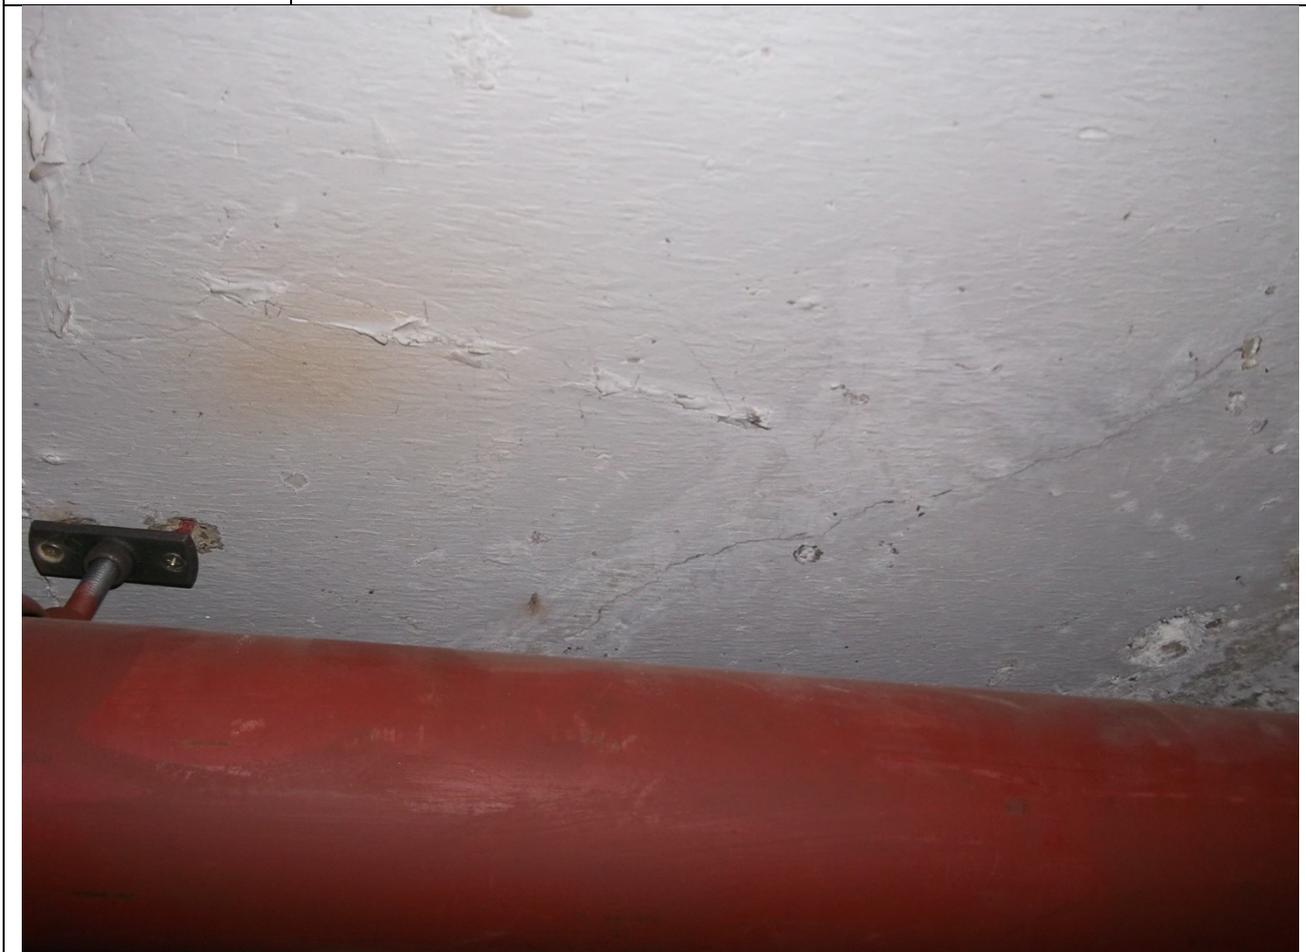
Photo 1 –	B.08 - Store
Sample Location –	Insulation residue to concrete –13/4/B/19/DS14
Analysis Result –	Amosite Chrysotile

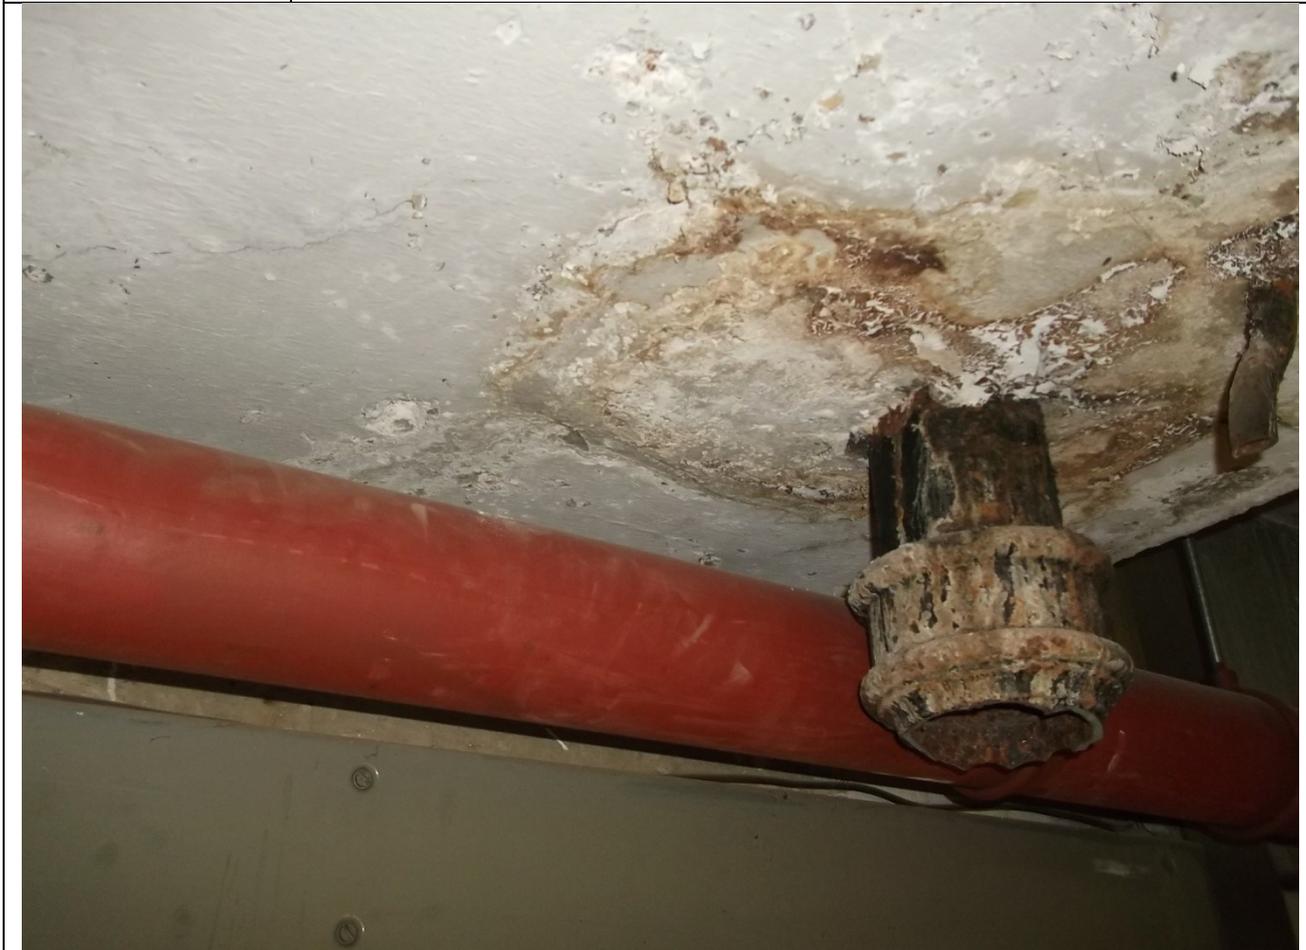
Photo 2 –	B.08 - Store
Sample Location –	Insulation residue to concrete –13/4/B/19/DS15
Analysis Result –	Amosite Chrysotile

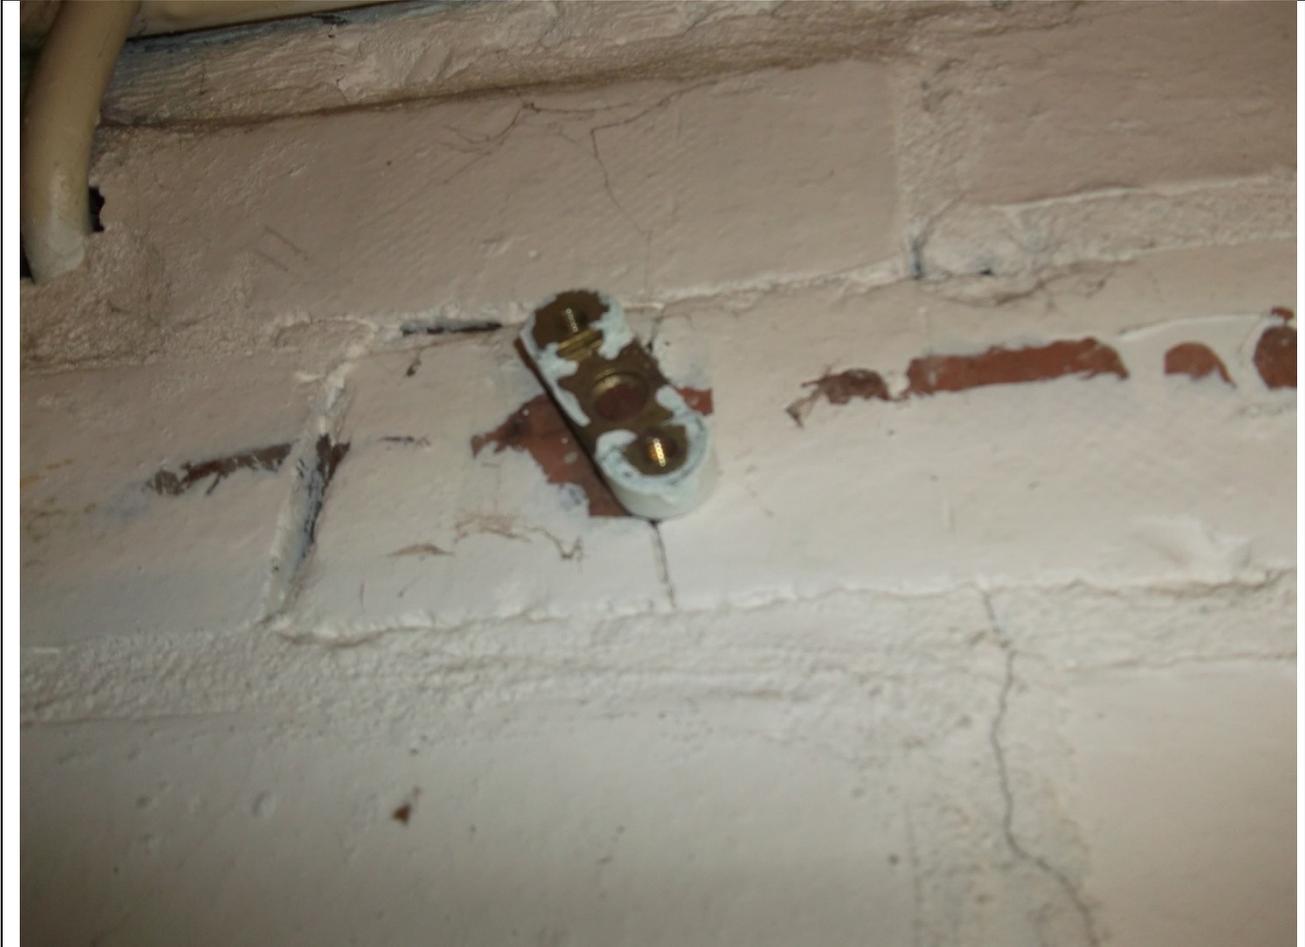
Photo 3 –	B.09 - Corridor
Sample Location –	Insulation residue to wall –13/4/B/19/DS16
Analysis Result –	Amosite Chrysotile

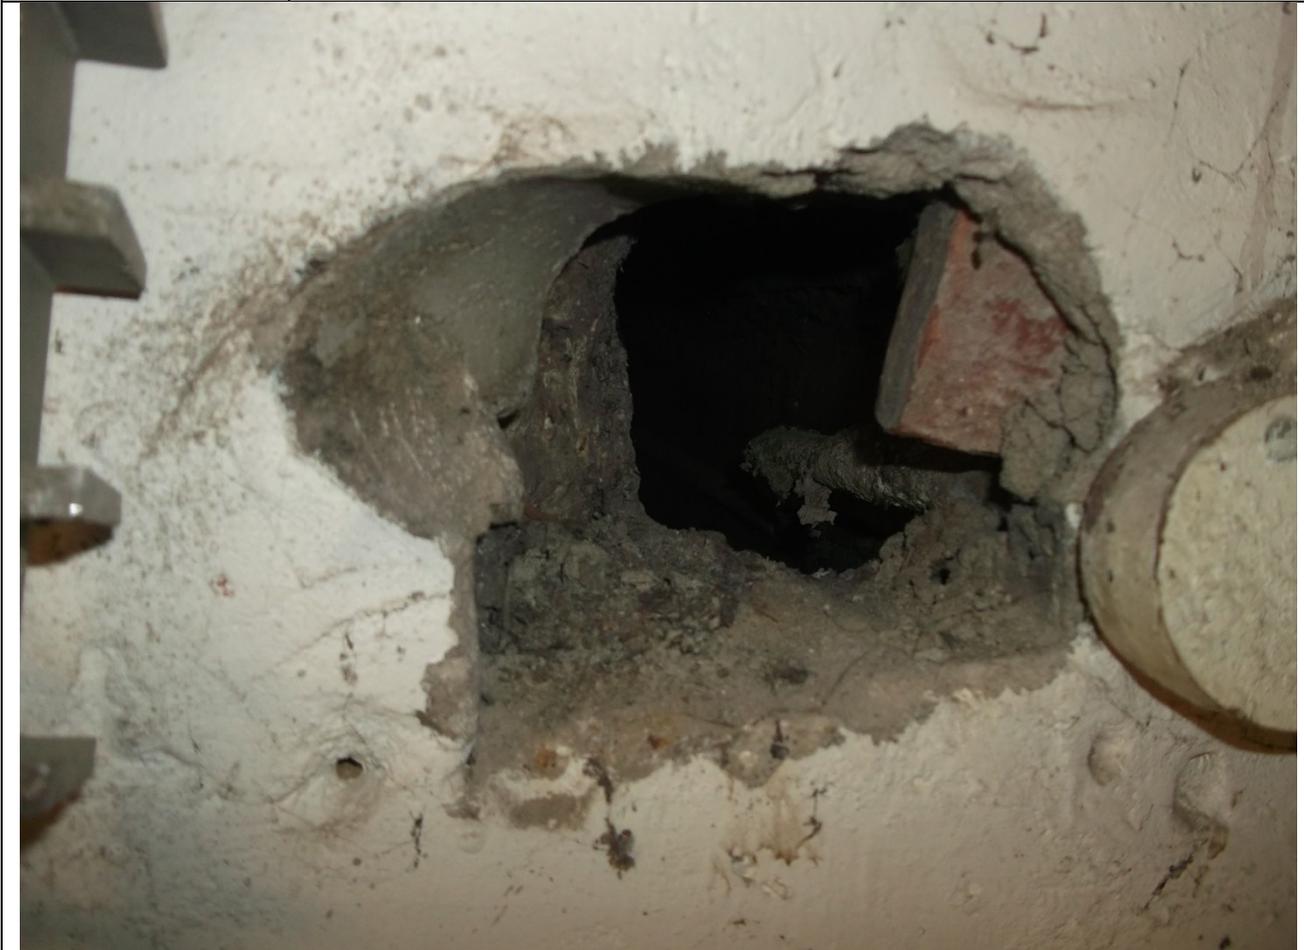
Photo 4 –	B.09 - Corridor
Sample Location –	Insulation debris to pipe penetration within wall –13/4/B/19/DS17
Analysis Result –	Chrysotile

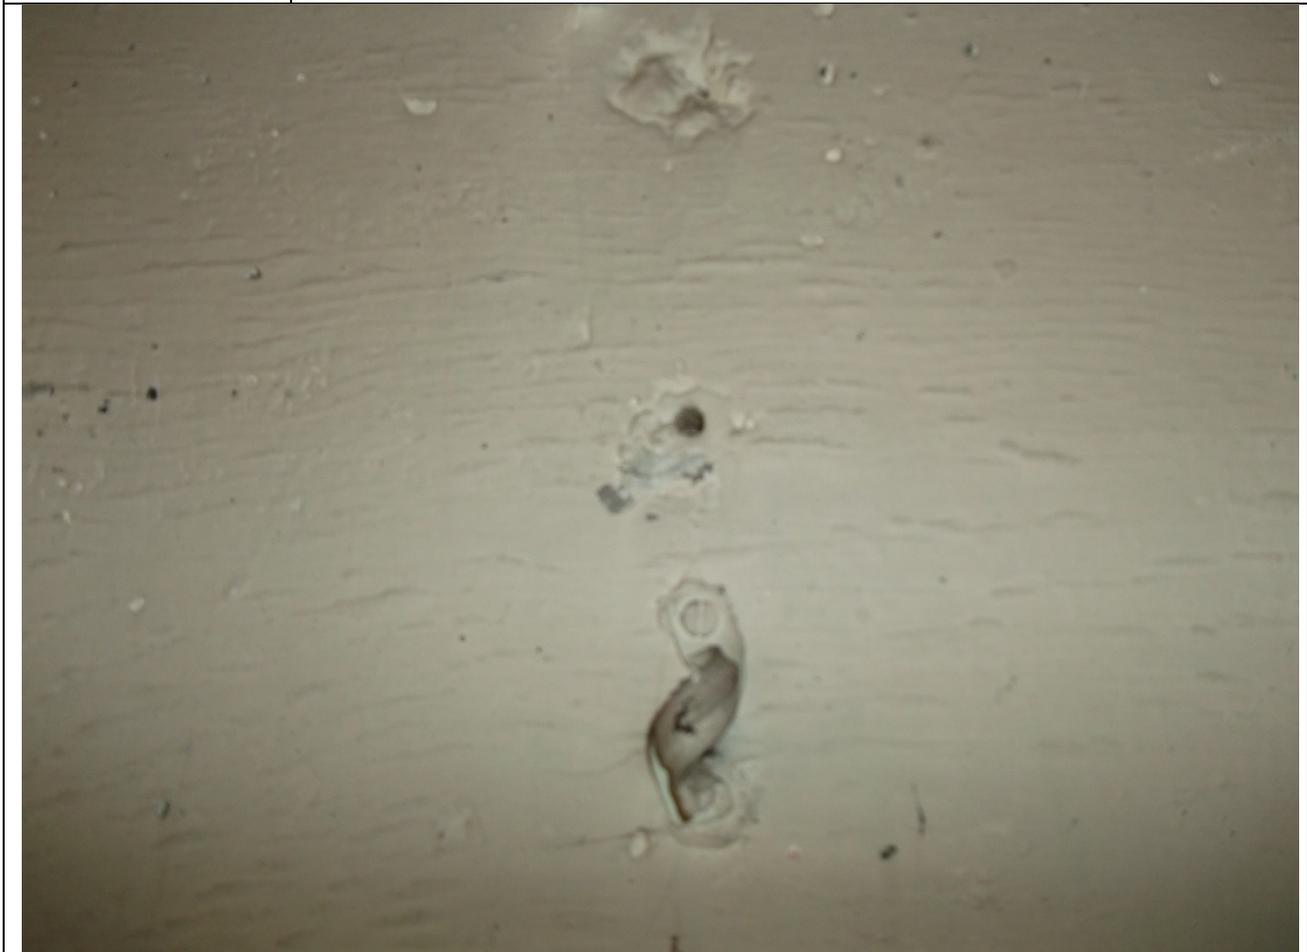
Photo 5 –	B.10 - Boiler room
Sample Location –	Insulation residue to wall –13/4/B/19/DS19
Analysis Result –	Amosite Chrysotile

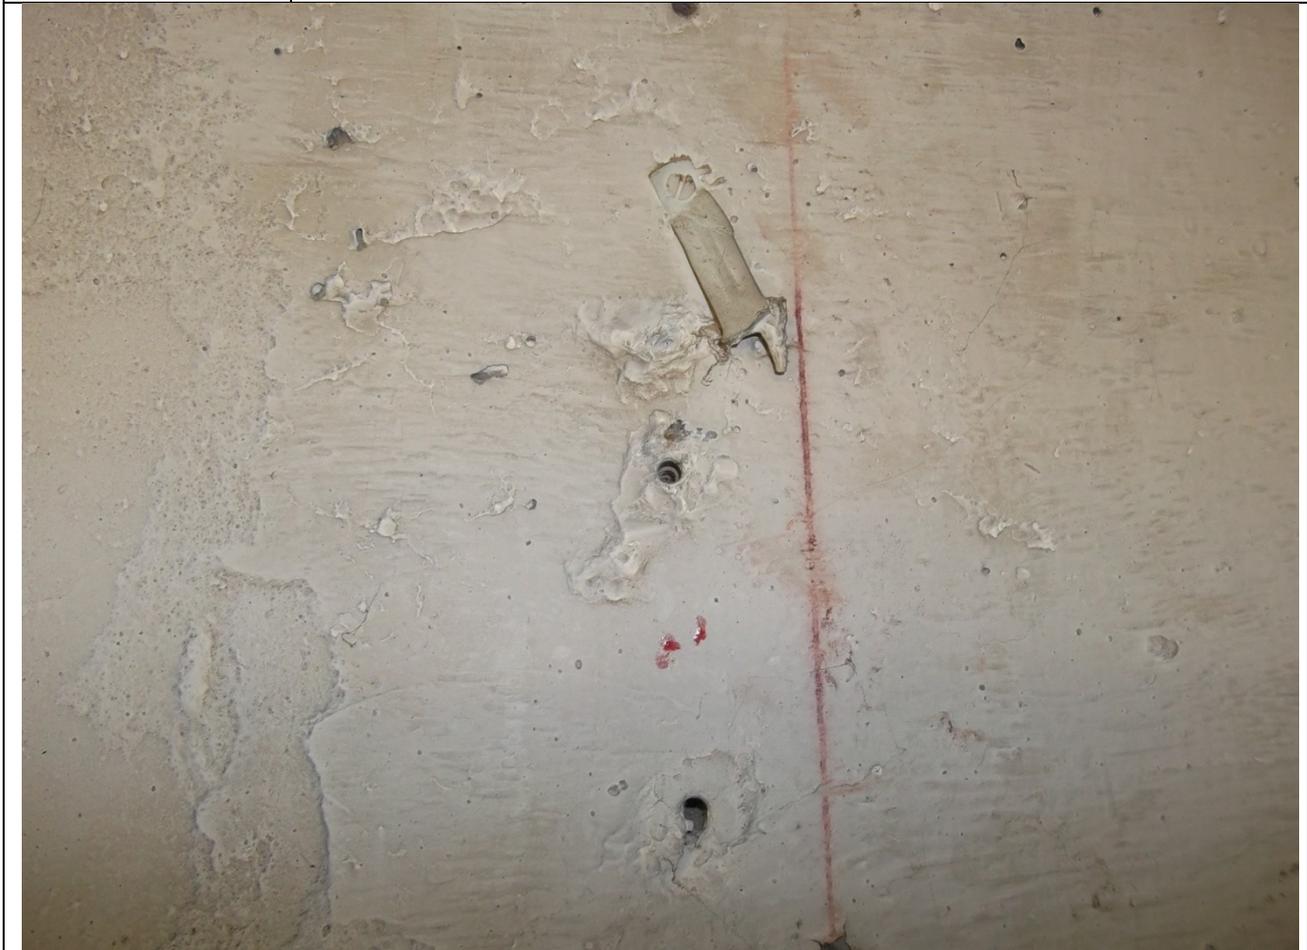
Photo 6 –	B.10 - Boiler room
Sample Location –	Insulation residue to wall –13/4/B/19/DS20
Analysis Result –	Amosite Chrysotile

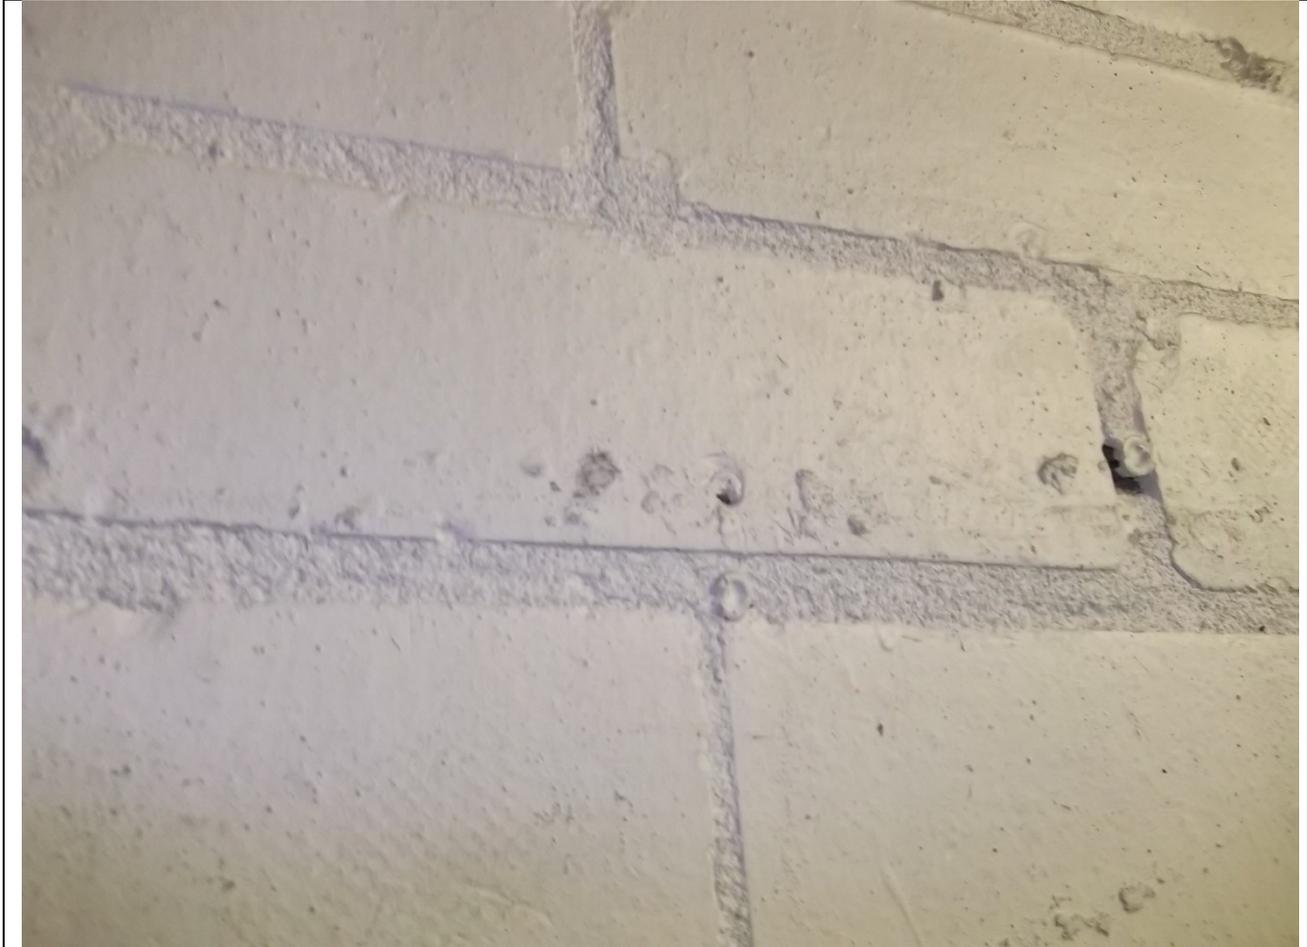
Photo 8 –	B.10 - Boiler room
Sample Location –	Insulation residue to wall –13/4/B/19/DS21
Analysis Result –	Chrysotile

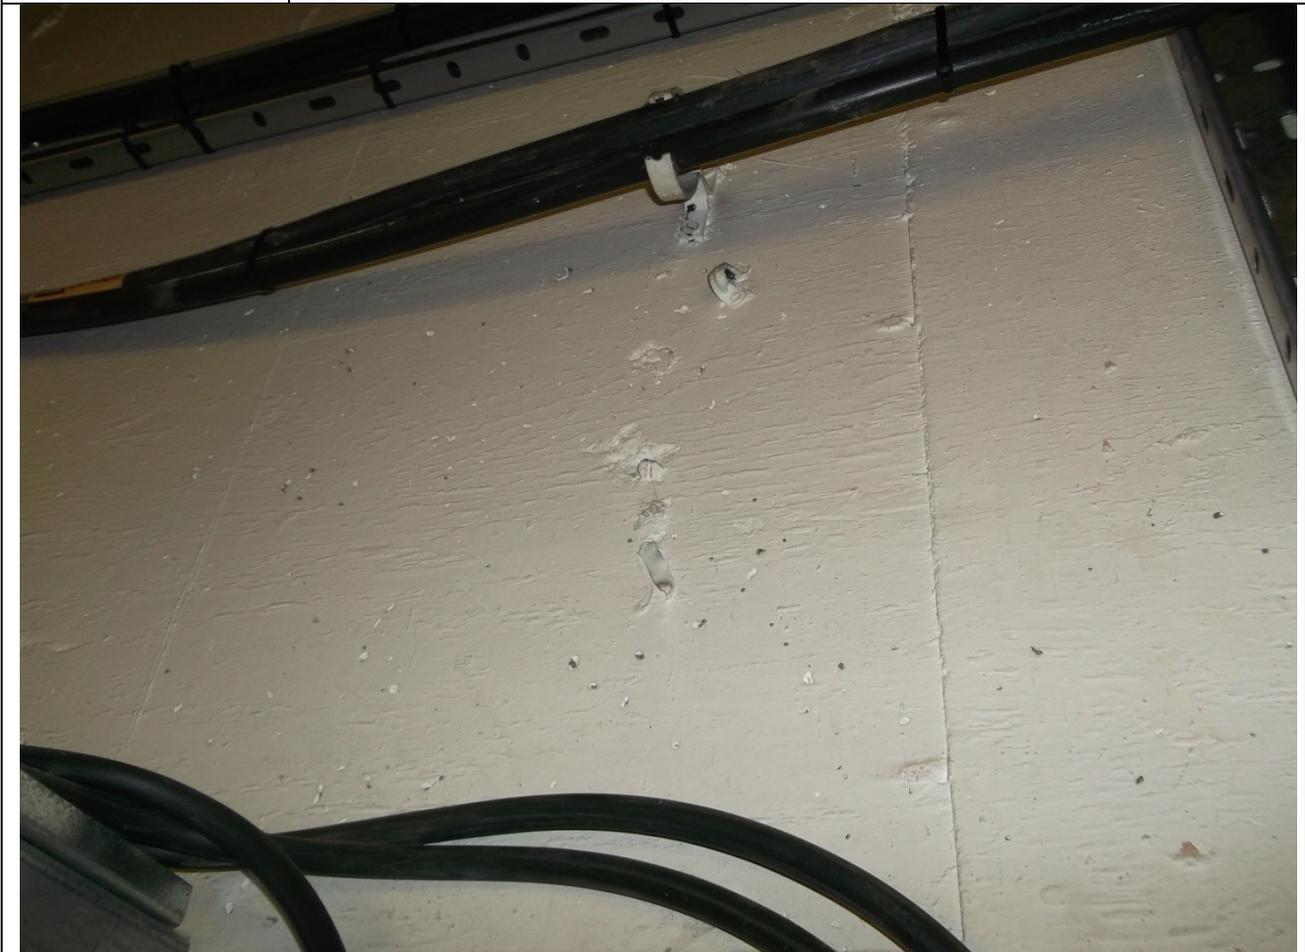
Photo 9 –	B.10 - Boiler room
Sample Location –	Insulation residue to wall –13/4/B/19/DS22
Analysis Result –	Amosite Chrysotile

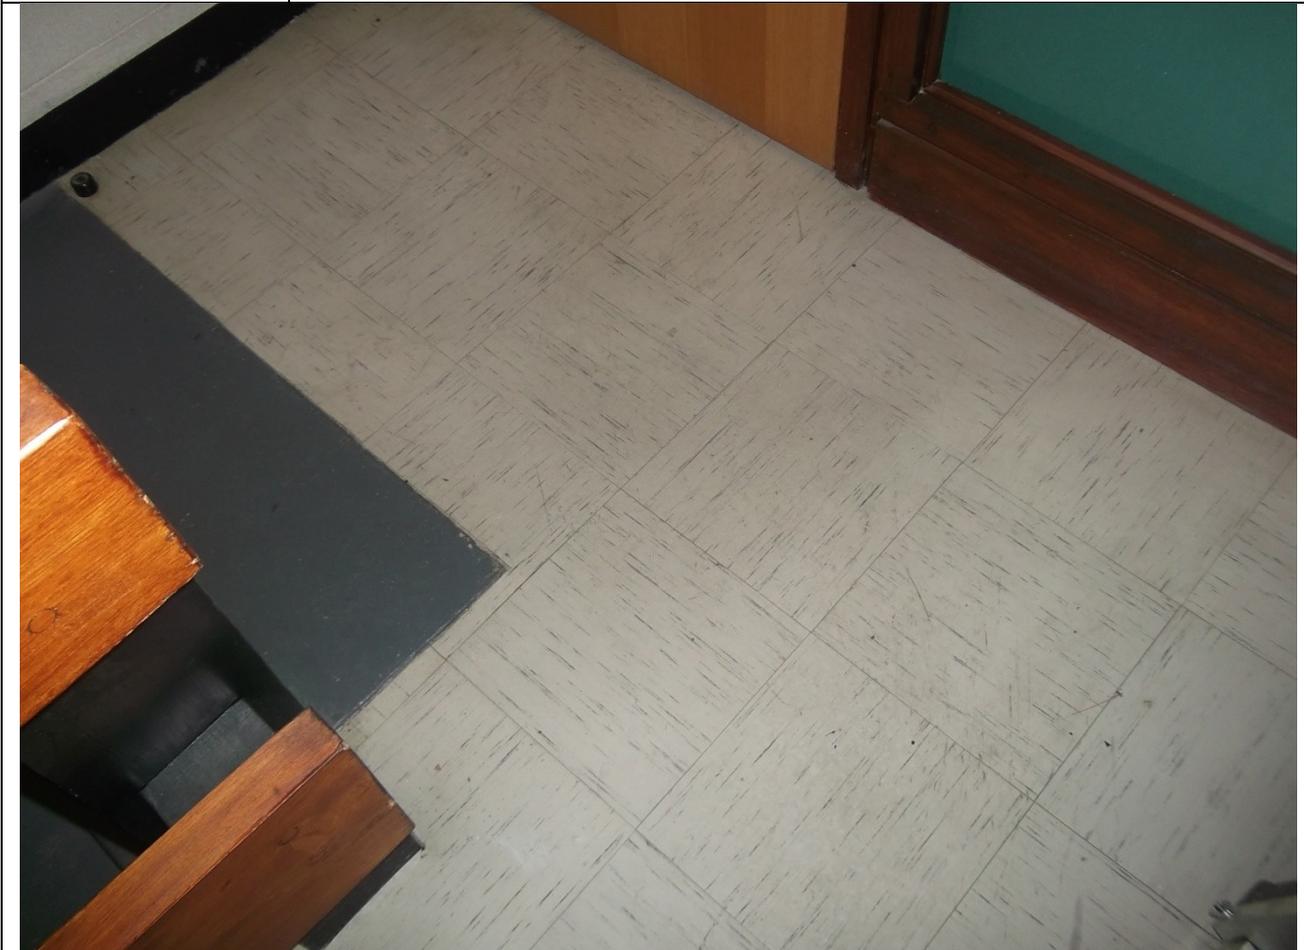
Photo 10 –	Rear Staircase
Sample Location –	Vinyl floor tiles with bitumen adhesive (asbestos present within bitumen layer) – 13/4/B/19/DS24
Analysis Result –	Chrysotile

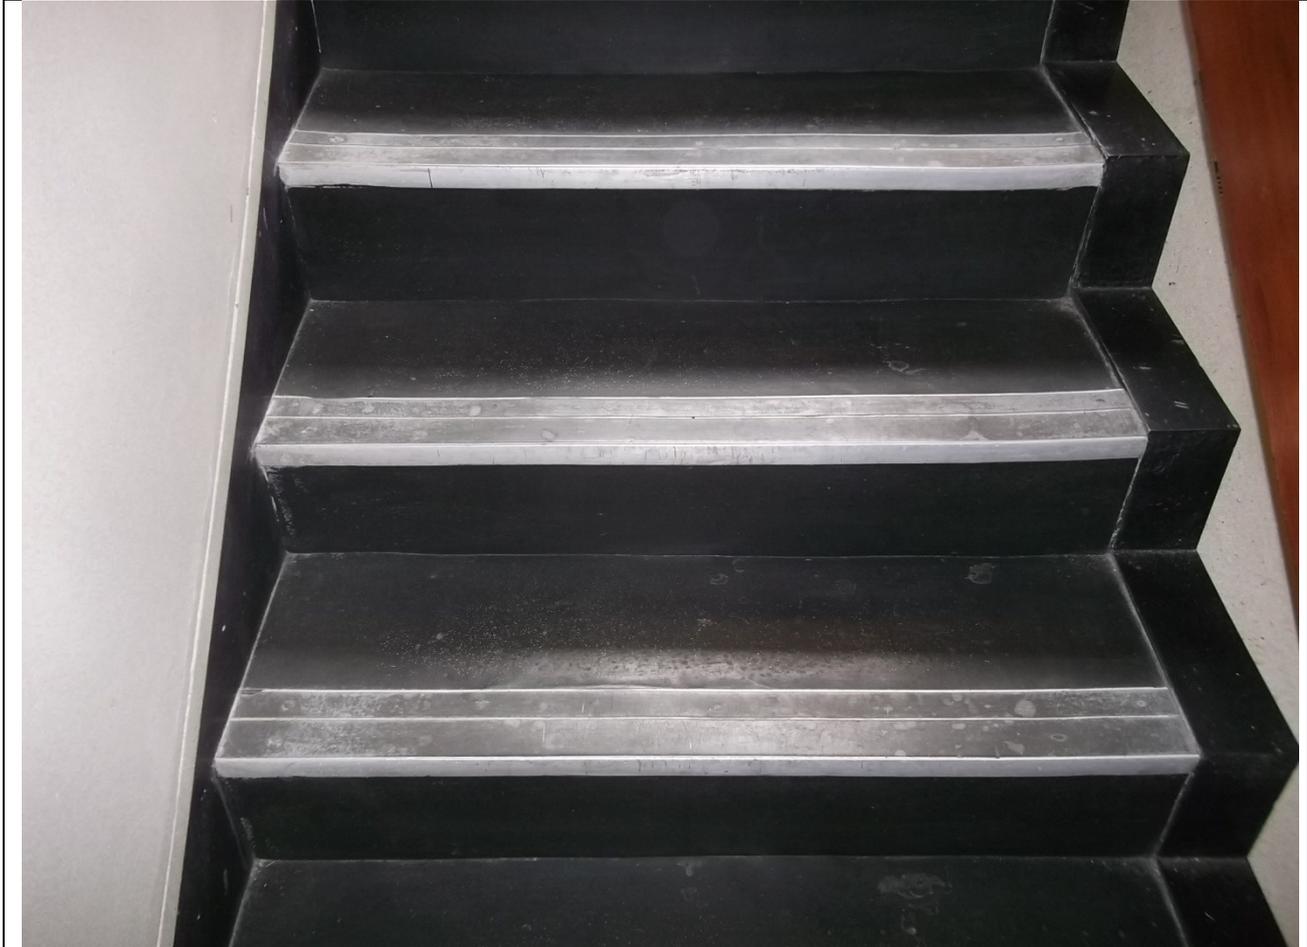
Photo 11 –	Rear Staircase
Sample Location –	Vinyl stair nosing –13/4/B/19/DS24
Analysis Result –	Chrysotile

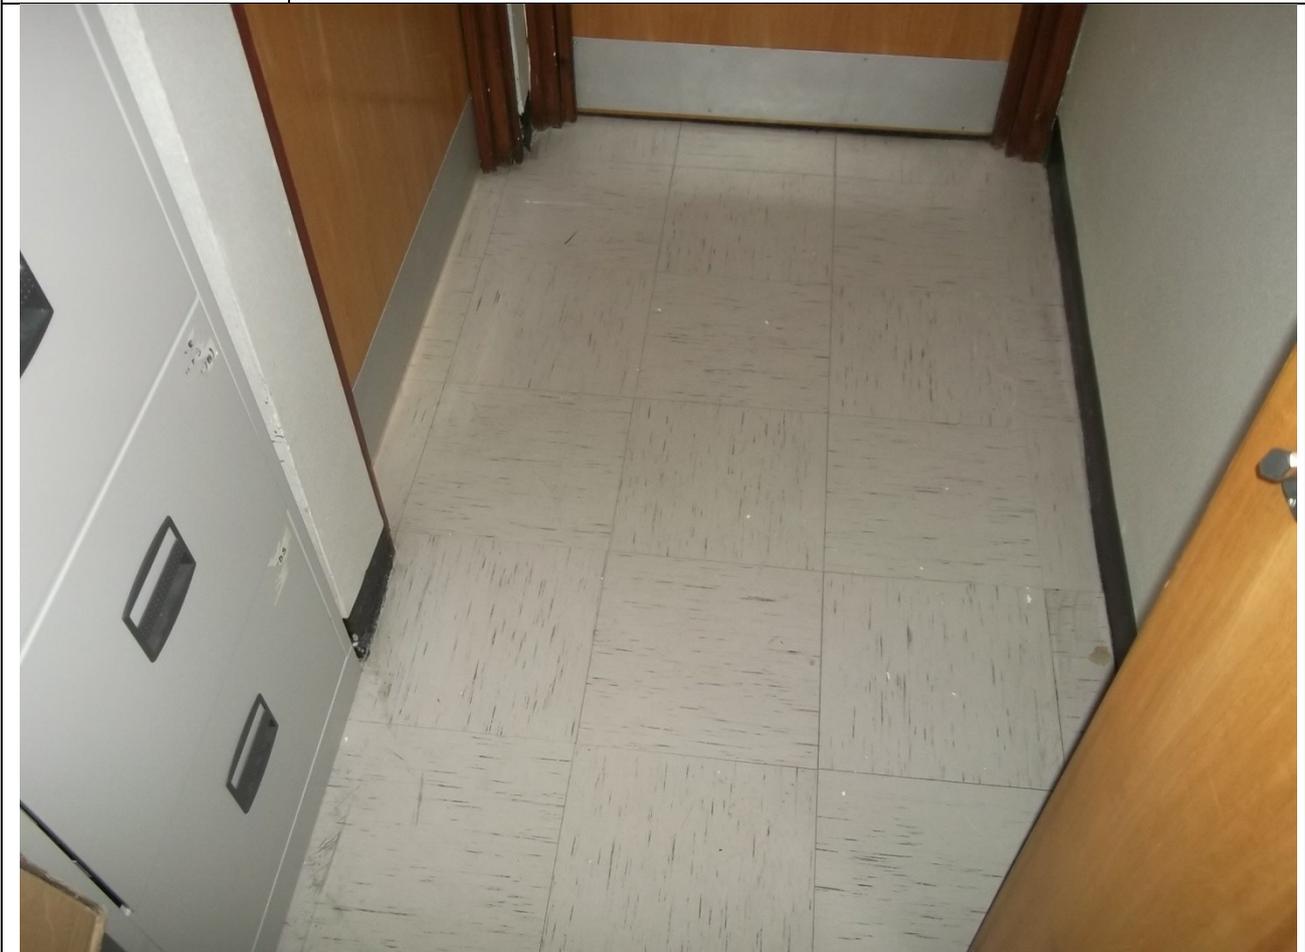
Photo 12 –	4.06 Lobby
Sample Location –	Vinyl floor tiles with bitumen adhesive (asbestos present within bitumen layer) – 13/4/B/10/CW10
Analysis Result –	Chrysotile

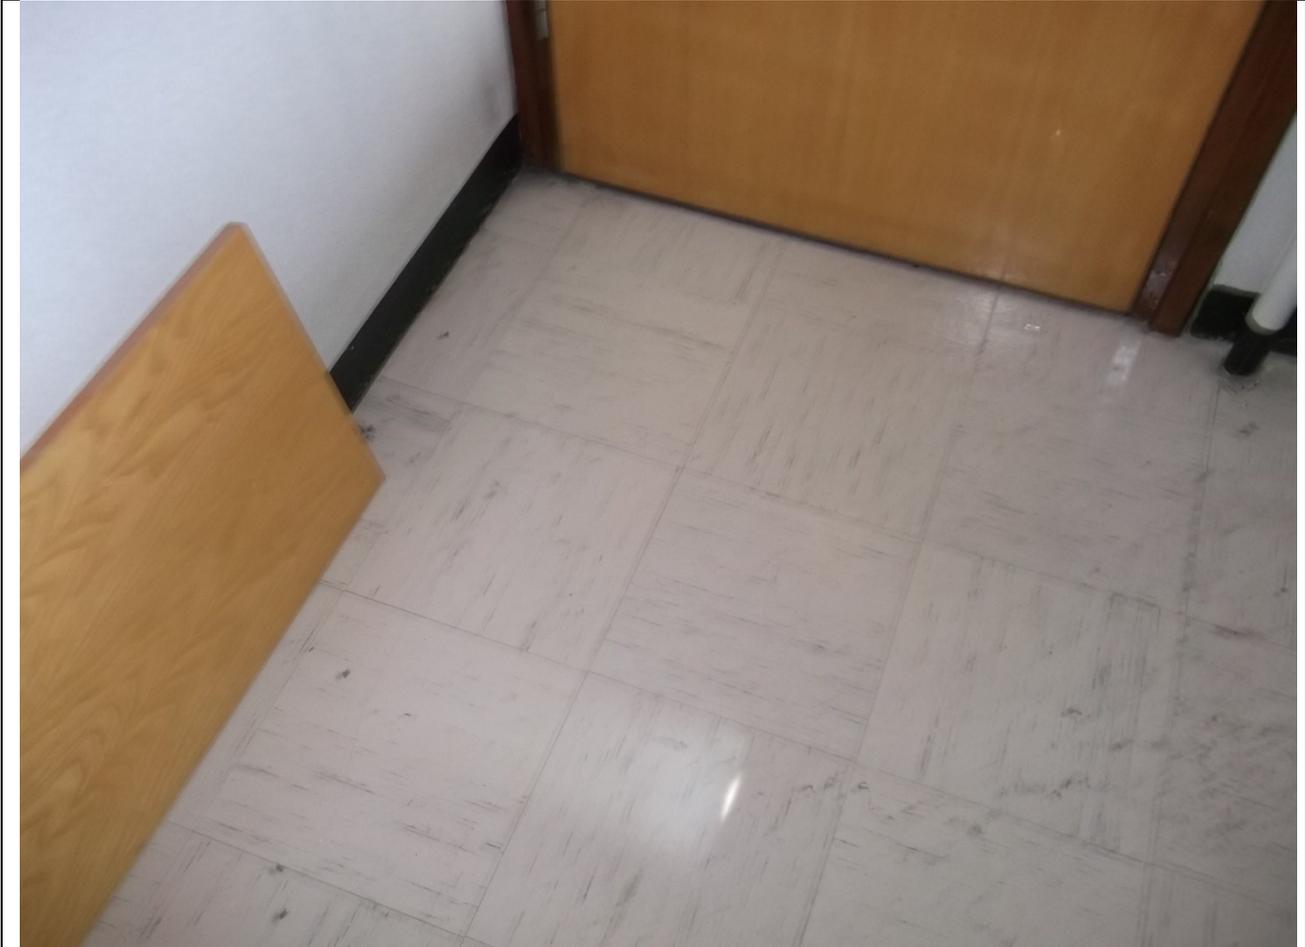
Photo 13 –	5.08 Lobby
Sample Location –	Vinyl floor tiles with bitumen adhesive (asbestos present within bitumen layer) – refer to 13/4/B/10/CW10
Analysis Result –	Chrysotile

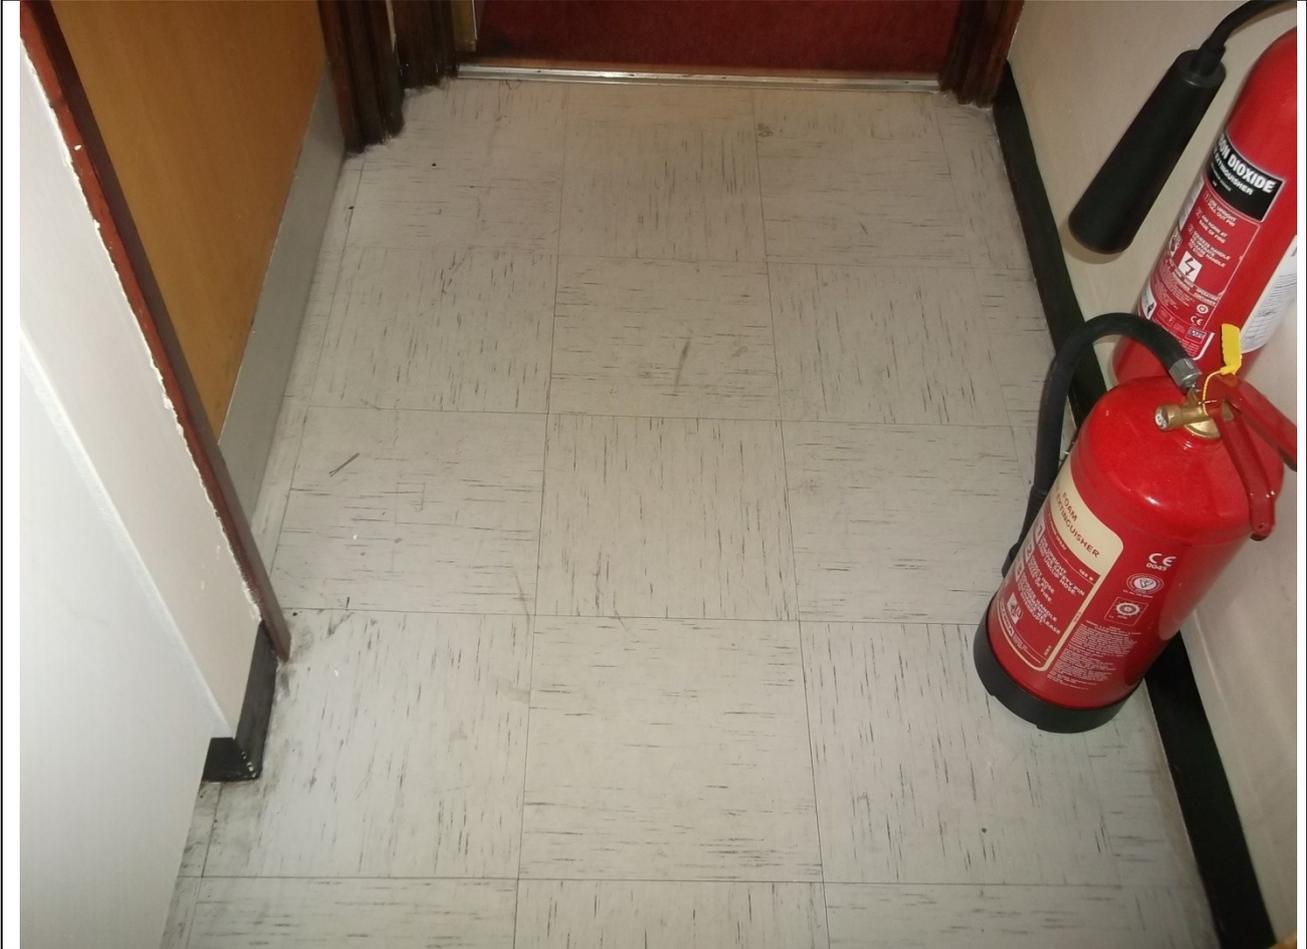
Photo 12 –	6.05 Kitchenette
Sample Location –	Vinyl floor tiles with bitumen adhesive (asbestos present within bitumen layer) – 13/4/B/10/CW13
Analysis Result –	Chrysotile
