Reinspection Survey

Hythe & Dibden Parish Council

Survey Reference Number: G-05168

The Grove
Clayfields Sport Centre and The Parish Hall
Hythe
SO45 6BZ

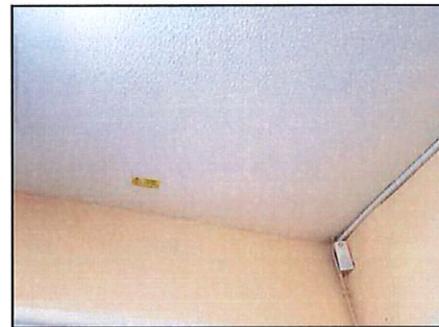
Entry Number 001
Lead Surveyor Graham Wainwright
Inspection Type Reinspection
Inspection Date 31/01/2019
Next Inspection Date 31/01/2020

Area Title	The Grove - Office
Floor / Level	Ground Floor
Product Type	Textured Coating
Sample Reference	Presumed
Item Description	Ceiling: Textured Coating
Estimated Extent	30 m ²

Material Factor Rating	Result from Material Assessment (above)	4
Material Category	Potential for fibre release	Very Low

Encapsulate - The material is structurally sound and can be sealed to reduce the risk of disturbance.

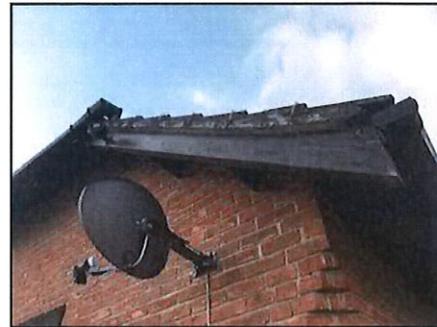
Entry Number 002
Lead Surveyor Graham Wainwright
Inspection Type Reinspection
Inspection Date 31/01/2019
Next Inspection Date 31/01/2020

Area Title	Clayfields Sports Centre - External
Floor / Level	External
Product Type	Cement
Sample Reference	Presumed
Item Description	Undercloaking: Cement
Estimated Extent	24 lin m

Material Factor Rating	Result from Material Assessment (above)	3
Material Category	Potential for fibre release	Very Low

Manage - Condition and surface treatment are adequate for the material to be left in place. Asbestos warning stickers may be applied.

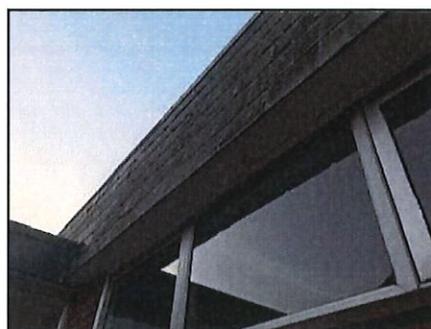
Entry Number 003
Lead Surveyor Graham Wainwright
Inspection Type Reinspection
Inspection Date 31/01/2019
Next Inspection Date 31/01/2020

Area Title	Parish Hall - External
Floor / Level	External
Product Type	Cement
Sample Reference	Presumed
Item Description	Soffits: Cement
Estimated Extent	80 lin m

Material Factor Rating	Result from Material Assessment (above)	5
Material Category	Potential for fibre release	Low

Manage - Condition and surface treatment are adequate for the material to be left in place. Asbestos warning stickers may be applied.

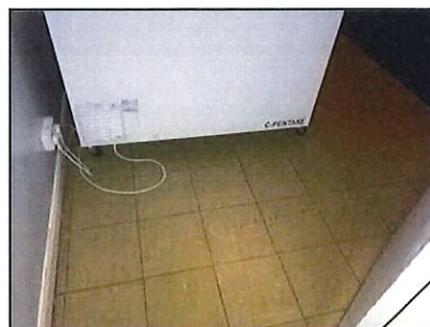
Entry Number 004
 Lead Surveyor Graham Wainwright
 Inspection Type Reinspection
 Inspection Date 31/01/2019
 Next Inspection Date 31/01/2020

Area Title	Parish Hall - Store room
Floor / Level	Ground Floor
Product Type	Vinyl Floor Tile
Sample Reference	Presumed
Item Description	Floor tiles: Vinyl Floor Tile
Estimated Extent	12 m ²

Material Factor Rating	Result from Material Assessment (above)	2
Material Category	Potential for fibre release	Very Low

Manage - Condition and surface treatment are adequate for the material to be left in place. Asbestos warning stickers may be applied.
