22062/IS/0810

MANAGEMENT ASBESTOS SURVEY REPORT

Shire House Suite,
Bodmin,
Cornwall.

FOR:
Bodmin Town Council
SURVEYED ON:
26th August 2010

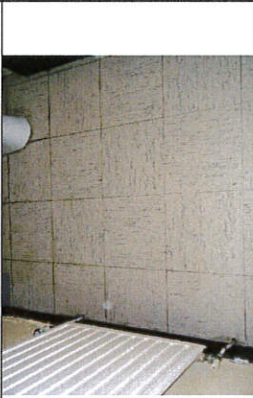
Ref	Sample No	Floor	Location	Description	Accessibility	(A) Product Type	(B) Condition	(C) Surface Treatment	(D) Asbestos Type	Material Assessment Score (A + B + C + D)	Priority	Photo
13	22062/IS/21	Ground	Disabled WC Floor	Vinyl Floor Tiles	High	1	1	0	1	3	LOW

Quantity		ID	Recommendations									
2m²		AD	Regularly monitor condition of ACM.									
Ref	Sample No	Floor	Location	Description	Accessibility	(A) Product Type	(B) Condition	(C) Surface Treatment	(D) Asbestos Type	Material Assessment Score (A + B + C + D)	Priority	Photo
16	22062/IS/24	External	Walls	Cladding	Medium	1	1	1	1	4	LOW
