# **Beverley Town Council New Town Hall Project Manager**

## **TENDER PACK**

# Condition Report

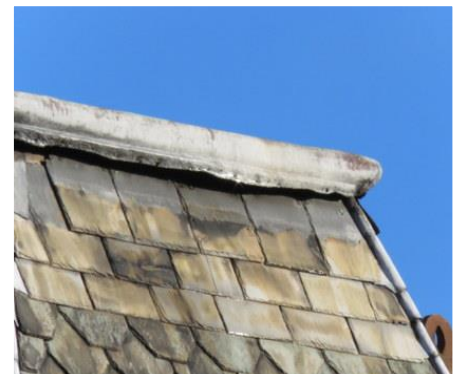
Missing flashing to cupola.

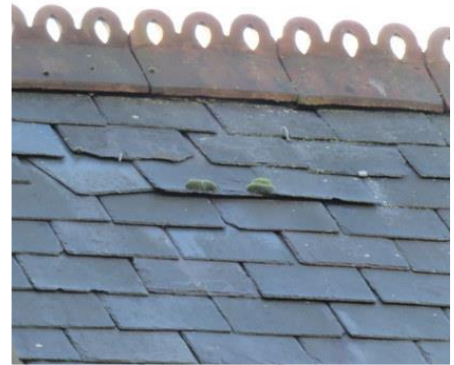
Pointing generally to ridge missing. Tingles in place in various locations.

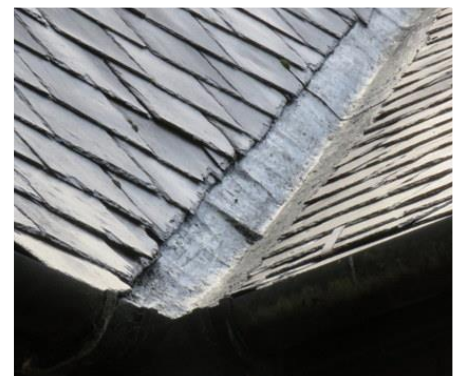
Liquid repair to valley gutter.

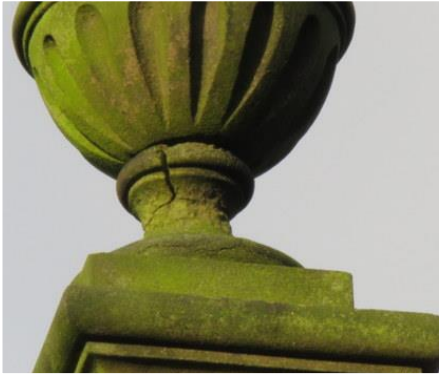
Cracking to stone support on finial on Wilbert lane gable.

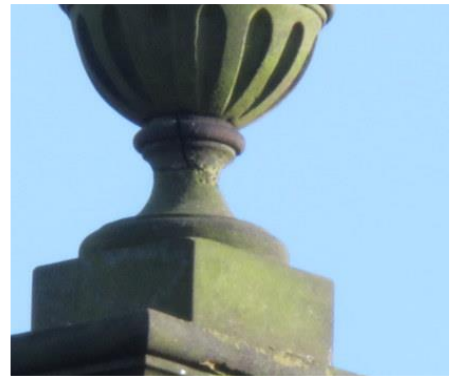
Cracking to stone support on finial on Wilbert lane gable.

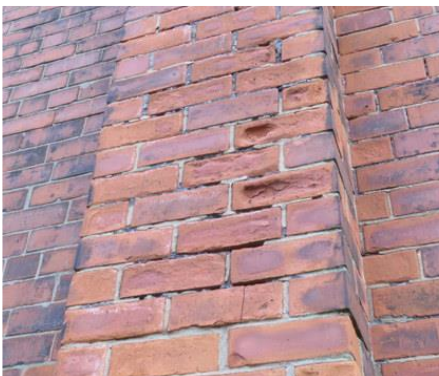
The chimney brickwork is generally spalled and with open brickwork joints, particularly near the top of the chimney and requires comprehensively overhauling.

Spalled bricks and open joints to chimney.

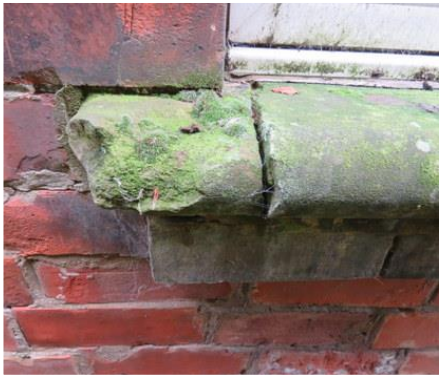
Damaged/cracked stone cills to a number of windows.

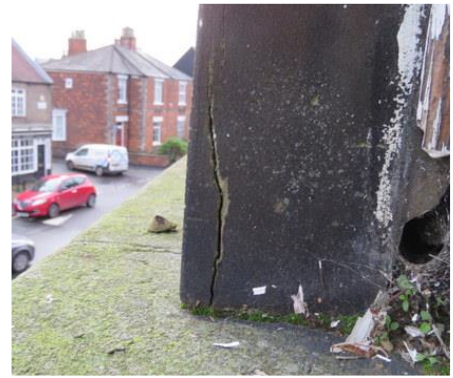
Cracking to face of stone column between Wilbert Lane gable window.

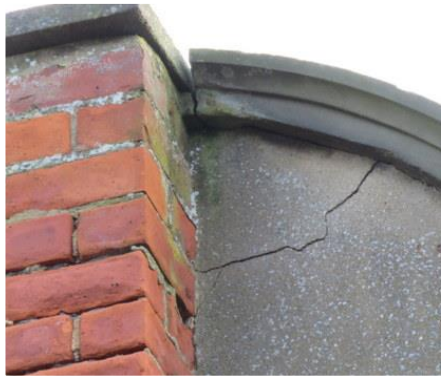
Cracking to high level render to chimney.

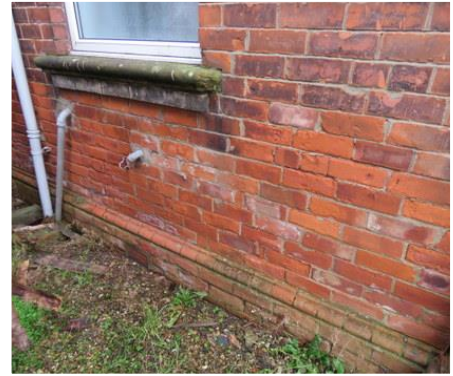
Poor pointing/spalled brick faces to a number of locations.

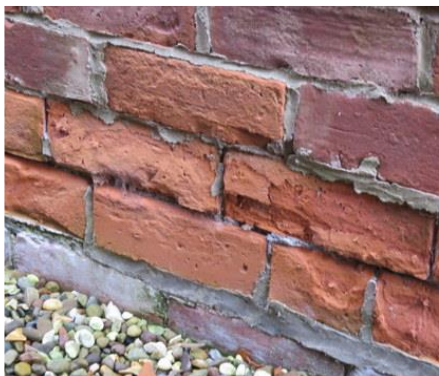
Low level brickwork spalled and pointing poor.

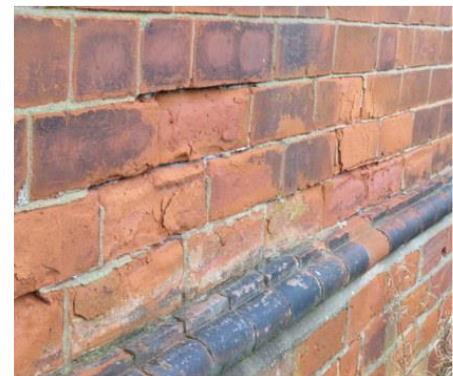
Poor pointing/spalled brick faces to a number of locations.

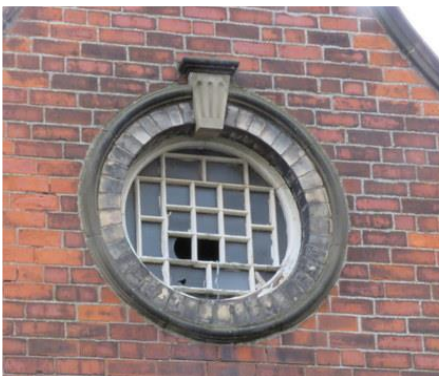
There is missing glazing to the circular window above the male WC window which requires replacing to prevent weather ingress and birds etc.

Broken glass to round window above Morton Lane entrance.

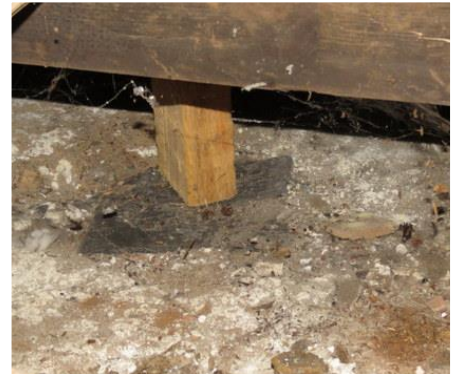
Additional supports fitted beneath damp joists to floor at Wilbert lane entrance.

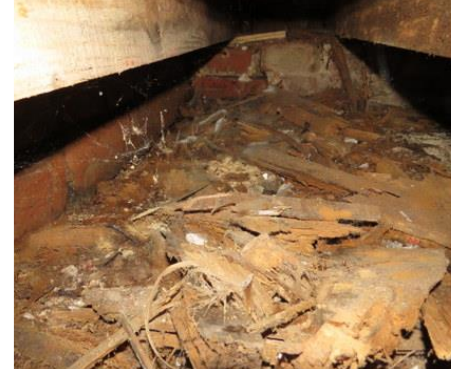
Debris and signs of wet rot to hall floor.

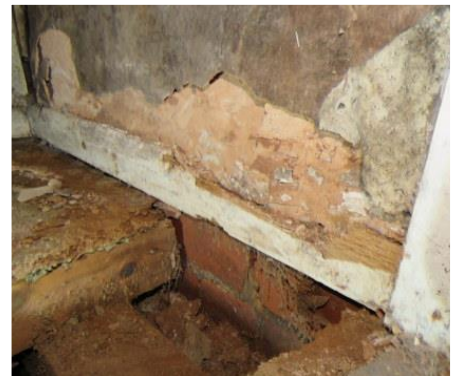
Rot to floor and skirtings in kitchen.

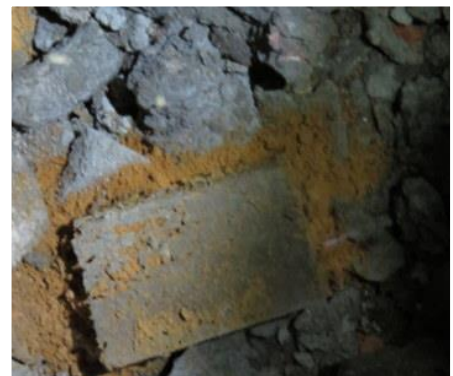
Beetle activity in floor void.

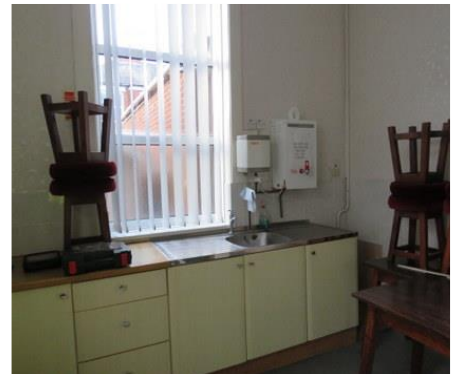
Kitchen dated, water heating dilapidated.
