Report on Internal Mastic
Joints, Node 49
Levels 3/4/5/6

National Oceanography
Centre, Southampton

Job Number: 2198

Date: 29th September 2017

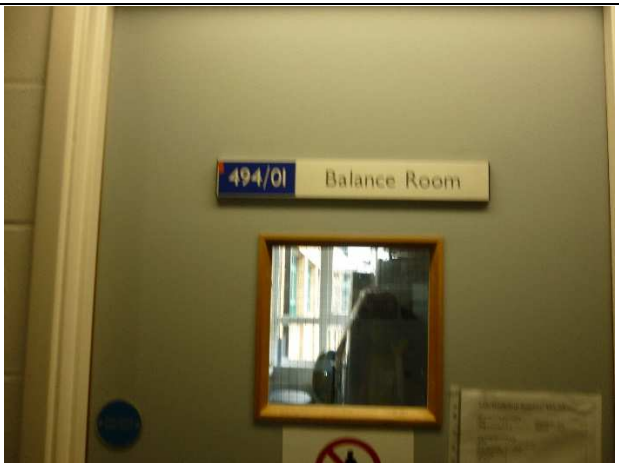
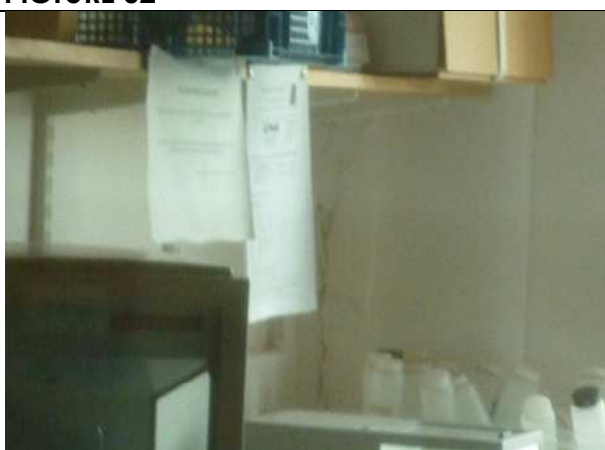
ROOM – BALANCE ROOM	494/01	INSPECTION DATE	21/09/2017
SCOPE	MASTIC JOINT INVESTIGATION		
SAMPLE	PICTURE 01		
No sample

RICS CONDITION RATING	VERTICAL	3	HORIZONTAL
			3
<p>NOTE:</p> <p>Mastic joints along the wall panel between 494/01 and node 4 form a primary movement joint for the main structural concrete frame and are in very poor condition throughout. To be completely replaced.</p>			
16mm MASTIC JOINT (length) m		21.40m

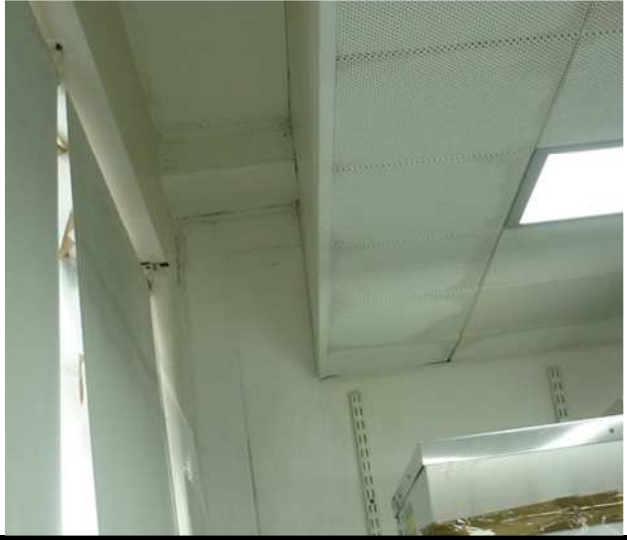
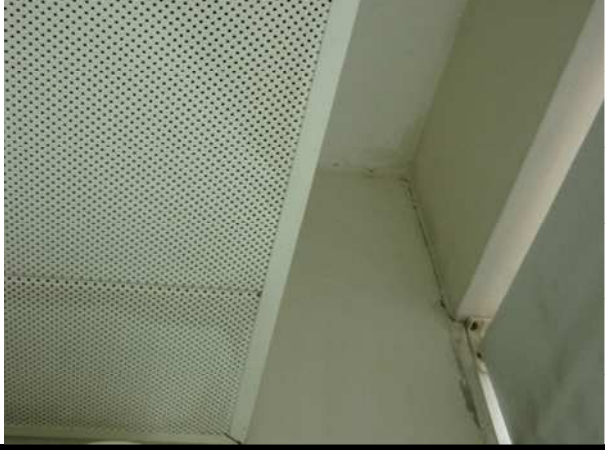
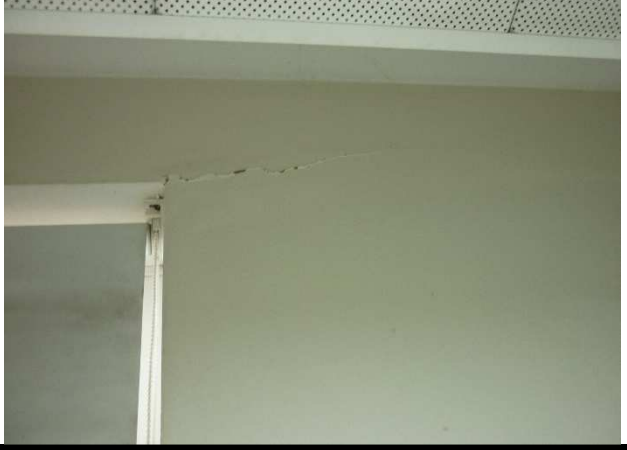
ROOM - LABORATORY	494/02	INSPECTION DATE	21/09/2017	
SCOPE	MASTIC JOINT INVESTIGATION			
SAMPLE	PICTURE 01			
No sample

RICS CONDITION RATING	VERTICAL	3	HORIZONTAL	3
<p>NOTE:</p> <p>Picture 01 - Mastic joints along the wall panel between 494/02 and node 4 form a primary movement joint for the main structural concrete frame and are in very poor condition throughout. To be completely replaced.</p> <p>Picture 02 – No mastic joint was found between partition wall (Room 02/06) and external wall panel.</p> <p>Picture 03 – Visible cracking to top right-hand corner of window.</p>				
16mm MASTIC JOINT (length) m		27.60m

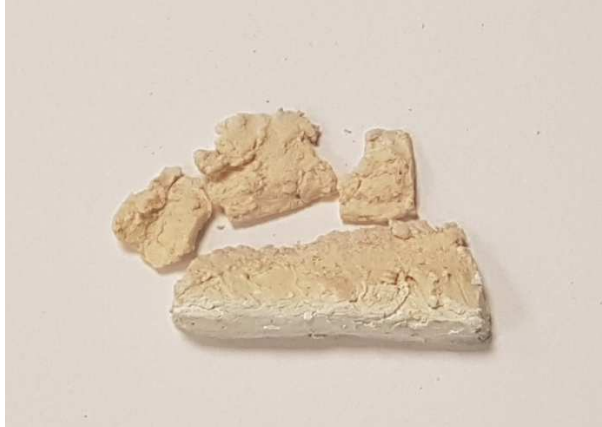
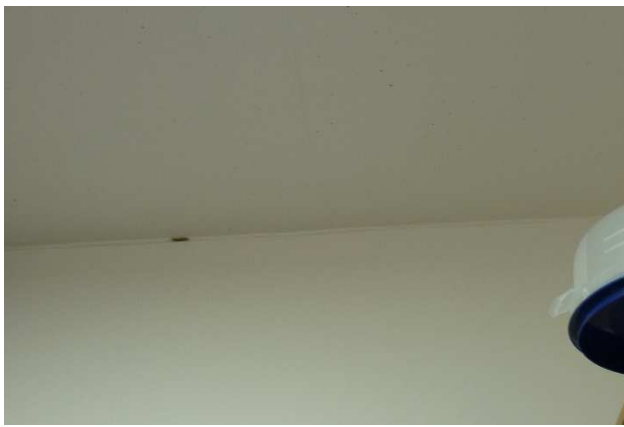
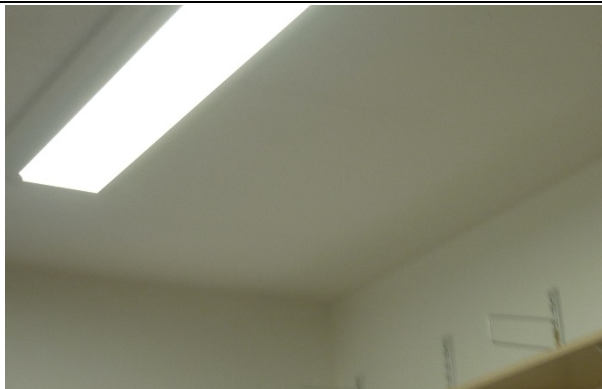
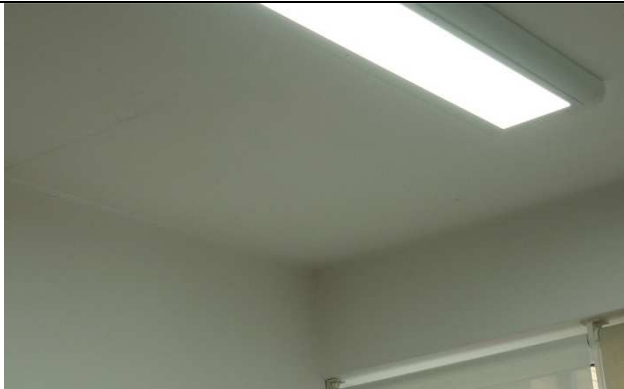
ROOM - OFFICE	494/03	INSPECTION DATE	21/09/2017
SCOPE	MASTIC JOINT INVESTIGATION		
SAMPLE	PICTURE 01

RICS CONDITION RATING	VERTICAL	no	HORIZONTAL 2
<p>NOTE:</p> <p>SAMPLE - Mastic joint not dry or cracked; flexibility and plasticity of sealant maintained. The movement joint width has been reduced (from expected 16mm), white foam filler (Compriband?) not found.</p> <p>Pictures 01-02-03 – The movement joints are not cracked and appear in good condition throughout.</p> <p>No movement joint found between partition and external wall panel.</p>			
16mm MASTIC JOINT (length) m		13.50m

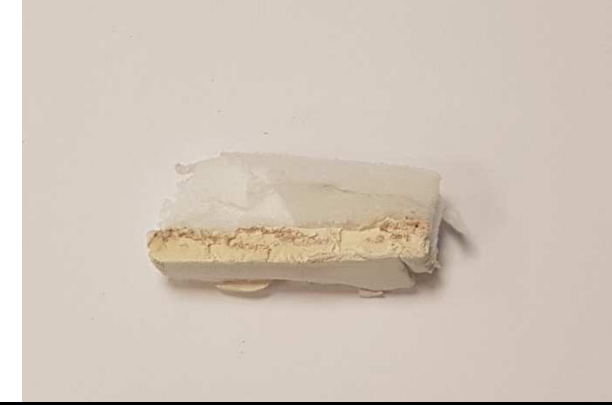
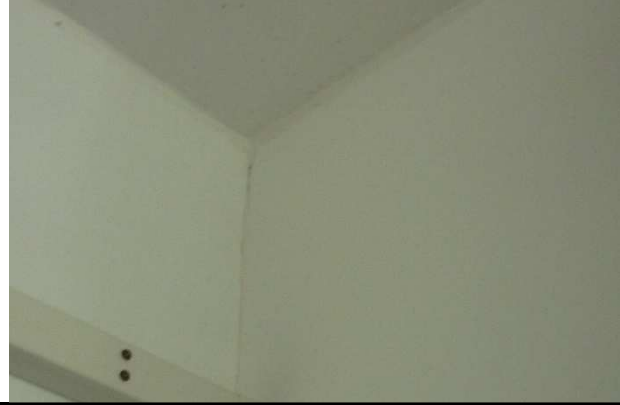
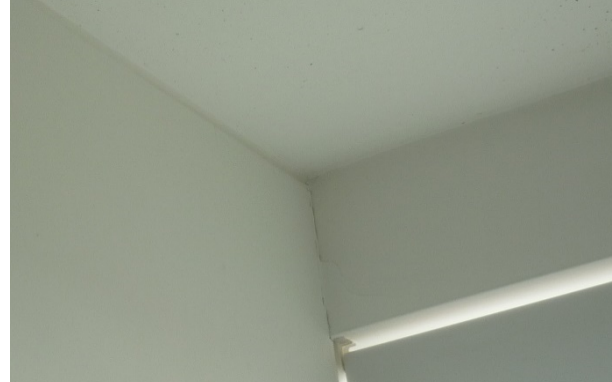
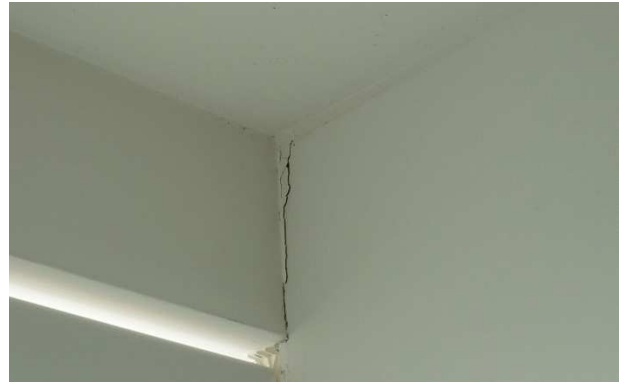
ROOM - OFFICE	494/06	INSPECTION DATE	21/09/2017
SCOPE	MASTIC JOINT INVESTIGATION		
SAMPLE	PICTURE 01

RICS CONDITION RATING	VERTICAL	no	HORIZONTAL 2
<p>NOTE:</p> <p>SAMPLE - Mastic joint not dry or cracked; flexibility and plasticity of sealant maintained. The movement joint width is 16mm, white foam filler (Compriband) was found, and in good condition.</p> <p>Picture 01 – The movement joints are not cracked and appear in good condition throughout.</p> <p>Pictures 02-03 – Cracking located between partition and external wall panel. No movement joint found.</p>			
16mm MASTIC JOINT (length) m		15.10m

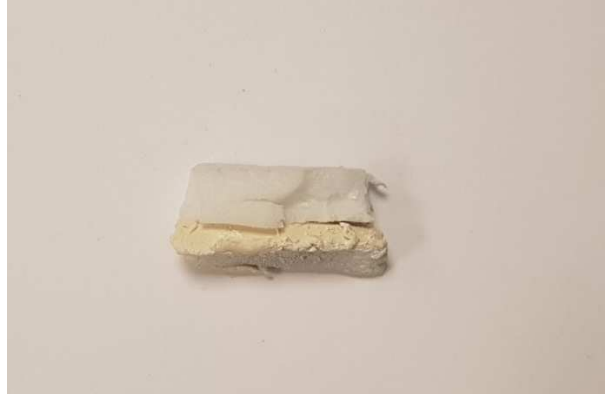
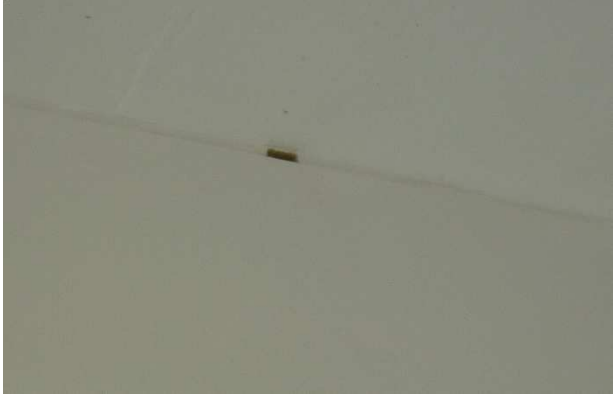
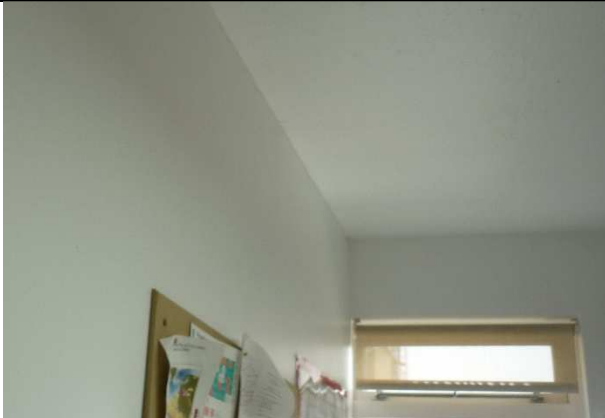
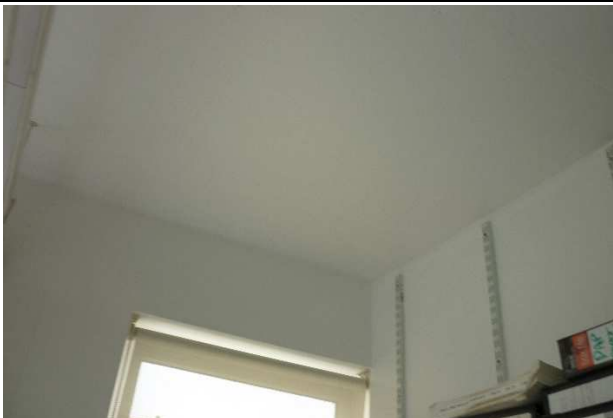
ROOM - OFFICE	494/07	INSPECTION DATE	21/09/2017
SCOPE	MASTIC JOINT INVESTIGATION		
SAMPLE	PICTURE 01

RICS CONDITION RATING	VERTICAL	no	HORIZONTAL 2
<p>NOTE:</p> <p>SAMPLE - Mastic joint not dry or cracked; flexibility and plasticity of sealant maintained. The movement joint width is 16mm, white foam filler (Compriband) was found, and in good condition.</p> <p>Picture 01 – The movement joints are not cracked and appear in good condition throughout.</p> <p>Pictures 02-03 – No movement joint found between partition and external wall panel.</p>			
16mm MASTIC JOINT (length) m		11.80m

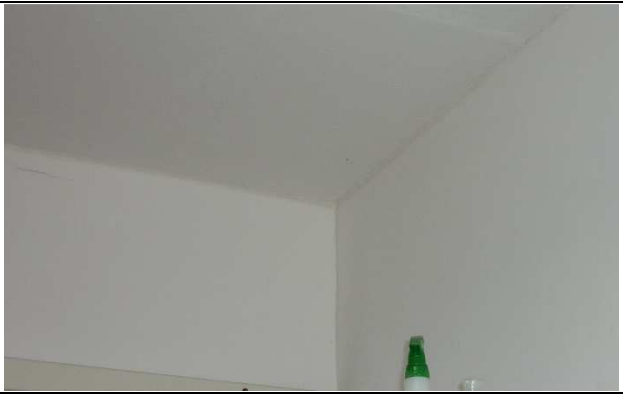
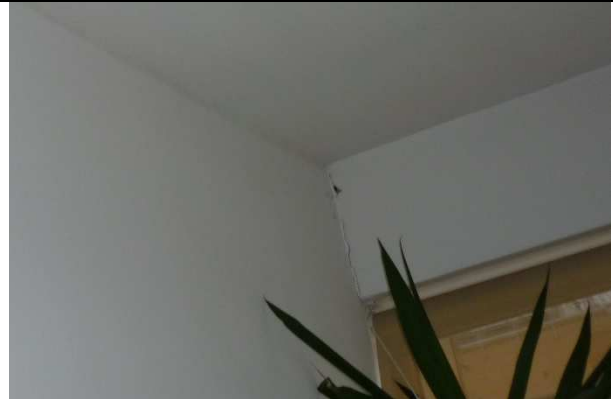
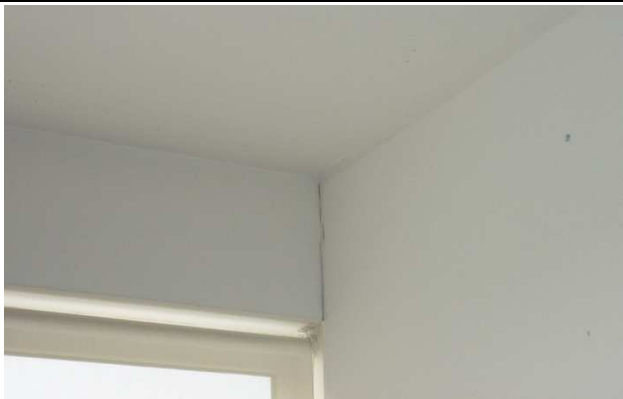
ROOM - OFFICE	494/09	INSPECTION DATE	21/09/2017
SCOPE	MASTIC JOINT INVESTIGATION		
SAMPLE	PICTURE 01		
No sample

RICS CONDITION RATING	VERTICAL	2	HORIZONTAL
			2
<p>NOTE:</p> <p>SAMPLE - Sample taken from adjacent rooms (494/03 and 494/07).</p> <p>Picture 01 – The movement joints are not cracked and appear in good condition throughout.</p> <p>Pictures 02-03 – No movement joint found between partitions and external wall panel.</p>			
16mm MASTIC JOINT (length) m		11.70m

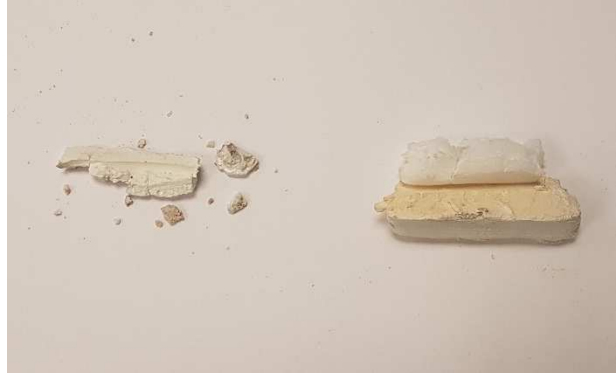
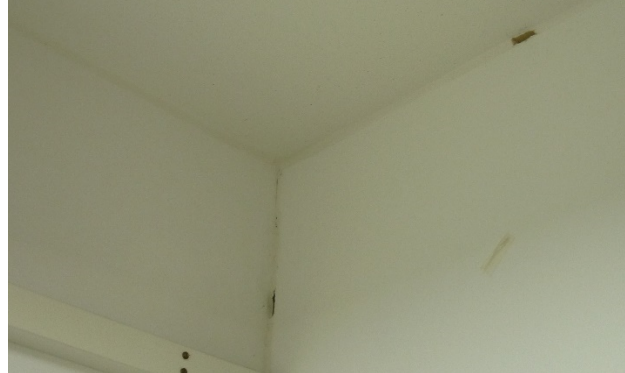
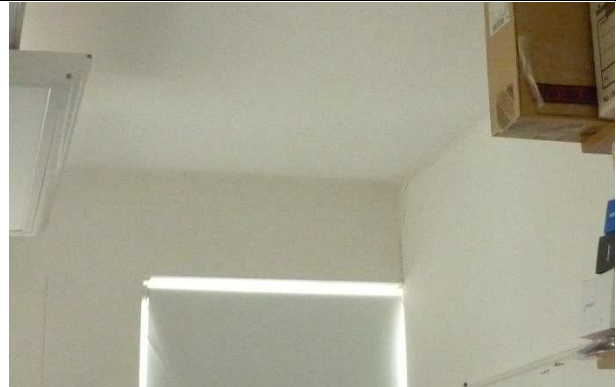
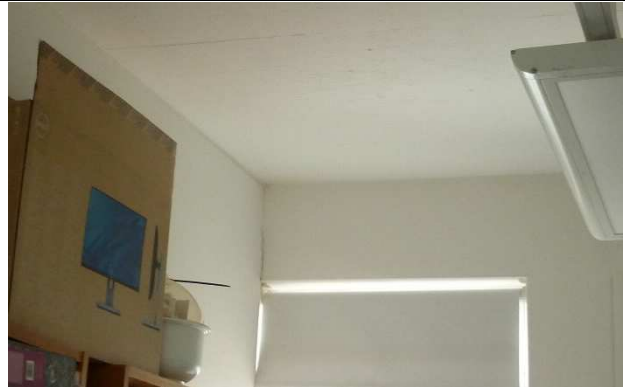
ROOM - OFFICE	494/10	INSPECTION DATE	21/09/2017
SCOPE	MASTIC JOINT INVESTIGATION		
SAMPLES	PICTURE 01

RICS CONDITION RATING	VERTICAL	3	HORIZONTAL 2
<p>NOTE:</p> <p>RIGHT SAMPLE – Horizontal mastic joint not dry or cracked; flexibility and plasticity of sealant maintained. The movement joint width is 16mm, white foam filler (Compriband) was found, and in good condition.</p> <p>LEFT SAMPLE – Wall/wall vertical joint between 494/10 and 494/101 not made with a suitable material (probably grout or caulk)</p> <p>Picture 01 – Shows where the horizontal and vertical samples have been taken.</p> <p>Pictures 02-03 – Cracking between partition and external wall panel. No movement joint found.</p>			
16mm MASTIC JOINT (length) m	15.05m

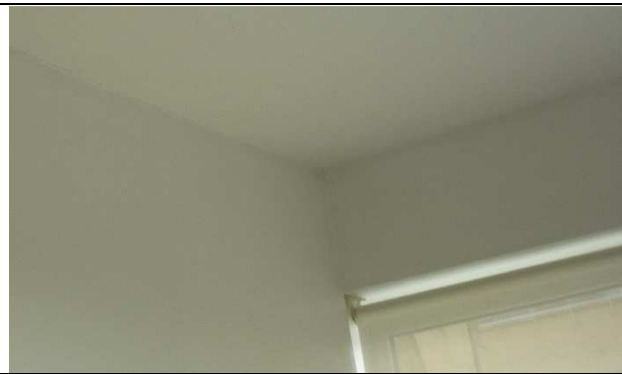
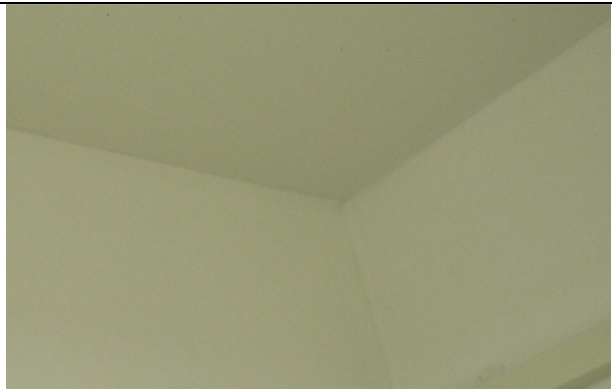
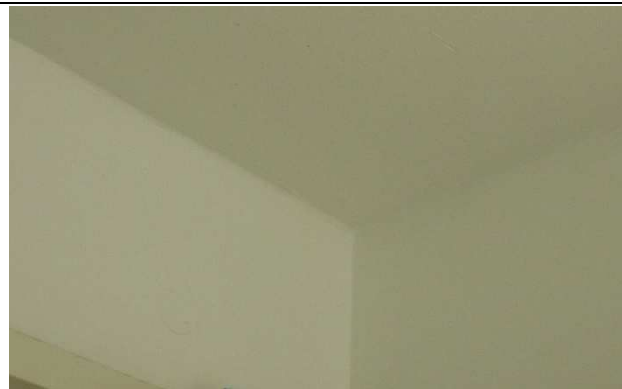
ROOM - OFFICE	494/11	INSPECTION DATE	21/09/2017
SCOPE	MASTIC JOINT INVESTIGATION		
SAMPLE	PICTURE 01		
No sample

RICS CONDITION RATING	VERTICAL	no	HORIZONTAL 2
<p>NOTE:</p> <p>SAMPLE - Sample taken from adjacent room (494/15).</p> <p>Picture 01 – The movement joints are not cracked and appear in good condition throughout.</p> <p>Pictures 02-03 – No movement joint found between partitions and external wall panel.</p>			
16mm MASTIC JOINT (length) m		11.75m

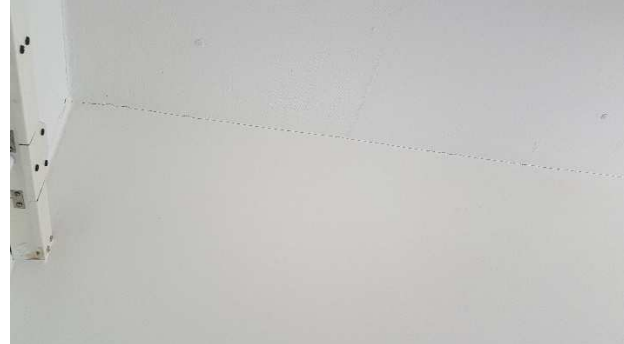
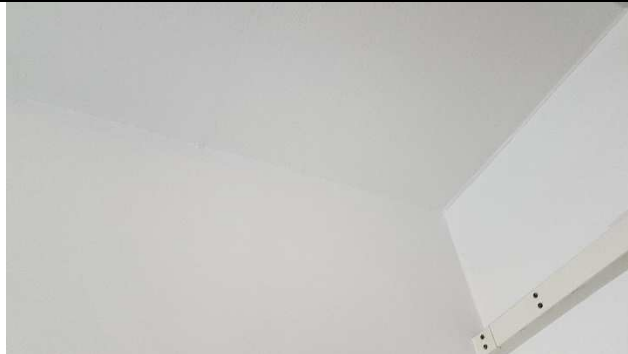
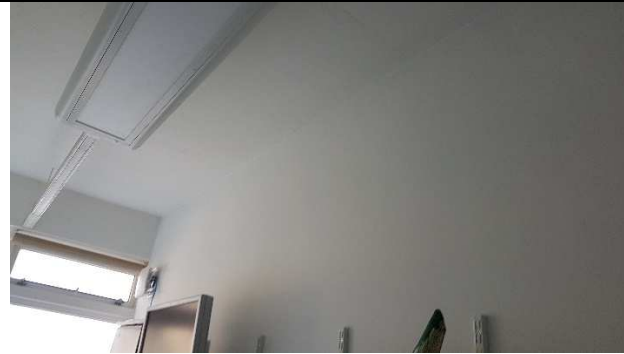
ROOM - OFFICE	494/13	INSPECTION DATE	21/09/2017	
SCOPE	MASTIC JOINT INVESTIGATION			
SAMPLE	PICTURE 01			
No sample

RICS CONDITION RATING	VERTICAL	no	HORIZONTAL	2
<p>NOTE:</p> <p>Picture 01 – No movement joint found on 494/11/494/13 partition.</p> <p>Picture 02 – The movement joints are not cracked and appear in good condition throughout.</p> <p>Pictures 03 – No movement joint found between partitions and external wall panel.</p>				
16mm MASTIC JOINT (length) m		11.80m

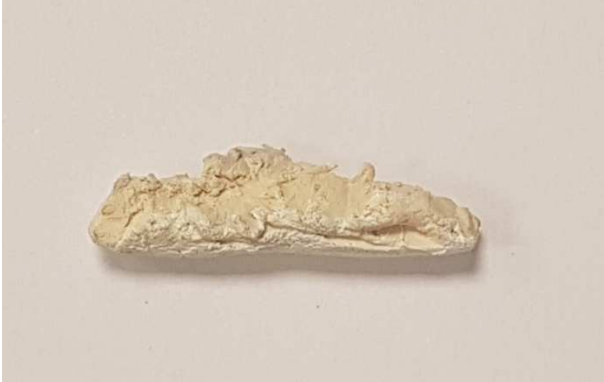
ROOM	494/14	INSPECTION DATE	21/09/2017
SCOPE	MASTIC JOINT INVESTIGATION		
SAMPLE	PICTURE 01

Not pictures		
PICTURE 02	PICTURE 03		
Not pictures	Not pictures		
RICS CONDITION RATING	VERTICAL	no	HORIZONTAL
			2
<p>NOTE:</p> <p>The movement joints are not cracked and appear in good condition throughout.</p> <p>No movement joint found between partitions and external wall panel.</p>			
16mm MASTIC JOINT (length) m		11.80m

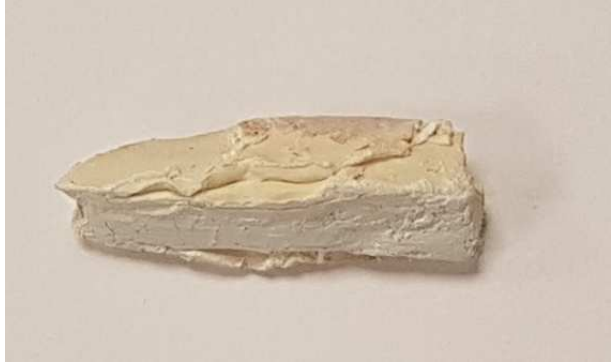
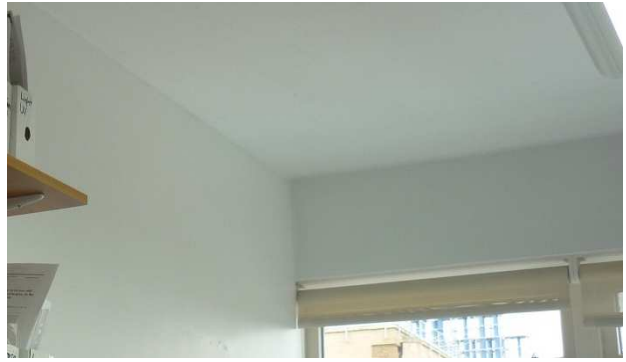
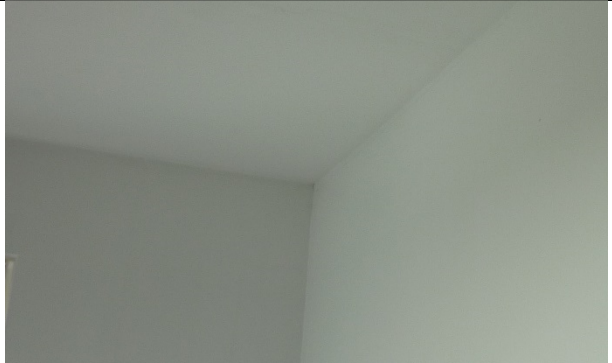
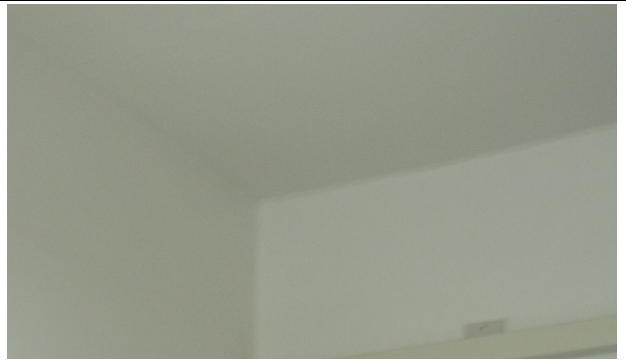
ROOM - OFFICE	494/15	INSPECTION DATE	21/09/2017	
SCOPE	MASTIC JOINT INVESTIGATION			
SAMPLE	PICTURE 01

RICS CONDITION RATING	VERTICAL	no	HORIZONTAL	2
<p>NOTE:</p> <p>SAMPLE - Mastic joint not dry or cracked; flexibility and plasticity of sealant maintained. The movement joint width is 16mm, white foam filler (Compriband) was found, and in good condition.</p> <p>Picture 01 – The movement joints are not cracked and appear in good condition throughout.</p> <p>Pictures 02-03 – Cracking located between partition and external wall panel. No movement joint found.</p>				
16mm MASTIC JOINT (length) m		11.70m

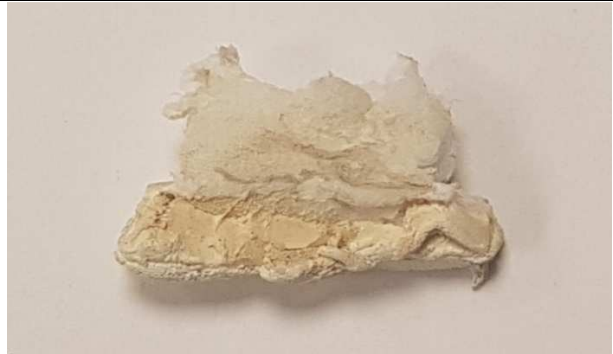
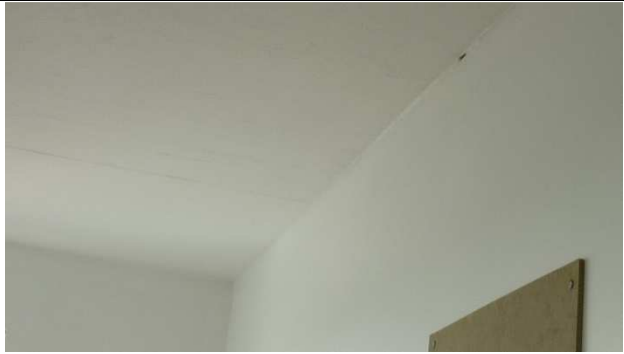
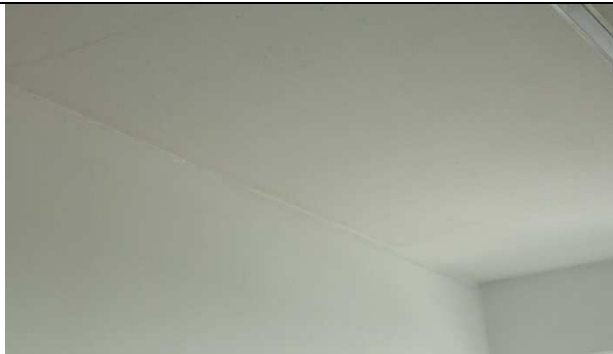
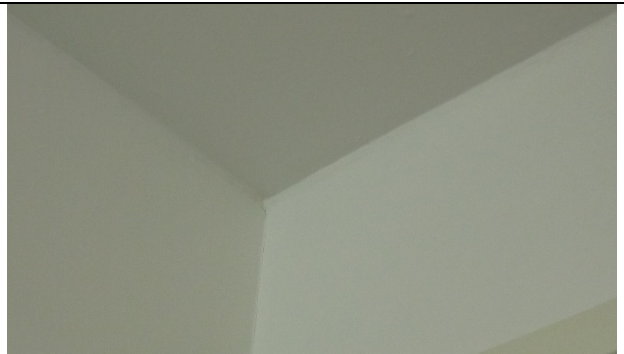
ROOM - OFFICE	494/16	INSPECTION DATE	21/09/2017	
SCOPE	MASTIC JOINT INVESTIGATION			
SAMPLE	PICTURE 01

RICS CONDITION RATING	VERTICAL	no	HORIZONTAL	2
<p>NOTE:</p> <p>SAMPLE - Mastic joint not dry or cracked; flexibility and plasticity of sealant maintained. The movement joint width is 16mm, white foam filler (Compriband) was found, and in good condition.</p> <p>Picture 01 – The movement joints are not cracked and appear in good condition throughout.</p> <p>Pictures 02-03 – Cracking located between partition and external wall panel. No movement joint found.</p>				
16mm MASTIC JOINT (length) m		15.10m

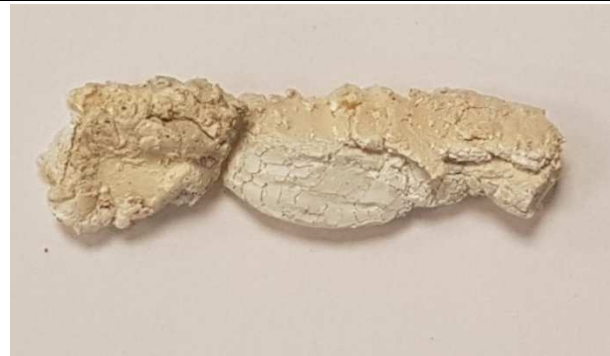
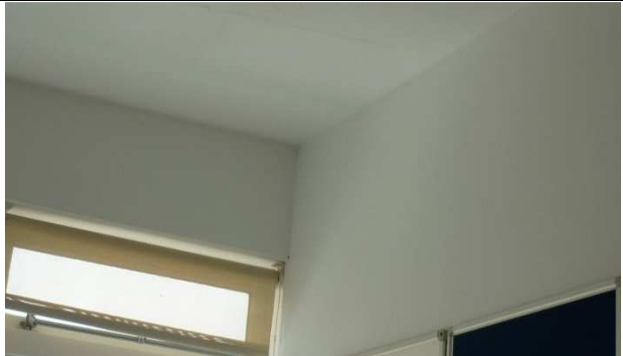
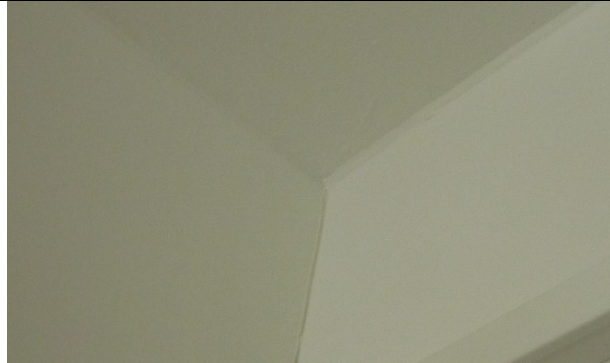
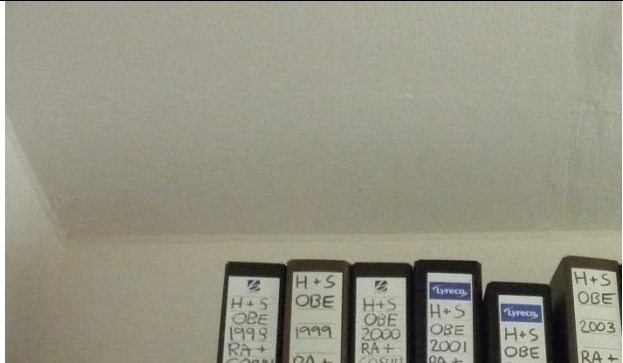
ROOM	494/17	INSPECTION DATE	21/09/2017	
SCOPE	MASTIC JOINT INVESTIGATION			
SAMPLE	PICTURE 01

RICS CONDITION RATING	VERTICAL	no	HORIZONTAL	2
NOTE: SAMPLE - Mastic joint not dry or cracked; flexibility and plasticity of sealant maintained. The movement joint width has been reduced (from expected 16mm), white foam filler (Compriband?) not found. Picture 01– No movement joint found between partition and external wall panel. Pictures 02-03 – The movement joints are not cracked and appear in good condition throughout.				
16mm MASTIC JOINT (length) m		11.70m

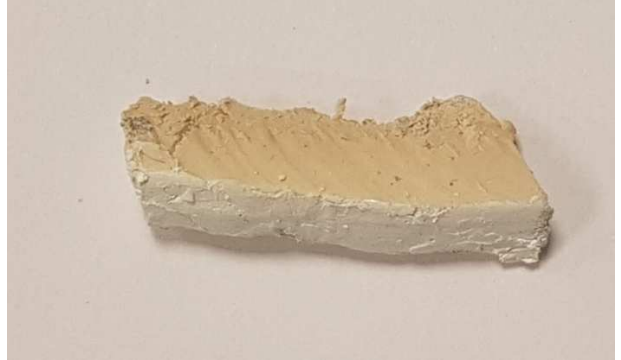
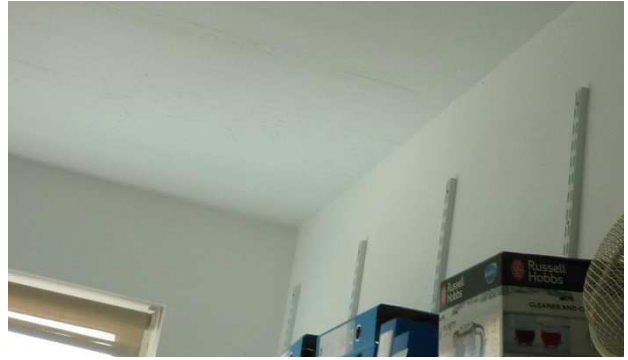
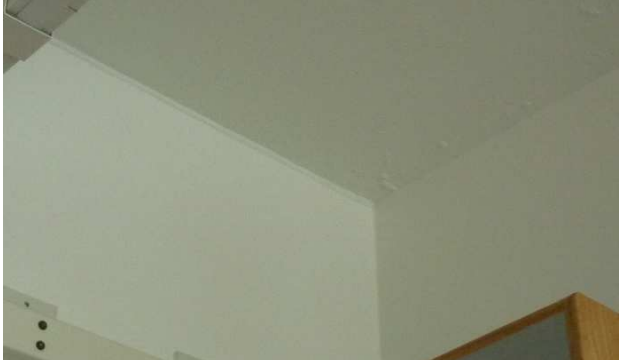
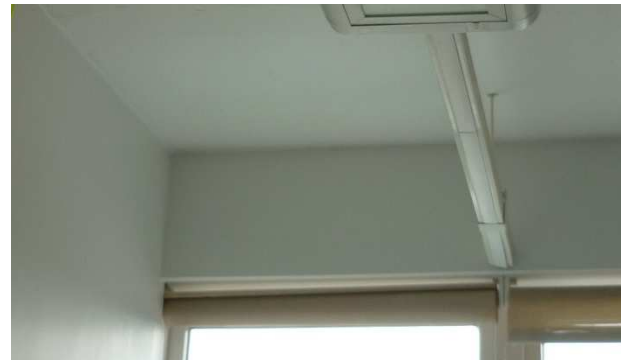
ROOM - OFFICE	494/19	INSPECTION DATE	21/09/2017	
SCOPE	MASTIC JOINT INVESTIGATION			
SAMPLE	PICTURE 01

RICS CONDITION RATING	VERTICAL	no	HORIZONTAL	2
<p>NOTE:</p> <p>SAMPLE - Mastic joint not dry or cracked; flexibility and plasticity of sealant maintained. The movement joint width is 16mm, white foam filler (Compriband) was found, and in good condition.</p> <p>Picture 01 – The movement joints are not cracked and appear in good condition throughout.</p> <p>Pictures 02-03 – No movement joint found between partition and external wall panel.</p>				
16mm MASTIC JOINT (length) m		11.35m

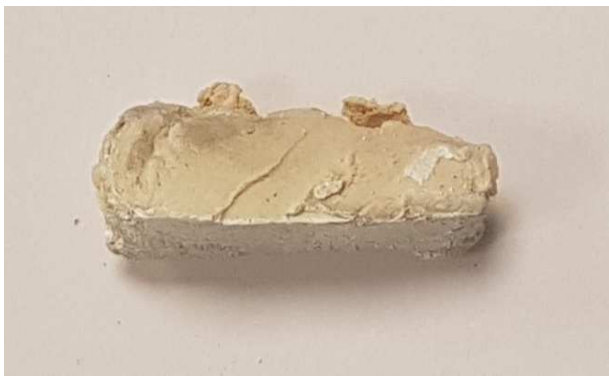
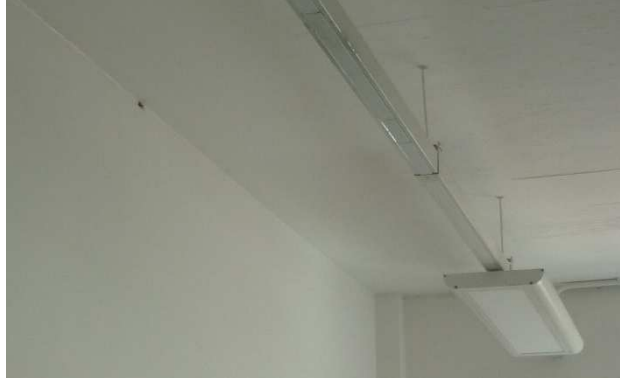
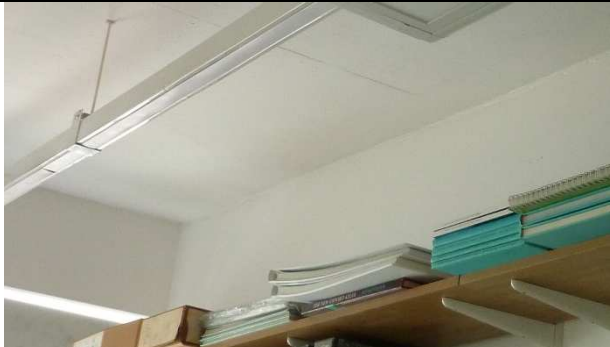
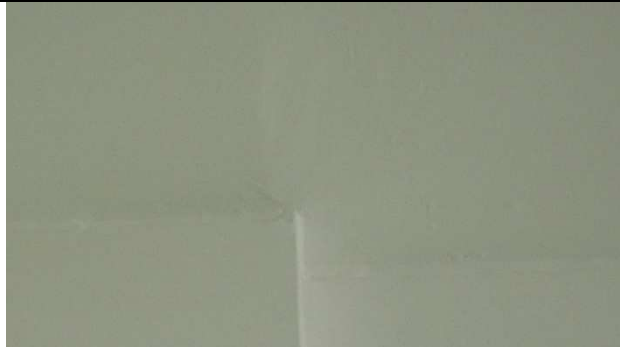
ROOM - OFFICE	494/20	INSPECTION DATE	21/09/2017	
SCOPE	MASTIC JOINT INVESTIGATION			
SAMPLE	PICTURE 01

RICS CONDITION RATING	VERTICAL	no	HORIZONTAL	2
<p>NOTE:</p> <p>SAMPLE - Mastic joint not dry or cracked; flexibility and plasticity of sealant maintained. The movement joint width is 16mm, white foam filler (Compriband) was found, and in good condition.</p> <p>Picture 01 – The movement joints are not cracked and appear in good condition throughout.</p> <p>Pictures 02-03 – No movement joint found between partition and external wall panel.</p>				
16mm MASTIC JOINT (length) m		15.50m

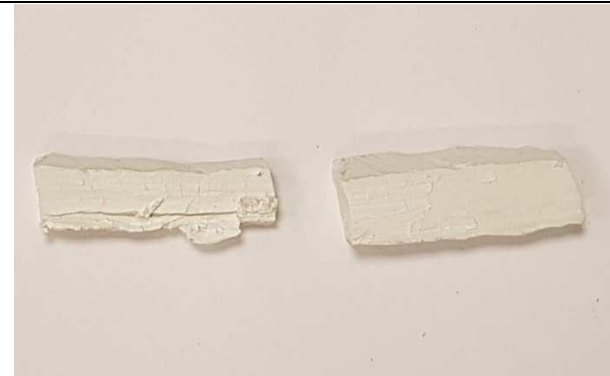
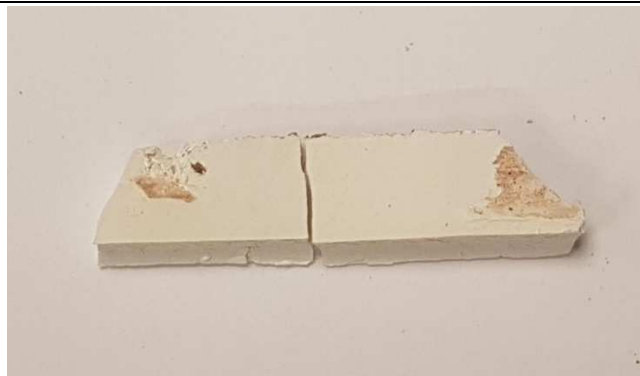
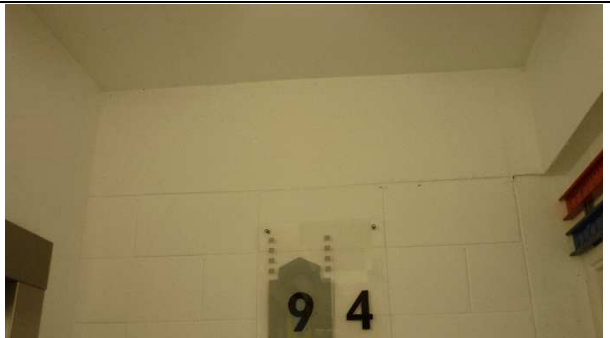
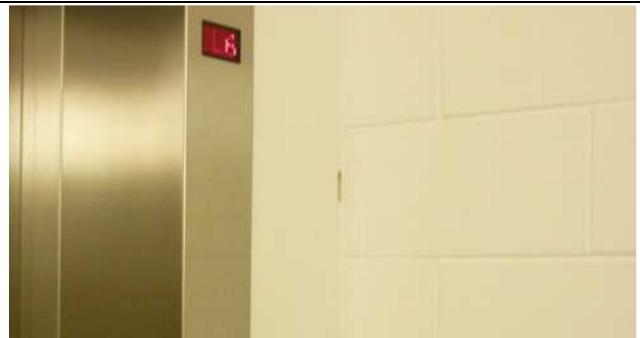
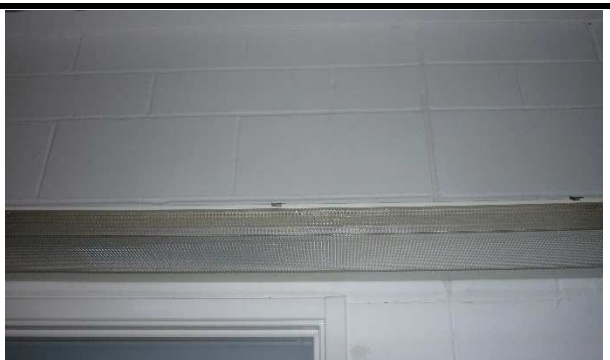
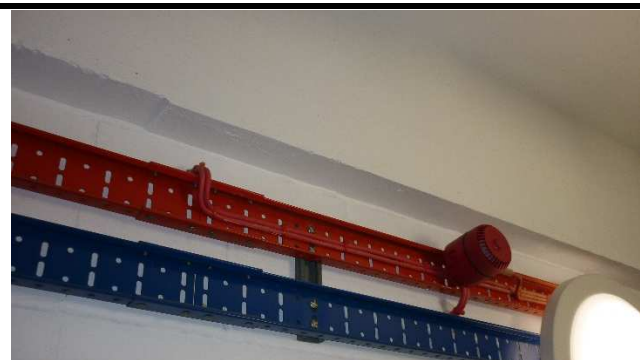
ROOM - CORRIDOR	494/100	INSPECTION DATE	21/09/2017	
SCOPE	MASTIC JOINT INVESTIGATION			
CEILING SAMPLES		WALL SAMPLE

RICS CONDITION RATING	VERTICAL	2	HORIZONTAL	2
<p>NOTE:</p> <p>CEILING SAMPLE - Mastic joint not dry or cracked; flexibility and plasticity of sealant maintained. The movement joint width is 16mm, white foam filler (Compriband) was found, and in good condition.</p> <p>WALL SAMPLE - Mastic joint not dry or cracked; flexibility and plasticity of sealant maintained. The movement joint width is 16mm, white foam filler (Compriband) was not found.</p> <p>Pictures 01/02/03/04 – Horizontal and vertical movement joints are not cracked and appear in good condition throughout.</p>				
16mm MASTIC JOINT (length) m		55.65m

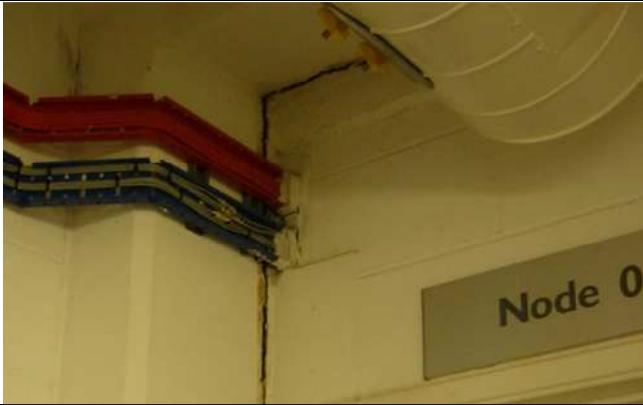
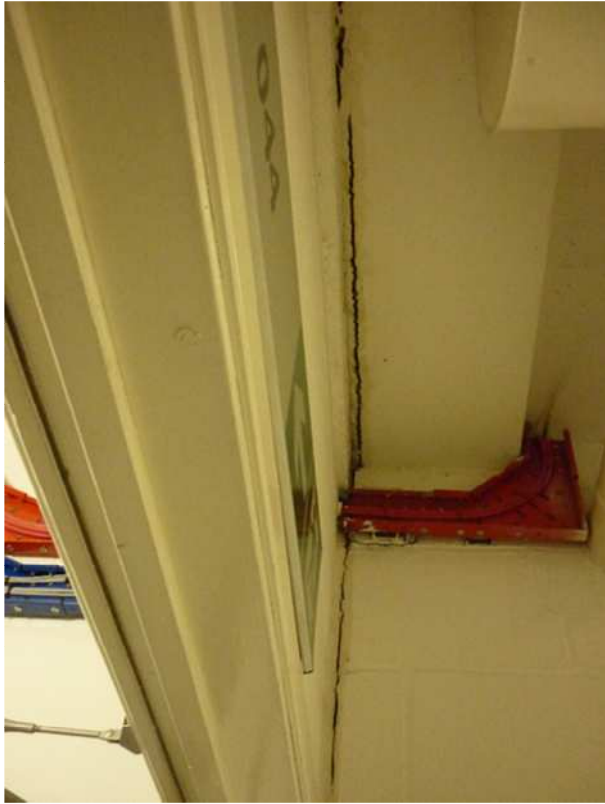
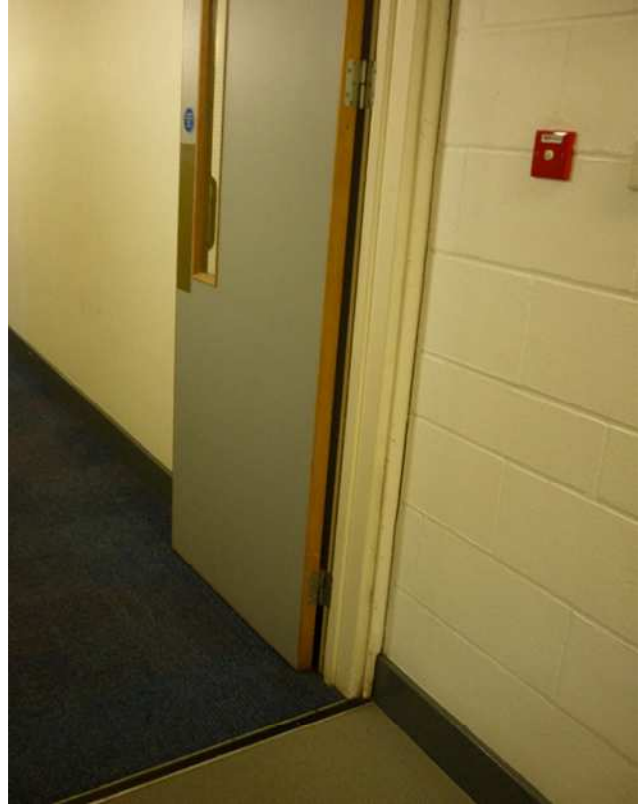
ROOM - CORRIDOR	494/101	INSPECTION DATE	21/09/2017
SCOPE	MASTIC JOINT INVESTIGATION		
SAMPLES	PICTURE 01		
No sample

RICS CONDITION RATING	VERTICAL	3	HORIZONTAL 3
<p>NOTE: SAMPLE; no sample has been taken.</p> <p>Pictures 01/02/03/ – Mastic joints in the corridor at the junction of Node 9 and Node 4 form a primary movement joint for the main structural concrete frame and are in very poor condition throughout. To be completely replaced.</p>			
16mm MASTIC JOINT (length) m	56.65m

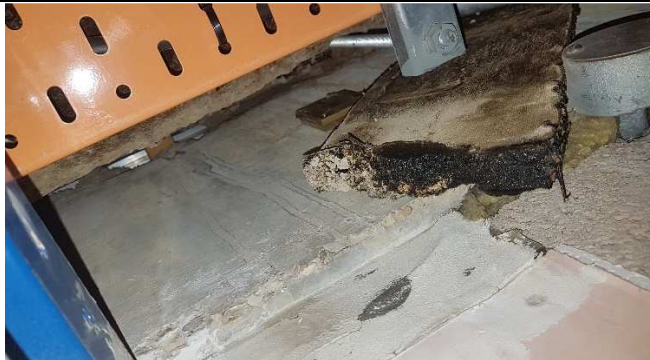
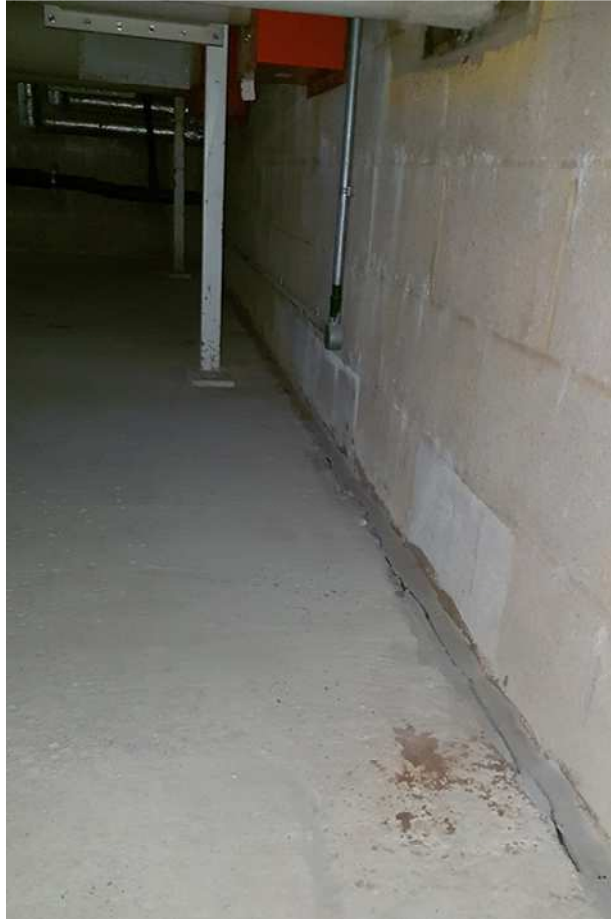
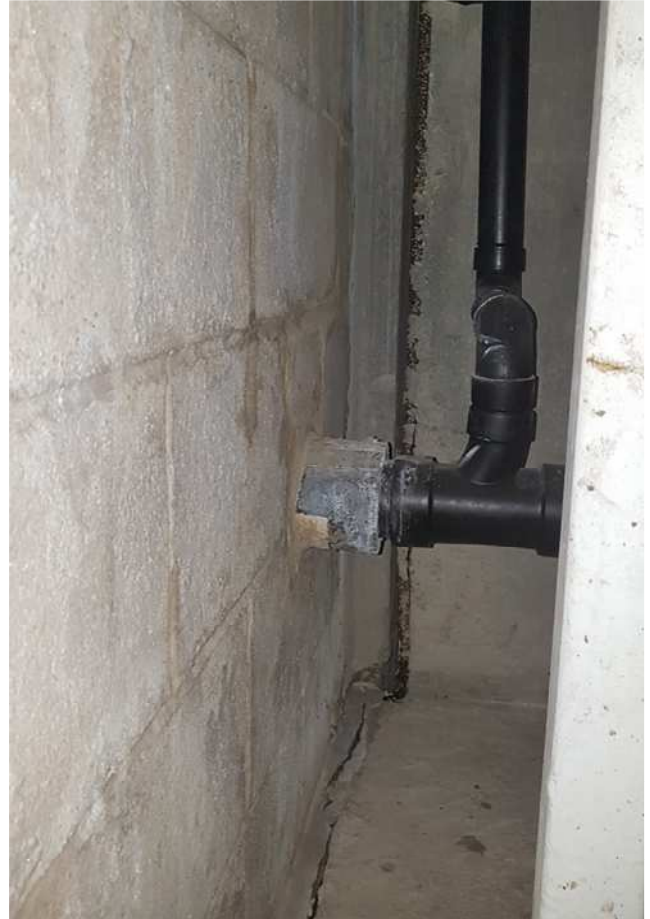
ROOM - MEDA		493/100		INSPECTION DATE		21/09/2017			
SCOPE		MASTIC JOINT INVESTIGATION							
SAMPLES				PICTURE 01					
No sample

RICS CONDITION RATING		VERTICAL		3		HORIZONTAL		3	
NOTE: SAMPLE; no sample has been taken.									
Pictures 01/02/03/ – Mastic joints at level 3 MEDA at the junction of Node 9 and Node 4 form a primary movement joint for the main structural concrete frame and are in very poor condition throughout. To be completely replaced.									
MASTIC JOINT (length) m				33.40m

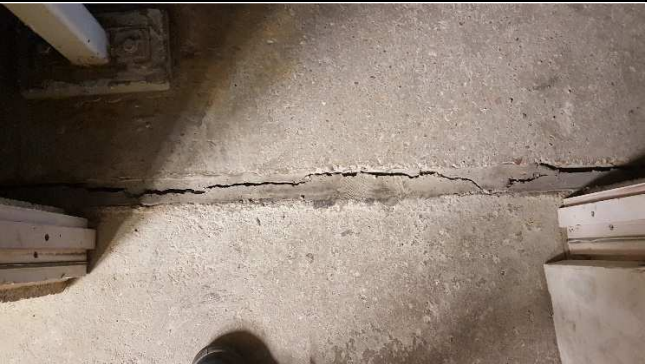
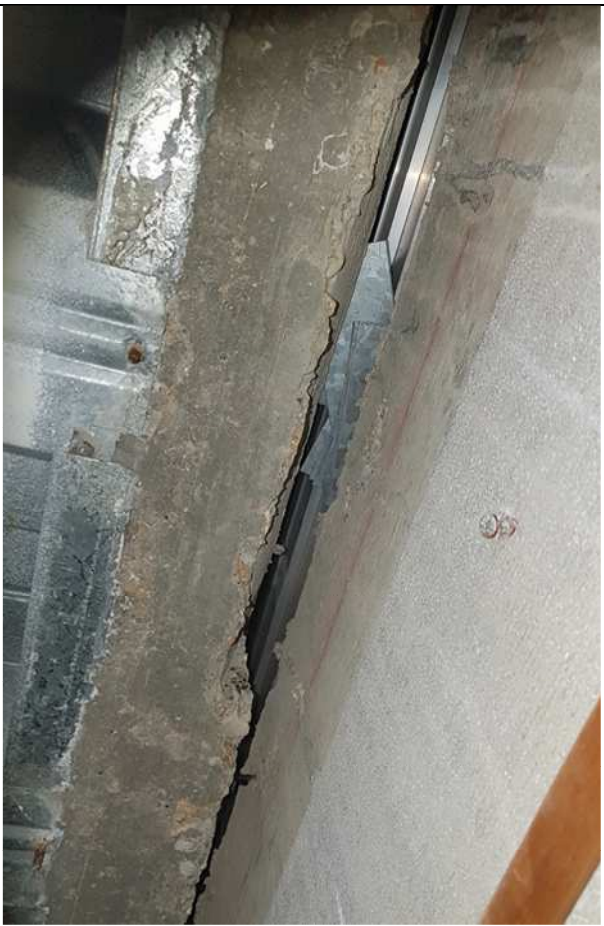
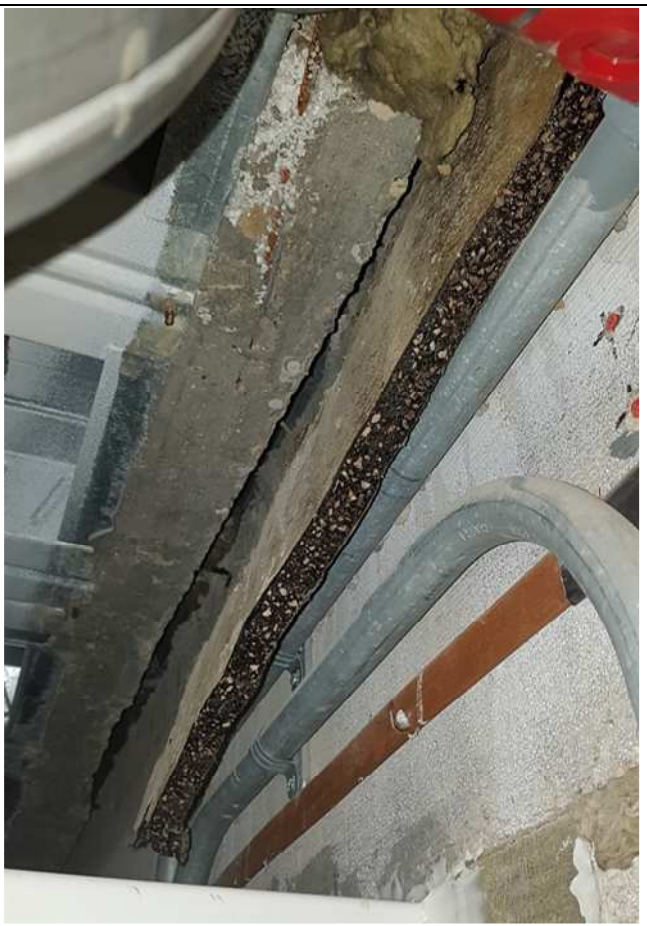
ROOM - MEDA	495/100	INSPECTION DATE	21/09/2017
SCOPE	MASTIC JOINT INVESTIGATION		
SAMPLES No sample	PICTURE 01

RICS CONDITION RATING	VERTICAL	3	HORIZONTAL 3
<p>NOTE:</p> <p>SAMPLE; no sample has been taken.</p> <p>Pictures 01/02/03/ – Mastic joints at level 5 MEDA at the junction of Node 9 and Node 4 form a primary movement joint for the main structural concrete frame and are in very poor condition throughout. To be completely replaced.</p>			
MASTIC JOINT (length) m		33.40m
