Ashton Consulting Engineers

ST JAMES CHURCH BOUNDARY WALL, LITTLE PAXTON

SCHEDULE OF CONDITION

PROPERTY: ST JAMES CHURCH BOUNDARY WALL

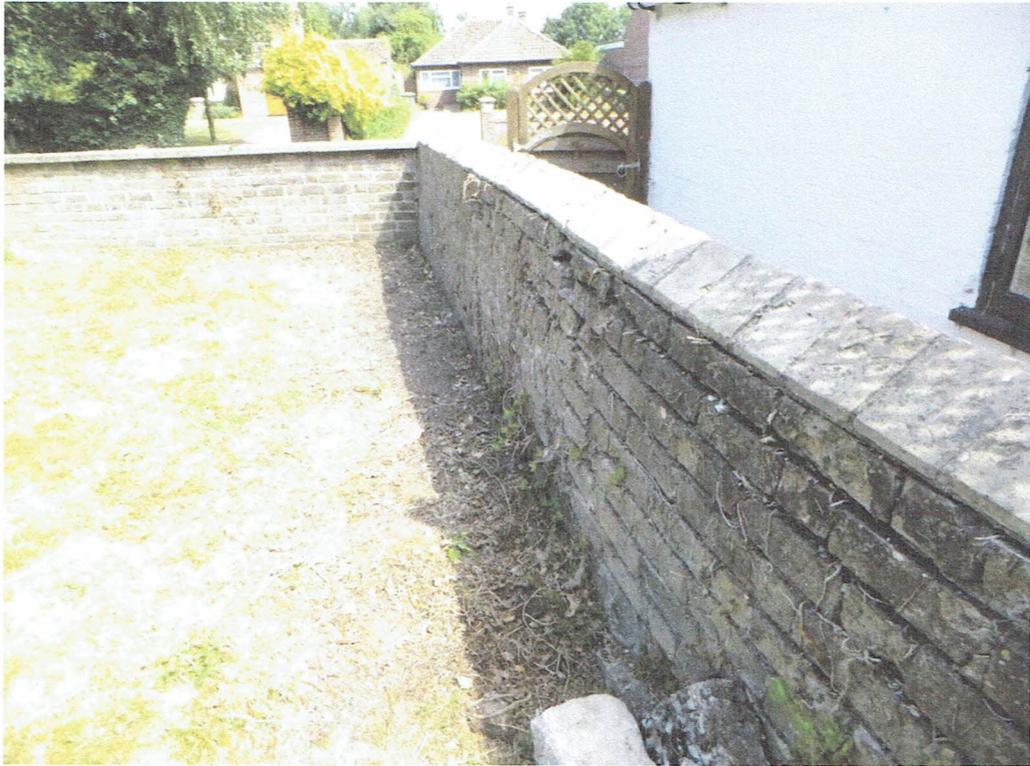
Photo No.1: Section 1 of the wall

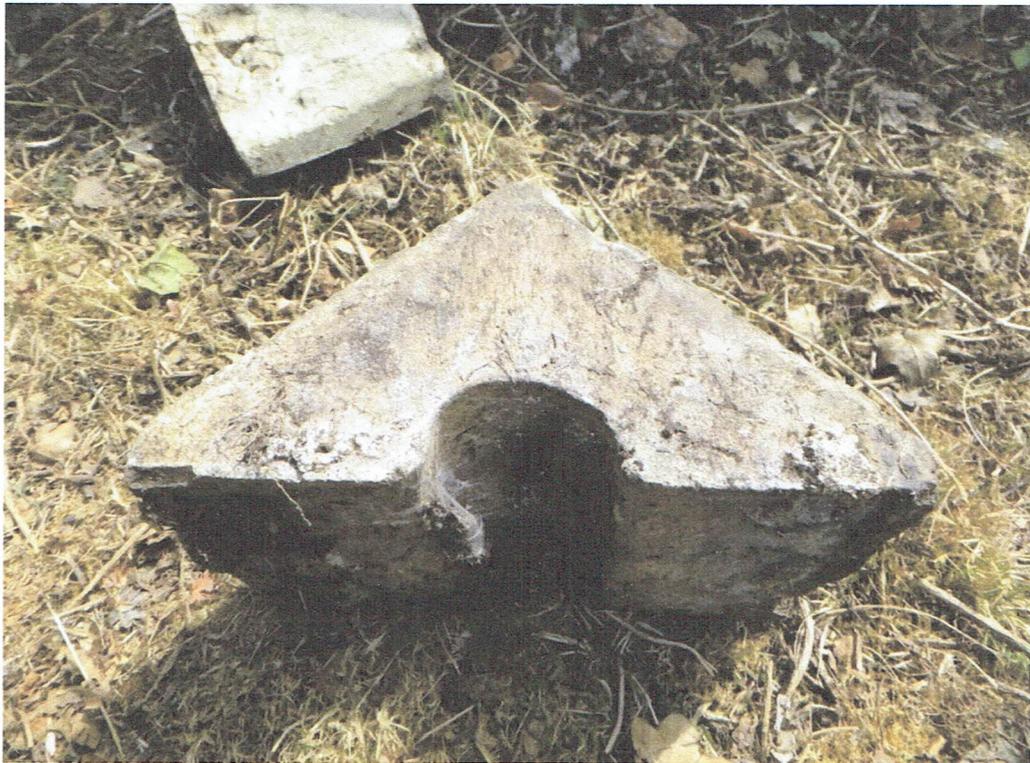
Photo No.2: Close up of wall coping brick

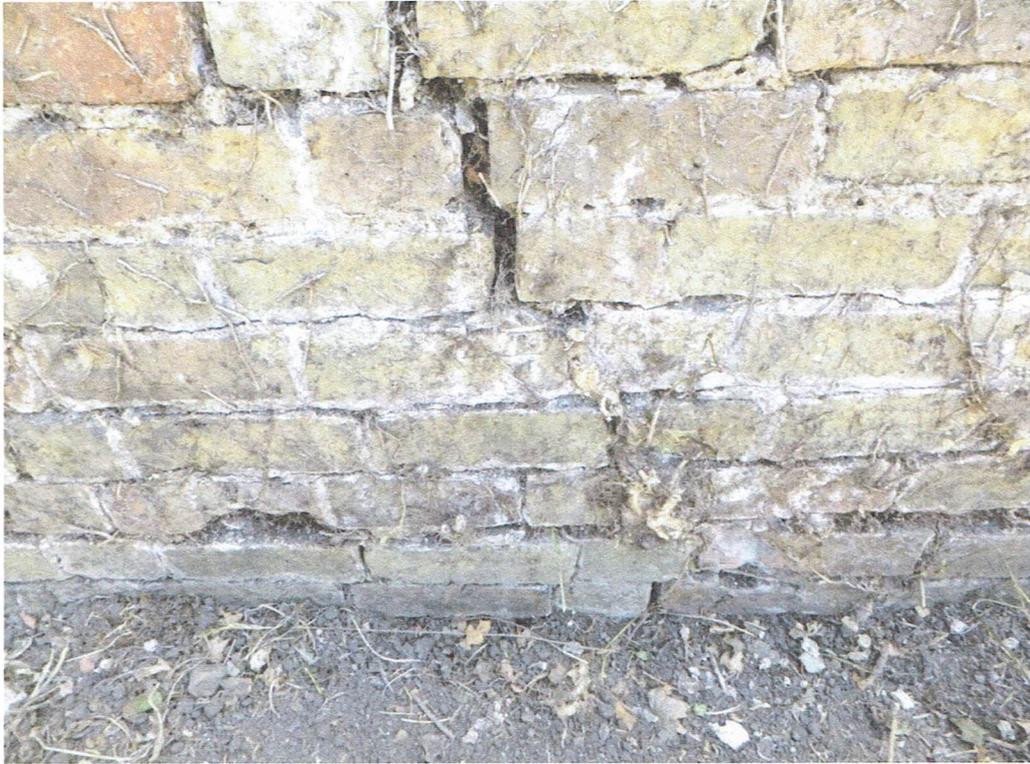
LOCATION	DESCRIPTION	COMMENT/ DEFECT
Section 1 (Front to 1st Timber Post of Trellis)	Refer to Report	<ul style="list-style-type: none"> - diagonal crack over full height of wall in mortar joints up to 20mm wide - loose coping bricks - five weathered bricks require replacement - ivy roots and stems in wall should be removed - areas of open and loose mortar joints - approximately 50mm lean of wall away from the Church
Section 2 (1st to 3rd Timber Post)	Refer to Report	<ul style="list-style-type: none"> - max lean is 15mm - four badly weathered bricks require replacement - one badly weathered wide coping brick could be replaced - ivy stems and roots remain in wall and should be removed - areas of open and loose mortar joints
Section 3 (3 rd to 6 th Timber Post)	Refer to Report	<ul style="list-style-type: none"> - max lean of wall is 100mm towards the Church - some burial stones are covering the base of the wall so it was not possible to inspect the wall behind these stones - eight badly weathered bricks - ivy stem and roots in wall - areas of open and loose mortar joints - an approximate length of 5.0 m of this wall should be re-built

Photo No.3: Crack in Section 1 with ivy stems and roots

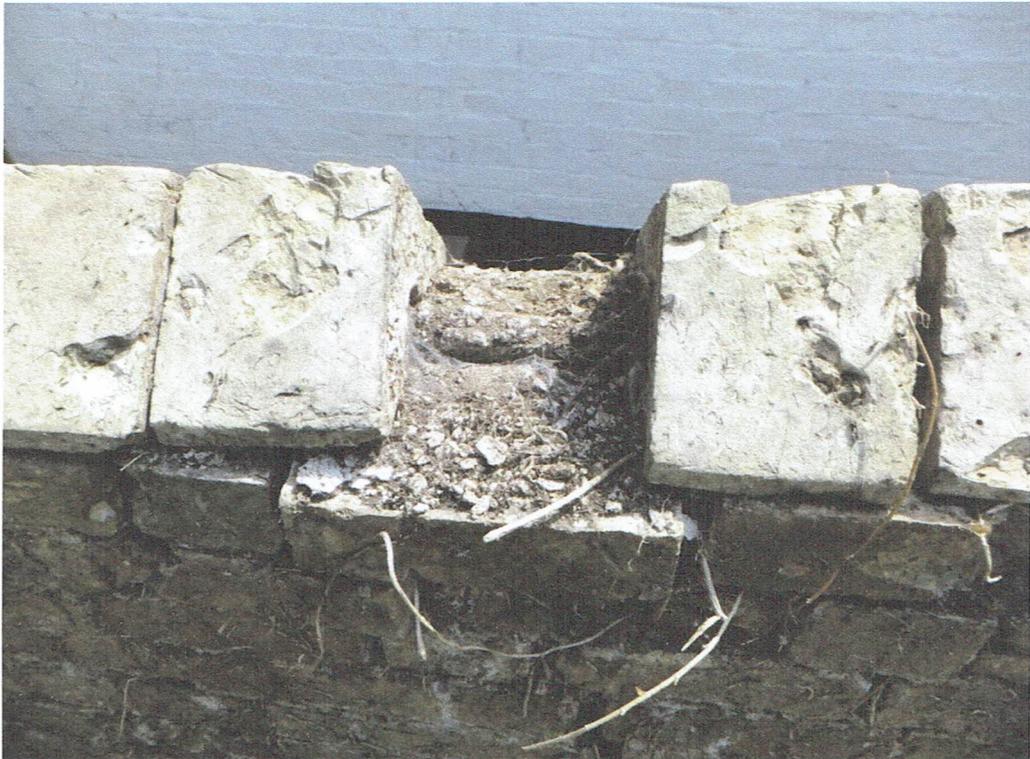
Photo No.4: Loose coping bricks in Section 1

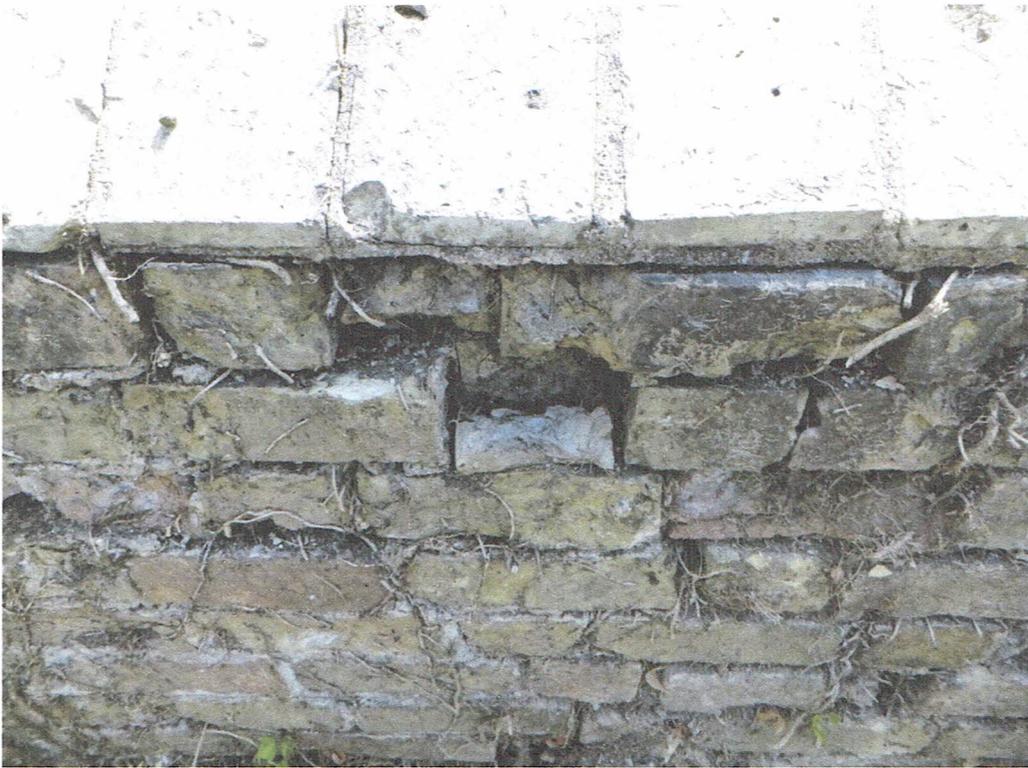
Photo No.5: Weathered bricks in Section 1

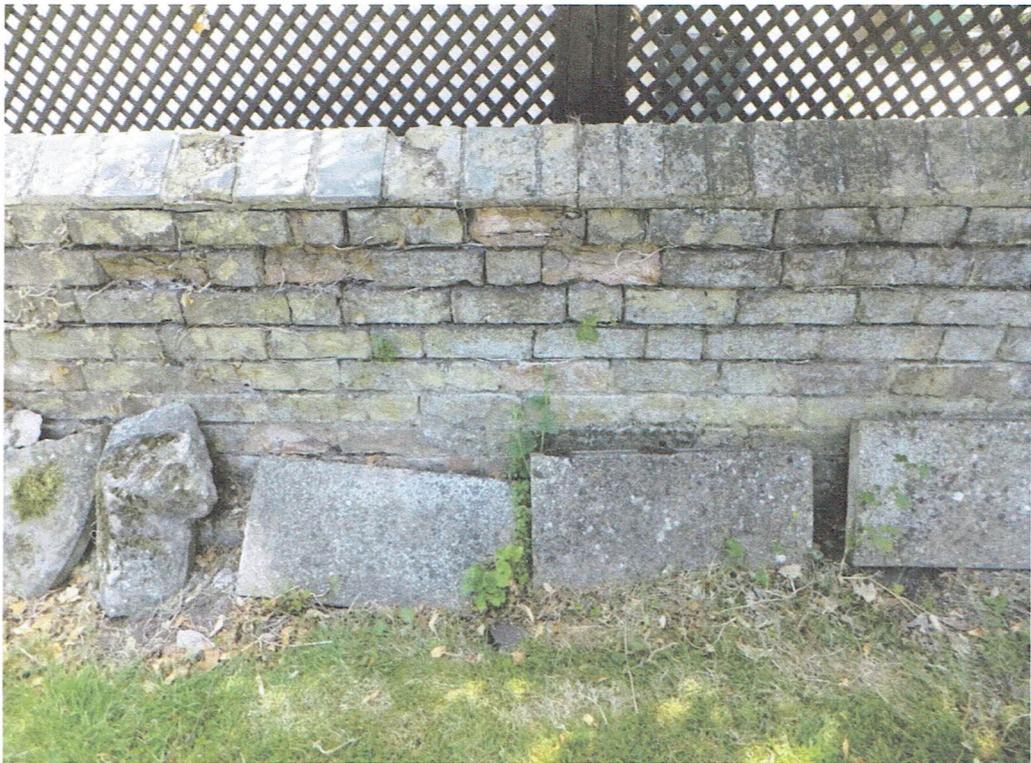
Photo No.6: Badly weathered coping bricks and mortar missing under bricks

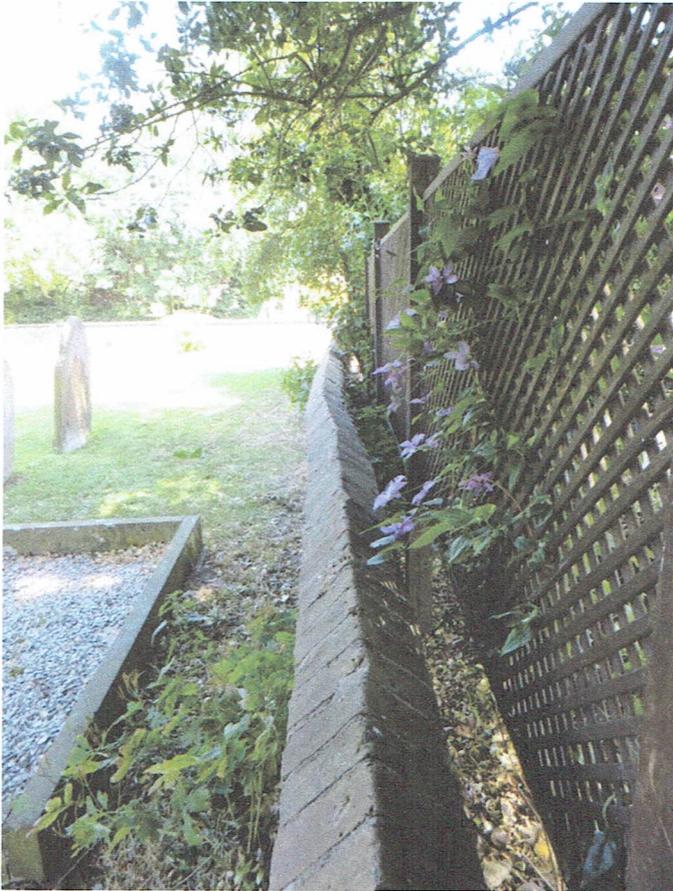
Photo No.7: Leaning wall in Section 3

The worst leaning in the wall is in Section 3 where the top of the wall is leaning approximately 100mm towards the church and it is recommended that a length of about 5.0 metres of the wall is carefully taken down and rebuilt using the reclaimed bricks and a suitable lime-based mortar to match the original mortar in the wall. Samples of mortar mixes should be made by an experienced brick-layer to with a variety of sands and hydraulic lime:sand mix ratios to identify the most appropriate mix.

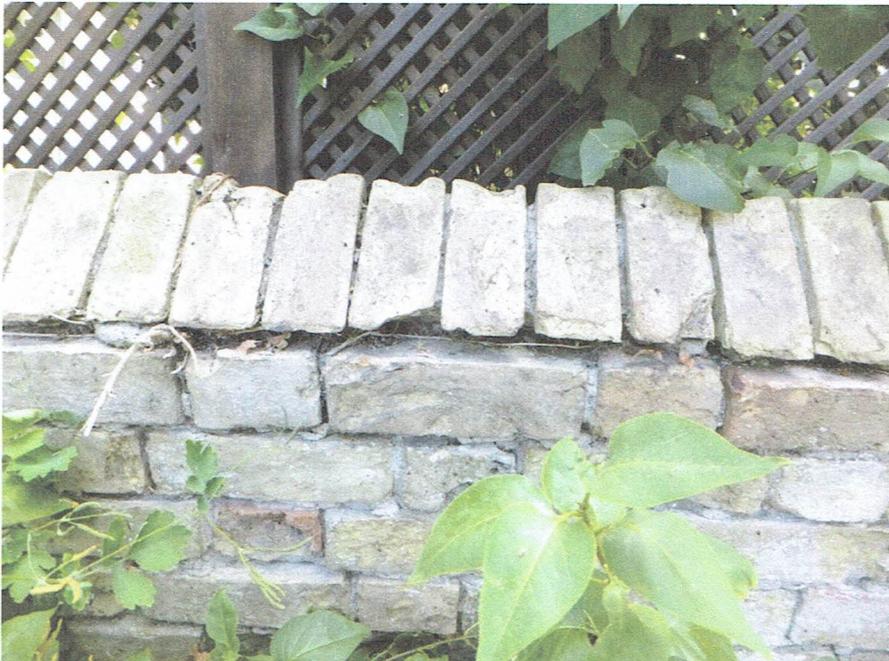
Photo No.8: Weathered coping bricks and mortar missing under bricks in Section 3

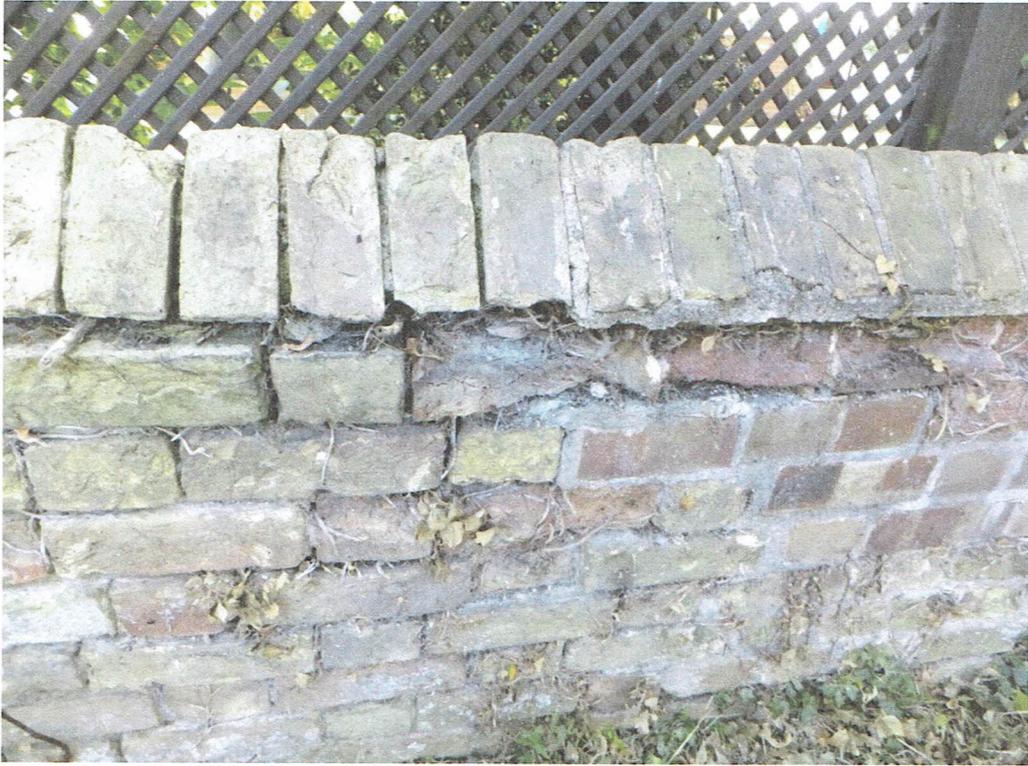
Photo No.9: Open joints in Section 3 from ivy growth

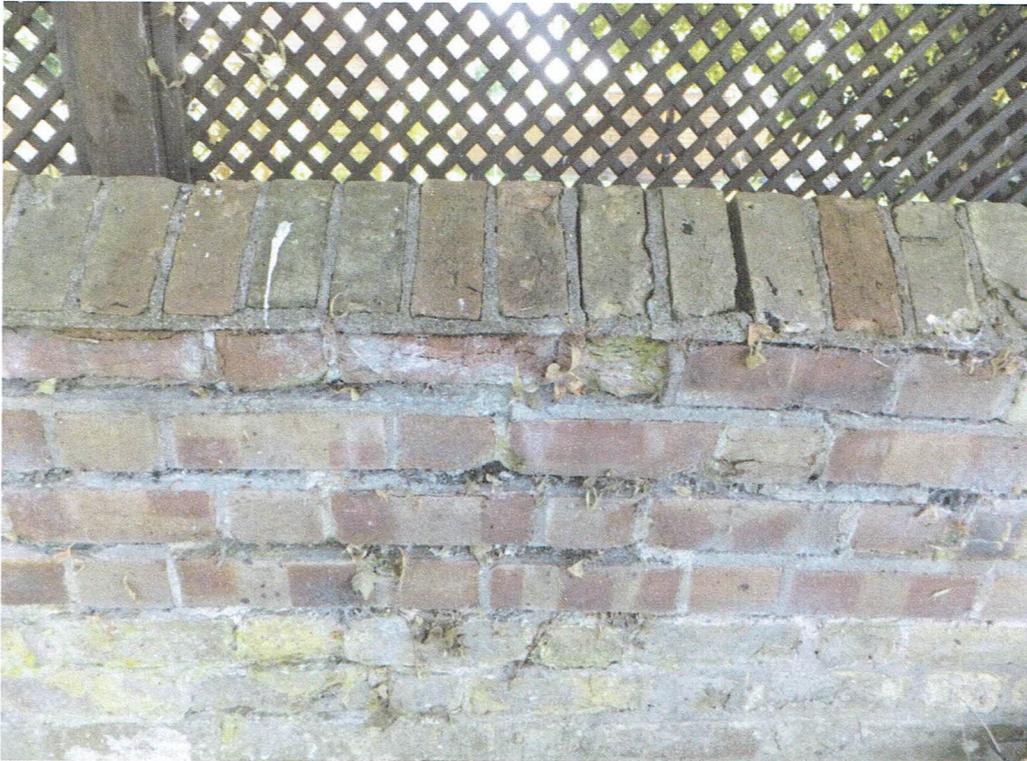
Section 4 (6 th Timber Post to Large Tree)	Refer to Report	<ul style="list-style-type: none"> - height of the wall at the tree is 730mm on both sides of the wall - max lean occurs near the tree and is 30mm towards the Church - approximately 12 bricks are badly weathered and require replacement - coping brickwork has some small gaps in the mortar which should be filled

Photo No.10: Open joint in coping brickwork in Section 4

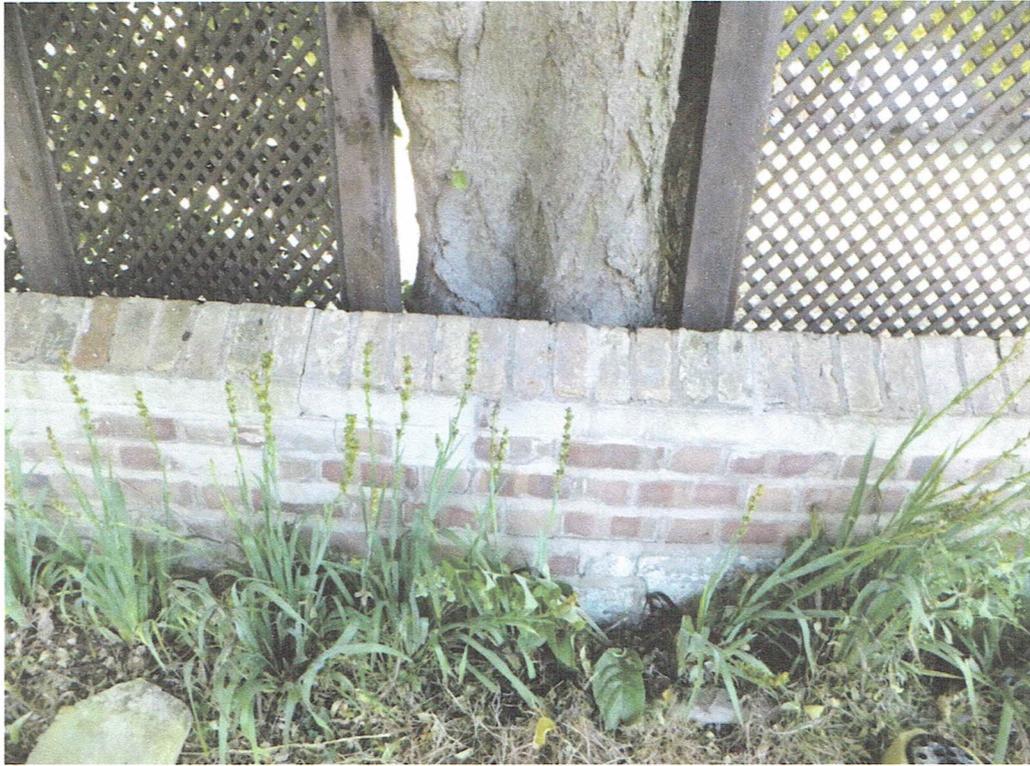
LOCATION	DESCRIPTION	COMMENT/ DEFECT
Section 4, continued	Refer to Report	<ul style="list-style-type: none"> - the wall near the tree has been re-built over an area of about 5m and re-pointed with a cement rich mortar - recent cracking has occurred on the wall from the growth of the base of the tree - the wall should be re-built across the width of the tree to prevent further damage to the wall - ivy stem and roots in wall - areas of open and loose mortar joints
Section 5 (Large Tree and next three Fence Panels)	Refer to Report	<ul style="list-style-type: none"> - open gaps in coping bricks - max lean is 20mm towards the Church - approximately 15 red bricks near the top of the wall are badly weathered and require replacement - loose and open mortar joints - ivy stems and roots in wall should be removed
Section 6 (Last section of wall up to Pier)	<p>Refer to Report</p> <p>Pier is 360mm wide and projects 120mm from the face of the wall.</p>	<ul style="list-style-type: none"> - max lean is 20mm towards the Church - five badly weathered bricks should be replaced - gaps in coping bricks should be filled - cracked coping brick should be replaced - mortar haunch on pier is loose and should be either re-done or replaced with matching bricks laid on edge - two loose sections of coping bricks near pier need to be re-laid on fresh mortar - some loose bricks under the coping should also be re-laid - loose and open mortar joints - ivy stems and roots in wall should be removed

Photo No.11: Cracking in wall near large tree in rebuilt length of wall

The wall near the large tree has been re-built in the past and new cracking has since occurred from the ongoing growth of the tree truck. It is recommended that a short length of wall is rebuilt as a semi-circle around the tree truck as shown on Page Nos.1 and 2 in Appendix 3. The existing footing should be removed near the tree to give a 200mm clear gap between the tree truck and the wall for the future growth of the tree. The existing bricks should be reclaimed and reused with mortar as described above.

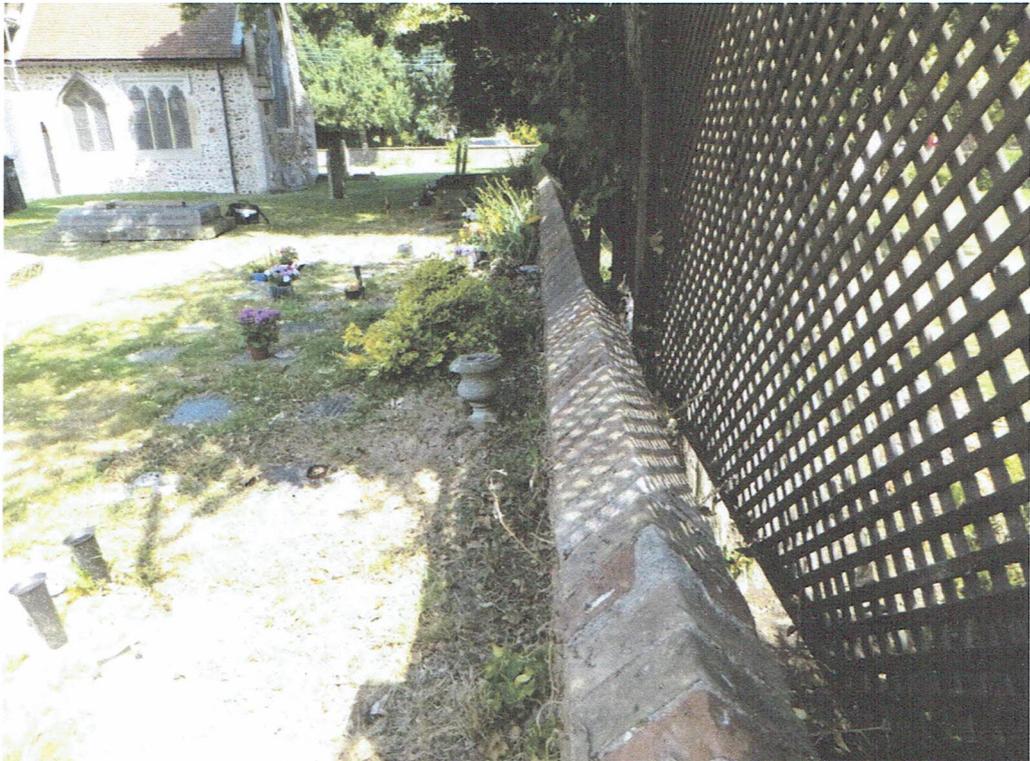
Photo No.12: Wall in Section 5

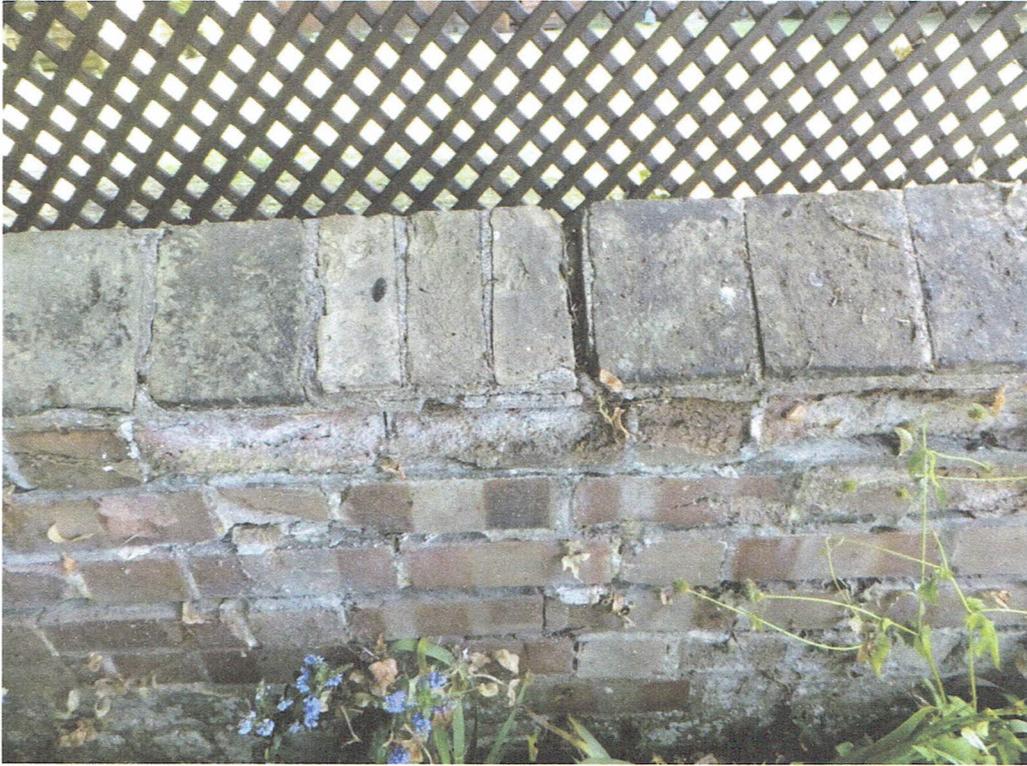
Photo No.13: Open joint in coping in Section 5

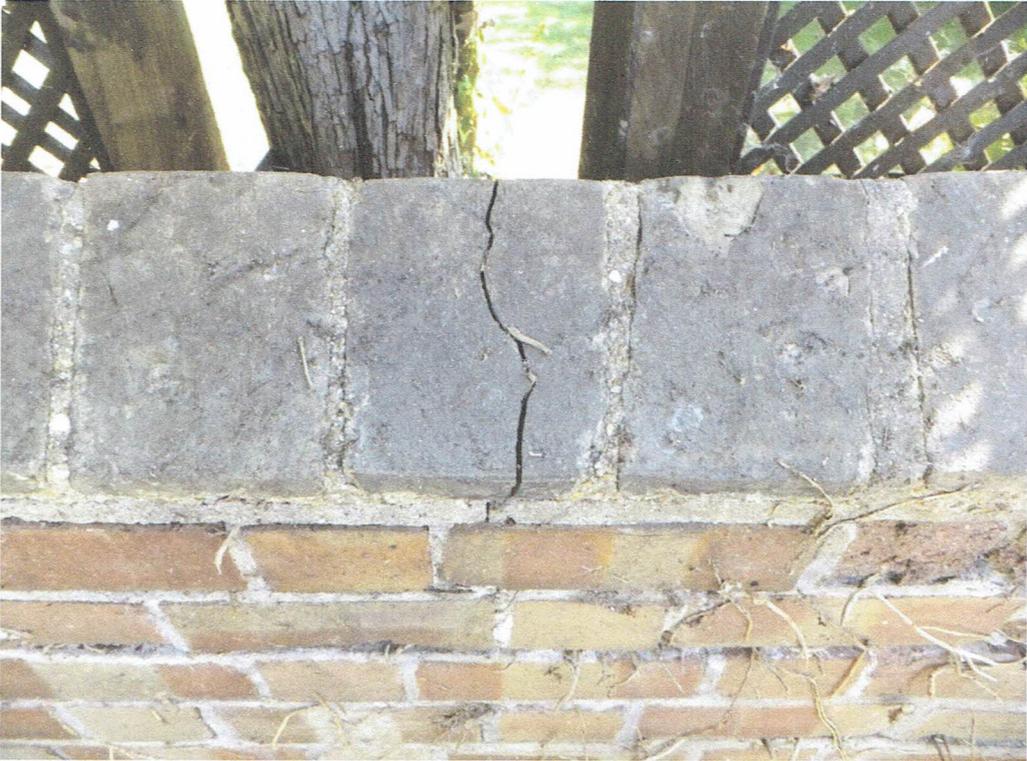
Photo No.14: Cracked coping brick in Section 6

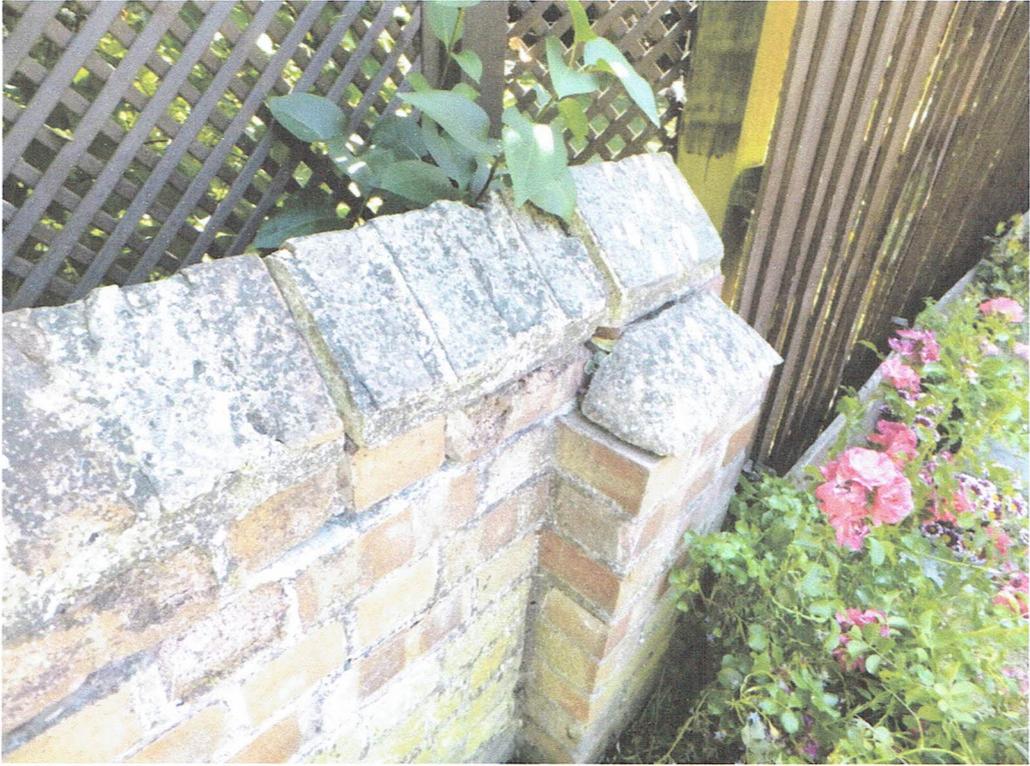
Photo No.15: Loose coping bricks and mortar haunching on pier at the end of the wall

I also recommend general repairs to the wall including: the removal of all the ivy and weeds; replacement of badly weathered bricks with matching bricks; re-laying of loose bricks; and re-pointing of loose and open joints with a suitable lime based mortar. The loose mortar haunch at the end pier should be replaced with either a new haunch or bricks laid on edge.
