**PD38/20**  
**Asbestos R&D Survey**

**IT Support Office, City College Plymouth**  
Kings Road, Plymouth, Devon.

By Mr P. Davies  
Of  
Applecliff Ltd

27/04/2020

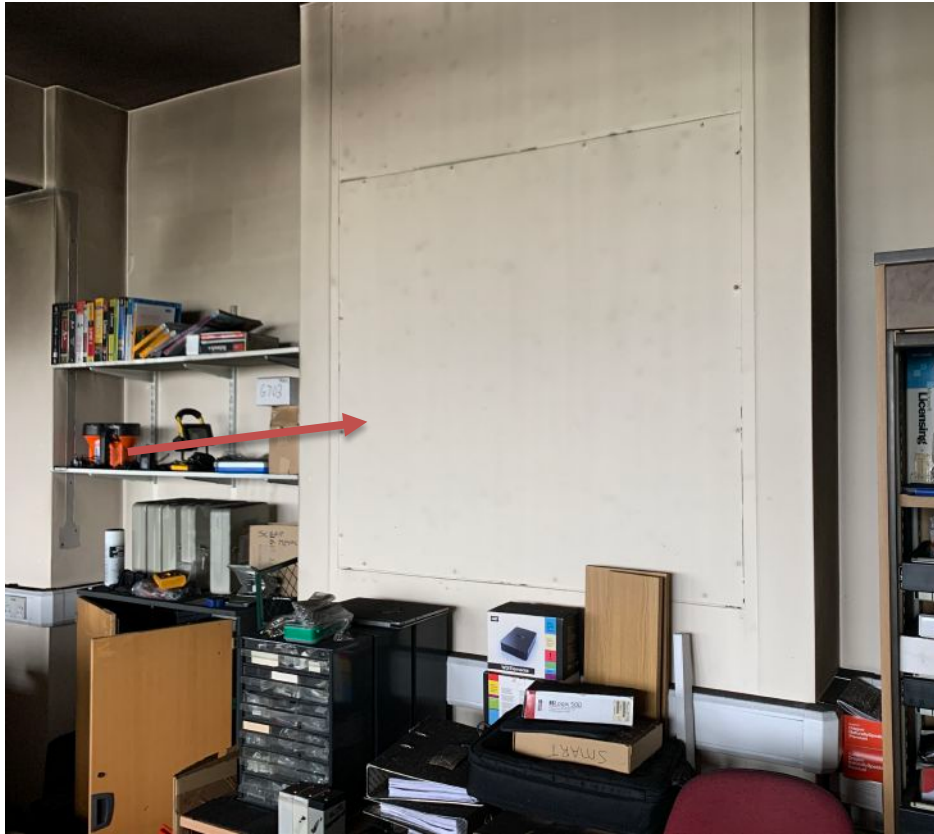
Photo 01

- Boxed service riser in room K702

| Plan Ref | Floor | Room | Location | Material | Quantity | Photo No. | Sampled | Condition | Risk | Comments |
|---|---|---|---|---|---|---|---|---|---|---|
| 7F04 | Seven | K702 | Riser Boxing | No Access Within | Unknown | 01 | Presumed | Good | Very Low | No Access. Outside scope of works. Refer to Recommendations |

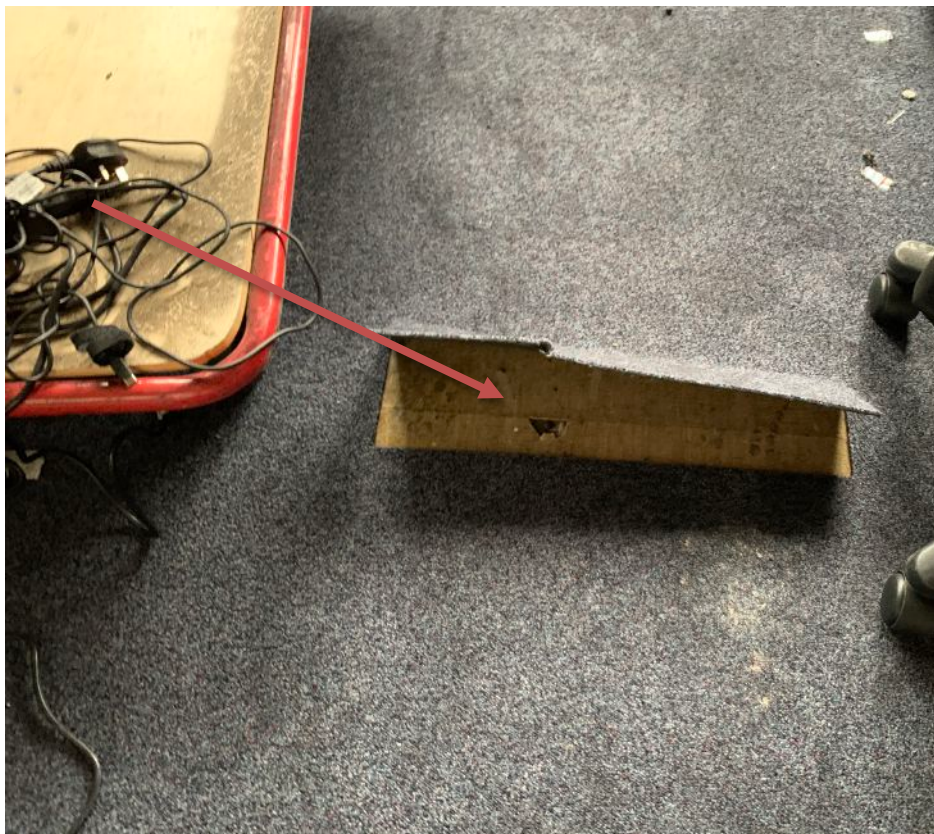
Photo 02

| SSL Number | Client Sample Number | Sample Type | Sample Details | Asbestos Type(s) Present |
|---|---|---|---|---|
| BS179335 | B270420/01 | Vinyl | Lino, Room K702, Floor Below Carpet | No Asbestos Detected |

| Plan Ref | Floor | Room | Location | Material | Quantity | Photo No. | Sampled | Condition | Risk | Comments |
|---|---|---|---|---|---|---|---|---|---|---|
| 7F04 | Seven | K702 | Floor below carpet | Lino | | 02 | PD27042<br>0/01 | | | No Asbestos Detected In Sample (N.A.D.I.S.) No Further Action Required |
