Lodge Park Sports Centre

Condition Survey Report

Client	Lodge Park Sports Centre 134-148 Shetland Way Corby NN17 2SG			
Project	Artificial Turf Pitch (ATP) Refurbishment			
SSL project code	SSL2593			
Document title	Condition Survey Report			
Document control	Revision	By	Checked	Date
	First Issue	NM		26.11.18

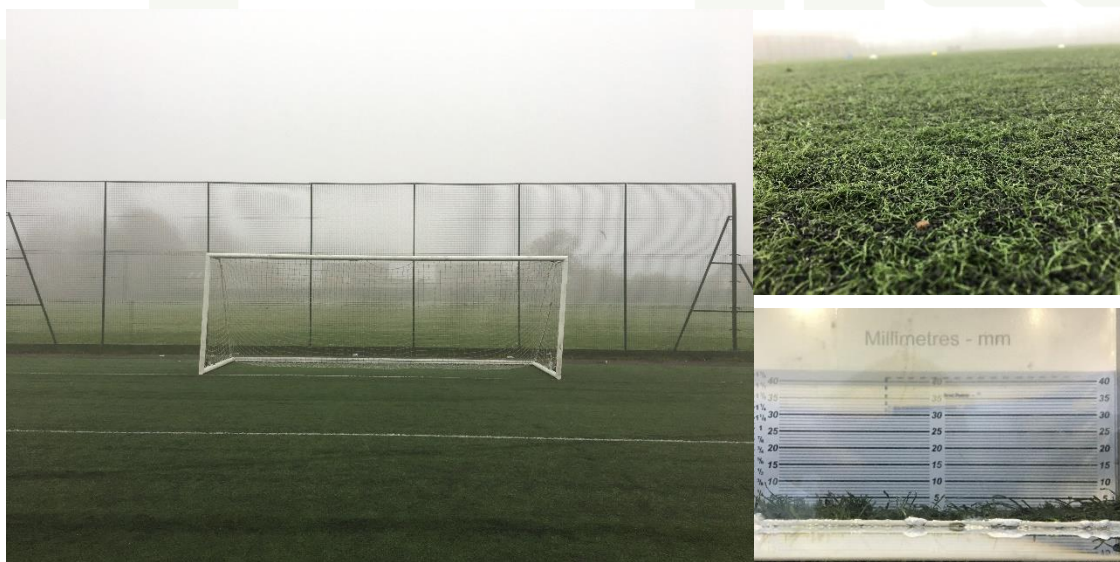
The playing surface comprises of a Fibrillating Yarn 3rd generation sand/rubber filled artificial turf. The carpet was worn in the high use areas with the fibres fibrillating and splitting. When this happens the fibres lose strength and lie flat across the top of the rubber. This results in fast ball roll as there is limited upright strands of fibre to slow the ball down, like natural grass, and modern day monofilament fibre 3G carpets.

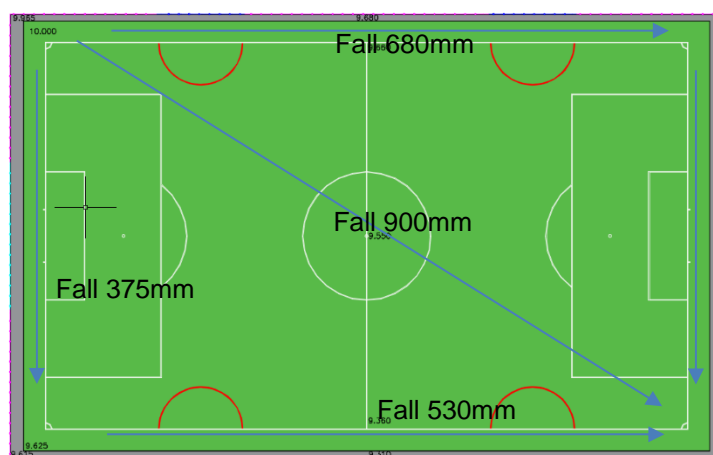
The topography of the existing ATP is even and consistent and generally running in a diagonal cross fall, from the east to the west corners by around 900mm with a slope of 1:128.
