ASBESTOS SURVEY REPORT

Site Address : **Thame Cricket Club Pavilion
Church Meadow
Church Road
Thame
OX9 3AJ**

Report Reference : **J000620**

Survey Type : **Management Survey**

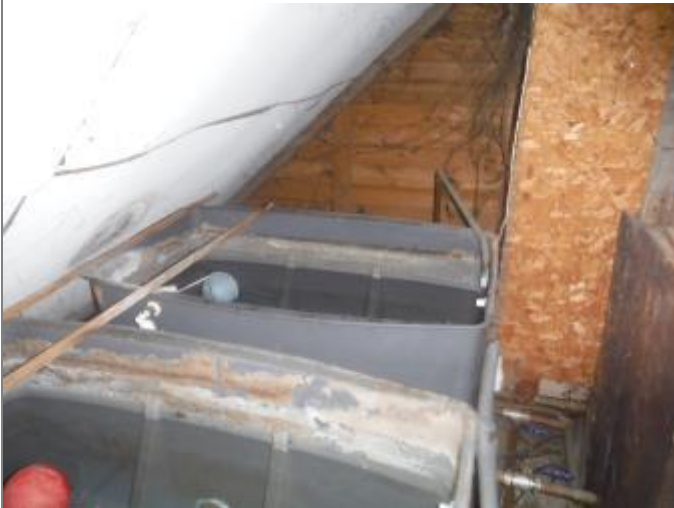
Item	Level	Location / Room number	Survey Type	Sample Reference	Quantity			
1	First Floor	Water Tank Room	Management	Visual Inspection	-

Material Description		Material Risk			
			No suspect materials observed within surveyed area		Product Type	Extent of Damage	Surface Treatment	Asbestos Type
			Additional Information		-	-	-	-
			Plastic water tanks Fibreboard lining to pitch of roof		Score - Material Risk			
					-		-	
			Recommendations		Accessibility			
-		-						
		Review Period						
		-						
Ceiling	Ceiling Soffit	Wall	Flooring	Other				
Fibreboard	Wood	Wood Panels	Screed	Pipework – Foam insulated

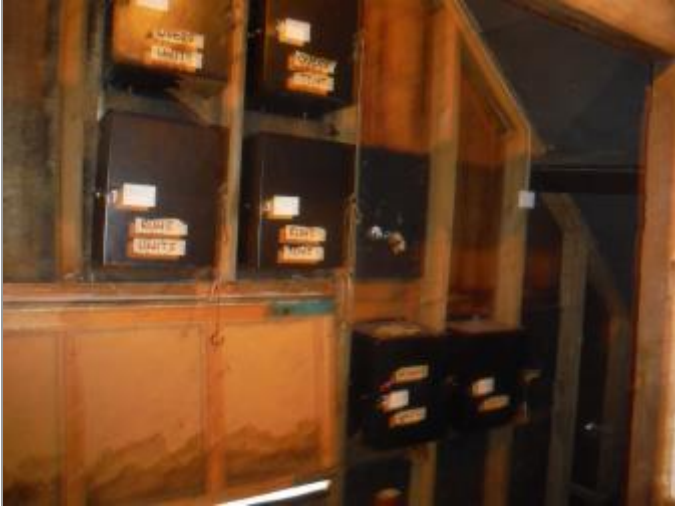
Item	Level	Location / Room number	Survey Type	Sample Reference	Quantity			
2	First Floor	Score Box	Management	Visual Inspection	-

Material Description		Material Risk			
			No suspect materials observed within surveyed area		Product Type	Extent of Damage	Surface Treatment	Asbestos Type
			Additional Information		-	-	-	-
			Fibreboard lining to pitch of roof Metal spiral staircase		Score - Material Risk			
					-	-		
			Recommendations		Accessibility			
			-		-			
					Review Period			
					-			
Ceiling		Ceiling Soffit	Wall	Flooring	Other			
Fibreboard		Wood	Wood panels	Timber	-

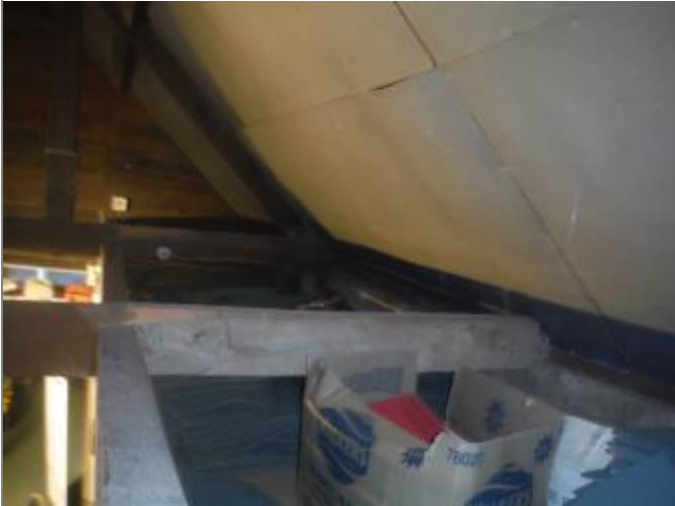
Item	Level	Location / Room number	Survey Type	Sample Reference	Quantity			
3	First Floor	Storage Balcony	Management	Visual Inspection	-

Material Description		Material Risk			
			No suspect materials observed within surveyed area		Product Type	Extent of Damage	Surface Treatment	Asbestos Type
			Additional Information		-	-	-	-
			Fibreboard lining to pitch of roof Plastic water tank		Score - Material Risk			
					-		-	
			Recommendations		Accessibility			
-		-						
		Review Period						
		-						
Ceiling		Ceiling Soffit	Wall	Flooring		Other		
Fibreboard		Wood	Wood panels	Strawboard		Pipework – Non insulated

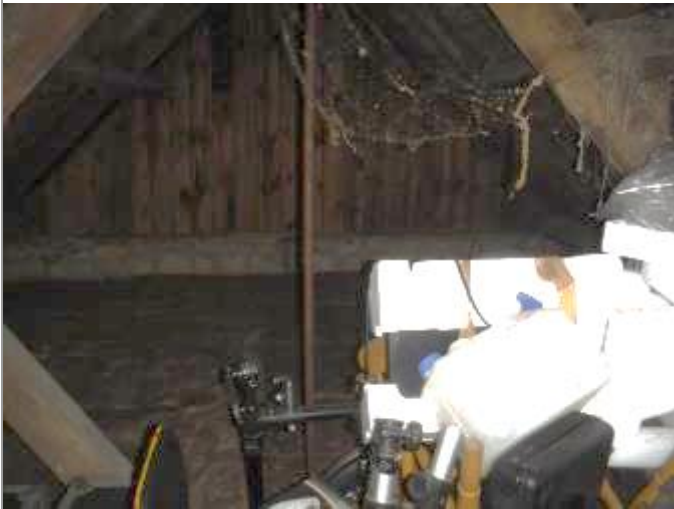
Item	Level	Location / Room number	Survey Type	Sample Reference	Quantity			
4	Roof	Music Room – Loft Space	Management	Visual Inspection	-

Material Description		Material Risk			
			No suspect materials observed within surveyed area		Product Type	Extent of Damage	Surface Treatment	Asbestos Type
			Additional Information		-	-	-	-
			MMMF insulation on plasterboard flooring		Score - Material Risk			
					-		-	
			Recommendations		Accessibility			
-		-						
		Review Period						
		-						
Ceiling	Ceiling Soffit	Wall	Flooring	Other				
-	-	-	-	-

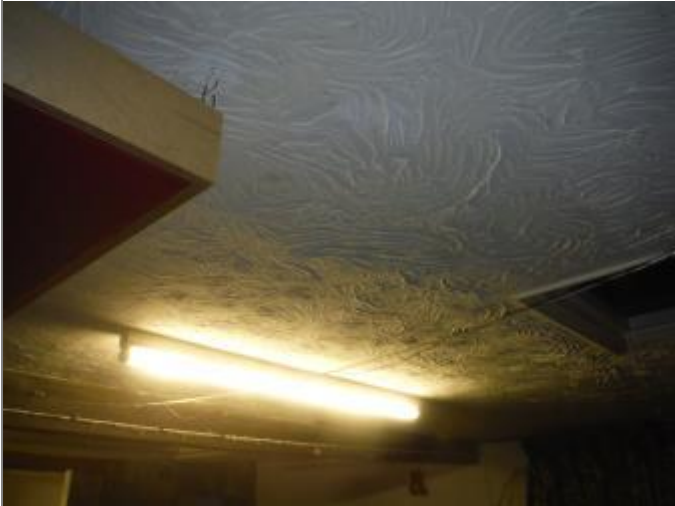
Item	Level	Location / Room number		Survey Type	Sample Reference	Quantity			
5	Ground Floor	Music Room		Management	J000620/01	-

Material Description		Material Risk			
				Textured coating to ceiling (Broken Leather effect)		Product Type	Extent of Damage	Surface Treatment	Asbestos Type
				Additional Information		-	-	-	-
				Non asbestos timber doors Timber loft access trap hatch		Score - Material Risk			
						-		-	
				Recommendations		Accessibility			
No asbestos detected in sample No further action required		-							
		Review Period							
		-							
Ceiling		Ceiling Soffit	Wall	Flooring		Other			
Plastered / Plasterboard panels		Wood	Block work	Carpet / Screed		Pipework – Non insulated

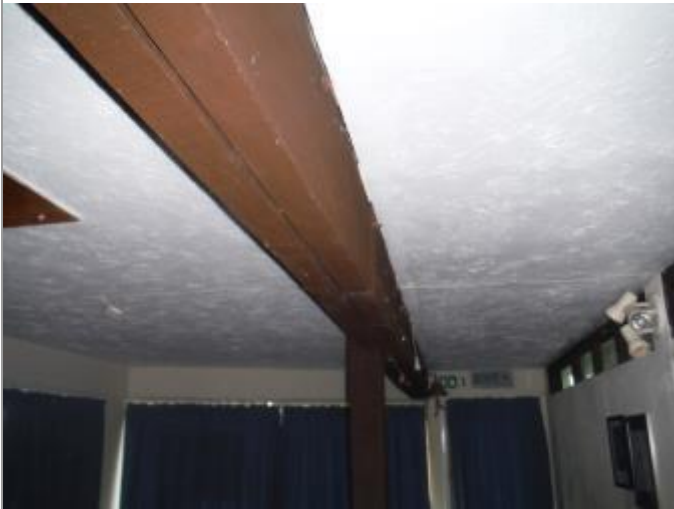
Item	Level	Location / Room number	Survey Type	Sample Reference	Quantity			
6	Ground Floor	Viewing Room	Management	J000620/02	-

Material Description		Material Risk			
			Textured coating to ceiling (Broken Leather effect)		Product Type	Extent of Damage	Surface Treatment	Asbestos Type
			Additional Information		-	-	-	-
			Timber-framed windows		Score - Material Risk			
					-		-	
			Recommendations		Accessibility			
No asbestos detected in sample No further action required		-						
		Review Period						
		-						
Ceiling	Ceiling Soffit	Wall	Flooring	Other				
Plastered / Plasterboard panels	No access	Wood panels	Carpet / Screed	Pipework – Non insulated

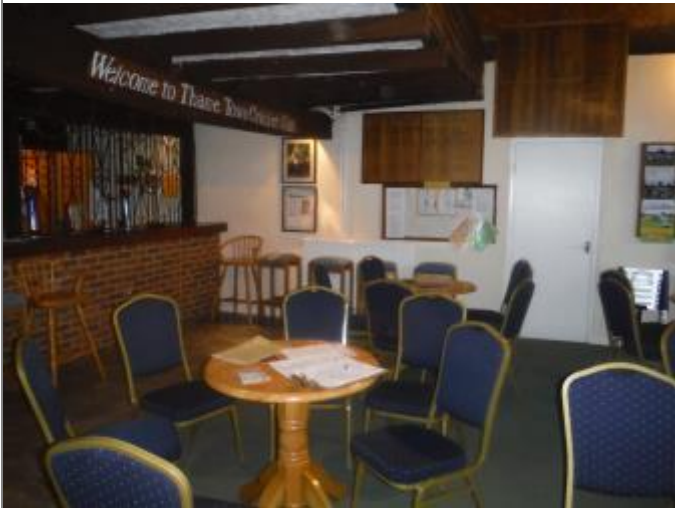
Item	Level	Location / Room number	Survey Type	Sample Reference	Quantity			
7	Ground Floor	Bar Seating Area	Management	Visual Inspection	-

Material Description		Material Risk			
			No suspect materials observed within surveyed area		Product Type	Extent of Damage	Surface Treatment	Asbestos Type
			Additional Information		-	-	-	-
			Non asbestos coating to strawboard soffit Fibreboard lining panels to pitch of roof Non asbestos timber doors		Score - Material Risk			
					-		-	
			Recommendations		Accessibility			
-		-						
		Review Period						
		-						
Ceiling	Ceiling Soffit	Wall	Flooring	Other				
Fibreboard	Strawboard	Wood panels / Block work	Carpet / Ceramic tiles / Screed	Pipework – Non insulated

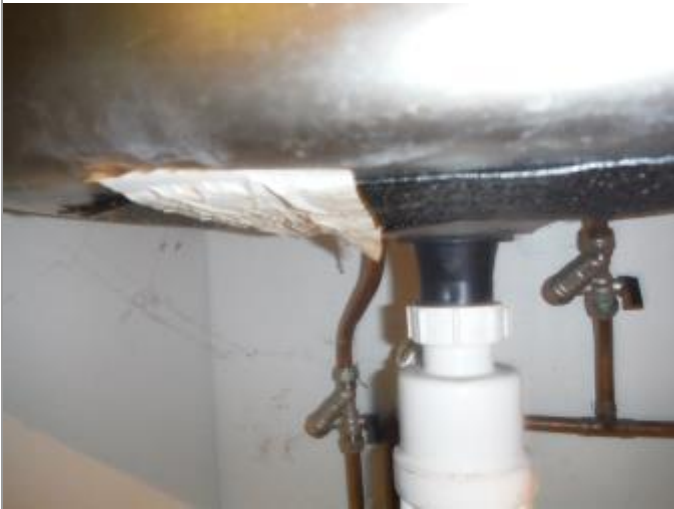
Item	Level	Location / Room number	Survey Type	Sample Reference	Quantity			
8	Ground Floor	Bar	Management	J000620/03	-

Material Description		Material Risk			
			Damper pad to base of sink		Product Type	Extent of Damage	Surface Treatment	Asbestos Type
			Additional Information		-	-	-	-
			1no. kitchen sink		Score - Material Risk			
					-		-	
			Recommendations		Accessibility			
No asbestos detected in sample No further action required		-						
		Review Period						
		-						
Ceiling	Ceiling Soffit	Wall	Flooring	Other				
-	Strawboard	Wood panels / Block work	Ceramic tiles / Screed	Pipework – Non insulated

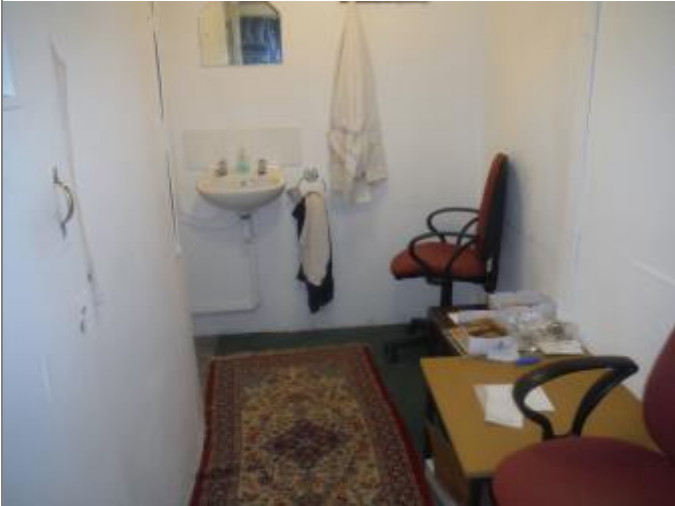
Item	Level	Location / Room number	Survey Type	Sample Reference	Quantity			
9	Ground Floor	Umpire Room	Management	Visual Inspection	-

Material Description		Material Risk			
			No suspect materials observed within surveyed area		Product Type	Extent of Damage	Surface Treatment	Asbestos Type
			Additional Information		-	-	-	-
			Timber wall panels		Score - Material Risk			
					-	-		
			Recommendations		Accessibility			
-		-						
		Review Period						
		-						
Ceiling	Ceiling Soffit	Wall	Flooring	Other				
-	Strawboard	Wood panels / Block work	Carpet / Screed	-

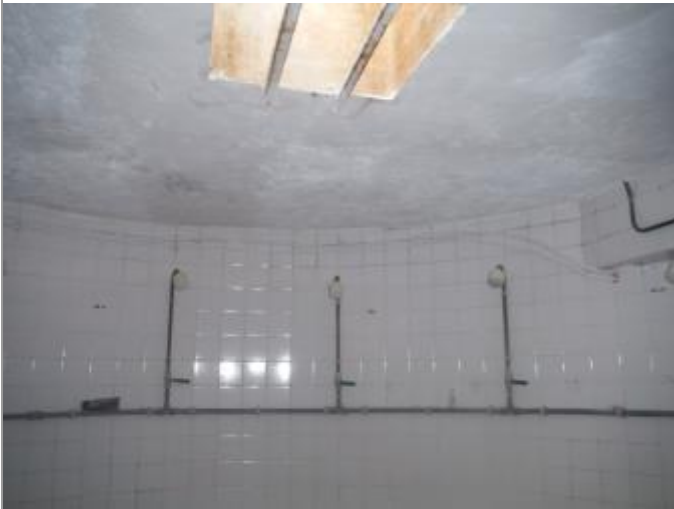
Item	Level	Location / Room number	Survey Type	Sample Reference	Quantity			
10	Ground Floor	Shower	Management	Visual Inspection	-

Material Description		Material Risk			
			No suspect materials observed within surveyed area		Product Type	Extent of Damage	Surface Treatment	Asbestos Type
			Additional Information		-	-	-	-
			Timber skylight cheeks No access within boxing		Score - Material Risk			
					-		-	
			Recommendations		Accessibility			
			-		-			
Review Period								
-								
Ceiling	Ceiling Soffit	Wall	Flooring	Other				
Plastered / Plasterboard panels	No access	Block work	Ceramic tiles / Screed	Pipework – Non insulated Riser covers - Timber

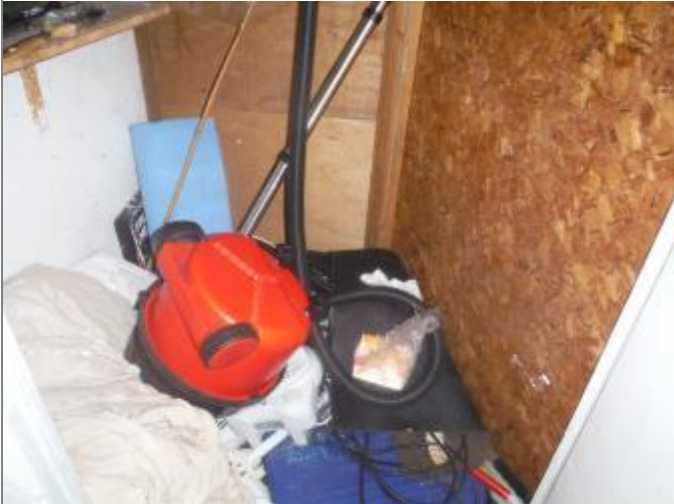
Item	Level	Location / Room number	Survey Type	Sample Reference	Quantity			
11	Ground Floor	Store	Management	Visual Inspection	-

Material Description		Material Risk			
			No suspect materials observed within surveyed area		Product Type	Extent of Damage	Surface Treatment	Asbestos Type
			Additional Information		-	-	-	-
			Timber wall lining panels		Score - Material Risk			
					-	-		
			Recommendations		Accessibility			
			-		-			
Review Period								
-								
Ceiling	Ceiling Soffit	Wall	Flooring	Other				
-	Strawboard	Wood panels / Block work	Screed	-

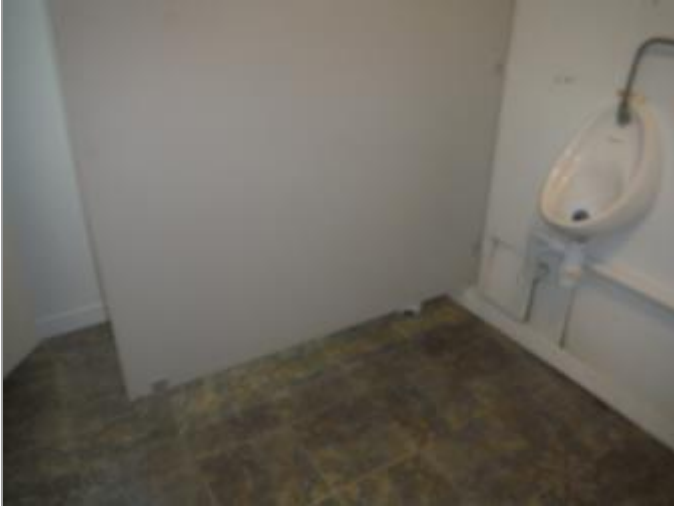
Item	Level	Location / Room number	Survey Type	Sample Reference	Quantity			
12	Ground Floor	Male W.C	Management	Visual Inspection	-

Material Description		Material Risk			
			No suspect materials observed within surveyed area		Product Type	Extent of Damage	Surface Treatment	Asbestos Type
					-	-	-	-
			Additional Information		Score - Material Risk			
			Ceramic W.C cistern Plastic soil pipe		-		-	
					Recommendations		Accessibility	
			-		-			
Review Period								
-								
Ceiling	Ceiling Soffit	Wall	Flooring	Other				
Plastered / Plasterboard panels	No access	Wood panels / Block work	Ceramic tiles / Screed	Pipework – Non insulated

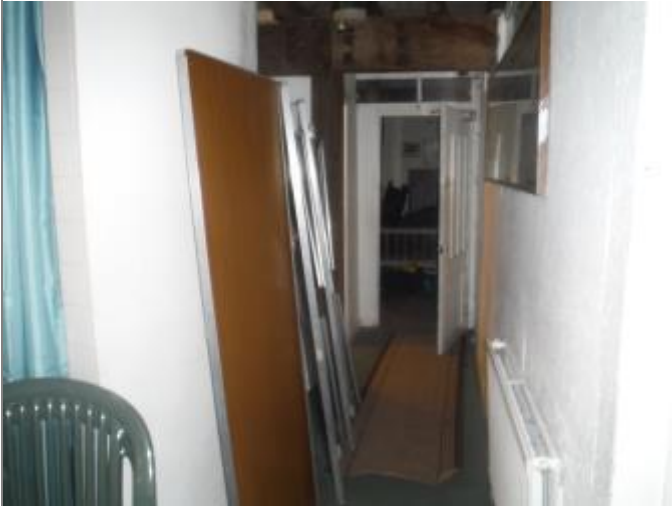
Item	Level	Location / Room number	Survey Type	Sample Reference	Quantity			
15	Ground Floor	Circulation	Management	Visual Inspection	-

Material Description		Material Risk			
			No suspect materials observed within surveyed area		Product Type	Extent of Damage	Surface Treatment	Asbestos Type
			Additional Information		-	-	-	-
			Timber wall panels Non asbestos timber doors		Score - Material Risk			
					-		-	
			Recommendations		Accessibility			
-		-						
		Review Period						
		-						
Ceiling	Ceiling Soffit	Wall	Flooring	Other				
-	Strawboard	Wood panels / Block work	Carpet / Screed	Pipework – Non insulated

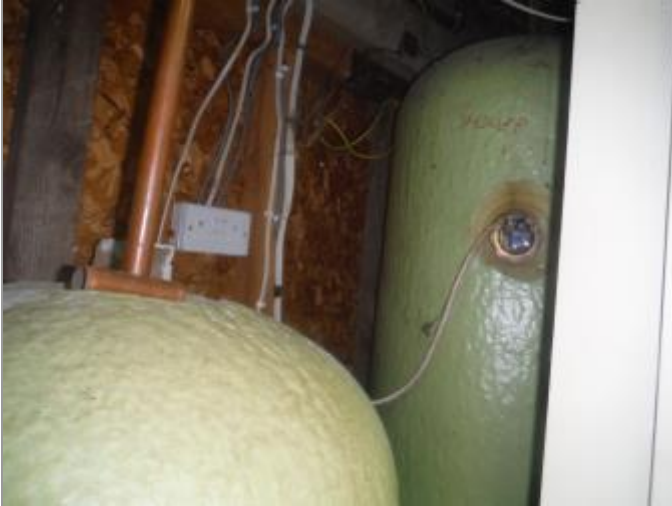
Item	Level	Location / Room number	Survey Type	Sample Reference	Quantity			
16	Ground Floor	Boiler Cupboard	Management	Visual Inspection	-

Material Description		Material Risk			
			No suspect materials observed within surveyed area		Product Type	Extent of Damage	Surface Treatment	Asbestos Type
			Additional Information		-	-	-	-
			Copper water tanks with foam jackets Non asbestos timber door		Score - Material Risk			
					-	-		
			Recommendations		Accessibility			
-		-						
		Review Period						
		-						
Ceiling	Ceiling Soffit	Wall	Flooring	Other				
Plasterboard panels	Strawboard	Wood panels	Carpet / Screed	Pipework – Non insulated

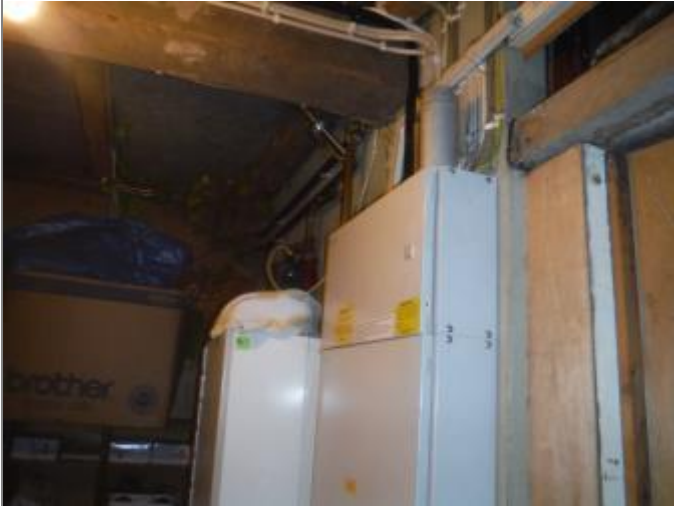
Item	Level	Location / Room number	Survey Type	Sample Reference	Quantity			
19	Ground Floor	Electrical Store	Management	Visual Inspection	-

Material Description		Material Risk			
			No suspect materials observed within surveyed area		Product Type	Extent of Damage	Surface Treatment	Asbestos Type
			Additional Information		-	-	-	-
			Non asbestos fuse board Non asbestos Ideal boiler		Score - Material Risk			
					-		-	
			Recommendations		Accessibility			
-		-						
		Review Period						
		-						
Ceiling	Ceiling Soffit	Wall	Flooring	Other				
-	Strawboard	Wood panels / Block work	Screed	Pipework – Non insulated

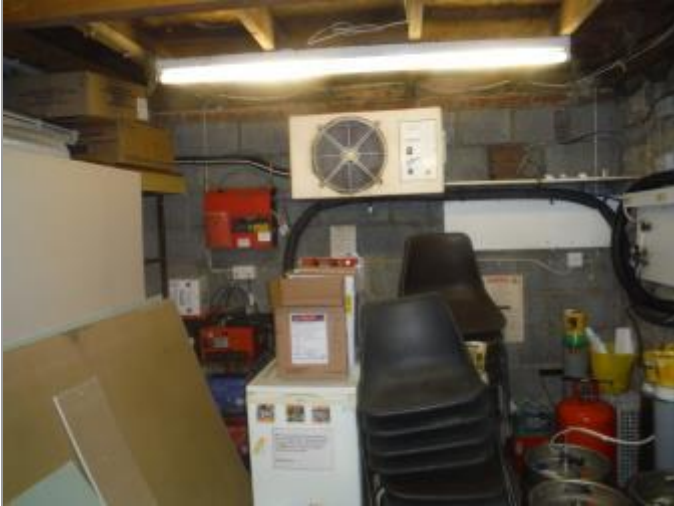
Item	Level	Location / Room number	Survey Type	Sample Reference	Quantity			
20	Ground Floor	Cellar	Management	Visual Inspection	-

Material Description		Material Risk			
			No suspect materials observed within surveyed area		Product Type	Extent of Damage	Surface Treatment	Asbestos Type
			Additional Information		-	-	-	-
			Plasterboard panels below timber soffit		Score - Material Risk			
					-		-	
			Recommendations		Accessibility			
			-		-			
Review Period								
-								
Ceiling	Ceiling Soffit	Wall	Flooring	Other				
Plasterboard panels	Wood	Block work	Screed	Pipework – Foam insulated

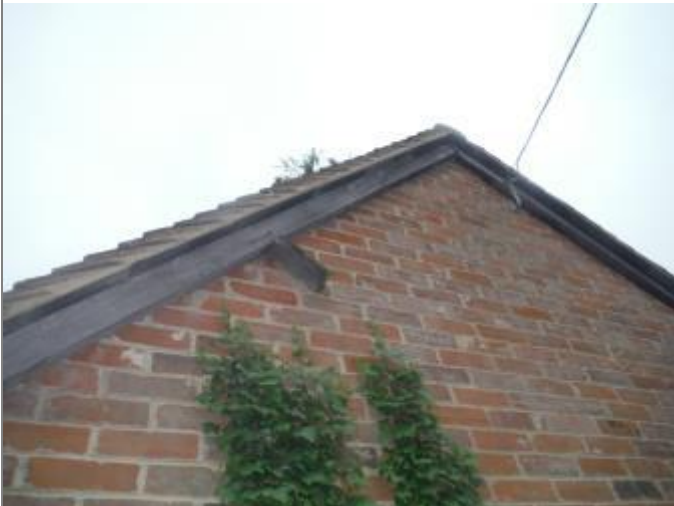
Item	Level	Location / Room number	Survey Type	Sample Reference	Quantity			
21	External	Garage	Management	J000620/04	-

Material Description		Material Risk			
			Tile underclanking		Product Type	Extent of Damage	Surface Treatment	Asbestos Type
			Additional Information		-	-	-	-
			Tile underclanking at high level to gable ends Plastic rainwater goods		Score - Material Risk			
					-		-	
			Recommendations		Accessibility			
			No asbestos detected in sample No further action required		-			
Review Period								
-								
Ceiling	Ceiling Soffit	Wall	Flooring	Other				
-	Wood	Block work	Screed	-

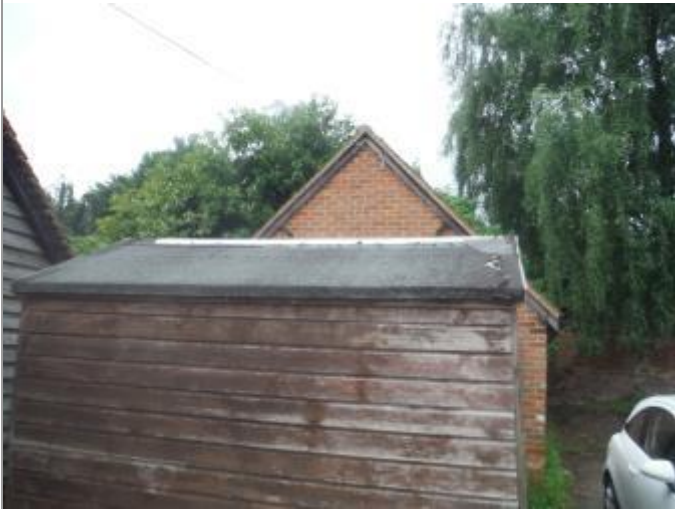
Item	Level	Location / Room number	Survey Type	Sample Reference	Quantity			
22	External	Garden Shed	Management	J000620/05	-

Material Description		Material Risk			
			Roofing felt		Product Type	Extent of Damage	Surface Treatment	Asbestos Type
			Additional Information		-	-	-	-
			Roofing felt to pitch of roof Timber lined shed		Score - Material Risk			
					-		-	
			Recommendations		Accessibility			
No asbestos detected in sample No further action required		-						
		Review Period						
		-						
Ceiling	Ceiling Soffit	Wall	Flooring	Other				
-	Wood	Wood panels	Screed	-

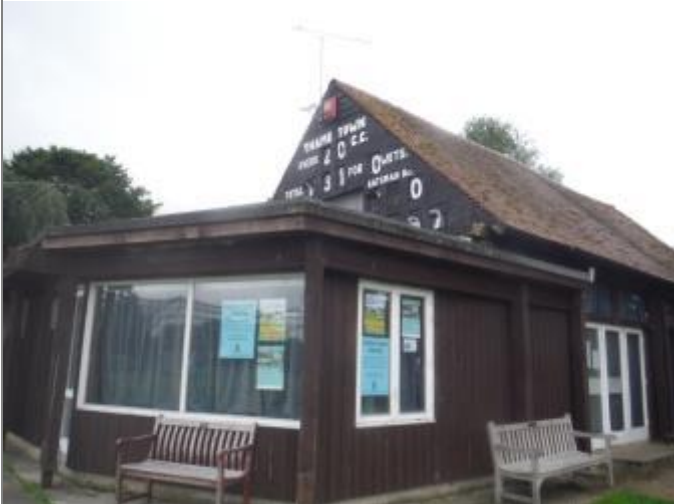
Item	Level	Location / Room number	Survey Type	Sample Reference	Quantity			
23	External	All Elevations	Management	Visual Inspection	-

Material Description		Material Risk			
			No suspect materials observed within surveyed area		Product Type	Extent of Damage	Surface Treatment	Asbestos Type
			Additional Information		-	-	-	-
			Timber soffit and fascia Plastic rainwater goods		Score - Material Risk			
					-	-		
			Recommendations		Accessibility			
					-			
		Review Period						
		-						
Ceiling		Ceiling Soffit	Wall	Flooring	Other			
-	-	-	-	-
