# Asbestos Demolition Survey

Benson The youth Hall  
Oxford Road  
Wallingford  
Oxfordshire  
OX10 6LX

**Job Reference:** J033322

**Survey Type:** Demolition Survey

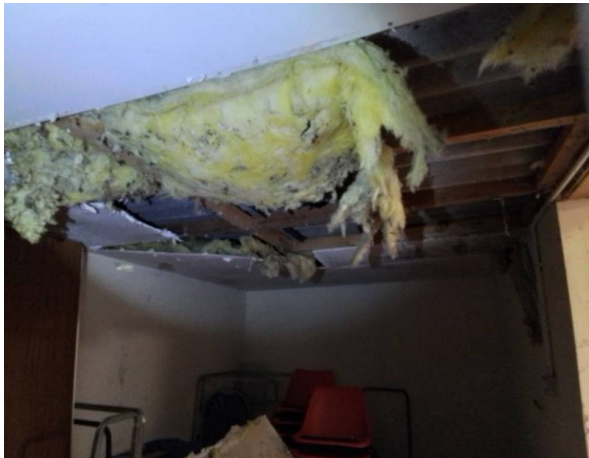
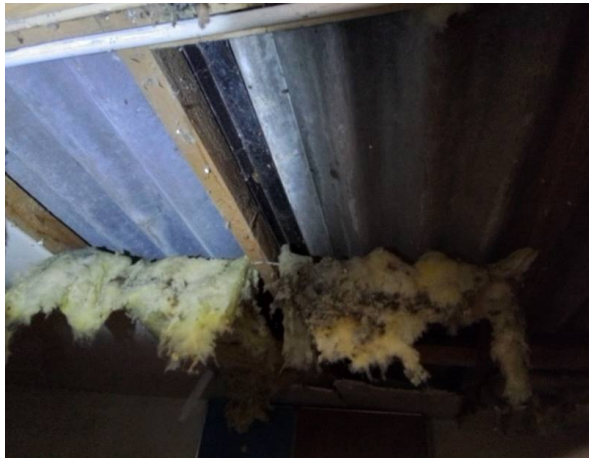
Item	Building	Level	Location / Room number	Survey Type	Quantity	Sample Reference
1	Main building	Ground Floor	G.001 - Store	Demolition Survey (with MA only)	N/A	DG000542

<b>Material Description</b>				<b>Material Risk</b>		
Roof – Cement sheeting Cement				Product Type	N/A	Surface Treatment
				Extent of Damage	N/A	Asbestos Type
<b>Asbestos Type</b>				<b>Score - Material Risk</b>		
No Asbestos Detected				N/A		N/A
<b>Additional Information</b>				<b>Accessibility</b>		
N/A				N/A		
<b>Recommendations</b>				<b>Review Date</b>		
No further action required				N/A

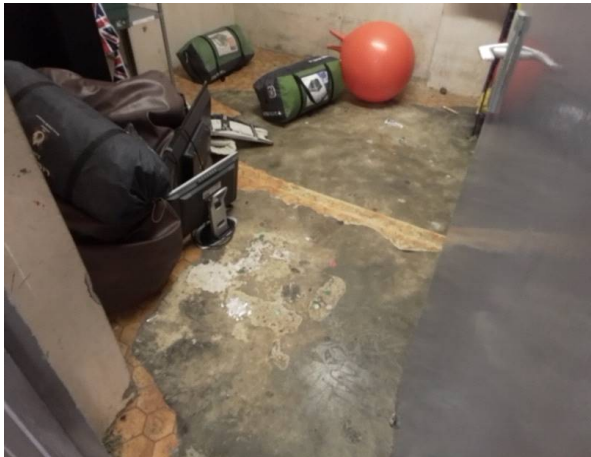
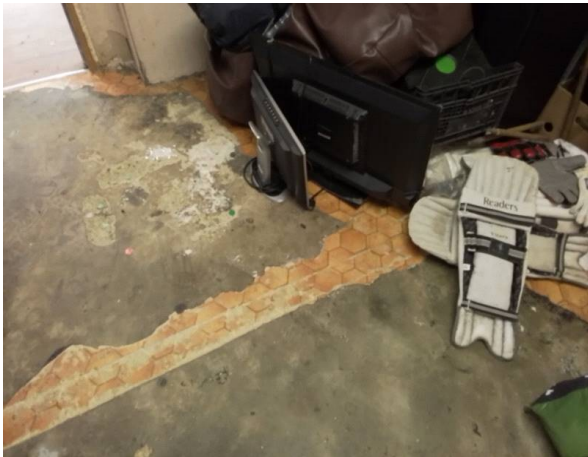
Item	Building	Level	Location / Room number	Survey Type	Quantity	Sample Reference
4	Main building	Ground Floor	G.003 - Store	Demolition Survey (with MA only)	N/A	DG000543

<b>Material Description</b>				<b>Material Risk</b>		
Floor – Paper lining and bitumen adhesive on linoleum Paper				Product Type	N/A	Surface Treatment
				Extent of Damage	N/A	Asbestos Type
<b>Asbestos Type</b>				<b>Score - Material Risk</b>		
No Asbestos Detected				N/A		N/A
<b>Additional Information</b>				<b>Accessibility</b>		
N/A				N/A		
<b>Recommendations</b>				<b>Review Date</b>		
No further action required				N/A

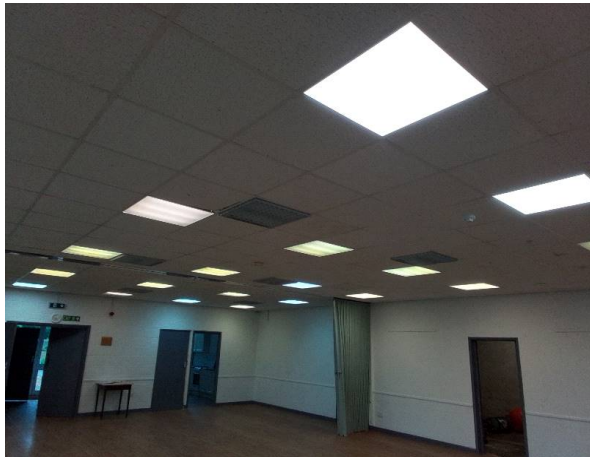
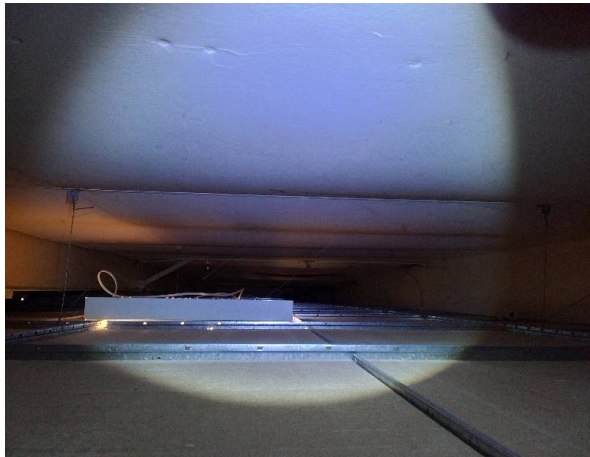
Item	Building	Level	Location / Room number	Survey Type	Quantity	Sample Reference	
7	Main building	Ground Floor	G.005 - Hall	Demolition Survey (with MA only)	>100m²	DG000544

Material Description				Material Risk			
Fibreboard panels above suspended tiles – Paper lining Paper				Product Type	2	Surface Treatment	2
				Extent of Damage	1	Asbestos Type	1
Asbestos Type				Score - Material Risk			
Chrysotile				6		Low	
Additional Information				Accessibility			
N/A				Usually inaccessible or unlikely to be disturbed			
Recommendations				Review Date			
Remove				November 2025

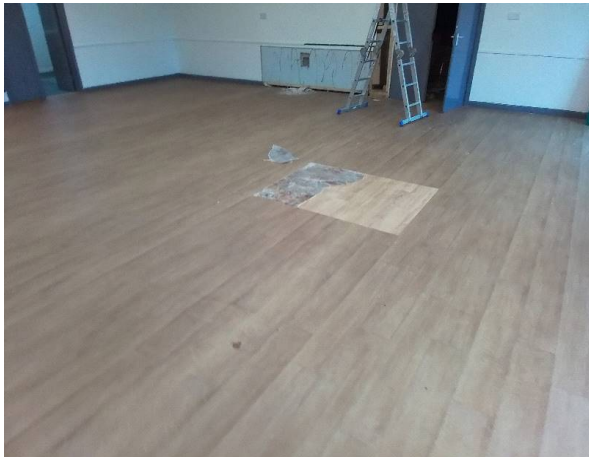
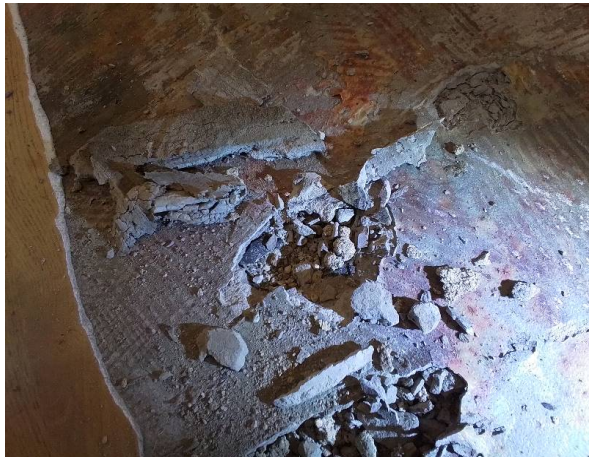
Item	Building	Level	Location / Room number	Survey Type	Quantity	Sample Reference
10	Main building	Ground Floor	G.005 - Hall	Demolition Survey (with MA only)	>100m²	DG000545

<b>Material Description</b>				<b>Material Risk</b>		
Floor beneath vinyl linoleum and screed – Bitumen adhesive Bitumen Material				Product Type	1	Surface Treatment
				Extent of Damage	1	Asbestos Type
<b>Asbestos Type</b>				<b>Score - Material Risk</b>		
Chrysotile				3	Very Low	
<b>Additional Information</b>				<b>Accessibility</b>		
N/A				Usually inaccessible or unlikely to be disturbed		
<b>Recommendations</b>				<b>Review Date</b>		
Remove				November 2025

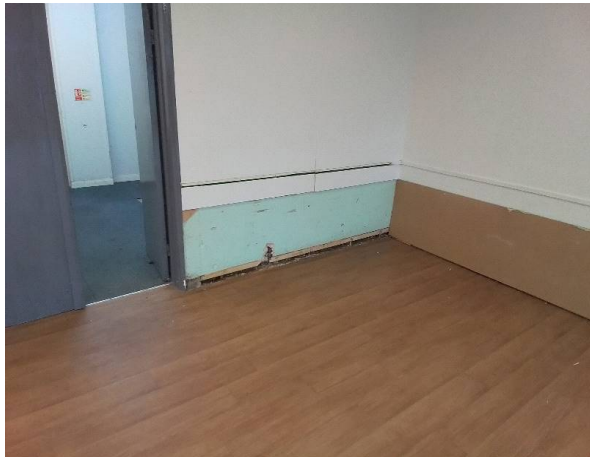
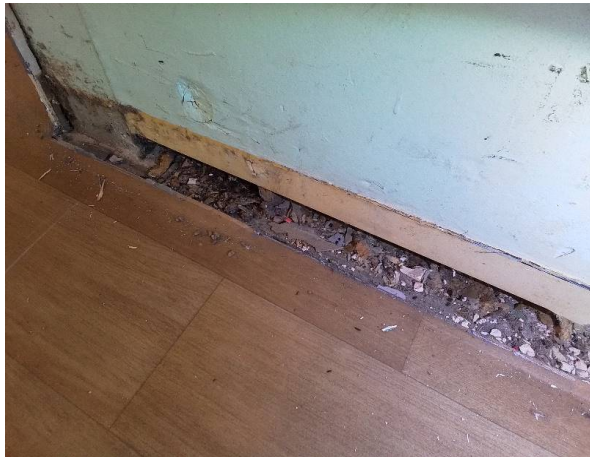
Item	Building	Level	Location / Room number	Survey Type	Quantity	Sample Reference
11	Main building	Ground Floor	G.005 - Hall	Demolition Survey (with MA only)	N/A	DG000546

<b>Material Description</b>				<b>Material Risk</b>		
Floor behind skirting – Beige thermoplastic tiles and bitumen adhesive debris Thermoplastic Floor Tile				Product Type	N/A	Surface Treatment
				Extent of Damage	N/A	Asbestos Type
<b>Asbestos Type</b>				<b>Score - Material Risk</b>		
No Asbestos Detected				N/A		N/A
<b>Additional Information</b>				<b>Accessibility</b>		
N/A				N/A		
<b>Recommendations</b>				<b>Review Date</b>		
No further action required				N/A

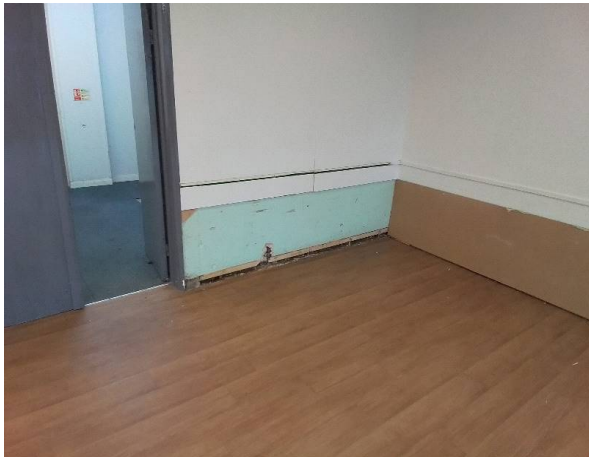
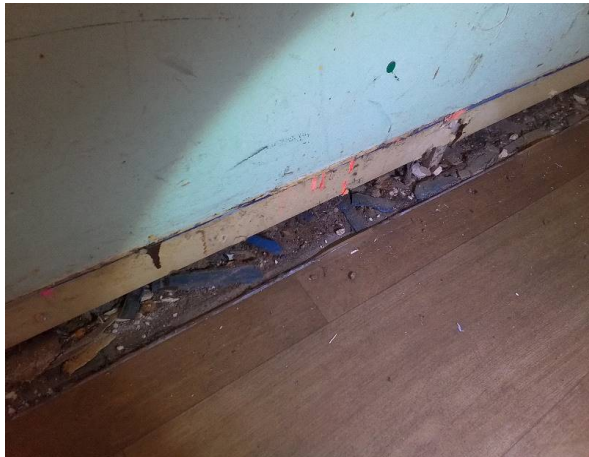
Item	Building	Level	Location / Room number	Survey Type	Quantity	Sample Reference	
12	Main building	Ground Floor	G.005 - Hall	Demolition Survey (with MA only)	N/A	DG000547

<b>Material Description</b>				<b>Material Risk</b>			
Floor behind skirting – Blue thermoplastic tiles and bitumen adhesive debris Thermoplastic Floor Tile				Product Type	N/A	Surface Treatment	N/A
				Extent of Damage	N/A	Asbestos Type	N/A
<b>Asbestos Type</b>				<b>Score - Material Risk</b>			
No Asbestos Detected				N/A		N/A	
<b>Additional Information</b>				<b>Accessibility</b>			
N/A				N/A			
<b>Recommendations</b>				<b>Review Date</b>			
No further action required				N/A

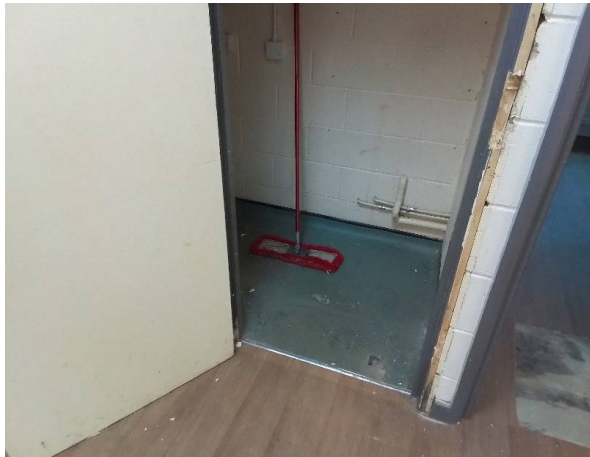
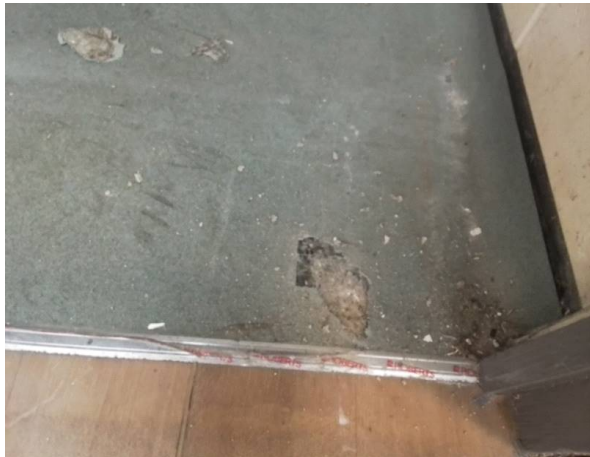
Item	Building	Level	Location / Room number	Survey Type	Quantity	Sample Reference
16	Main building	Ground Floor	G.006 - Kitchen	Demolition Survey (with MA only)	2.5m <sup>2</sup>	As DG000548

<b>Material Description</b>				<b>Material Risk</b>		
Floor beneath vinyl linoleum and screed – Bitumen adhesive Bitumen Material				Product Type	1	Surface Treatment
				Extent of Damage	1	Asbestos Type
<b>Asbestos Type</b>				<b>Score - Material Risk</b>		
Chrysotile				3	Very Low	
<b>Additional Information</b>				<b>Accessibility</b>		
N/A				Easily disturbed		
<b>Recommendations</b>				<b>Review Date</b>		
Remove				November 2025

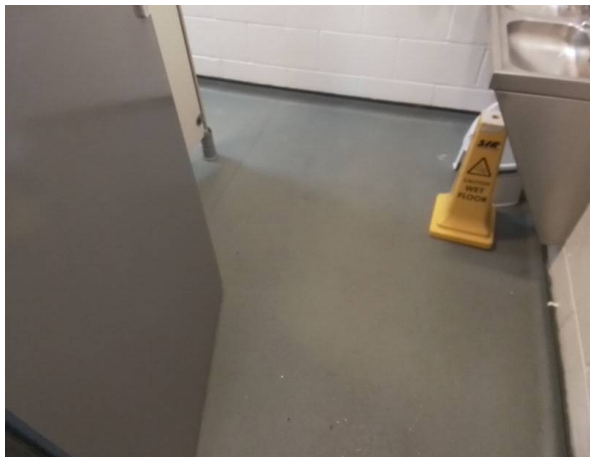
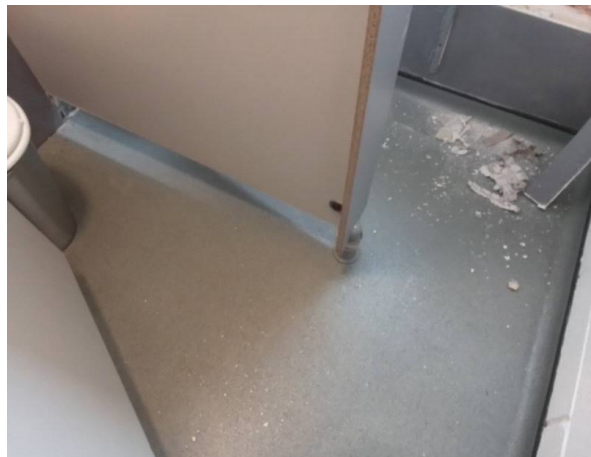
Item	Building	Level	Location / Room number	Survey Type	Quantity	Sample Reference	
17	Main building	Ground Floor	G.008 - Toilets	Demolition Survey (with MA only)	8m²	As DG000548

Material Description				Material Risk			
Floor beneath vinyl linoleum and screed – Bitumen adhesive Bitumen Material				Product Type	1	Surface Treatment	0
				Extent of Damage	1	Asbestos Type	1
Asbestos Type				Score - Material Risk			
Chrysotile				3		Very Low	
Additional Information				Accessibility			
N/A				Easily disturbed			
Recommendations				Review Date			
Remove				November 2025

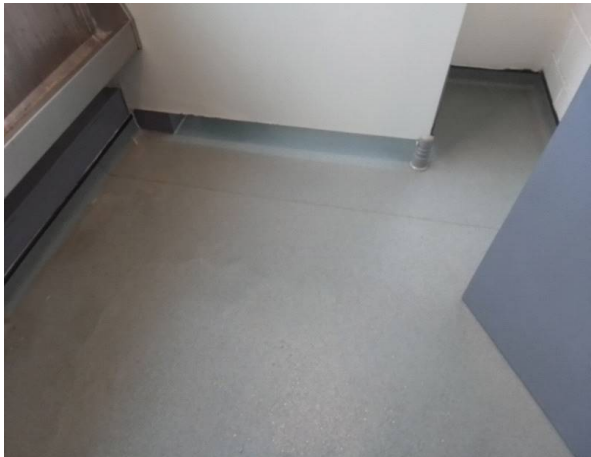
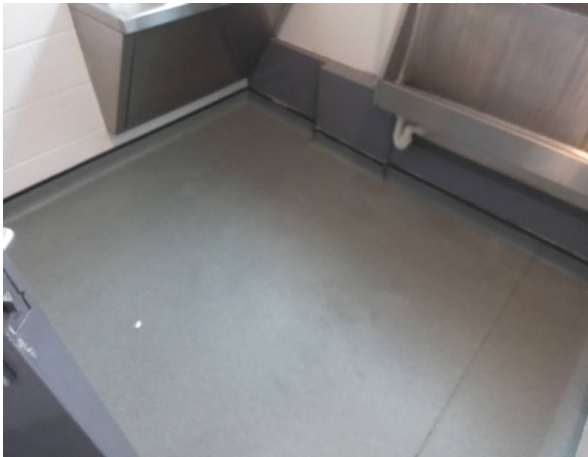
Item	Building	Level	Location / Room number	Survey Type	Quantity	Sample Reference
18	Main building	Ground Floor	G.009 - Toilets	Demolition Survey (with MA only)	7m²	As DG000548

Material Description				Material Risk		
Floor beneath vinyl linoleum and screed – Bitumen adhesive Bitumen Material				Product Type	1	Surface Treatment
				Extent of Damage	1	Asbestos Type
Asbestos Type				Score - Material Risk		
Chrysotile				3		Very Low
Additional Information				Accessibility		
N/A				Easily disturbed		
Recommendations				Review Date		
Remove				November 2025

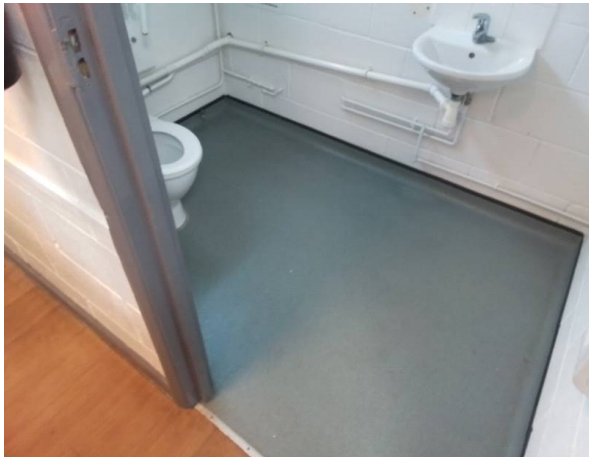
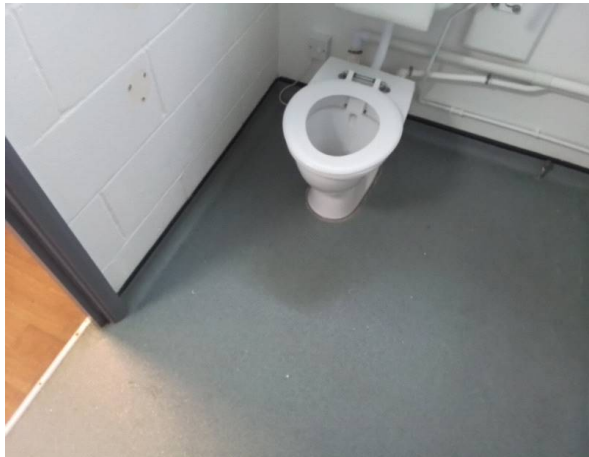
Item	Building	Level	Location / Room number	Survey Type	Quantity	Sample Reference
19	Main building	Ground Floor	G.010 - Toilet	Demolition Survey (with MA only)	3.5m²	As DG000548

<b>Material Description</b>				<b>Material Risk</b>		
Floor beneath vinyl linoleum and screed – Bitumen adhesive Bitumen Material				Product Type	1	Surface Treatment
				Extent of Damage	1	Asbestos Type
<b>Asbestos Type</b>				<b>Score - Material Risk</b>		
Chrysotile				3	Very Low	
<b>Additional Information</b>				<b>Accessibility</b>		
N/A				Easily disturbed		
<b>Recommendations</b>				<b>Review Date</b>		
Remove				November 2025

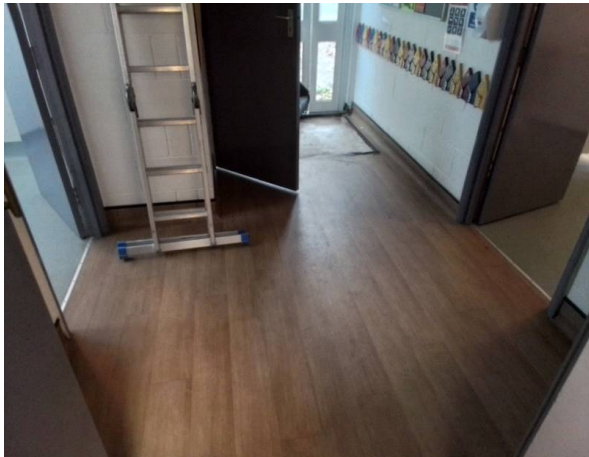
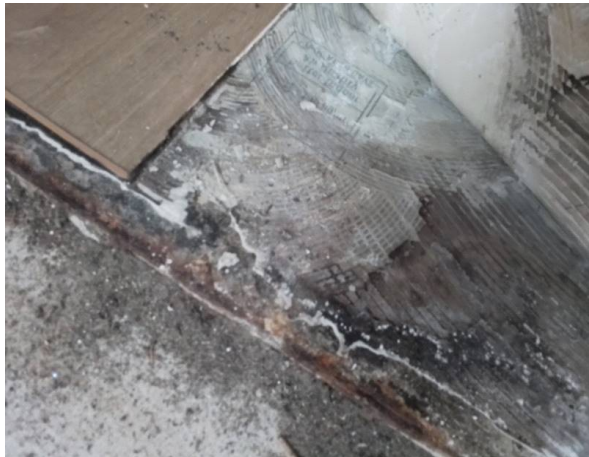
Item	Building	Level	Location / Room number	Survey Type	Quantity	Sample Reference	
20	Main building	Ground Floor	G.011 - Lobby	Demolition Survey (with MA only)	10m²	DG000549

Material Description				Material Risk			
Floor beneath vinyl linoleum and screed – Bitumen adhesive Bitumen Material				Product Type	1	Surface Treatment	0
				Extent of Damage	1	Asbestos Type	1
Asbestos Type				Score - Material Risk			
Chrysotile				3		Very Low	
Additional Information				Accessibility			
N/A				Easily disturbed			
Recommendations				Review Date			
Remove				November 2025

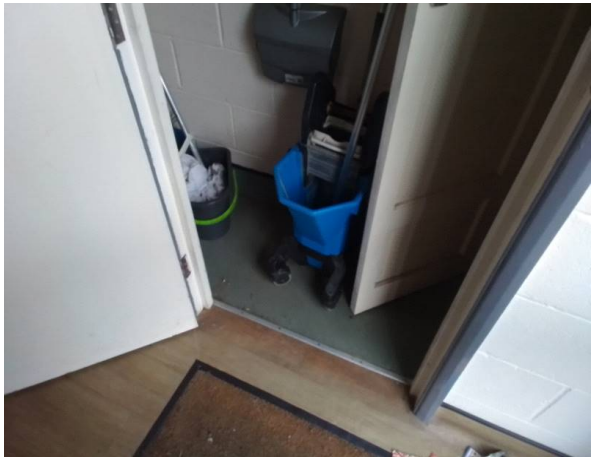
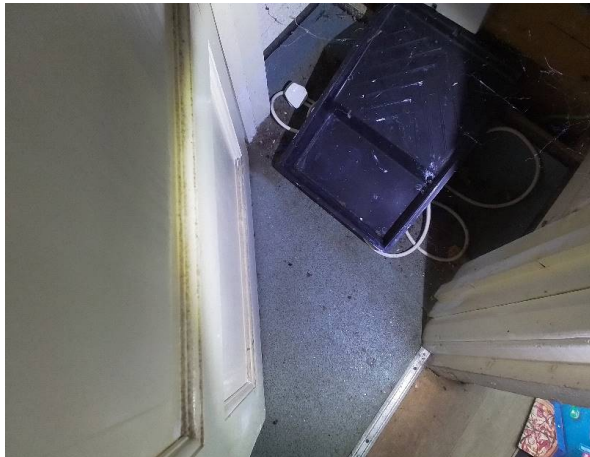
Item	Building	Level	Location / Room number	Survey Type	Quantity	Sample Reference	
21	Main building	Ground Floor	G.012 - Electrical Cupboard	Demolition Survey (with MA only)	2m²	As DG000548

<b>Material Description</b>				<b>Material Risk</b>			
Floor beneath vinyl linoleum and screed – Bitumen adhesive Bitumen Material				Product Type	1	Surface Treatment	0
				Extent of Damage	1	Asbestos Type	1
<b>Asbestos Type</b>				<b>Score - Material Risk</b>			
Chrysotile				3		Very Low	
<b>Additional Information</b>				<b>Accessibility</b>			
N/A				Easily disturbed			
<b>Recommendations</b>				<b>Review Date</b>			
Remove				November 2025

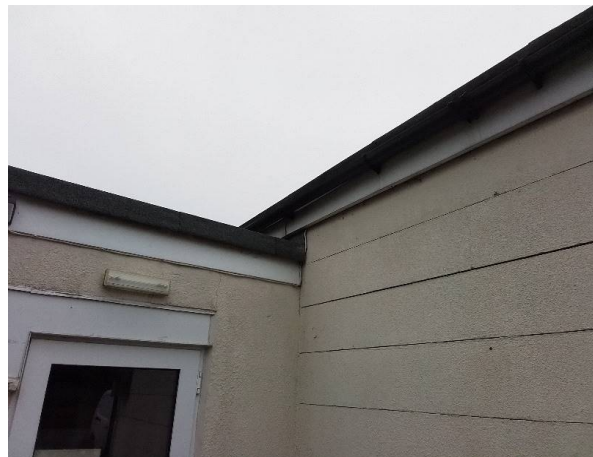
Item	Building	Level	Location / Room number	Survey Type	Quantity	Sample Reference	
23	Main building	External	E.001 - External	Demolition Survey (with MA only)	N/A	DG000550

Material Description				Material Risk			
Over flat roof – Felt Bitumen Material				Product Type	N/A	Surface Treatment	N/A
				Extent of Damage	N/A	Asbestos Type	N/A
Asbestos Type				Score - Material Risk			
No Asbestos Detected				N/A		N/A	
Additional Information				Accessibility			
N/A				N/A			
Recommendations				Review Date			
No further action required				N/A
