Building Surveying, Norwich

## **Report on Roof Condition**

**The Carnegie, Cage Lane, Thetford**

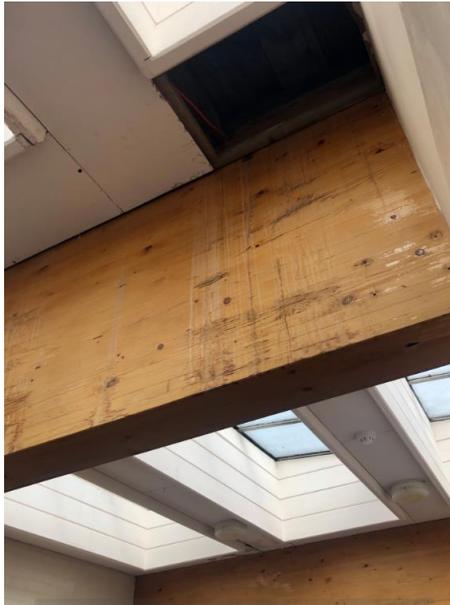
Photo 1 – Evidence of water leak to offices

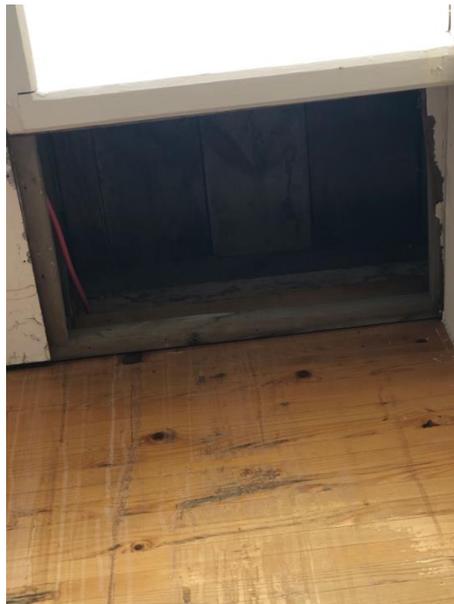
Photo 2 – Evidence of water leak to offices

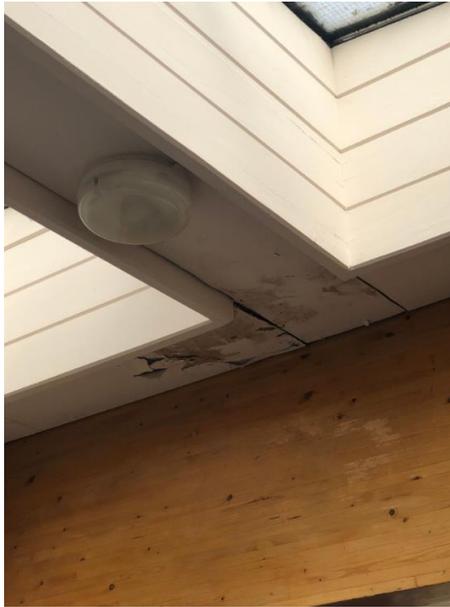
Photo 3 – Evidence of water leak around roof light

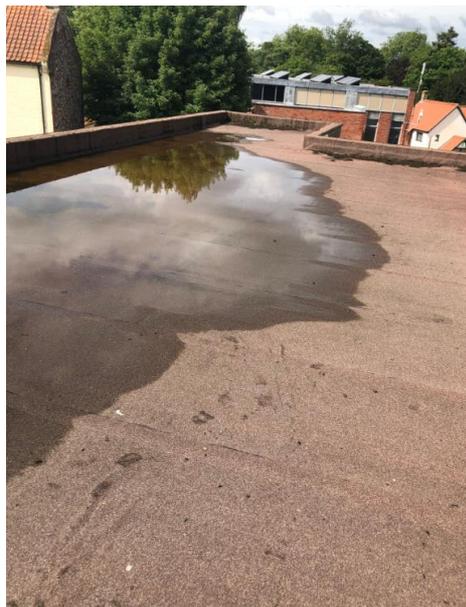
Photo 4 – Ponding to the flat roof area above the offices

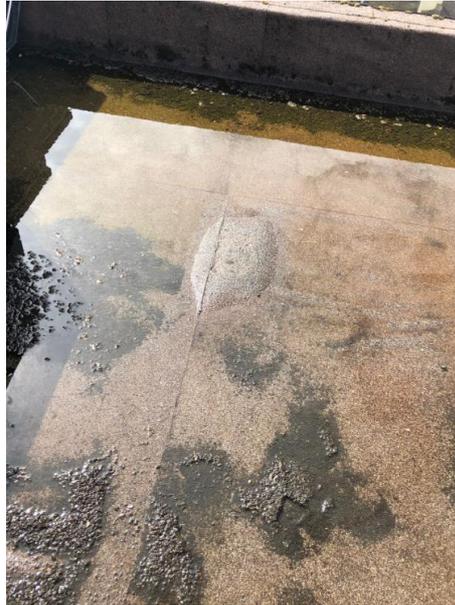
Photo 5 – Ponding and blistering to the flat roof area above the offices

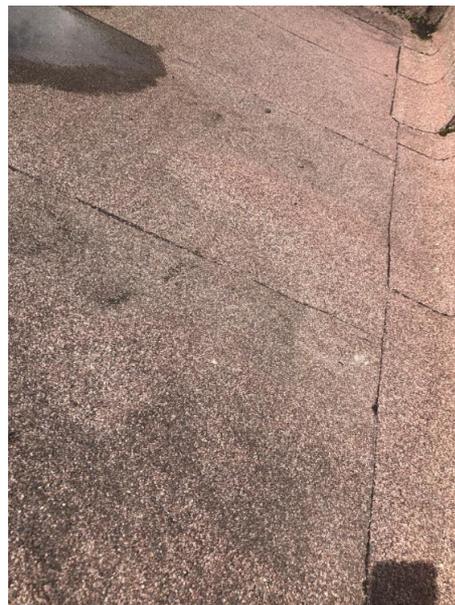
Photo 6 – Felt staining and delamination to the flat roof area above the offices

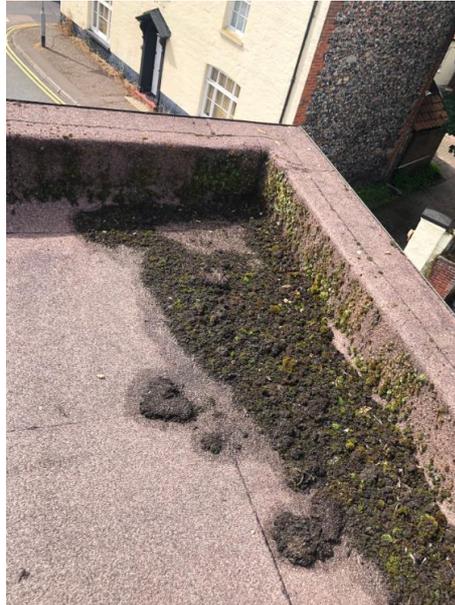
Photo 7 – Moss and debris build up to the flat roof area above the offices

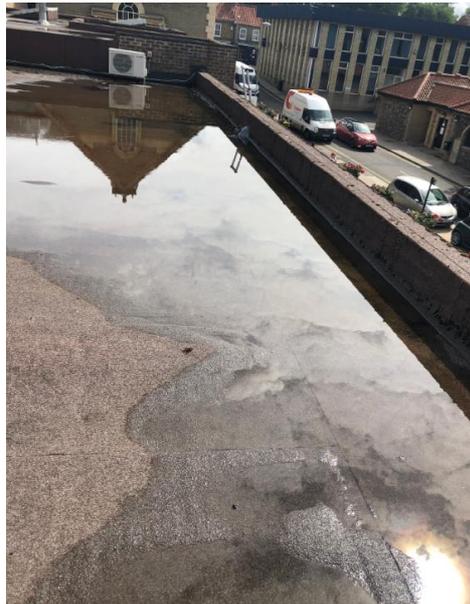
Photo 8 – Ponding to the flat roof area above the offices

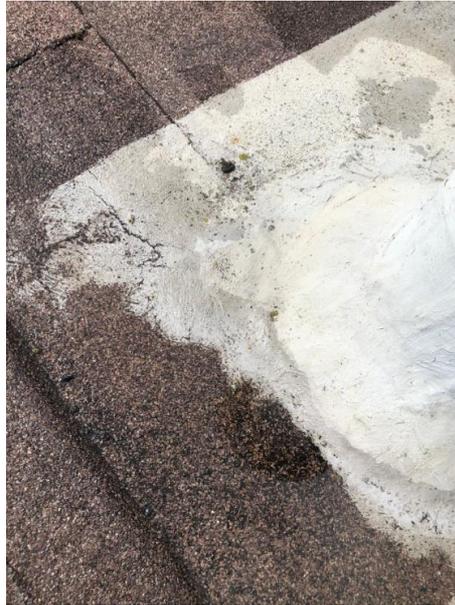
Photo 9 – Protective cover cracking to service penetration flat roof area above the offices

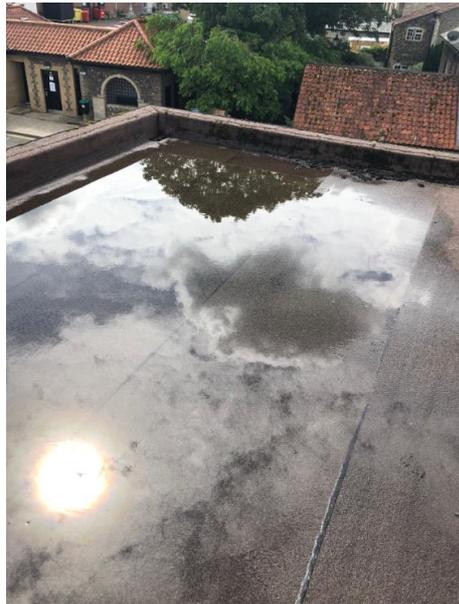
Photo 10 – Ponding to additional flat roof area above the offices

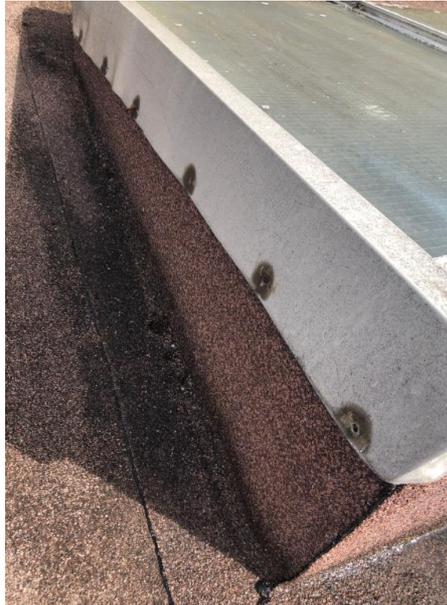
Photo 11 – Roof light flashing and missing screws to flat roof area above the offices

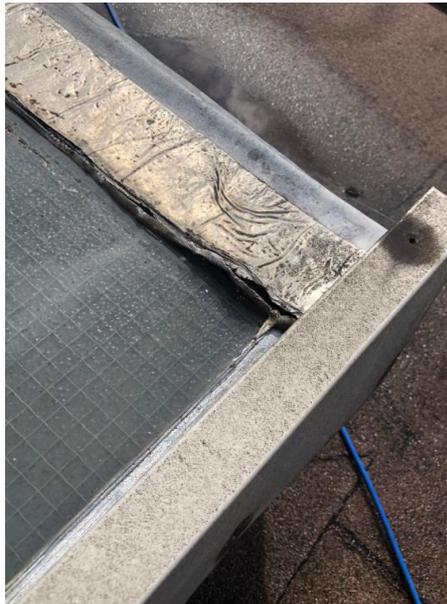
Photo 12 – Roof light membrane failure and gap to roof light frame to flat roof area above the offices

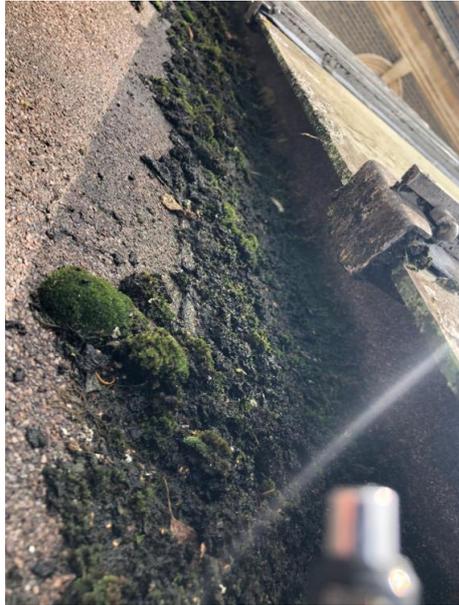
Photo 13 – Moss building up beneath the roof lights upstand to flat roof area above the offices

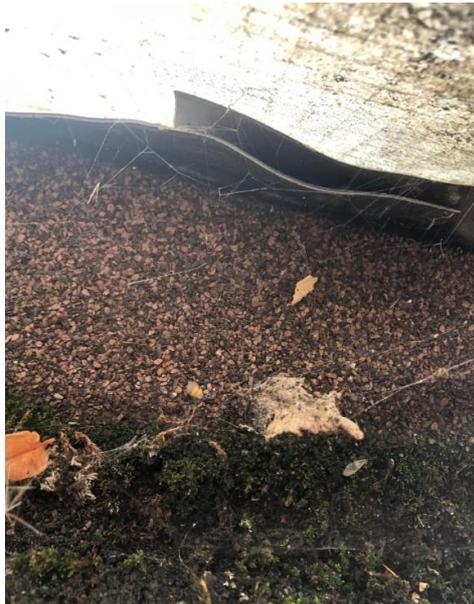
Photo 14 - Moss building up beneath the roof lights upstand and flashing loose beneath roof light to flat roof area above the offices

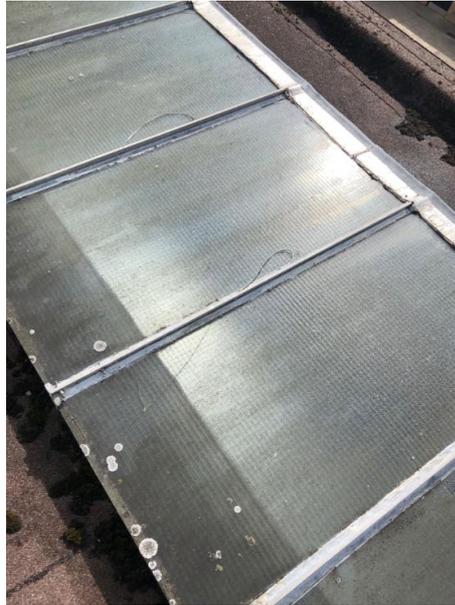
Photo 15 – Condition of roof lights (cracked glazing) to flat roof area above the offices

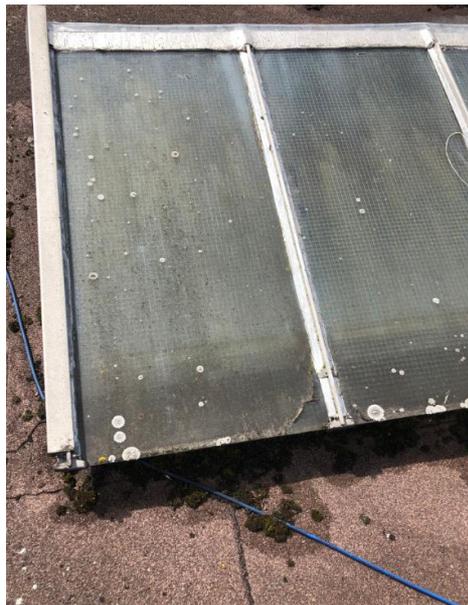
Photo 16 – Condition of roof lights (cracked glazing) to flat roof area above the offices

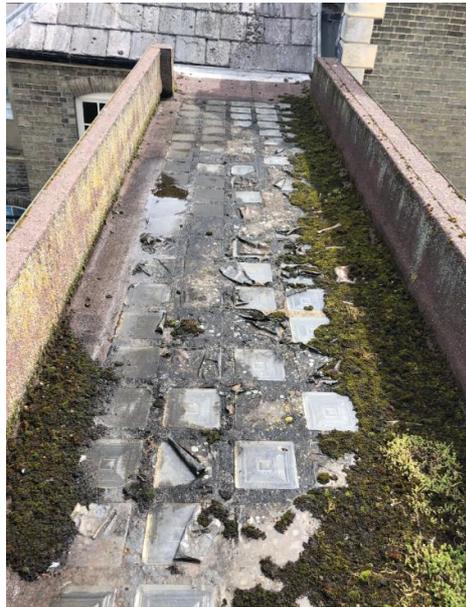
Photo 17 – Condition of link area with adjacent building. Protective film to glass panes delaminating and heavy moss build up

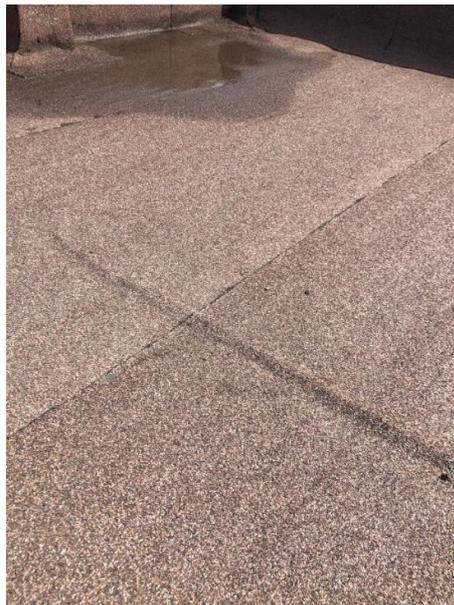
Photo 18 – Thermal movement crease to flat roof area above offices and stairwell

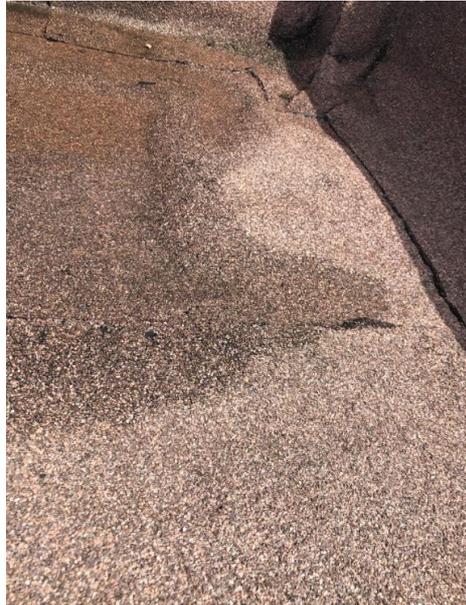
Photo 19 – Blistering to corner of parapet upstand to flat roof area above offices and stairwell

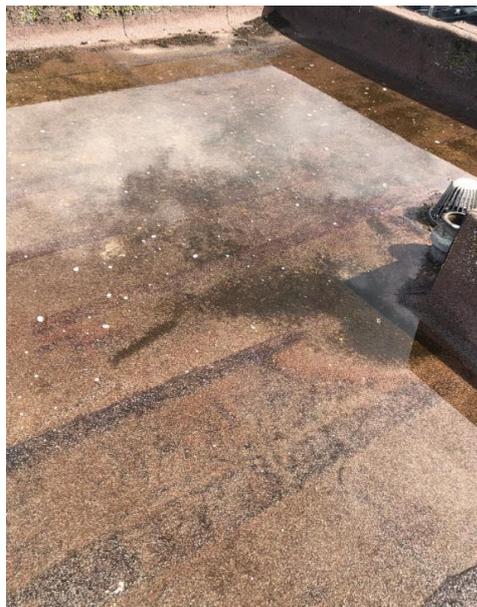
Photo 20 – Ponding to flat roof area and lack of drainage to flat roof area above offices and stairwell

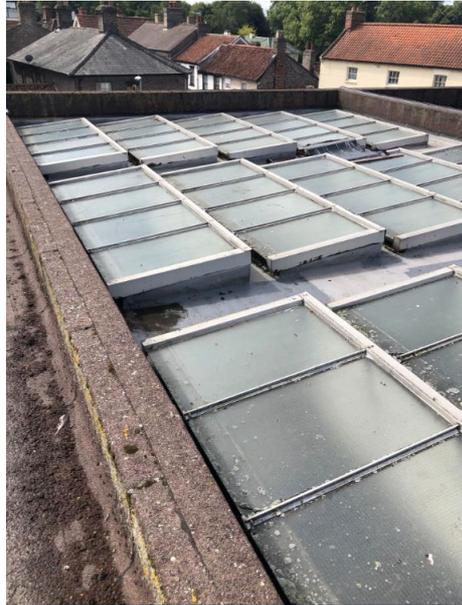
Photo 21 – Condition of roof lights to flat PVC roof area above offices/kitchenette

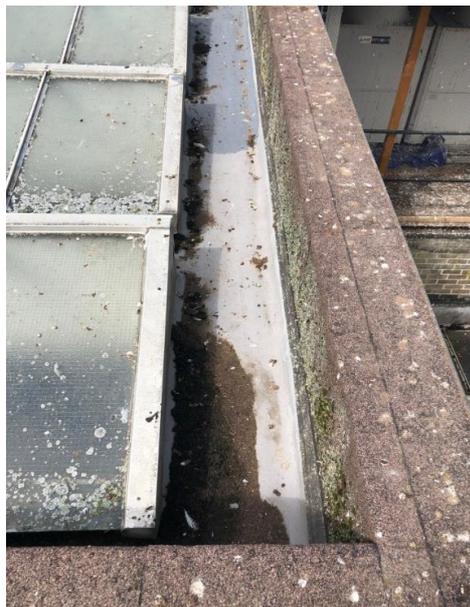
Photo 22 – Debris building up and ponding around roof light perimeter to flat rubber membrane roof area above offices/kitchenette

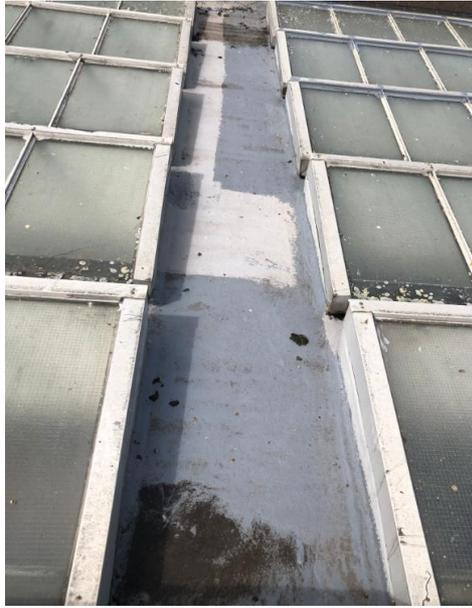
Photo 23 – Evidence of previous patch repair to flat rubber membrane roof area above offices/kitchenette

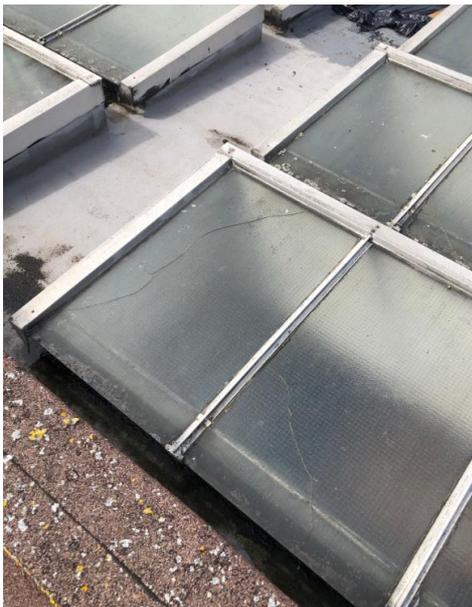
Photo 24 – Cracked glazing panels to roof lights to flat rubber membrane roof area above offices/kitchenette

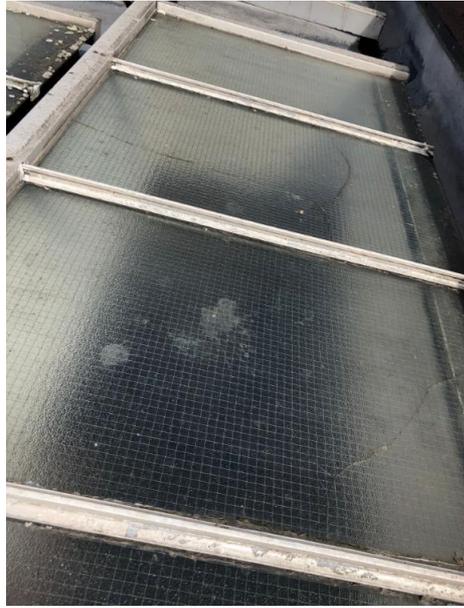
Photo 25 – Further cracked glazing panels to roof lights to flat rubber membrane roof area above offices/kitchenette

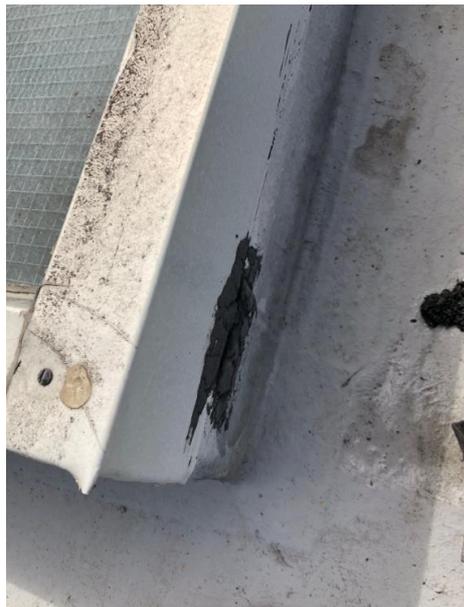
Photo 26 – Cracks to mastic and roof light/flat roof abutment to flat rubber membrane roof area above offices/kitchenette

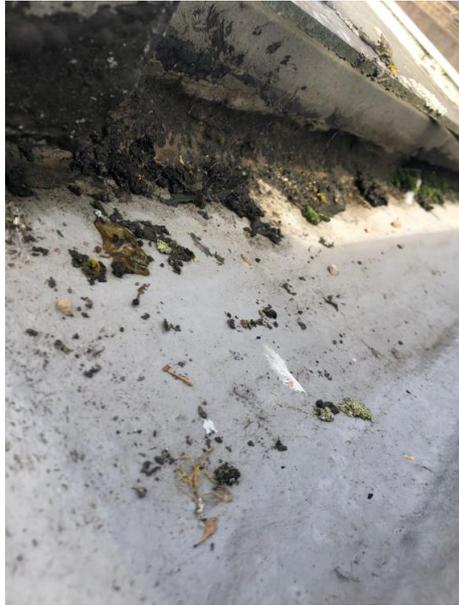
Photo 27 – Moss and moisture build up beneath roof light glazing to the upstand to flat rubber membrane roof area above offices/kitchenette

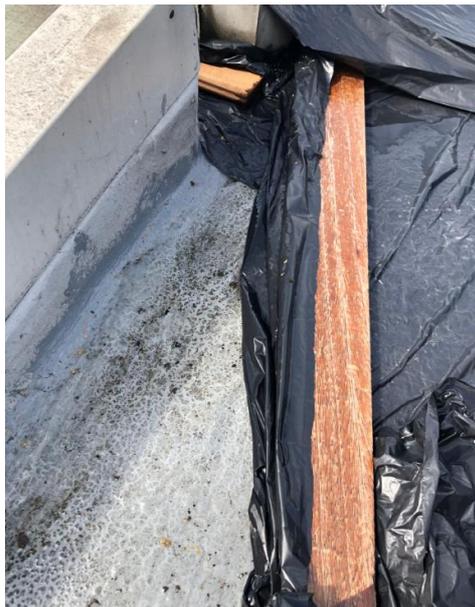
Photo 28 – Temporary repair to flat rubber membrane roof area above offices/kitchenette

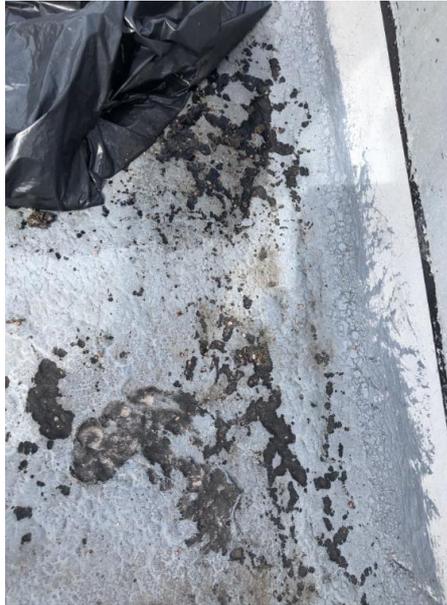
Photo 29 – Roof surface alligating/delamination to flat rubber membrane roof area above offices/kitchenette

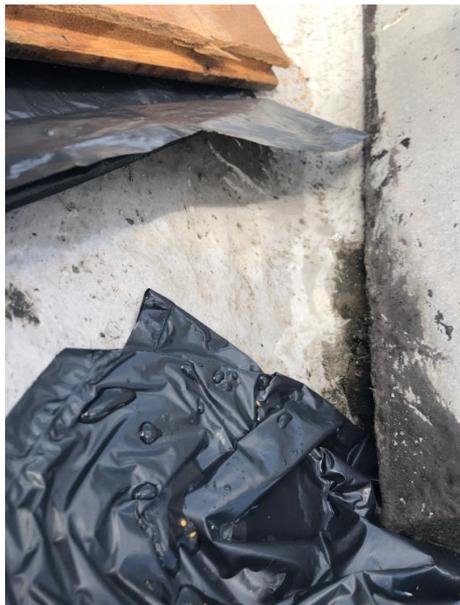
Photo 30 – Mastic seal failure to corner of roof light to flat rubber membrane roof area above offices/kitchenette

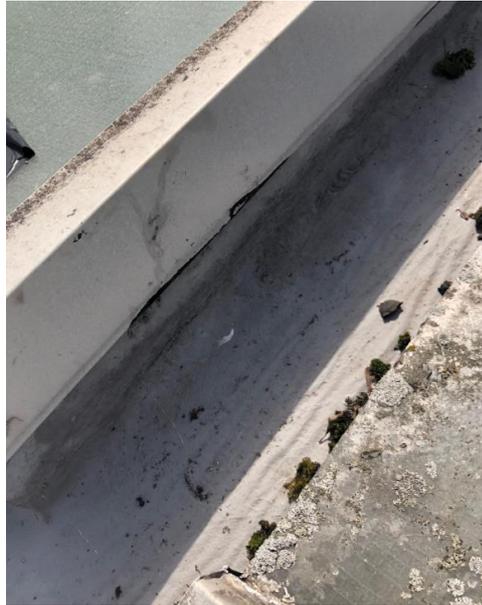
Photo 31 – Gap between roof upstand and roof light to flat rubber membrane roof area above offices/kitchenette

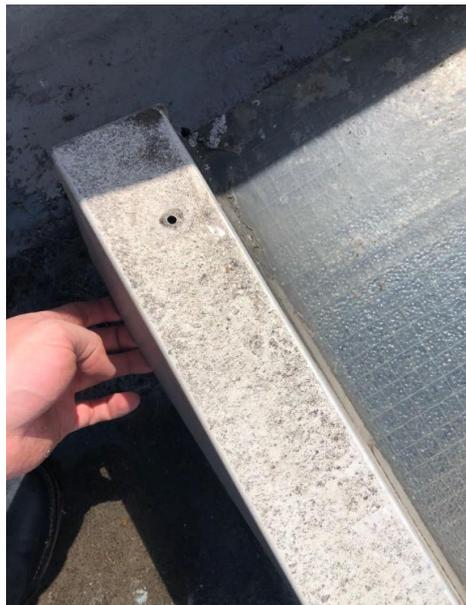
Photo 32 – Missing screws to roof light capping to flat rubber membrane roof area above offices/kitchenette

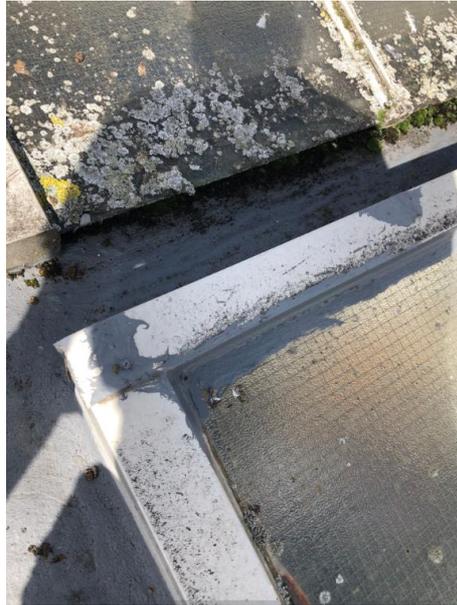
Photo 33 – Evidence of previous roof light seal repair to flat rubber membrane roof area above offices/kitchenette

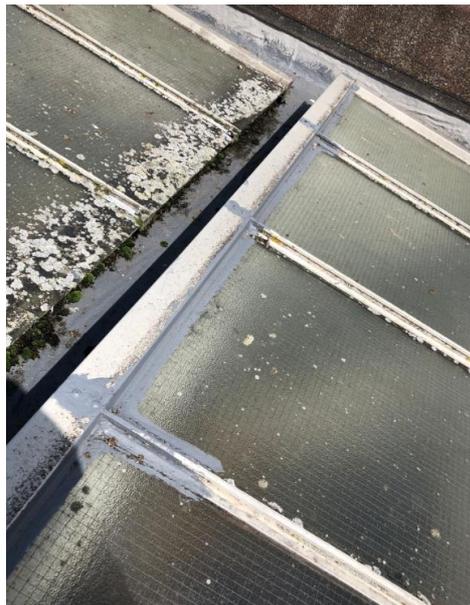
Photo 34 – Further evidence of previous roof light seal repair to flat rubber membrane roof area above offices/kitchenette

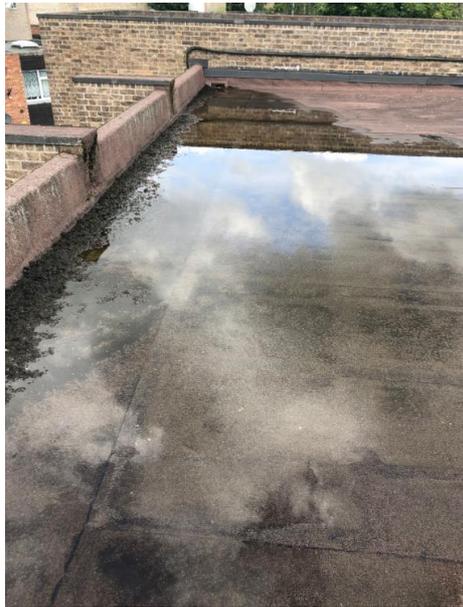
Photo 35 – Ponding to flat roof area above the Carnegie room

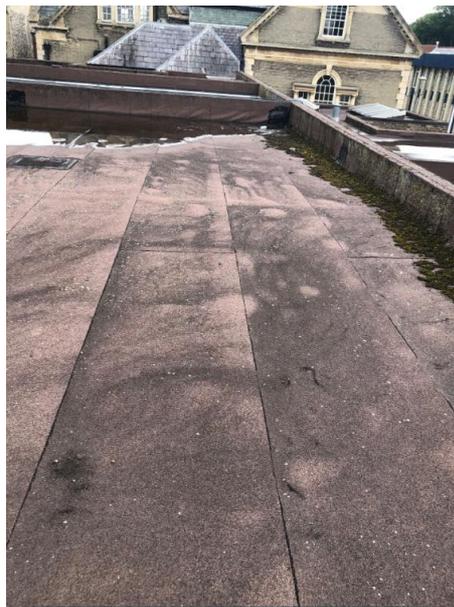
Photo 36 – Blistering and surface weathering to flat roof area above the Carnegie room

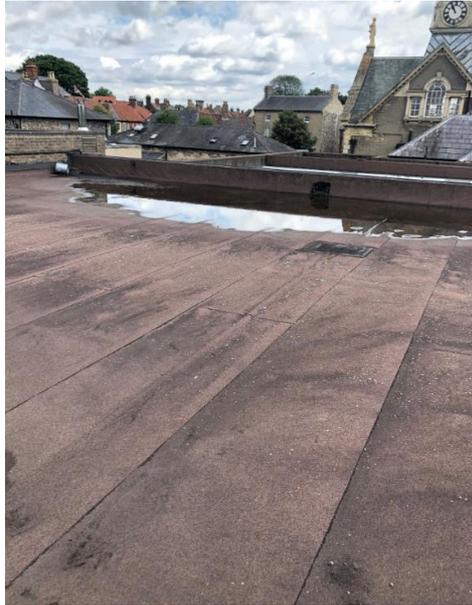
Photo 37 – Thermal movement creases, ponding and surface weathering to flat roof area above the Carnegie room

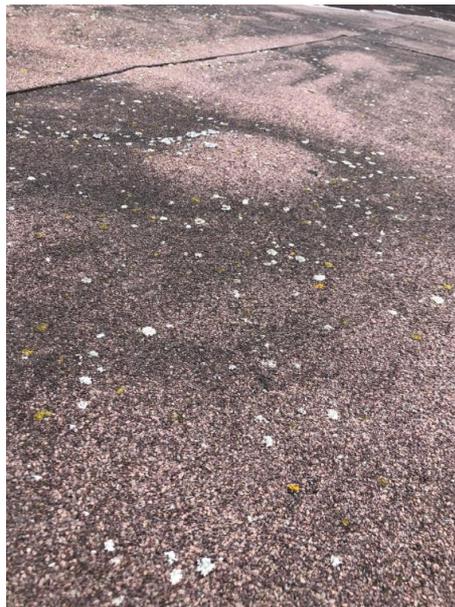
Photo 38 – Blistering to flat roof area above the Carnegie room

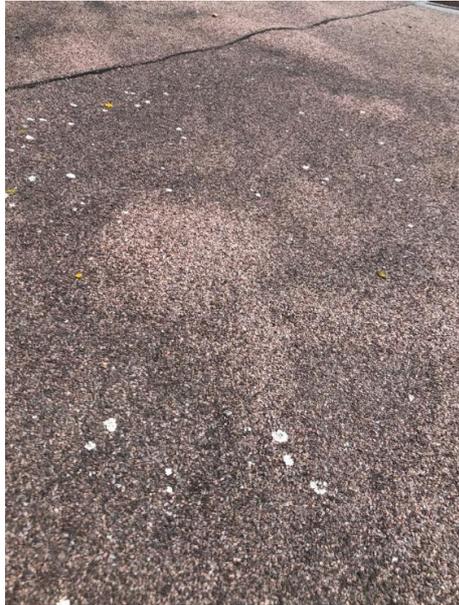
Photo 39 – Blistering to flat roof area above the Carnegie room

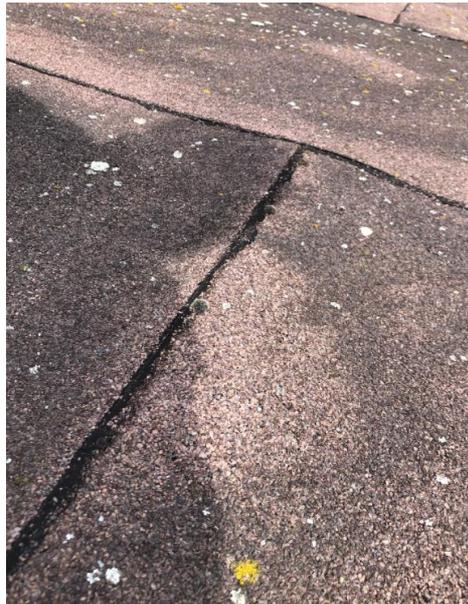
Photo 40 – Blistering beneath felt joints to flat roof area above the Carnegie room

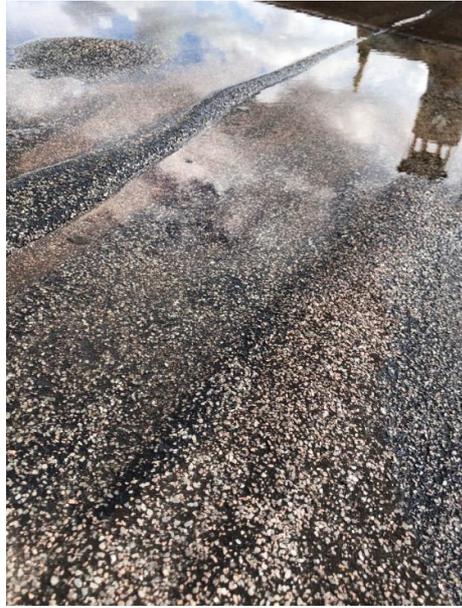
Photo 41 – Blistering, ponding and thermal movement creases to flat roof area above the Carnegie room

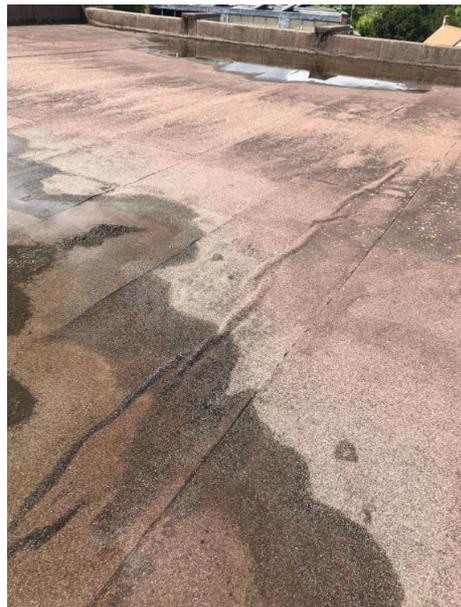
Photo 42 – Thermal movement creases and surface weathering to flat roof area above the Carnegie room

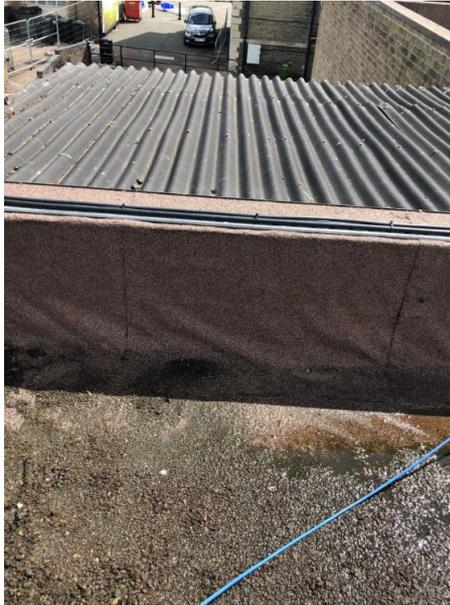
Photo 43 – Thermal movement creases to upstands on flat roof area above the Carnegie room

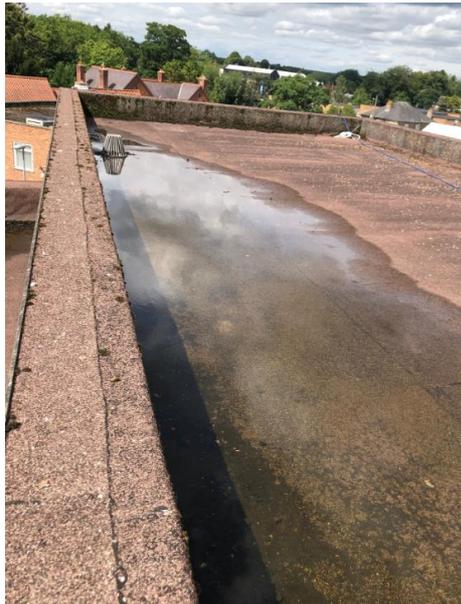
Photo 44 – Ponding to flat roof area above the stage area

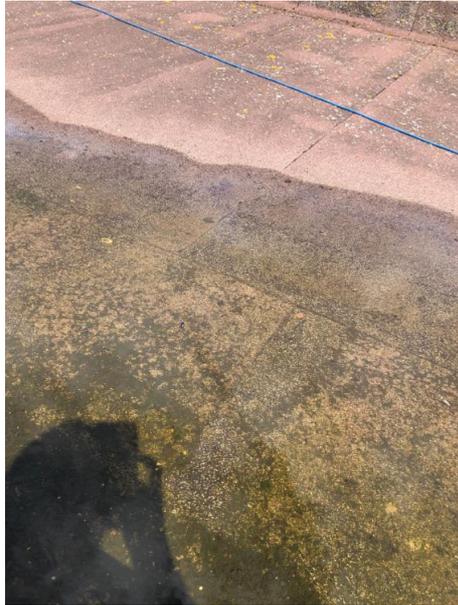
Photo 45 – Ponding and blistering to flat roof area above the stage area

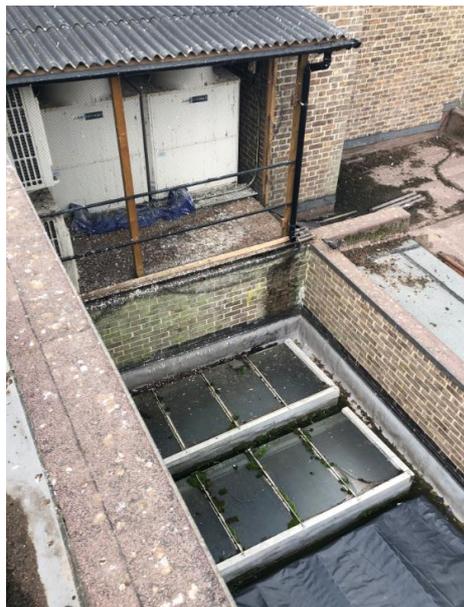
Photo 46 – Roof lights and PVC roofing above the kitchen area (access not available at time of survey)

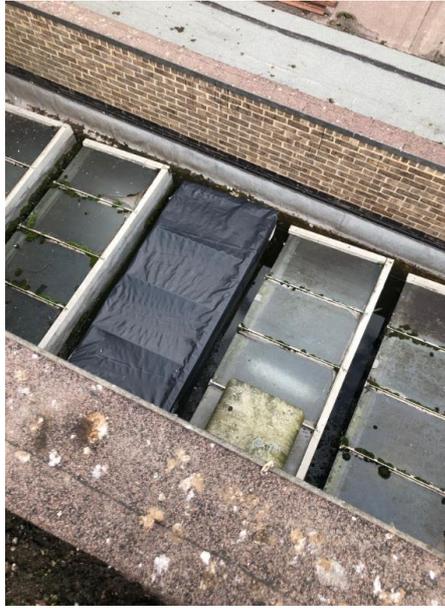
Photo 47 – Roof lights and PVC roofing with temporary repair above the kitchen area (access not available at time of survey)

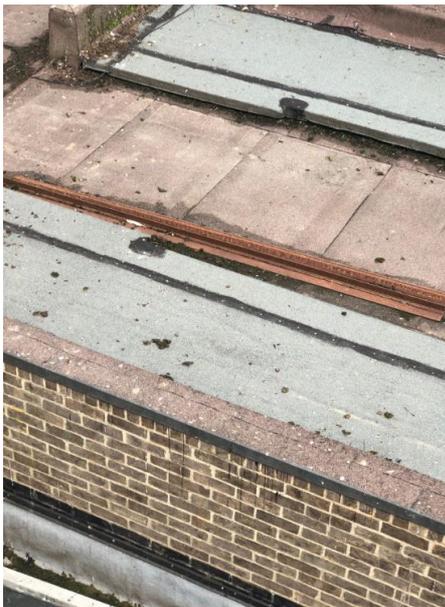
Photo 48 – Flat roof area above dressing room area (access not available at time of survey)

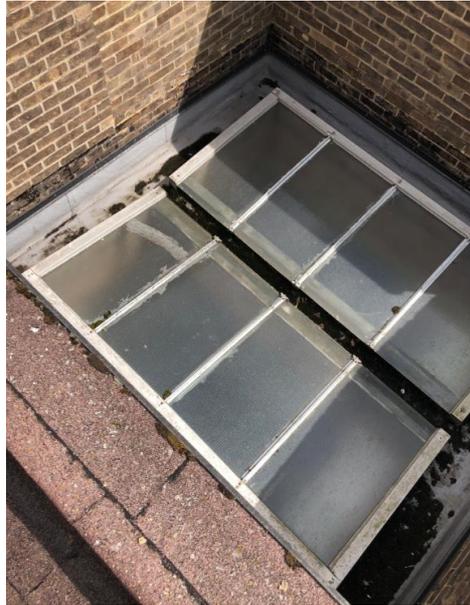
Photo 49 – Roof lights and PVC roofing above toilet corridor (access not available at time of survey)

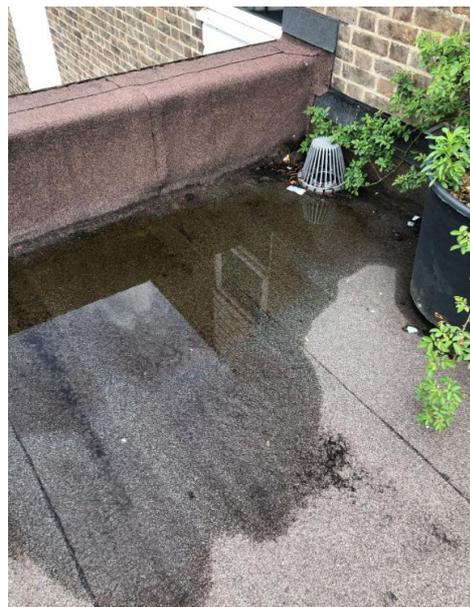
Photo 50 – Ponding around drainage outlet to flat roof area above caretaker office/foyer area

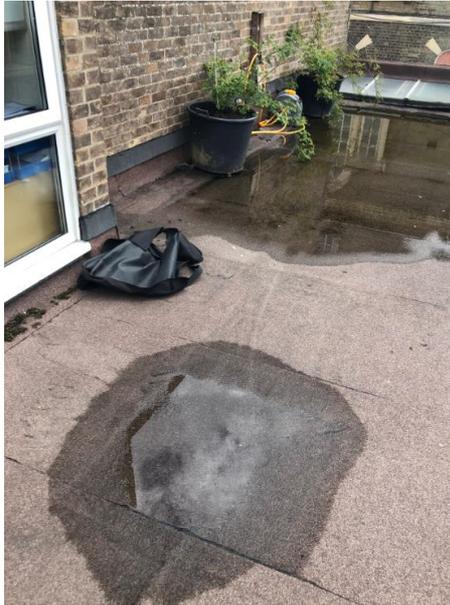
Photo 51 – Ponding and blistering to flat roof area above caretaker office/foyer area

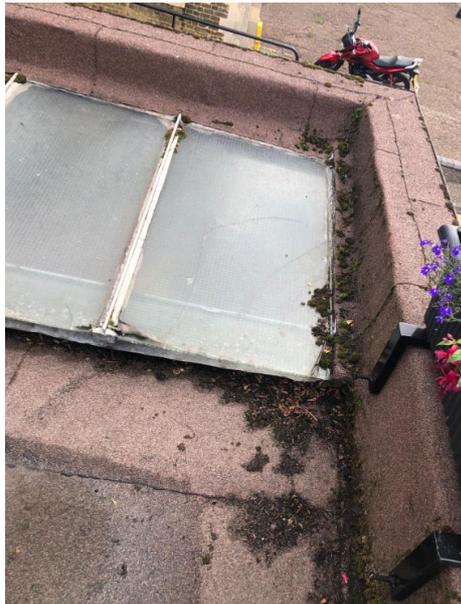
Photo 52 – Condition of roof lights to flat roof area above caretaker office/foyer area

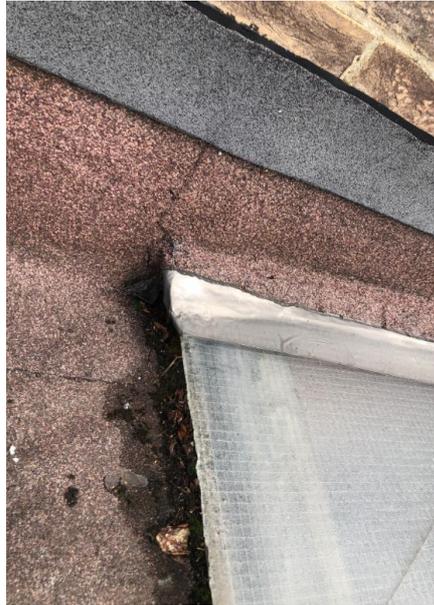
Photo 53 – Evidence of flash band repair to roof lights to flat roof area above caretaker office/foyer area

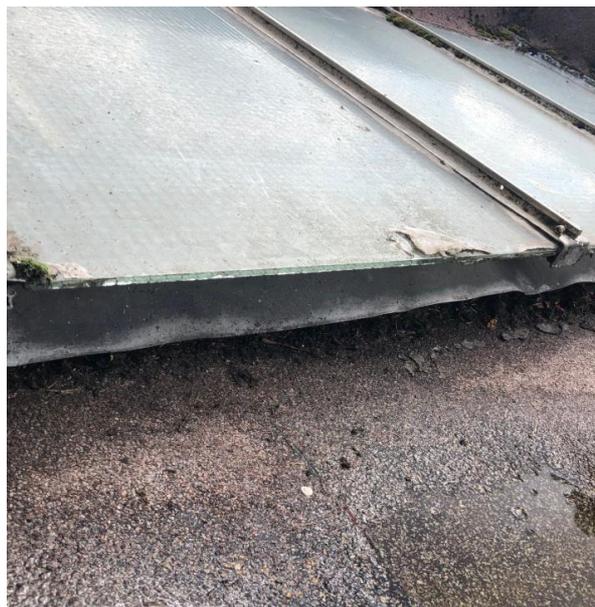
Photo 54 – Condition of flashing to roof lights to flat roof area above caretaker office/foyer area

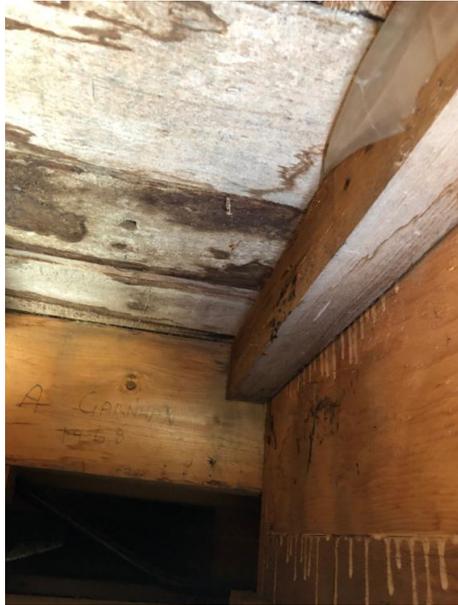
Photo 55 – Condition of roof deck and evidence of water staining within roof structure in office area

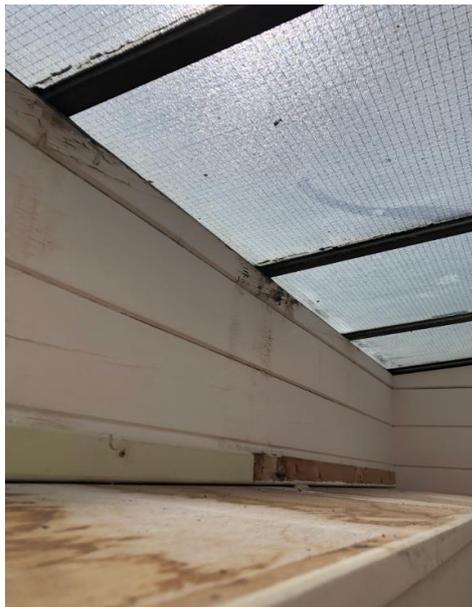
Photo 56 – Evidence of water staining and moisture ingress evidence to roof lights in office area
