Annual Inspection

Surrey Heath Borough Council

School Lane Field

School Lane, Bagshot, GU19 5BP

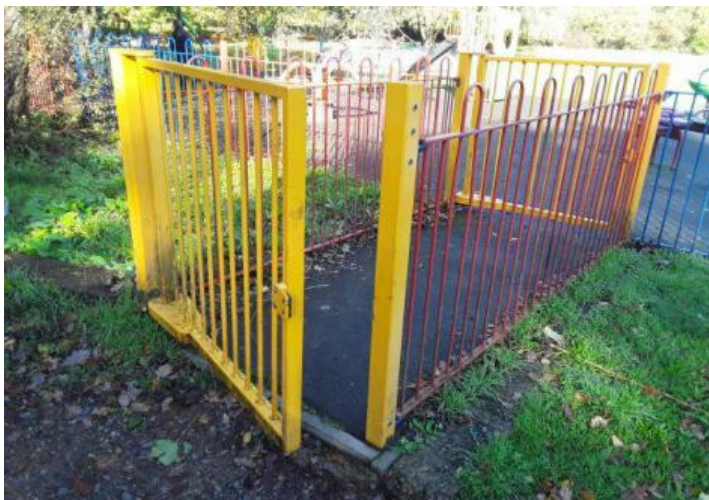
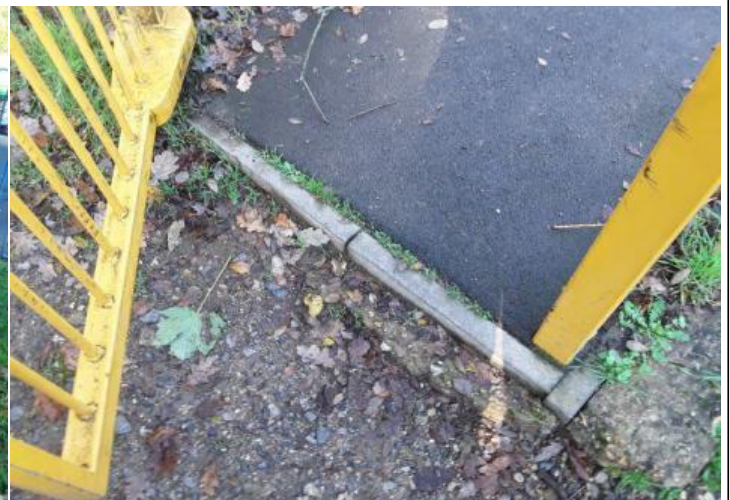
Item: Gates - Gate - Self Closing
Manufacturer: I.A.E. Fencing

The area under the gate has eroded leaving uneven areas, or the concrete foundations exposed, resulting in trip hazards at the entrance/exit to the playground - Reinststate to level with surrounding surfaces

Finding: The area under the gate has eroded leaving uneven areas, or the concrete foundations exposed, resulting in trip hazards at the entrance/exit to the playground

Action: Reinstate to level with surrounding surfaces

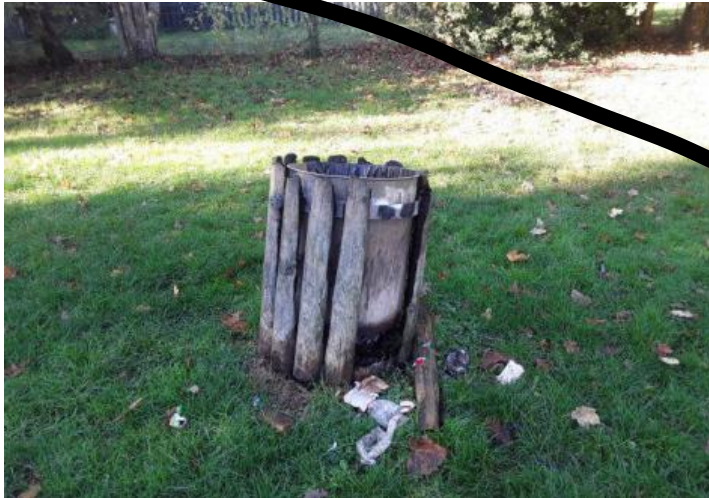
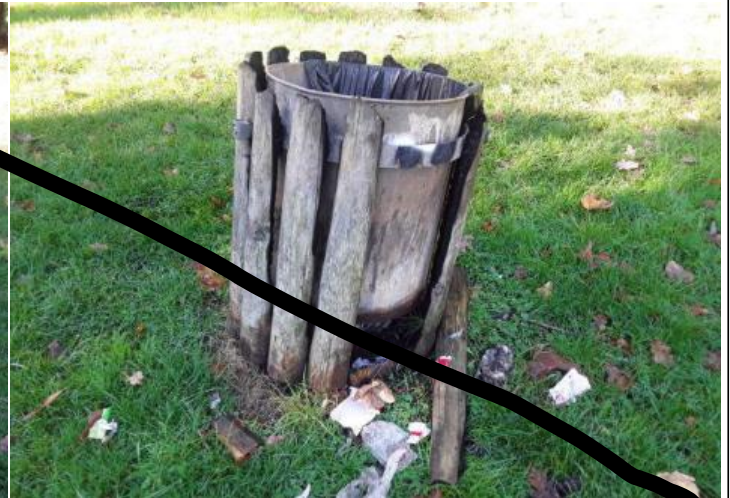
Item: Ancillary Items - Litter Bin
Manufacturer: Not Identified

There is some evidence of fire damage to the item - Replace

Finding: There is some evidence of fire damage to the item **Action:** Replace

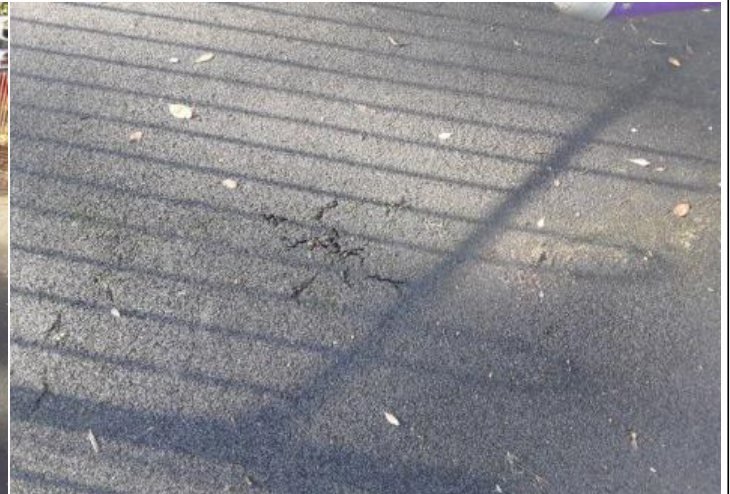
Item: Rocking Equipment - See Saw
Manufacturer: Wicksteed Playgrounds

Finding: There is some minor damage to the surface **Action:** Monitor for any further deterioration and repair as required

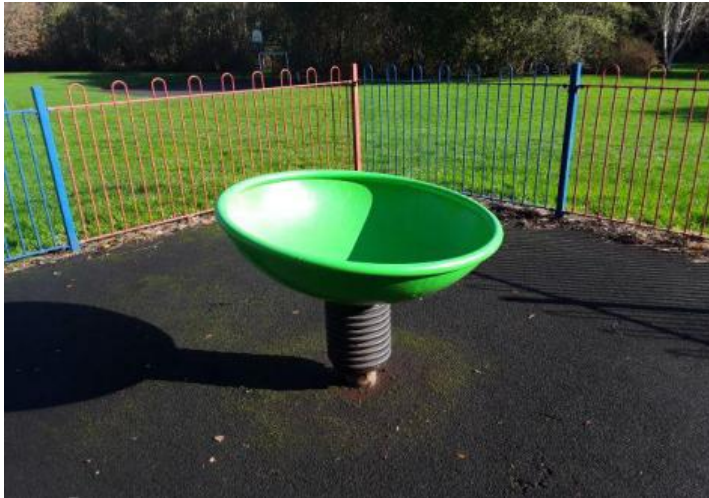
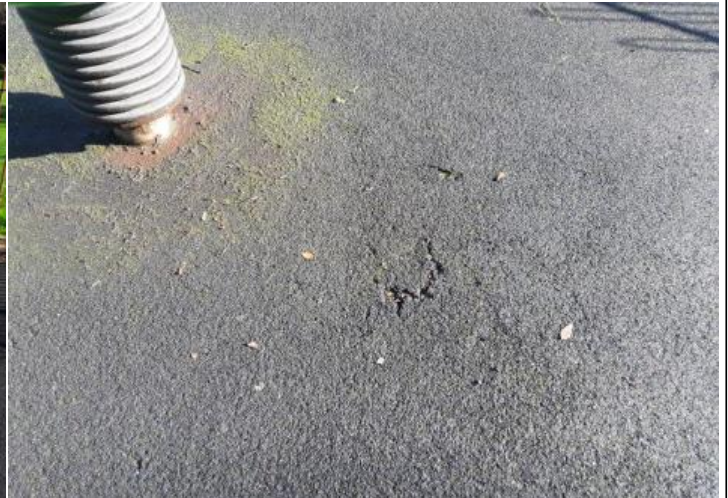
Item: Rotor Play - Spinner Bowl
Manufacturer: Wicksteed Playgrounds

Finding: There is some minor damage to the surface

Action: Monitor for any further deterioration and repair as required

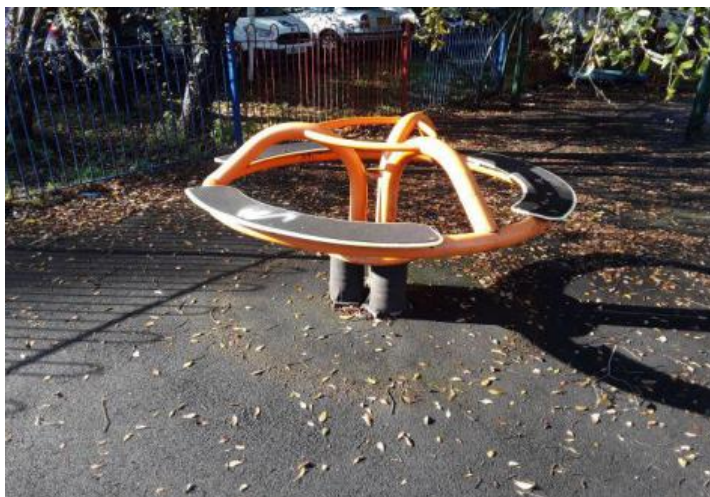
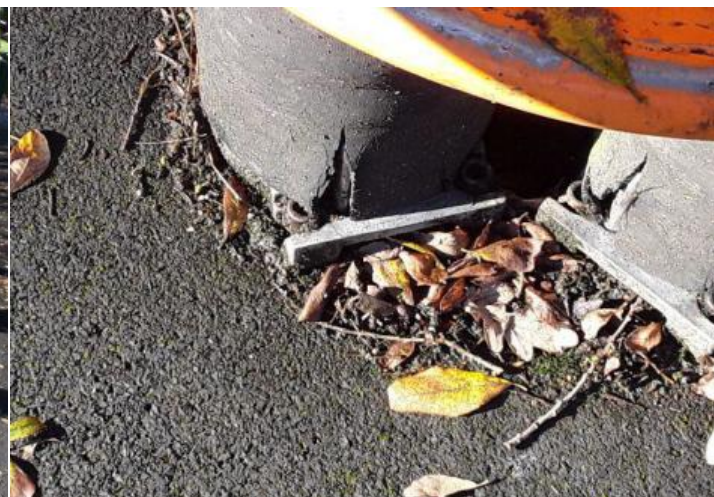
Item: Rocking Equipment - Misc Springer
Manufacturer: Wicksteed Playgrounds

There is some damage to the spring gaiters - Monitor for any further deterioration and replace as required

Finding: There is some damage to the spring gaiters

Action: Monitor for any further deterioration and replace as required

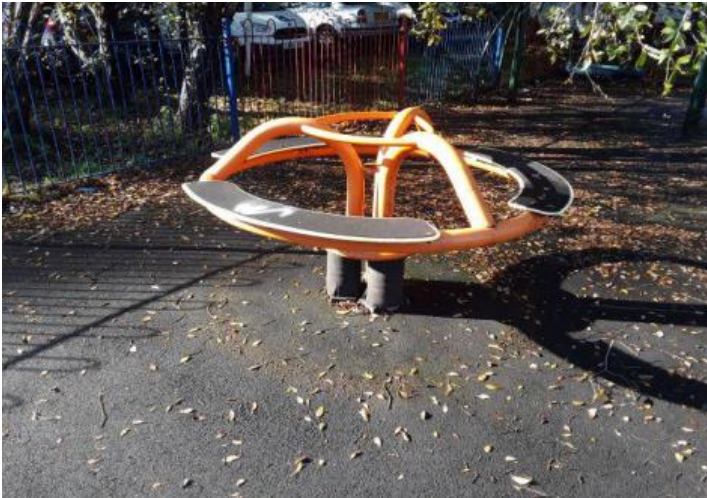
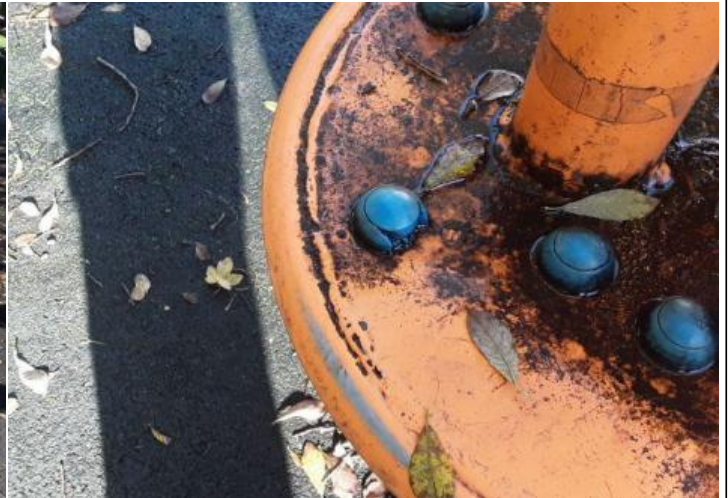
Item: Rocking Equipment - Misc Springer
Manufacturer: Wicksteed Playgrounds

There is/are bolt cap covers missing or damaged on the item - Replace missing or damaged bolt cap covers

Finding: There is/are bolt cap covers missing or damaged on the item

Action: Replace missing or damaged bolt cap covers

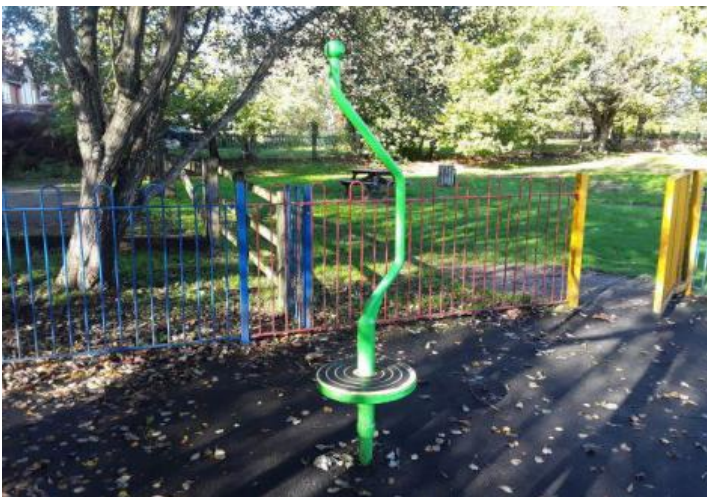
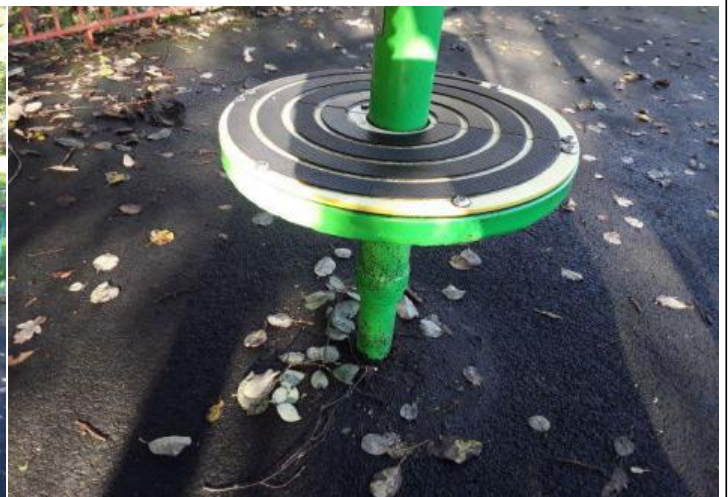
Item: Rotor Play - Spinning Pole
Manufacturer: Wicksteed Playgrounds

The bearing is showing signs of wear - Monitor for any further deterioration and replace as required

Finding: The bearing is showing signs of wear

Action: Monitor for any further deterioration and replace as required

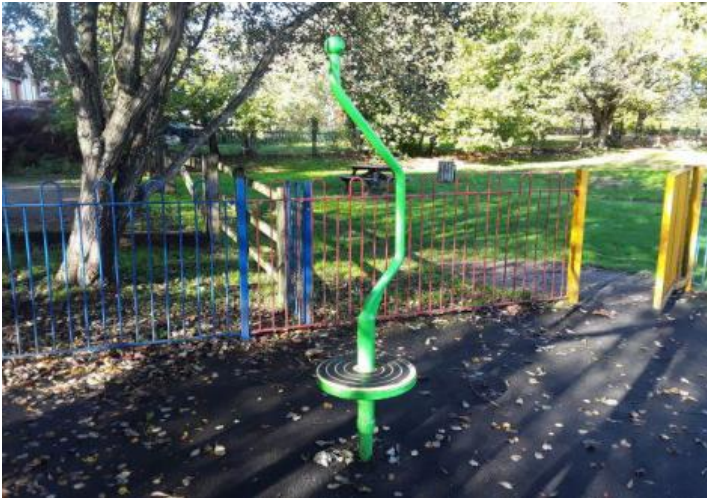
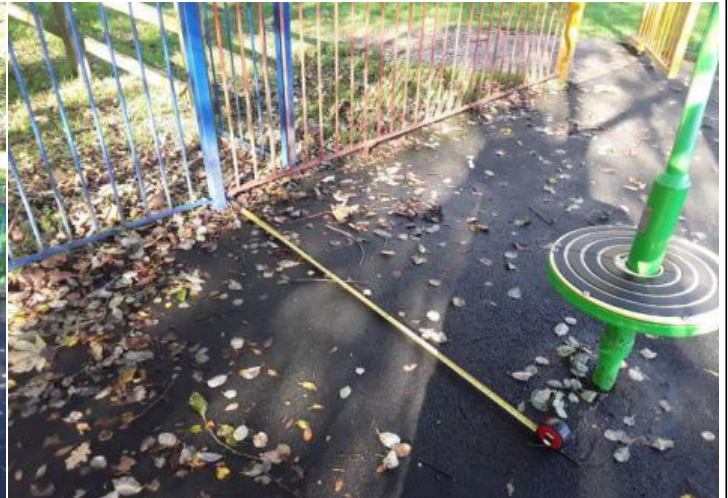
Item: Rotor Play - Spinning Pole
Manufacturer: Wicksteed Playgrounds

The fencing forms a hard object within the falling space of the equipment and there is also insufficient surfacing provided in contravention of BS EN 1176 Part 1 - Monitor - no remedial work recommended

Finding: The fencing forms a hard object within the falling space of the equipment and there is also insufficient surfacing provided in contravention of BS EN 1176 Part 1

Action: Monitor - no remedial work recommended

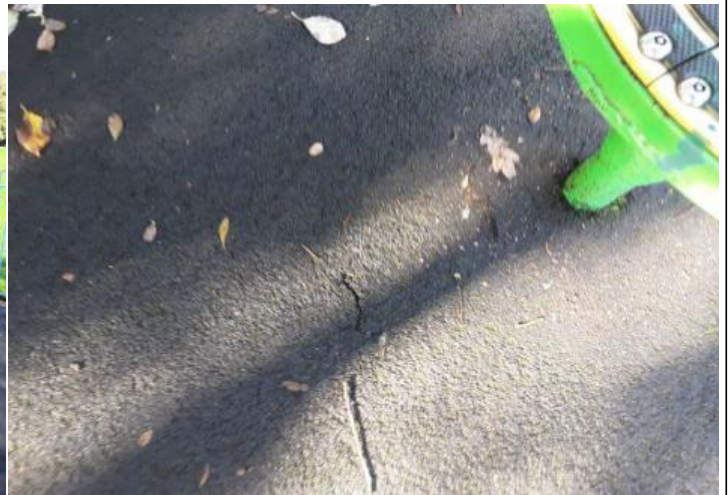
Item: Rotor Play - Spinning Pole
Manufacturer: Wicksteed Playgrounds

Finding: There is some minor damage to the surface

Action: Monitor for any further deterioration and repair as required

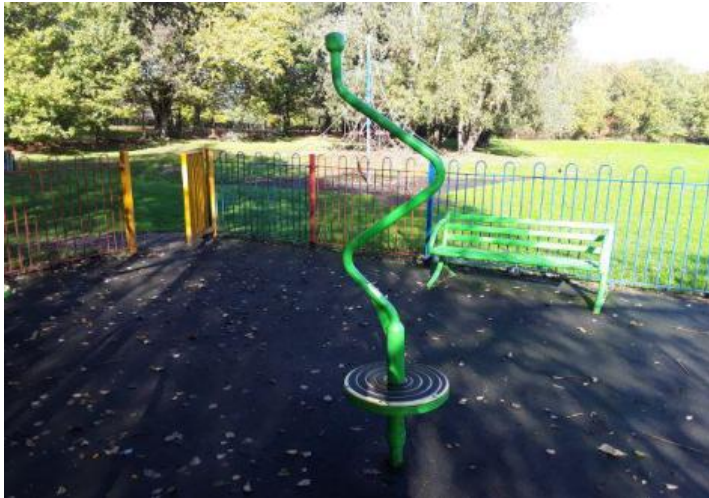
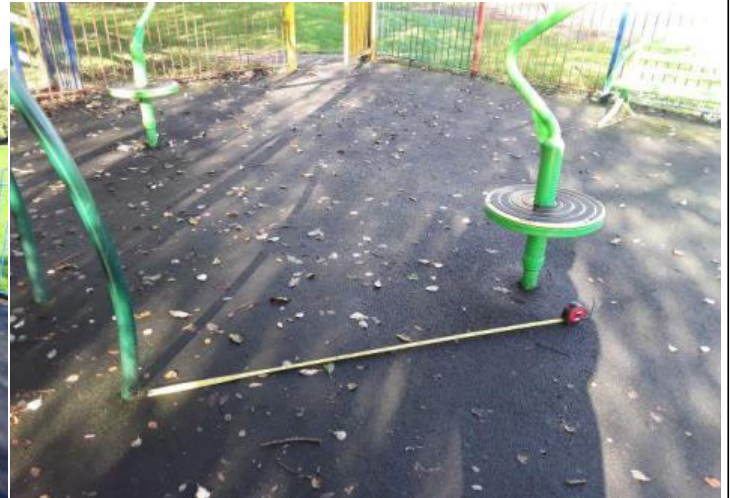
Item: Rotor Play - Spinning Pole
Manufacturer: Wicksteed Playgrounds

The swing frame forms a hard object within the falling space of the equipment in contravention of the requirements of BS EN 1176 Part 1 - Monitor - No remedial work recommended

Finding: The swing frame forms a hard object within the falling space of the equipment in contravention of the requirements of BS EN 1176 Part 1

Action: Monitor - No remedial work recommended

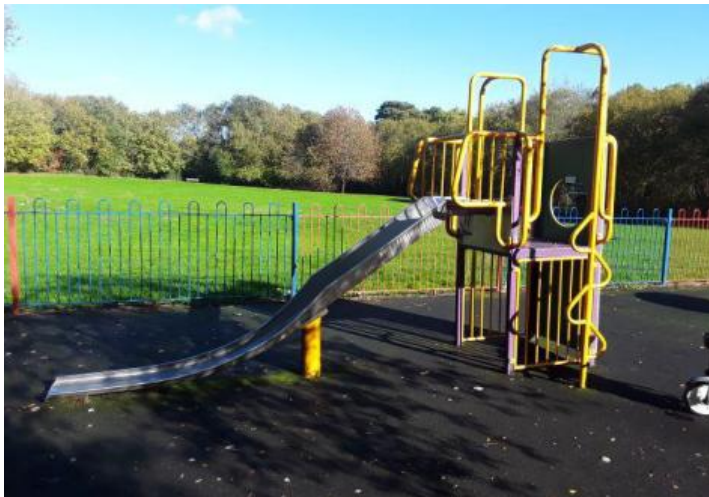
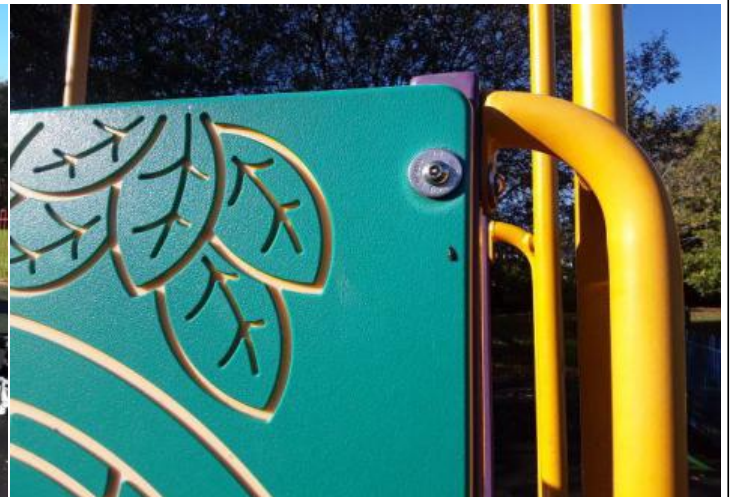
Item: Activity Equipment - Multi Play (Junior)
Manufacturer: Wicksteed Playgrounds

A number of fixing(s) have worked loose - Secure all loose fixings

Finding: A number of fixing(s) have worked loose

Action: Secure all loose fixings

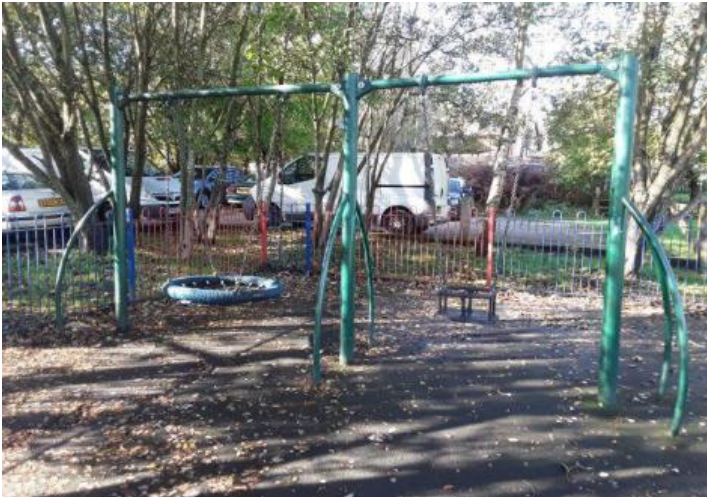
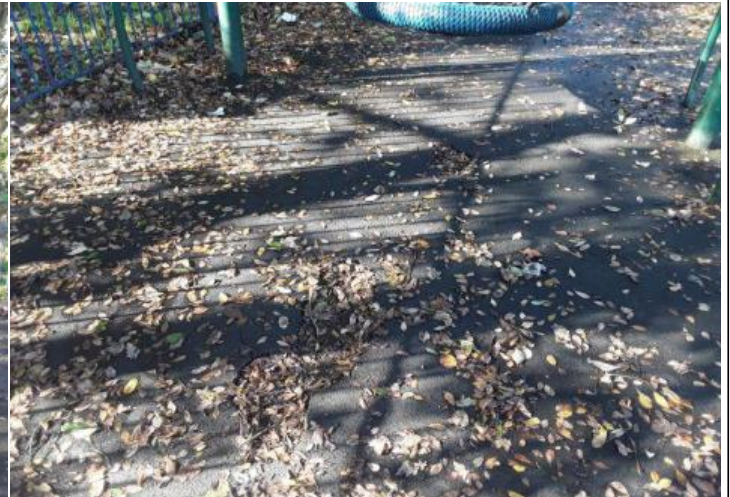
Item: Swings - 2 Bay Swing
Manufacturer: Wicksteed Playgrounds

Finding: There is moderate damage to the surface

Action: Repair the damaged areas of surfacing

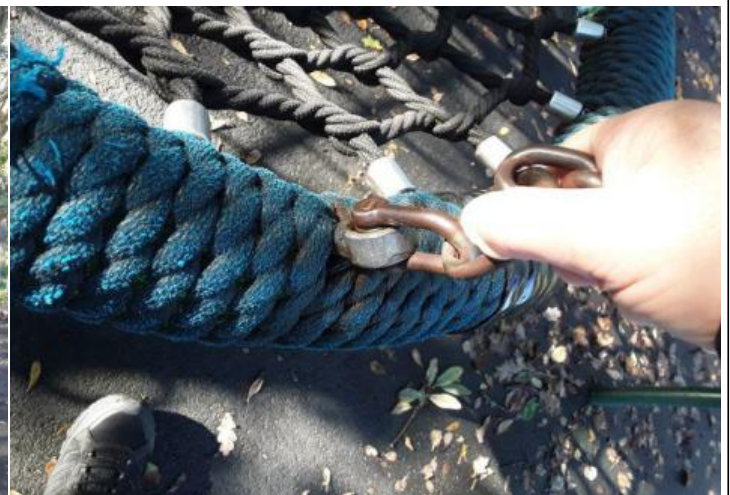
Item: Swings - 2 Bay Swing
Manufacturer: Wicksteed Playgrounds

There is some notable evidence of chain wear - Monitor for any further deterioration and replace when 40% worn

Finding: There is some notable evidence of chain wear

Action: Monitor for any further deterioration and replace when 40% worn

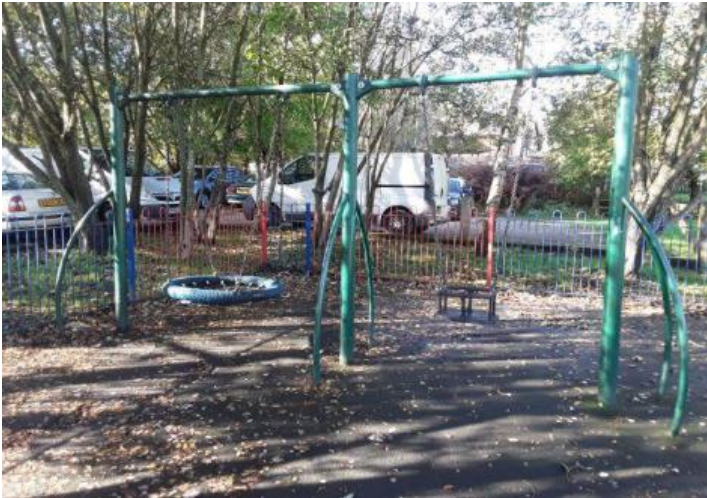
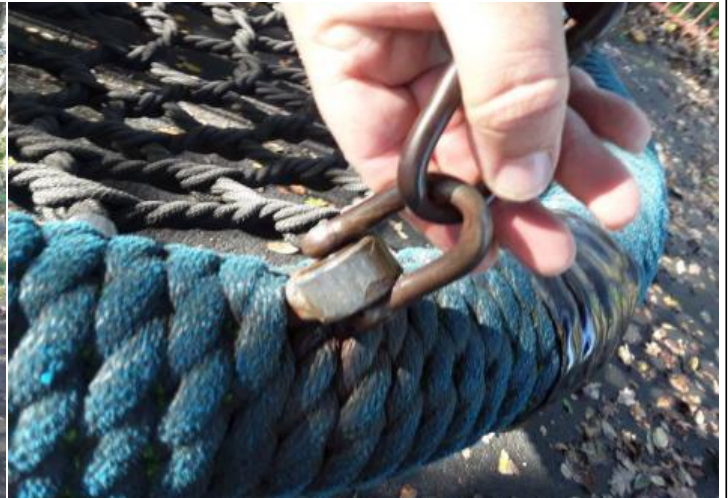
Item: Swings - 2 Bay Swing
Manufacturer: Wicksteed Playgrounds

There is some wear to the shackles. - Monitor for any further deterioration and replace when 40% worn

Finding: There is some wear to the shackles.

Action: Monitor for any further deterioration and replace when 40% worn

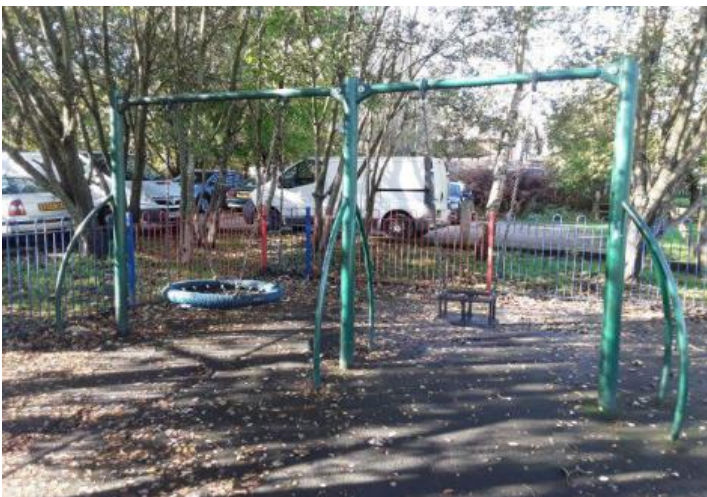
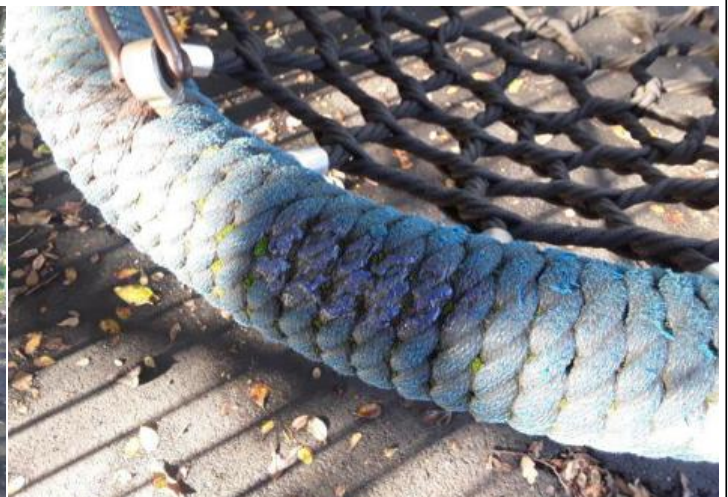
Item: Swings - 2 Bay Swing
Manufacturer: Wicksteed Playgrounds

There is some evidence of fire damage to the item - Monitor for any further deterioration and repair as required

Finding: There is some evidence of fire damage to the item

Action: Monitor for any further deterioration and repair as required

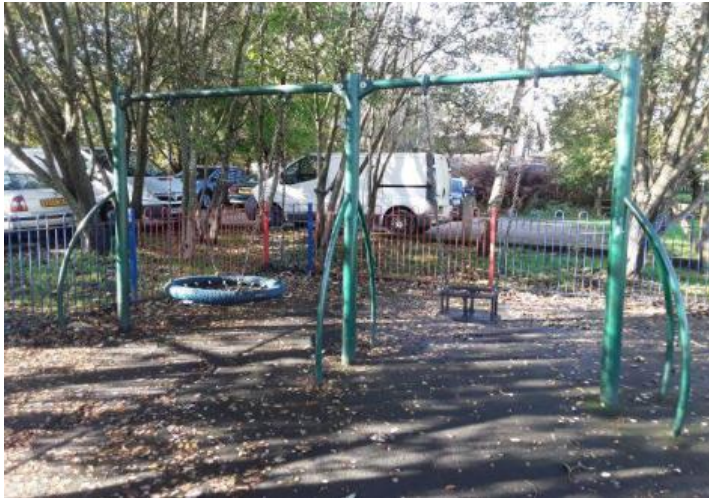
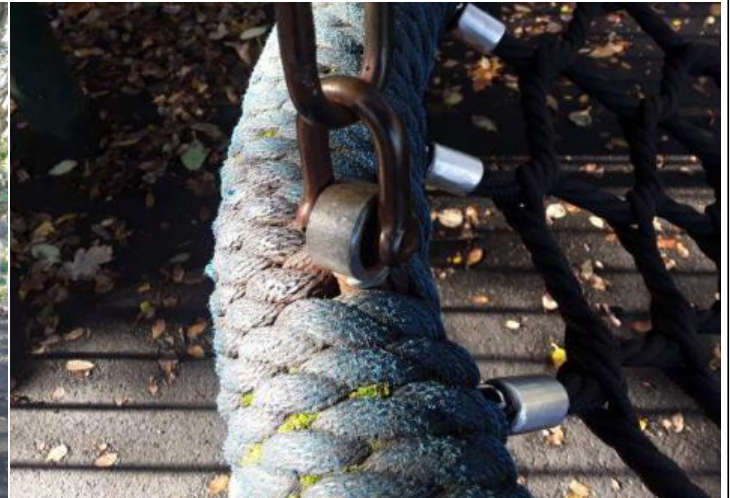
Item: Swings - 2 Bay Swing
Manufacturer: Wicksteed Playgrounds

The seat bushes are showing signs of wear - Monitor for any further deterioration and replace as required

Finding: The seat bushes are showing signs of wear

Action: Monitor for any further deterioration and replace as required

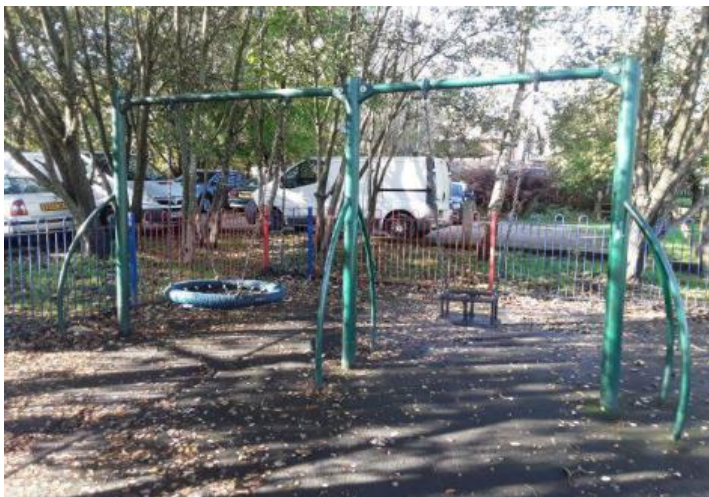
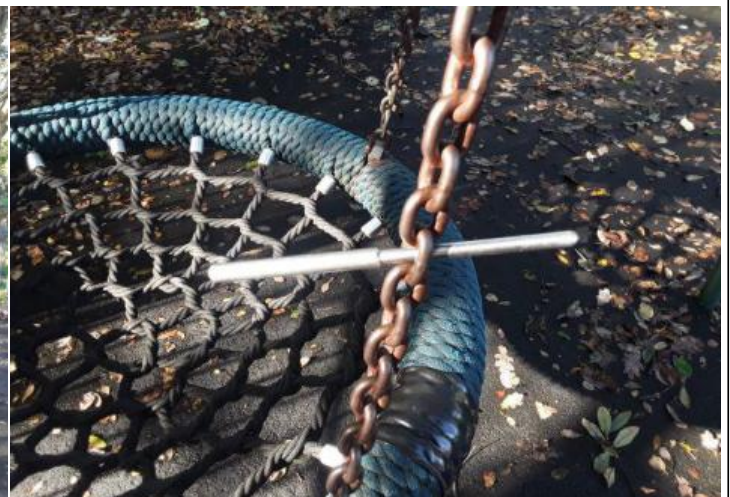
Item: Swings - 2 Bay Swing
Manufacturer: Wicksteed Playgrounds

The chain openings are in excess of the 8.6mm as recommended by BS EN 1176 - Monitor - No remedial work recommended

Finding: The chain openings are in excess of the 8.6mm as recommended by BS EN 1176

Action: Monitor - No remedial work recommended

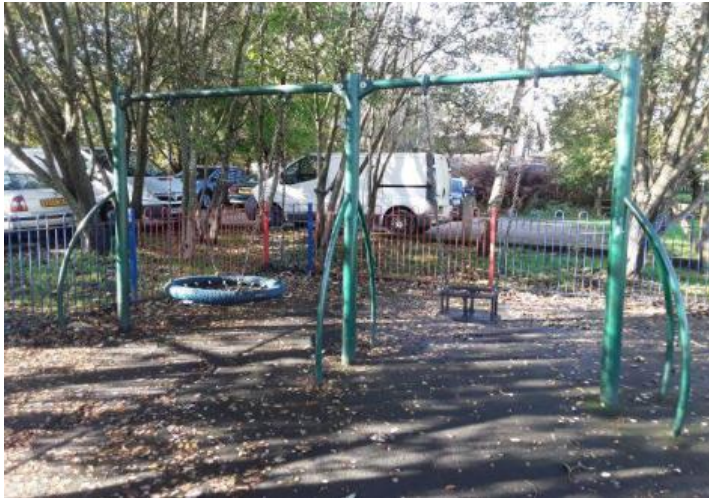
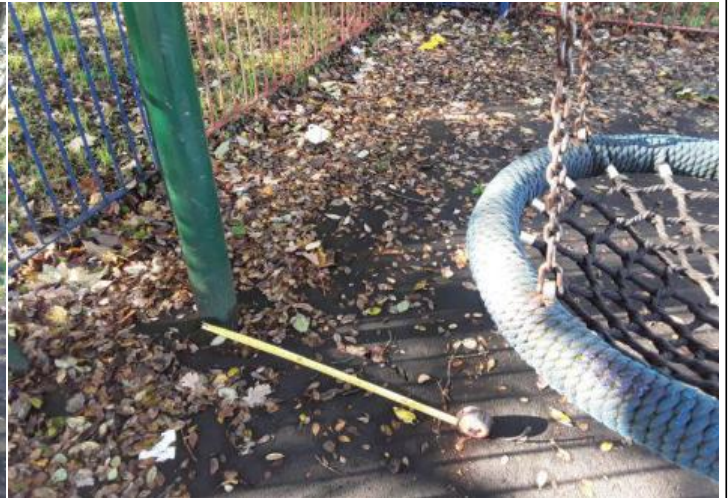
Item: Swings - 2 Bay Swing
Manufacturer: Wicksteed Playgrounds

The seats are too close to the frame as defined in BS EN 1176 Part 2; this is a low risk failure and no remedial action is required - Monitor - No remedial work recommended

Finding: The seats are too close to the frame as defined in BS EN 1176 Part 2; this is a low risk failure and no remedial action is required

Action: Monitor - No remedial work recommended

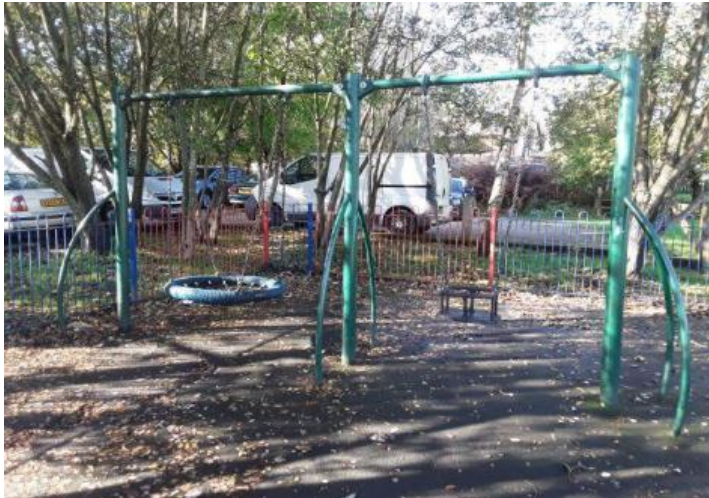
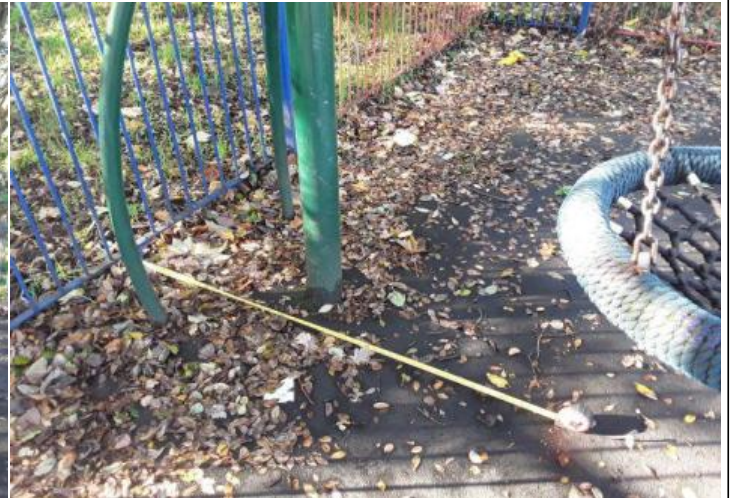
Item: Swings - 2 Bay Swing
Manufacturer: Wicksteed Playgrounds

BS EN 1176 Part 2: Annex A makes a recommendation that fences or enclosures should be upto 1.50m from the edges of the swing seat to the sides, and subject to risk assessment, from the edge of the impact area. This is however, a low risk finding and no remedial action is recommended. - Monitor - No remedial work recommended

Finding: BS EN 1176 Part 2: Annex A makes a recommendation that fences or enclosures should be up to 1.50m from the edges of the swing seat to the sides, and subject to risk assessment, from the edge of the impact area. This is however, a low risk finding and no remedial action is recommended.

Action: Monitor - No remedial work recommended

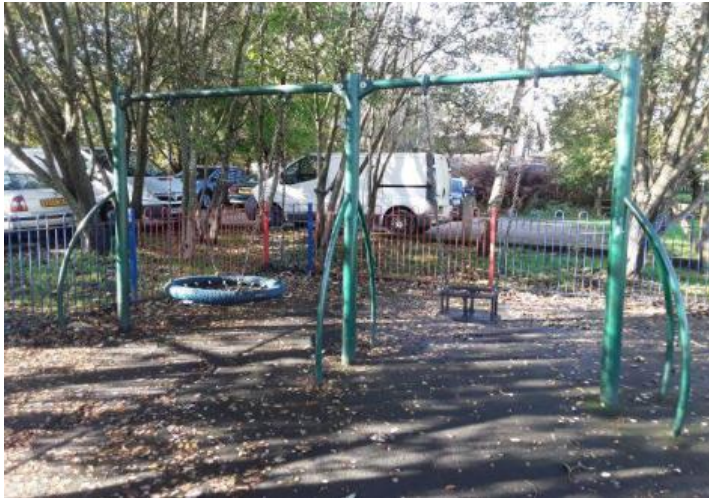
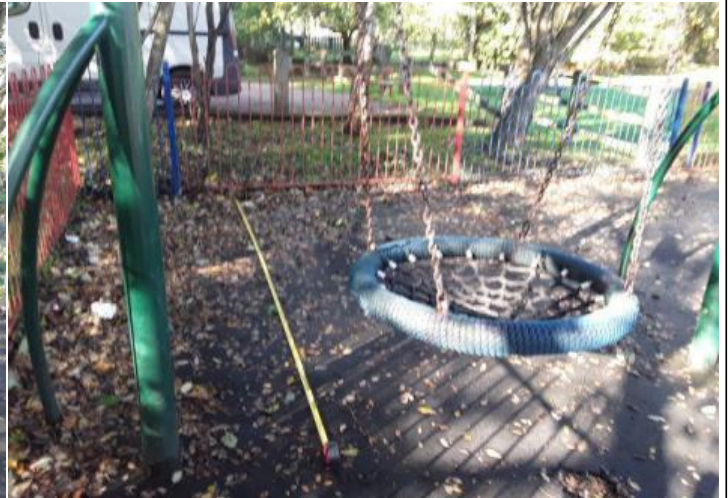
Item: Swings - 2 Bay Swing
Manufacturer: Wicksteed Playgrounds

BS EN 1176 requires an additional 0.5m of unobstructed space at each end of the swing surfacing area. This is a relatively low risk finding and no remedial action is recommended at this point. - Monitor - No remedial work recommended

Finding: BS EN 1176 requires an additional 0.5m of unobstructed space at each end of the swing surfacing area. This is a relatively low risk finding and no remedial action is recommended at this point.

Action: Monitor - No remedial work recommended

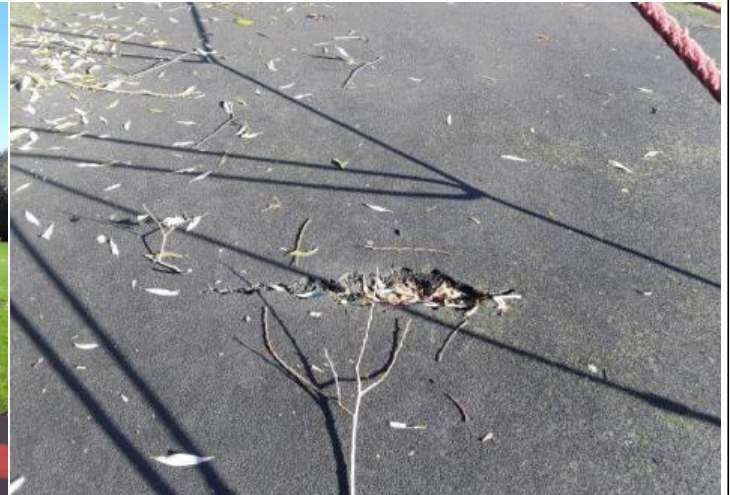
Item: Activity Equipment - Space Net
Manufacturer: Wicksteed Playgrounds

Finding: There is moderate damage to the surface

Action: Repair the damaged areas of surfacing

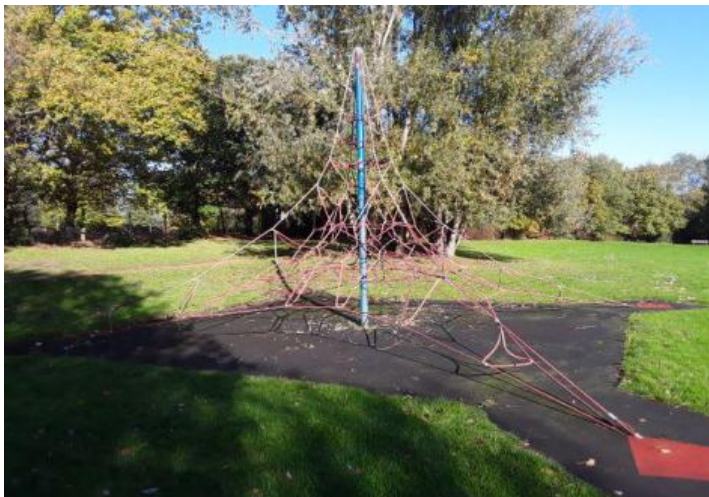
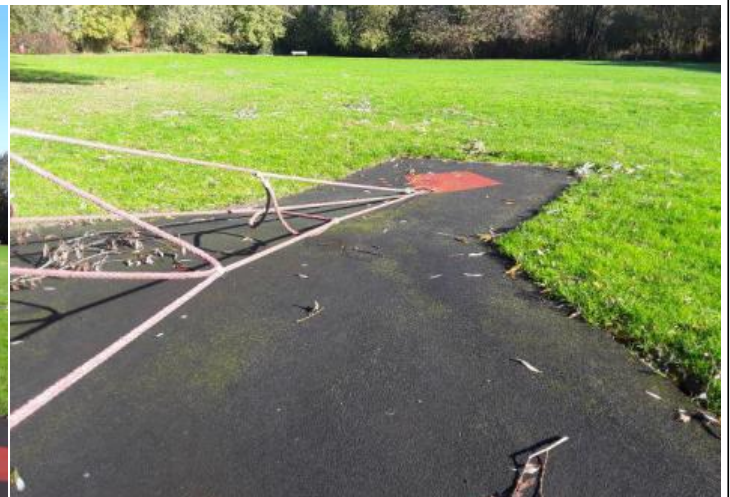
Item: Activity Equipment - Space Net
Manufacturer: Wicksteed Playgrounds

There is algae, silt or moss growth on the surface resulting in slippery conditions - Clean and treat appropriately

Finding: There is algae, silt or moss growth on the surface resulting in slippery conditions

Action: Clean and treat appropriately

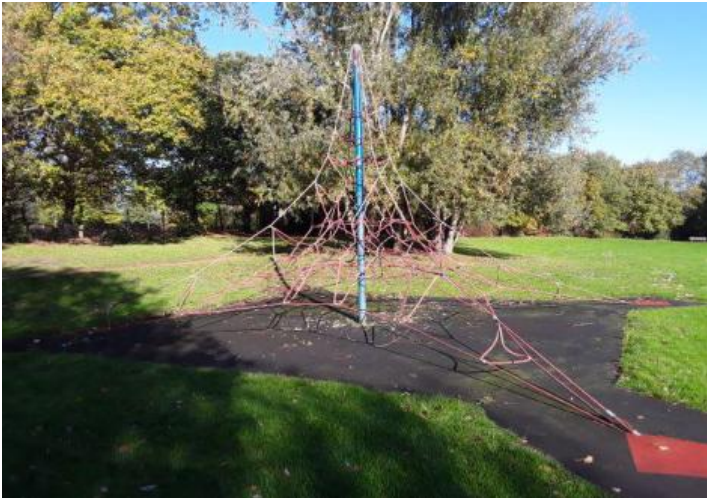
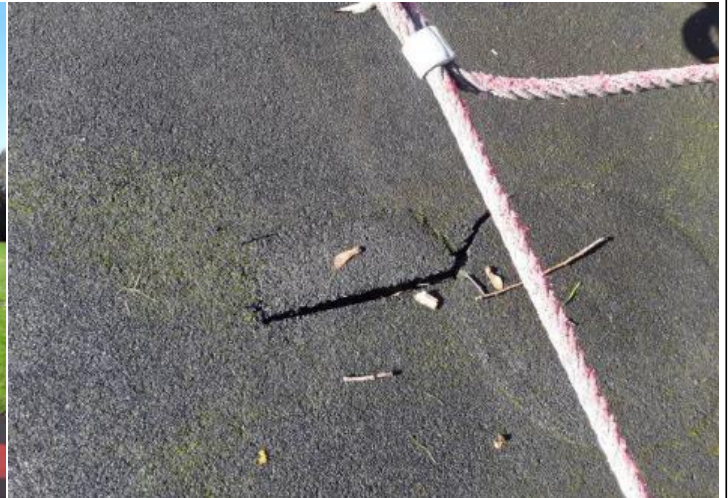
Item: Activity Equipment - Space Net
Manufacturer: Wicksteed Playgrounds

There are gaps opening between the surfacing and the edging surround or between the joints in the surfacing - Monitor for any further deterioration and repair as required

Finding: There are gaps opening between the surfacing and the edging surround or between the joints in the surfacing **Action:** Monitor for any further deterioration and repair as required

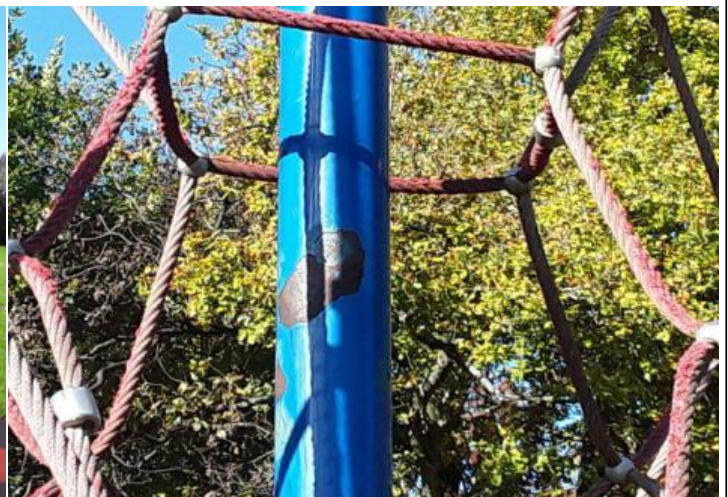
Item: Activity Equipment - Space Net
Manufacturer: Wicksteed Playgrounds

The paintwork on this item has been damaged or worn exposing the metal underneath which is rusting - Treat any rusting components and repaint

Finding: The paintwork on this item has been damaged or worn exposing the metal underneath which is rusting

Action: Treat any rusting components and repaint

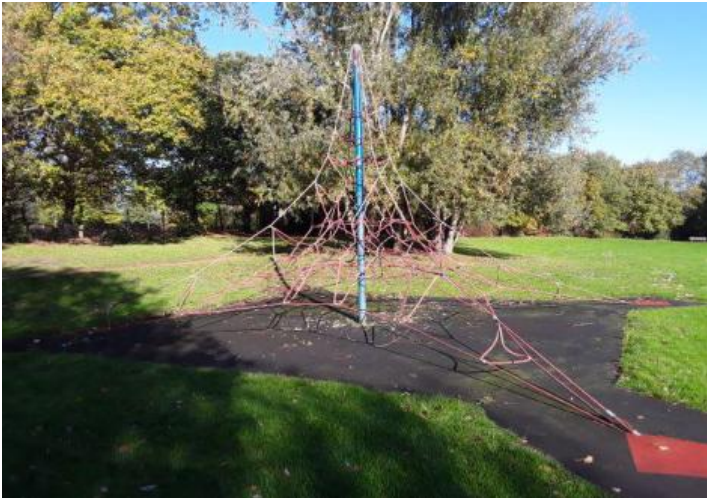
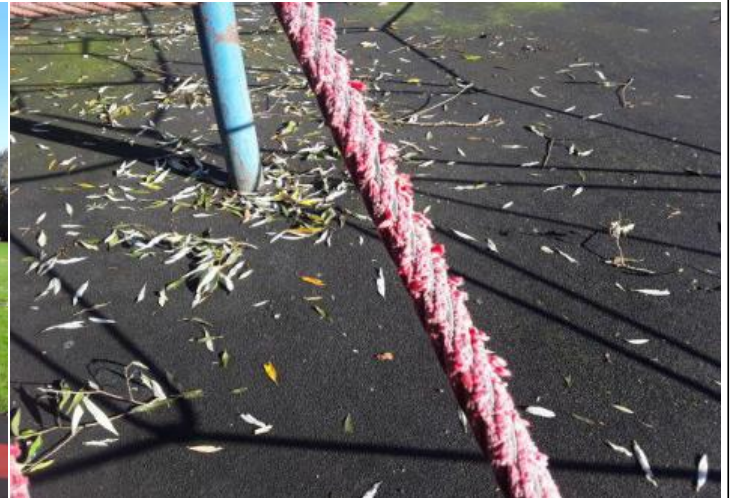
Item: Activity Equipment - Space Net
Manufacturer: Wicksteed Playgrounds

The ropes/nets are worn/damaged in places - Monitor for any further deterioration and repair or replace as required

Finding: The ropes/nets are worn/damaged in places

Action: Monitor for any further deterioration and repair or replace as required

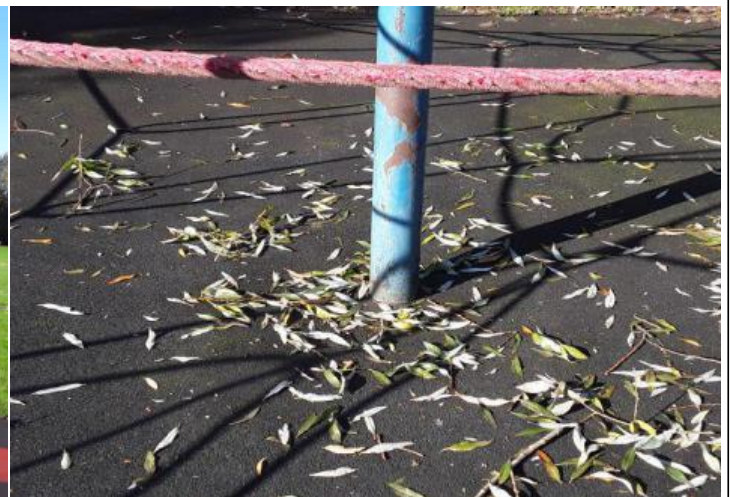
Item: Activity Equipment - Space Net
Manufacturer: Wicksteed Playgrounds

The post is slightly loose in the ground - Monitor for any further deterioration and repair as required

Finding: The post is slightly loose in the ground

Action: Monitor for any further deterioration and repair as required

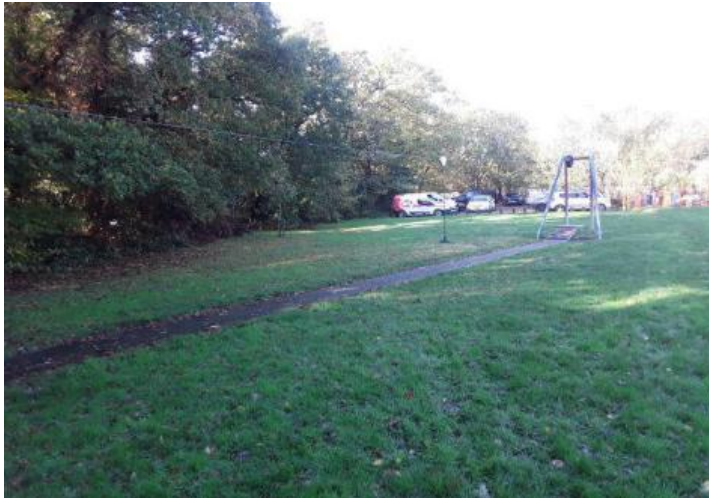
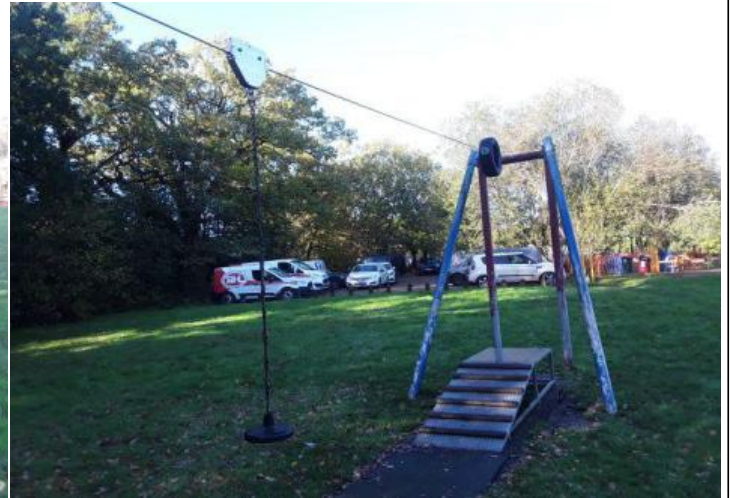
Item: Other - Cable Runway
Manufacturer: Wicksteed Playgrounds

We have completed a visual inspection of the suspension links, cable and fixing points from ground level, however it is not possible to fully inspect these areas without either hiring equipment to gain access or removing the cable and suspension and inspecting at ground level. We recommend that the main cable and fixing security is thoroughly inspected at least in accordance with the manufacturers recommendations to check for wear, damage, security or internal rusting; this will help to ensure the continued safe use of the equipment - Inspect in accordance with the manufacturers recommendations

Finding: We have completed a visual inspection of the suspension links, cable and fixing points from ground level, however it is not possible to fully inspect these areas without either hiring equipment to gain access or removing the cable and suspension and inspecting at ground level. We recommend that the main cable and fixing security is thoroughly inspected at least in accordance with the manufacturers recommendations to check for wear, damage, security or internal rusting; this will help to ensure the continued safe use of the equipment

Action: Inspect in accordance with the manufacturers recommendations

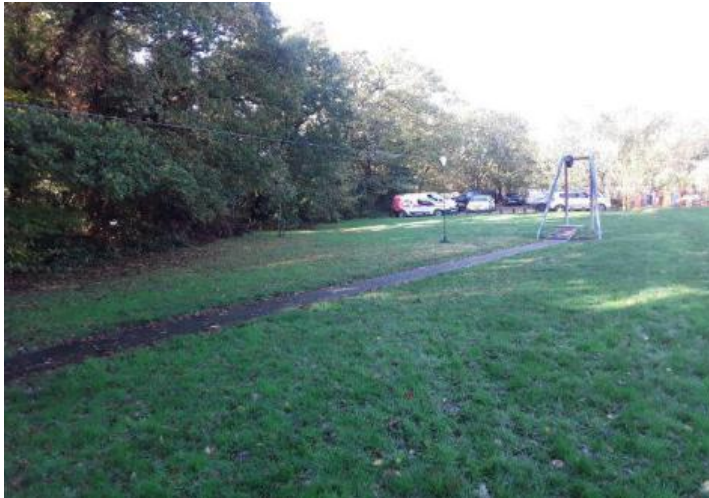
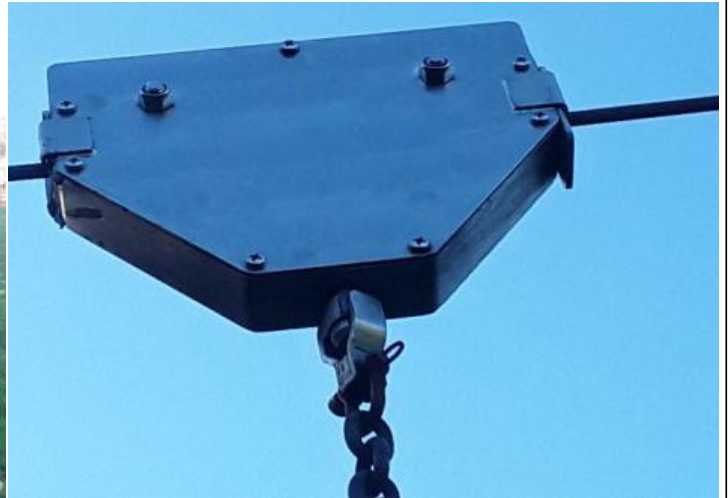
Item: Other - Cable Runway
Manufacturer: Wicksteed Playgrounds

There is some notable evidence of chain wear - Monitor for any further deterioration and replace when 40% worn

Finding: There is some notable evidence of chain wear

Action: Monitor for any further deterioration and replace when 40% worn

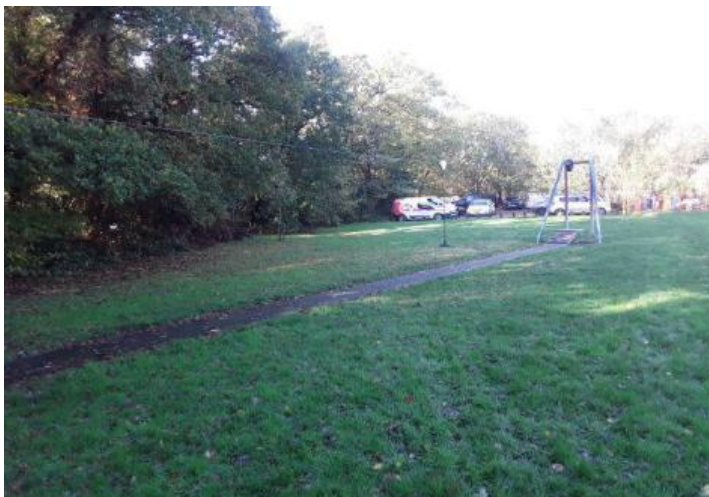
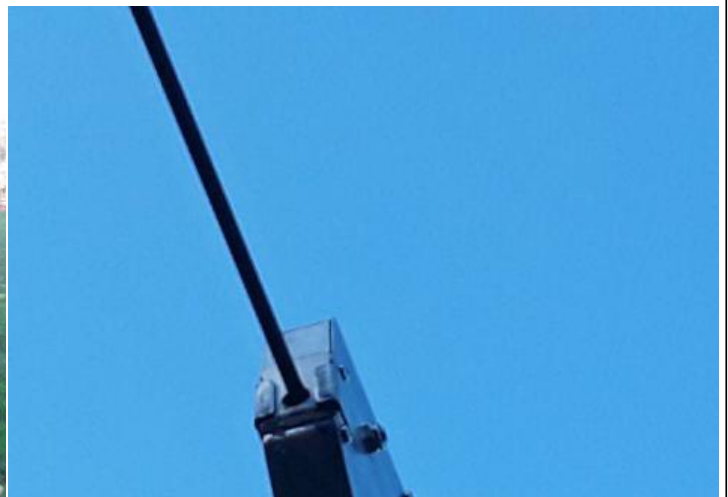
Item: Other - Cable Runway
Manufacturer: Wicksteed Playgrounds

The nylon inserts are worn or missing at the point the cable enters the traveller - Replace worn or missing inserts as required

Finding: The nylon inserts are worn or missing at the point the cable enters the traveller

Action: Replace worn or missing inserts as required

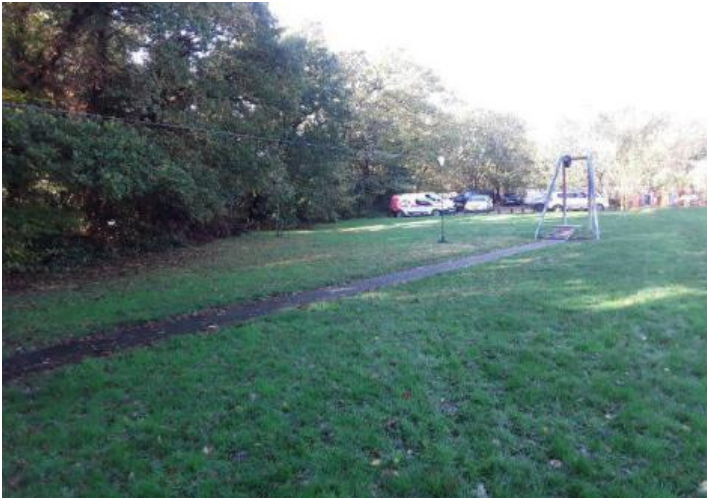
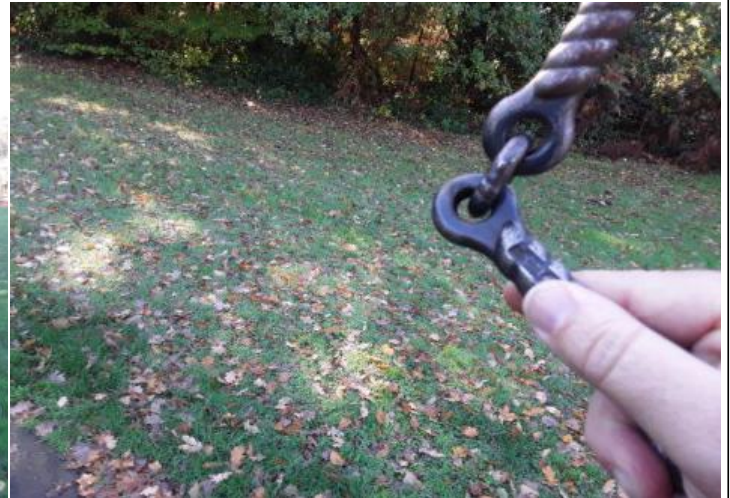
Item: Other - Cable Runway
Manufacturer: Wicksteed Playgrounds

There is some wear to the chain bars - Monitor for any further deterioration and replace when 40% worn

Finding: There is some wear to the chain bars

Action: Monitor for any further deterioration and replace when 40% worn

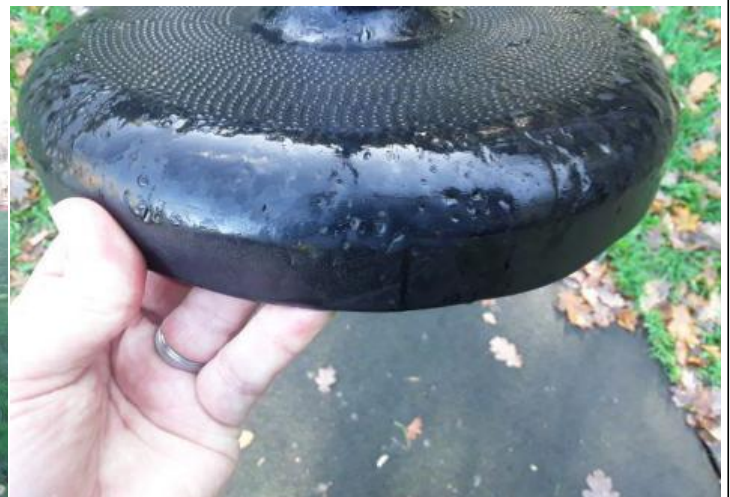
Item: Other - Cable Runway
Manufacturer: Wicksteed Playgrounds

The cableway seat has been damaged - Monitor for any further deterioration and replace as required

Finding: The cableway seat has been damaged

Action: Monitor for any further deterioration and replace as required
