Annual Inspection

Surrey Heath Borough Council

School Lane Field

School Lane, Bagshot, GU19 5BP

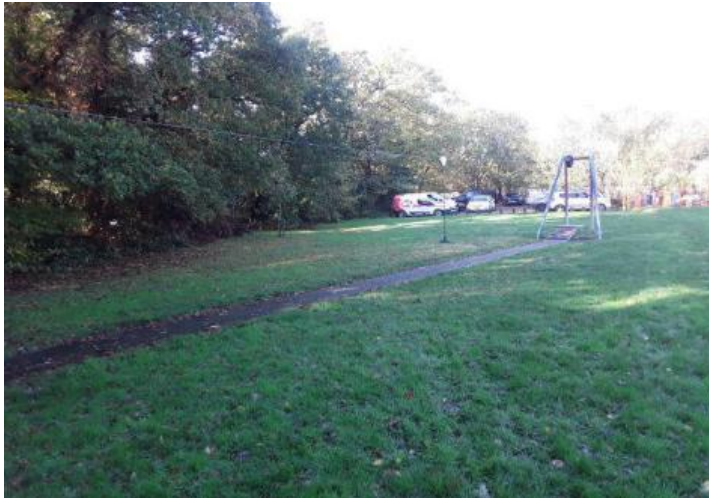
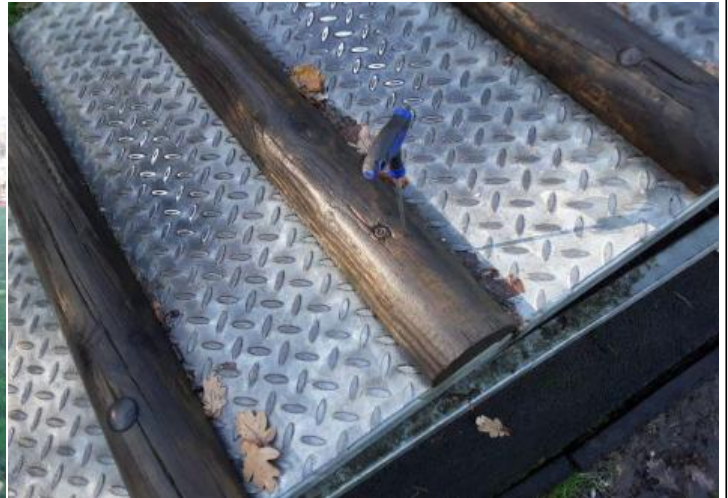
Item: Other - Cable Runway
Manufacturer: Wicksteed Playgrounds

There is some evidence of rot in the ramp treads - Monitor for any further deterioration and replace as required

Finding: There is some evidence of rot in the ramp treads

Action: Monitor for any further deterioration and replace as required

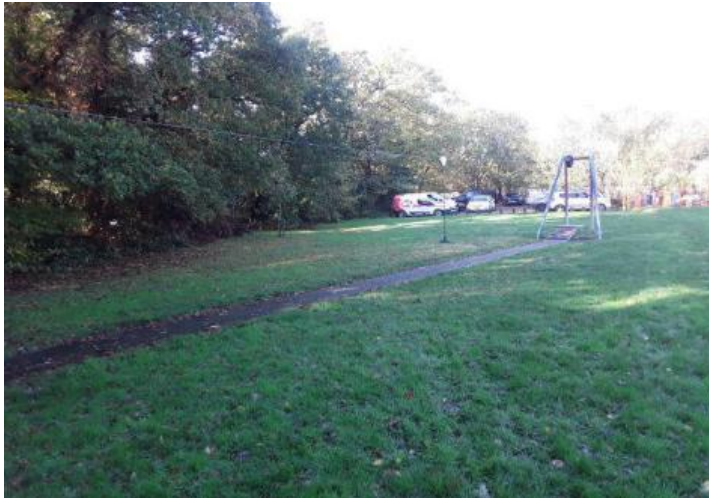
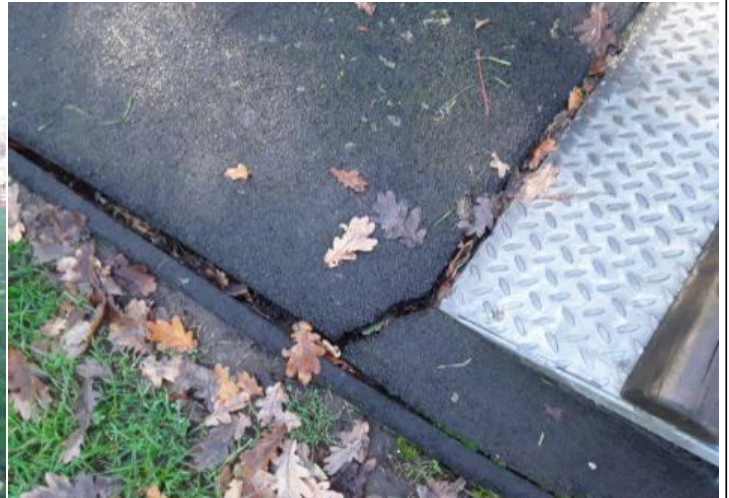
Item: Other - Cable Runway
Manufacturer: Wicksteed Playgrounds

There is moderate damage to the surface - Repair the damaged areas of surfacing

Finding: There is moderate damage to the surface

Action: Repair the damaged areas of surfacing

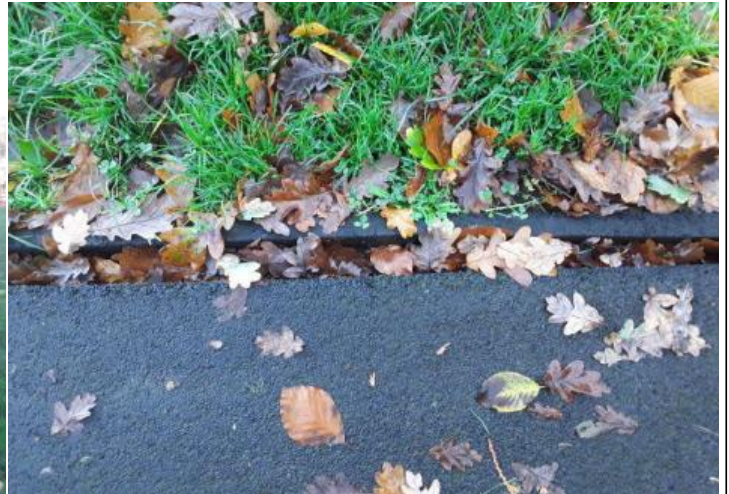
Item: Other - Cable Runway
Manufacturer: Wicksteed Playgrounds

There are significant gaps (over 30mm) between the surface and the edging or between the joints in the surface; these are large enough for a small foot to enter - Repair surfacing

Finding: There are significant gaps (over 30mm) between the surface and the edging or between the joints in the surface; these are large enough for a small foot to enter

Action: Repair surfacing

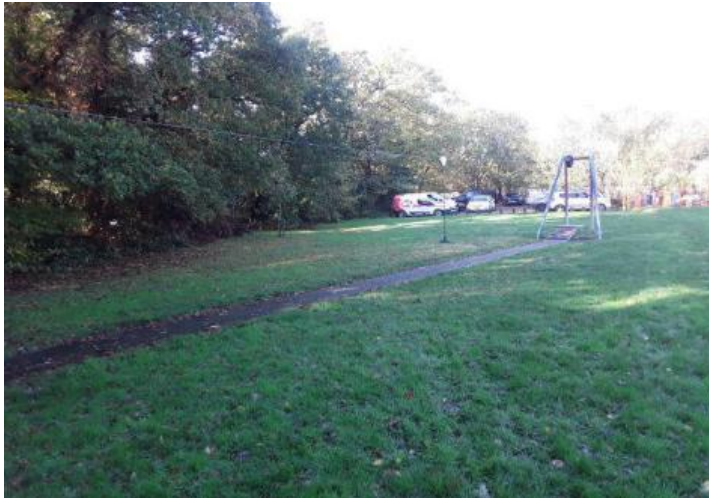
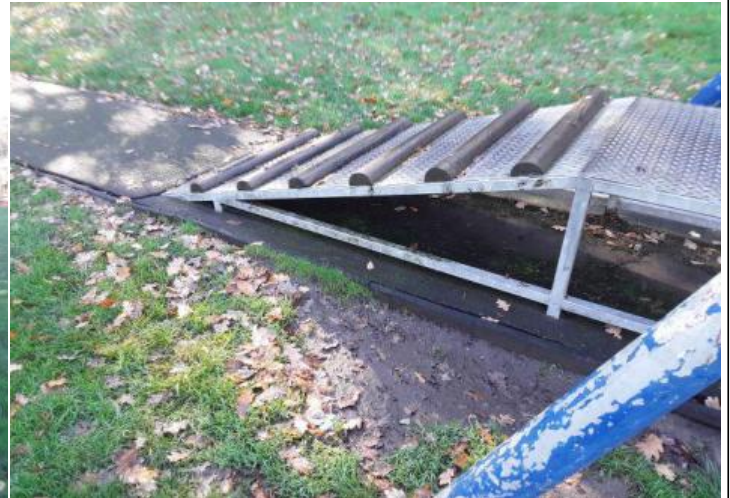
Item: Other - Cable Runway
Manufacturer: Wicksteed Playgrounds

There are trip hazards at the edges of the surface - Reinstate surrounding surface levels to remove the trip points

Finding: There are trip hazards at the edges of the surface
Action: Reinstate surrounding surface levels to remove the trip points

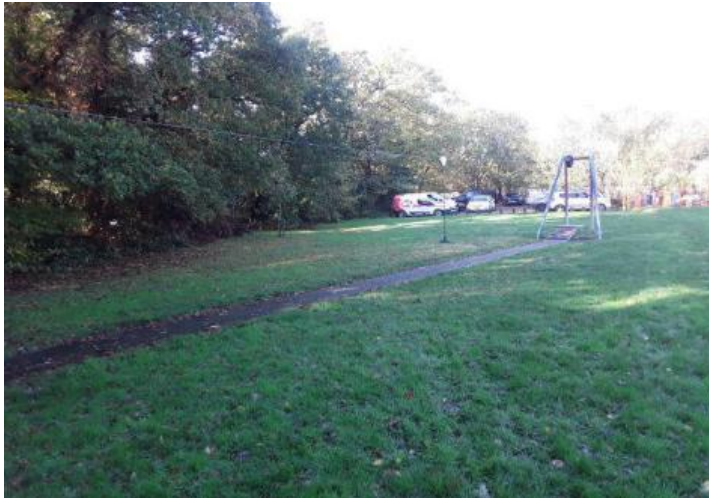
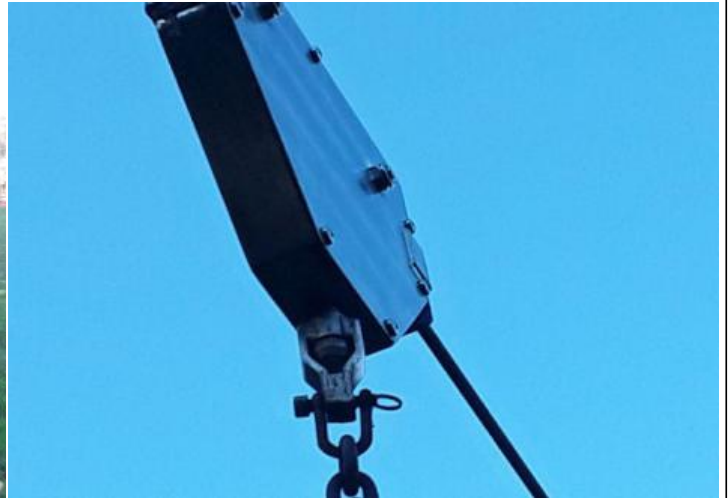
Item: Other - Cable Runway
Manufacturer: Wicksteed Playgrounds

There is some wear to the shackles. - Monitor for any further deterioration and replace when 40% worn

Finding: There is some wear to the shackles.

Action: Monitor for any further deterioration and replace when 40% worn

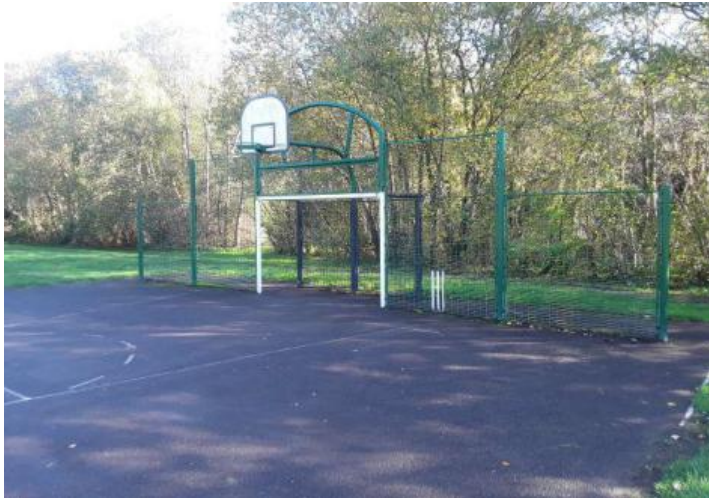
Item: Multi Use Games Area - Goal End
Manufacturer: Bigfoot Play Systems

A clearly visible facility sign should be provided in a prominent position with the wording as detailed BS EN 15312- the equipment is not intended for children less than 3 years old- the warning - Do not climb on the framework or nets- the warning - Do not hang on the ring (if provided)- the warning - Do not wear rings or other jewellery- name and telephone number of the administrator- number to call in case of accident - Provide signage to BS EN 15312

Finding: A clearly visible facility sign should be provided in a prominent position with the wording as detailed BS EN 15312- the equipment is not intended for children less than 3 years old- the warning - Do not climb on the framework or nets- the warning - Do not hang on the ring (if provided)- the warning - Do not wear rings or other jewellery- name and telephone number of the administrator- number to call in case of accident

Action: Provide signage to BS EN 15312

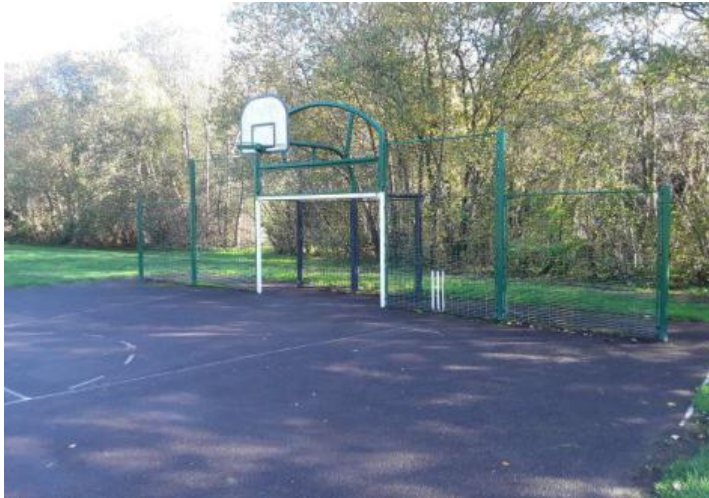
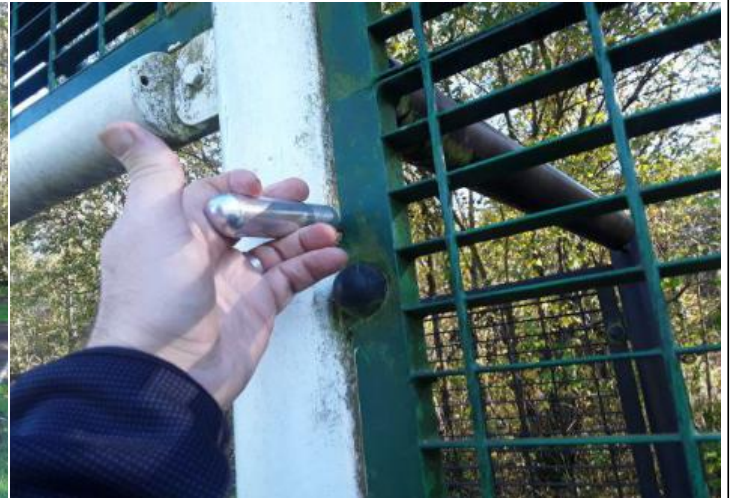
Finding: There is/are finger entrapments in the framework and the item fails to meet the requirements of BS EN 15312 Clause 4.4.2.2 Entrapment of fingers

Action: Monitor - No remedial work recommended

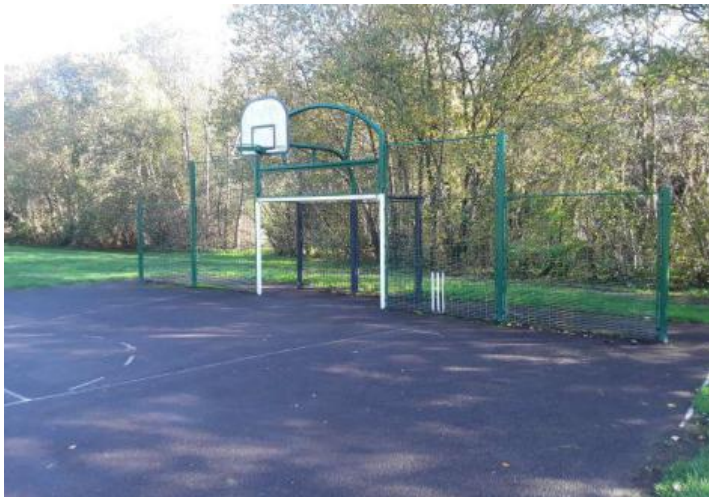
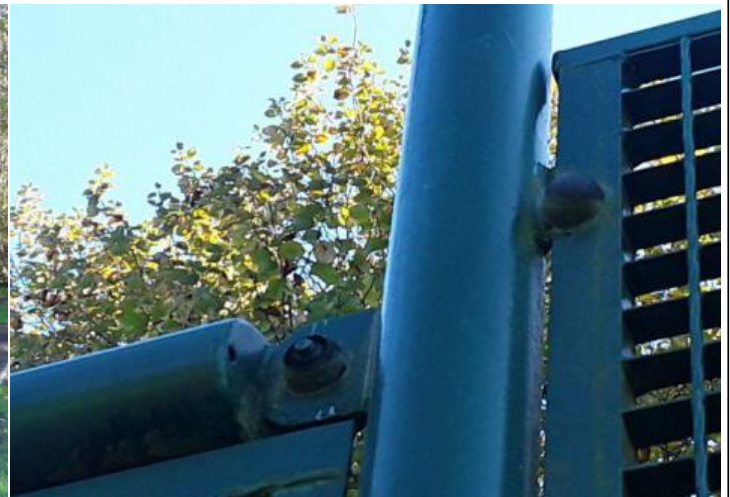
There is/are bolt cap covers missing or damaged on the item - Replace missing or damaged bolt cap covers

Finding: There is/are bolt cap covers missing or damaged on the item

Action: Replace missing or damaged bolt cap covers
