Asbestos Refurbishment Survey

The Horniman Museum & Gardens

South Hall – Boiler Room

Job Number 17173

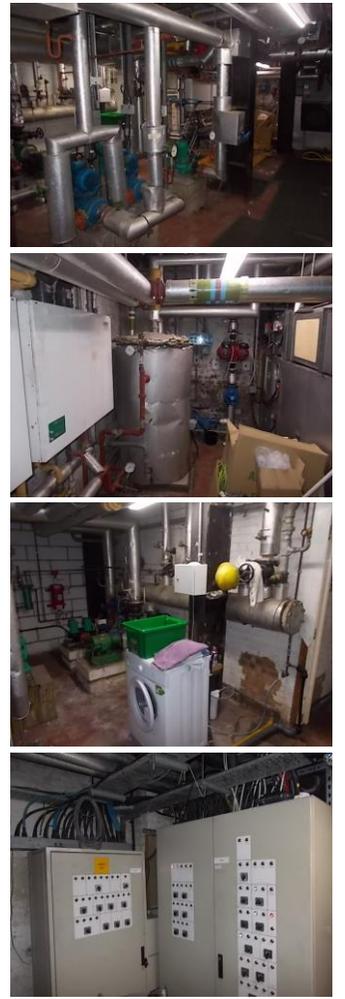
Room/Area	Observation/Comment	Inspection/ Sample No.	Analysis Result	Product	Quantity	Extent of Damage	Surface Treatment	Recommendation	Photo
B.01 Boiler Room	Solid soffit ceiling. Breezeblock and brick walls (painted white). Solid floor painted red. Ali cased MMMF lagged metal pipes painted white. Unlagged metal pipes painted red. Plastic pipes. RSJ beams and columns. Electric distribution boxes. Metal ductwork. Metal boiler and generators. Metal cable tray and cables. Metal conduits. Timber header panel. Timber frames. Two timber doors with a timber core and no lining panels. Solid drainage pit. Brick built chimney stack with a metal extraction pipe and metal hatch door.	01	-	-	-	-	-	-

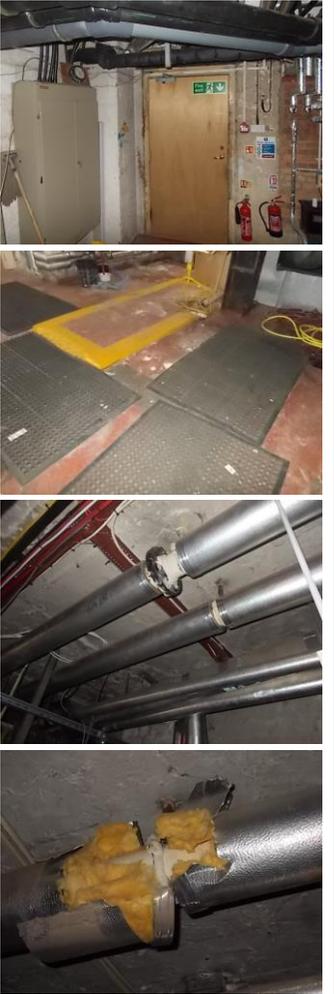
Room/Area	Observation/Comment	Inspection/ Sample No.	Analysis Result	Product	Quantity	Extent of Damage	Surface Treatment	Recommendation	Photo
B.01 Boiler Room	Inspection 01 continued.	01	-	-	-	-	-	-

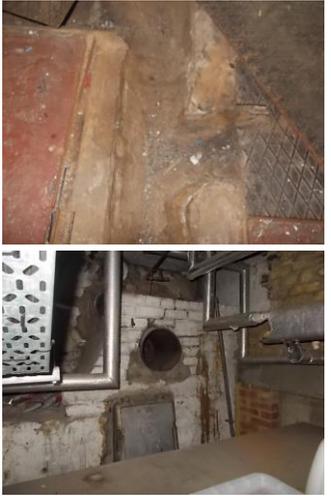
Room/Area	Observation/Comment	Inspection/ Sample No.	Analysis Result	Product	Quantity	Extent of Damage	Surface Treatment	Recommendation	Photo
B.01 Boiler Room	Inspection 01 continued.	01	-	-	-	-	-	-

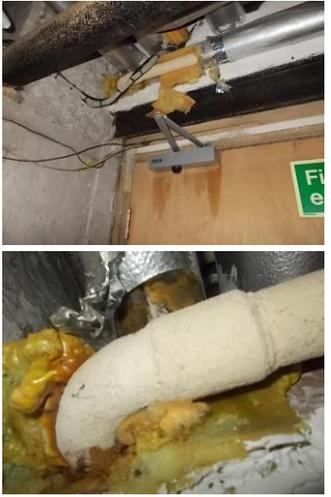
B.01 Boiler Room	Residue to the white painted metal pipe. Located above the boiler door entrance.	02	Amosite	Residue	9m	Low	Sealed	Remove and environmentally clean area.

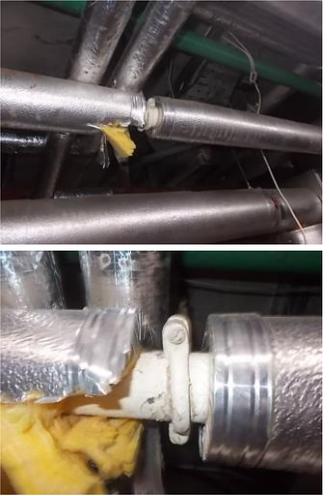
Room/Area	Observation/Comment	Inspection/ Sample No.	Analysis Result	Product	Quantity	Extent of Damage	Surface Treatment	Recommendation	Photo
B.01 Boiler Room	Residue to the white painted pipe. Located at high level.	03	Amosite Chrysotile	Residue	9m	Low	Sealed	Remove and environmentally clean area.

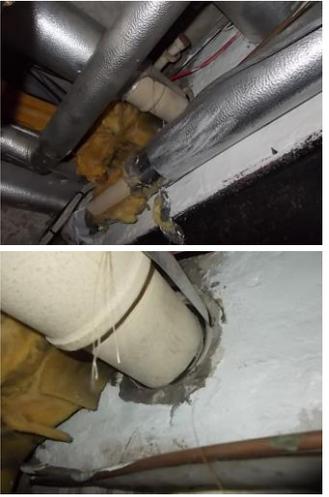
B.01 Boiler Room	Residue to the white painted metal pipe. Located at high level.	04	Amosite Chrysotile	Residue	13m	Low	Sealed	Remove and environmentally clean area.

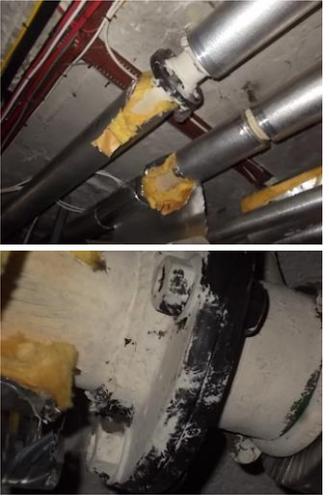
Room/Area	Observation/Comment	Inspection/ Sample No.	Analysis Result	Product	Quantity	Extent of Damage	Surface Treatment	Recommendation	Photo
B.01 Boiler Room	Residue to the white painted metal pipe. Located at high level.	05	Non- asbestos	Residue	13m	Low	Sealed	N/A

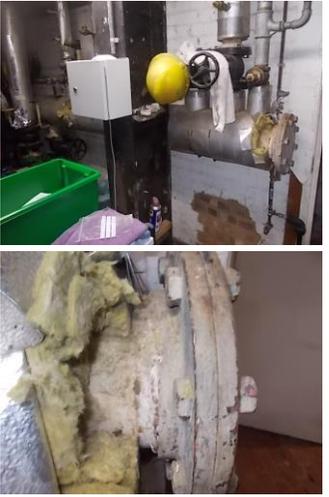
B.01 Boiler Room	Residue to the white painted metal pipe.	06	Non- asbestos	Residue	12m	Low	Sealed	N/A

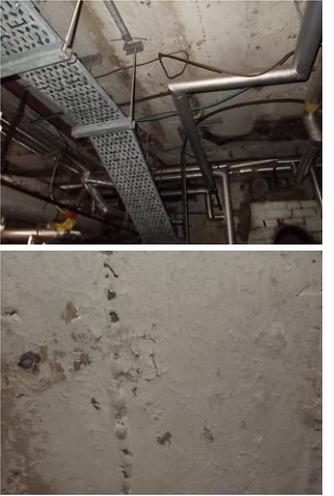
Room/Area	Observation/Comment	Inspection/ Sample No.	Analysis Result	Product	Quantity	Extent of Damage	Surface Treatment	Recommendation	Photo
B.01 Boiler Room	Residue to the white painted solid ceiling.	14	Amosite	Residue	80m ²	Medium	Sealed	Remove and environmentally clean area.

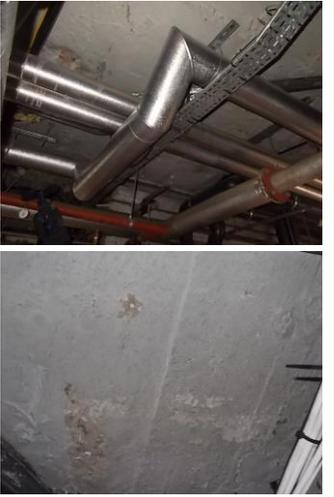
Room/ Area Location and Description	Inspection/ Sample No.	MATERIAL ASSESSMENT				Hazard Score	Hazard Rating	Quantity	Recommendation
		Asbestos Type	Product	Extent of Damage	Surface Treatment				
B.01 Boiler Room Residue to the white painted metal pipe. Located above the boiler door entrance.	02	Amosite	Residue	Low	Sealed	7	Medium	9m	Remove
B.01 Boiler Room Residue to the white painted pipe. Located at high level.	03	Amosite Chrysotile	Residue	Low	Sealed	7	Medium	9m	Remove
B.01 Boiler Room Residue to the white painted metal pipe. Located at high level.	04	Amosite Chrysotile	Residue	Low	Sealed	7	Medium	13m	Remove
B.01 Boiler Room Gasket to the metal flange to the pipe.	09	Chrysotile	Gaskets	Good Condition	Composite	3	Very Low	2 no.	Remove
B.01 Boiler Room Residue to the white painted solid ceiling.	14	Amosite	Residue	Medium	Sealed	8	Medium	80m ²	Remove
B.01 Boiler Room Residue to the white painted solid ceiling.	15	Amosite	Residue	Medium	Sealed	8	Medium	80m ²	Remove

B.01 Boiler Room	Residue to the white painted solid ceiling.	15	Amosite	Residue	80m ²	Medium	Sealed	Remove and environmentally clean area.

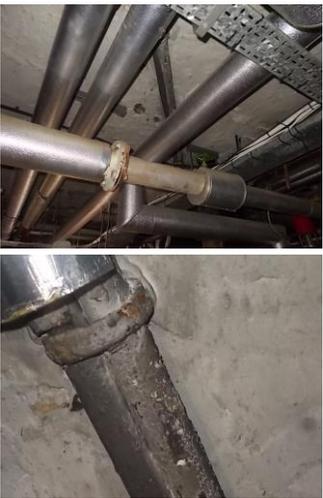
B.01 Boiler Room Residue to the two painted pipes from the solid ceiling level. Paint is flaking from the two pipes.	16	Amosite	Residue	Medium	Unsealed	9	Medium	10m	Remove

Room/Area	Observation/Comment	Inspection/ Sample No.	Analysis Result	Product	Quantity	Extent of Damage	Surface Treatment	Recommendation	Photo
B.01 Boiler Room	Residue to the two painted pipes from the solid ceiling level. Paint is flaking from the two pipes.	16	Amosite	Residue	10m	Medium	Unsealed	Remove and environmentally clean area.

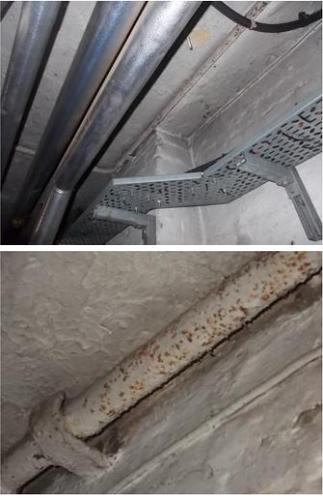
B.01 Boiler Room	Residue to the painted single metal pipe. Painted pipe is flaking.	17	Amosite	Residue	6m	Medium	Unsealed	Remove and environmentally clean area.

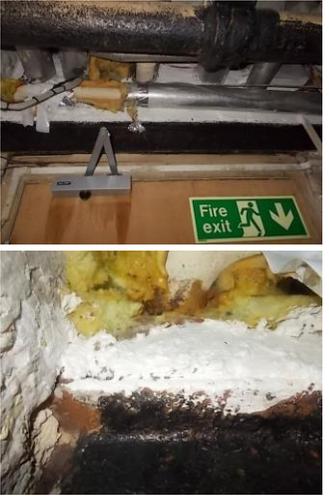
Room/Area	Observation/Comment	Inspection/ Sample No.	Analysis Result	Product	Quantity	Extent of Damage	Surface Treatment	Recommendation	Photo
B.01 Boiler Room	Snots off the white painted brick wall. Located above the front boiler room entrance.	18	Amosite	Residue	200m ²	Low	Sealed	Remove and environmentally clean area.

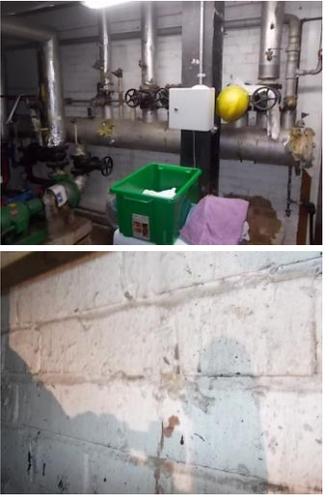
B.01 Boiler Room	Snots off white painted brick walls. The walls are heavily painted, intrusion made to the brick walls through all the layers of the white paint.	19	Non- asbestos	Residue	200m ²	Low	Sealed	N/A

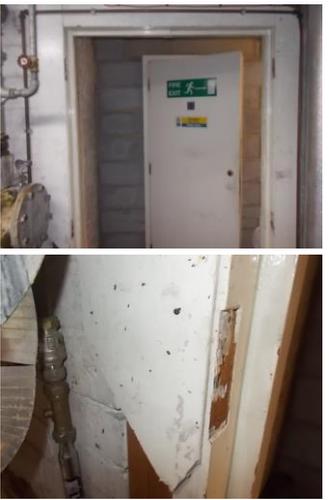
Room/Area	Observation/Comment	Inspection/ Sample No.	Analysis Result	Product	Quantity	Extent of Damage	Surface Treatment	Recommendation	Photo
B.01 Boiler Room	Insulating panels to the perimeter timber door frames.	20	Non- asbestos	Insulating Board	<1m ²	Medium	Composite	N/A

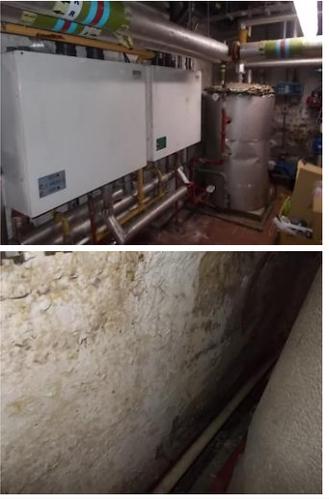
B.01 Boiler Room	Snots off the white painted brick walls.	21	Amosite Chrysotile	Residue	200m ²	Low	Sealed	Remove and environmentally clean area.

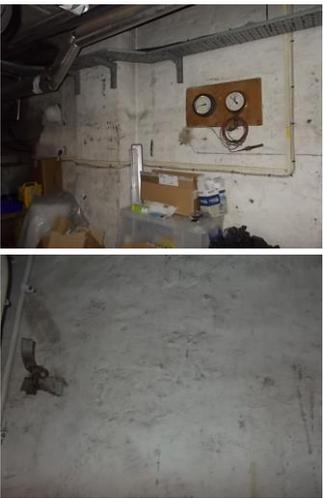
Room/Area	Observation/Comment	Inspection/ Sample No.	Analysis Result	Product	Quantity	Extent of Damage	Surface Treatment	Recommendation	Photo
B.01 Boiler Room	Snots off the white painted brick walls.	22	Non- asbestos	Residue	200m ²	Low	Composite	N/A

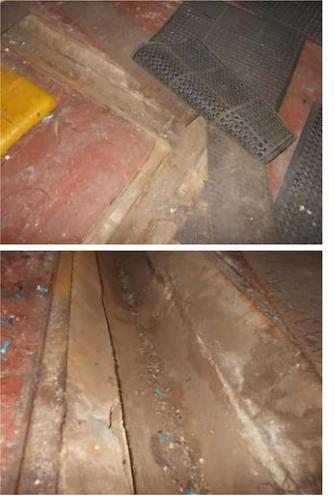
Room/ Area Location and Description	Inspection/ Sample No.	MATERIAL ASSESSMENT				Hazard Score	Hazard Rating	Quantity	Recommendation
		Asbestos Type	Product	Extent of Damage	Surface Treatment				
B.01 Boiler Room Residue to the painted single metal pipe. Painted pipe is flaking.	17	Amosite	Residue	Medium	Unsealed	9	Medium	6m	Remove
B.01 Boiler Room Snots off the white painted brick wall. Located above the front boiler room entrance.	18	Amosite	Residue	Low	Sealed	7	Medium	200m ²	Remove
B.01 Boiler Room Snots off the white painted brick walls.	21	Amosite Chrysotile	Residue	Low	Sealed	7	Medium	200m ²	Remove
B.01 Boiler Room Debris from beneath the red painted solid floor.	23	Amosite	Debris	Low	Sealed	6	Low	80m ²	Remove
B.01 Boiler Room Dust and Debris to solid drainage pit. Dust and debris present internally inside drainage pit beneath the metal drainage covers.	25	Amosite Chrysotile	Dust Debris	High	Unsealed	11	High	3m ²	Remove

Room/Area	Observation/Comment	Inspection/ Sample No.	Analysis Result	Product	Quantity	Extent of Damage	Surface Treatment	Recommendation	Photo
B.01 Boiler Room	Dust and debris to the solid drainage pit. Dust and debris present internally inside drainage pit beneath the metal drainage covers.	25	Amosite Chrysotile	Dust Debris	3m ²	High	Unsealed	Remove and environmentally clean area.

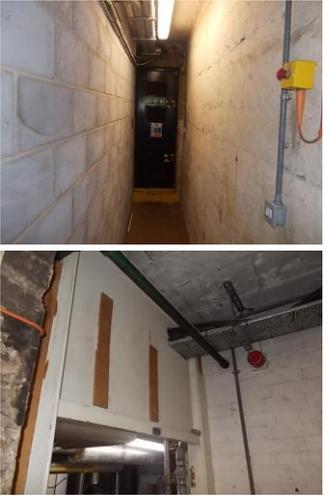
Room/Area	Observation/Comment	Inspection/ Sample No.	Analysis Result	Product	Quantity	Extent of Damage	Surface Treatment	Recommendation	Photo
B.02 Fire Escape Walkway	Solid soffit ceiling. Breezeblock walls. White painted brick walls. Solid floor. Metal fire door, no lining panels present. Unlagged metal pipes.	27	-	-	-	-	-	-

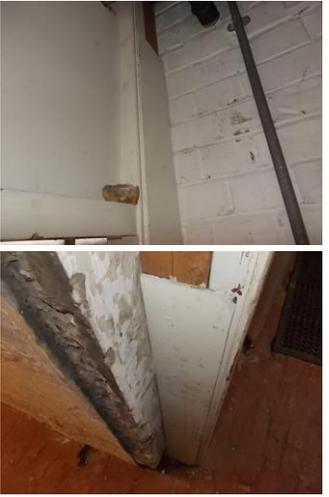
B.02 Fire Escape Walkway	Insulating panels to the timber door frames. Refer to sample 20 for analysis.	28R	Non- asbestos	Insulating Board	<1m ²	Medium	Sealed	N/A

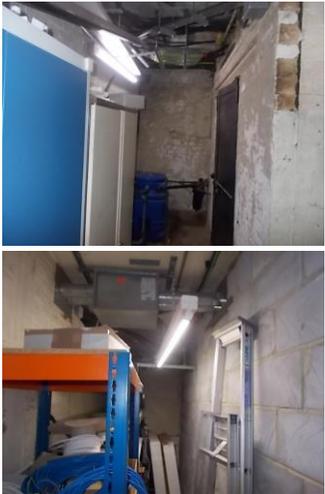
B.03 Electric Store	Solid soffit ceiling. Breezeblock walls. White painted brick walls. Solid floor. Unlagged metal pipes. Timber door with a timber core and no lining panels.	30	-	-	-	-	-	-

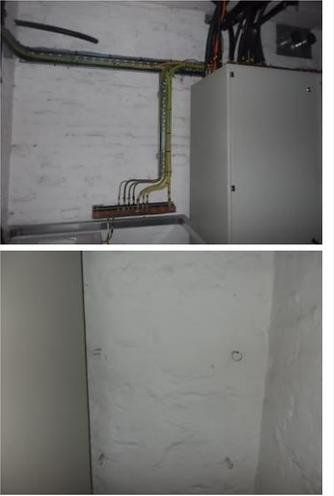
Room/Area	Observation/Comment	Inspection/ Sample No.	Analysis Result	Product	Quantity	Extent of Damage	Surface Treatment	Recommendation	Photo
B.04 Electrical Intake Room	Snots to the white painted brick walls.	32	Non- asbestos	Residue	60m ²	Low	Sealed	N/A

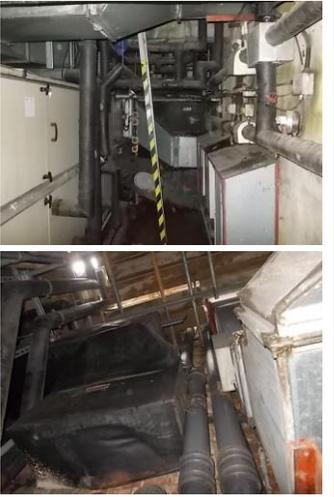
B.05 Plant Pit	Metal ductwork. MMMF insulation wrapped around the metal pipes. Plastic drainage down pipes. Metal fire door. Solid floor. No Gaskets or flange joints present.	33	-	-	-	-	-	-
