Project Information

Job Number
512806

RELIANCE HOUSE
LONG STREET
DURSLEY
GL11 4HR

CCTV SURVEY

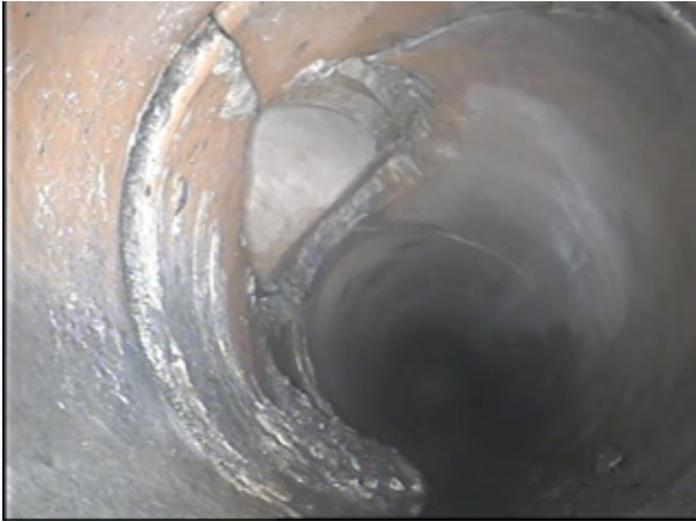
Cracks multiple from 10 to 12 o'clock at joint

Manholes: **MHC5 to MHC4**
 Pipe Length: **18.98 metres**
 Structural Grade: **3**
 Service Grade: **0**
 Material: **Vitrified clay**
 Pipe Size: **225mm**
 Use: **Combined**

Structural Defects			
Section	PLR	Grade	Fault Description
3	MHC5 X	3	Cracks multiple from 10 to 12 o'clock at joint

Grade 3; Best practice suggests consideration to be given to repair in the medium term.

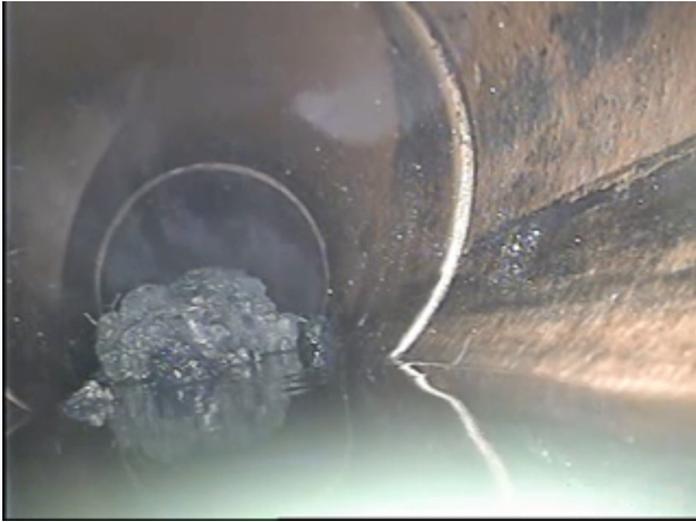
Settled deposits coarse 10% cross-sectional area loss

Manholes: **MHC1 to MHC4**
 Pipe Length: **18.6 metres**
 Structural Grade: **0**
 Service Grade: **3**
 Material: **Vitrified clay**
 Pipe Size: **225mm**
 Use: **Combined**

Service Defects			
Section	PLR	Grade	Fault Description
4	MHC1 X	3	Settled deposits coarse 10% cross-sectional area loss
6	RWP3 X	3	Settled deposits coarse 10% cross-sectional area loss, Start
			Settled deposits coarse 10% cross-sectional area loss, Finished
12	MHC6 X	3	Settled deposits coarse 10% cross-sectional area loss, Start
			Settled deposits coarse 10% cross-sectional area loss, Finished

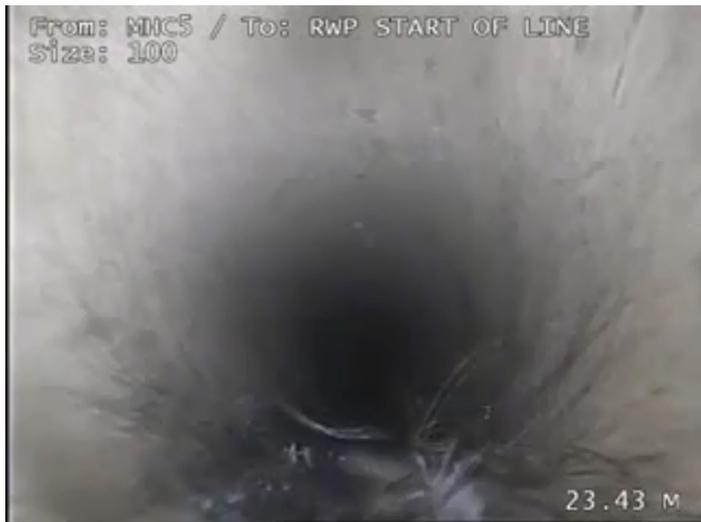
Roots fine

Manholes: **MHC5 to RWP2 START OF**
LINE
 Pipe Length: **26.18 metres**
 Structural Grade: **0**
 Service Grade: **2**
 Material: **Vitrified clay**
 Pipe Size: **100mm**
 Use: **Combined**

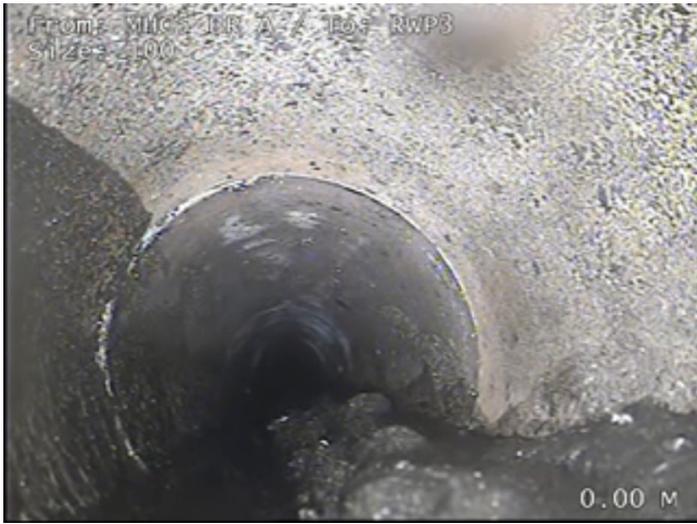
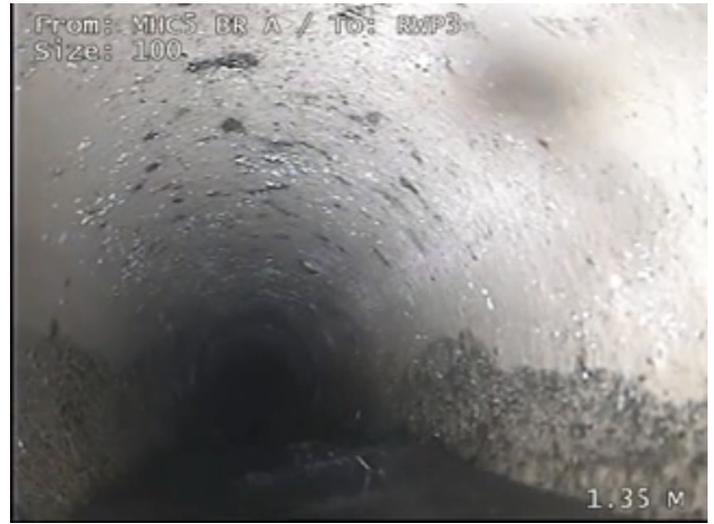
Settled deposits coarse 10% cross-sectional area loss, Start

Settled deposits coarse 10% cross-sectional area loss, Finished

Manholes: **MHC5 BR A to RWP3**
 Pipe Length: **6.55 metres**
 Structural Grade: **0**
 Service Grade: **3**
 Material: **Vitrified clay**
 Pipe Size: **100mm**
 Use: **Combined**

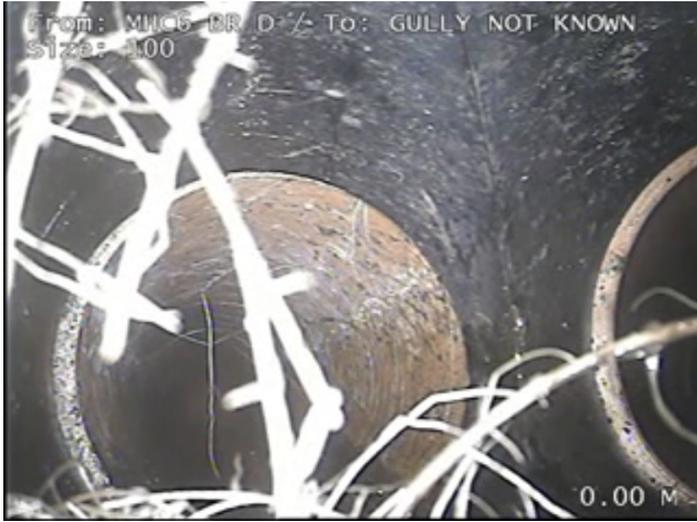
Roots fine

RECOMMEND 4 HOURS 2 MEN WITH WARTHOG TO FURTHER HPWJ GULLY IN BOTTOM OF CAR PARK WITH SONAR TRACE AND CCTV TO GIVE ACCURATE POSITION AND LINE OF PIPEWORK .

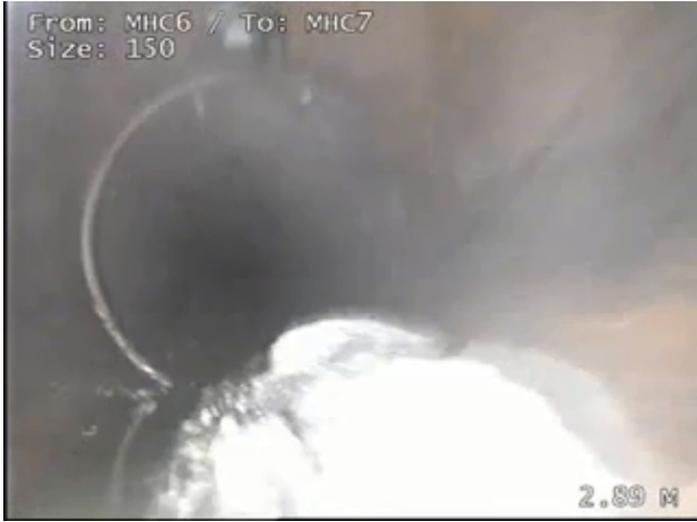
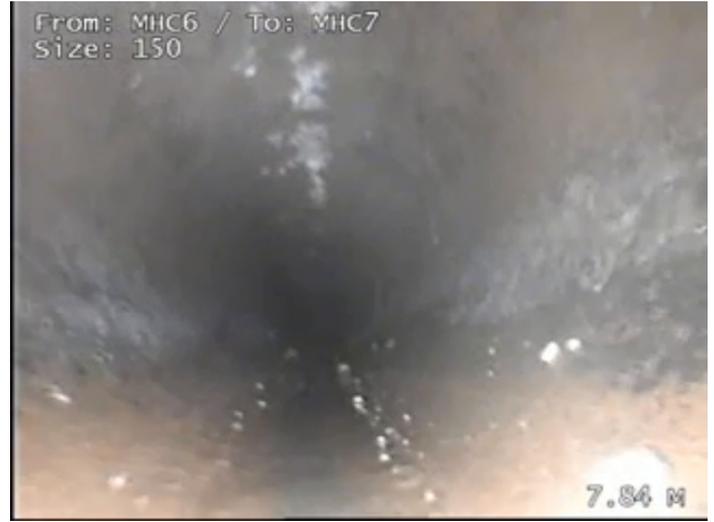
Settled deposits coarse 10% cross-sectional area loss, Start

Settled deposits coarse 10% cross-sectional area loss, Finished

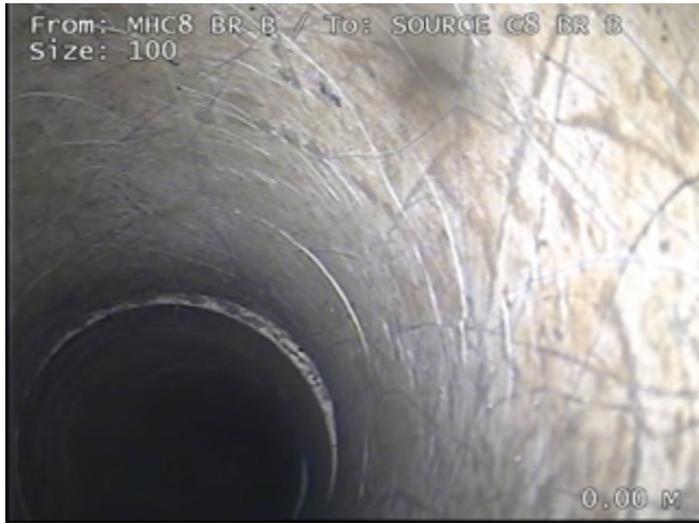
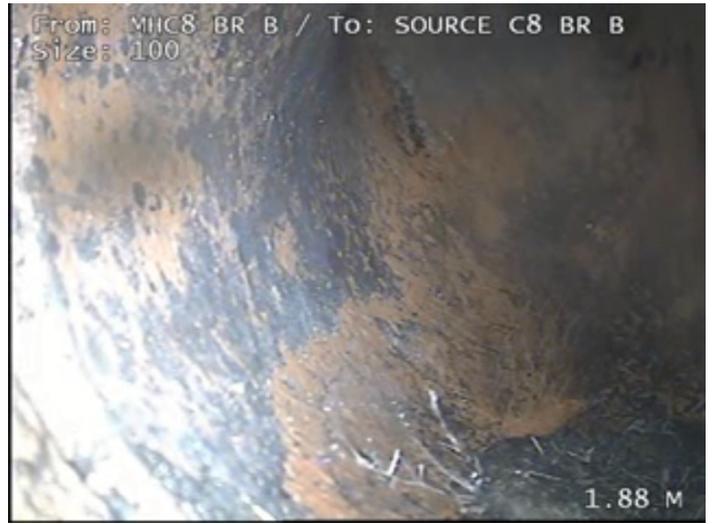
Roots fine, Start

Roots fine, Finished

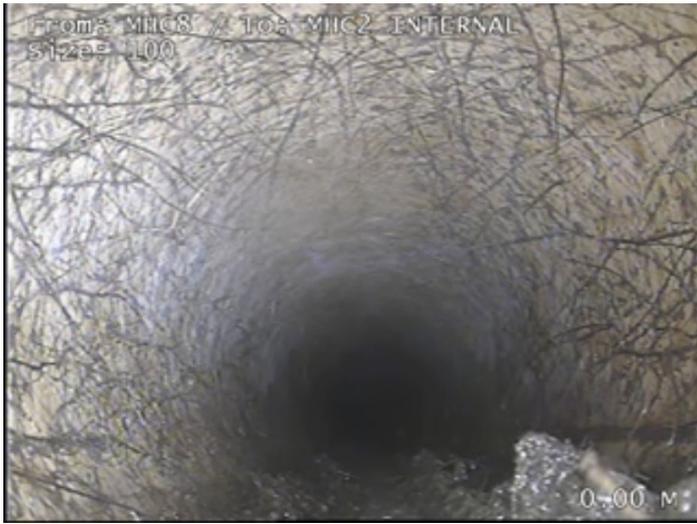
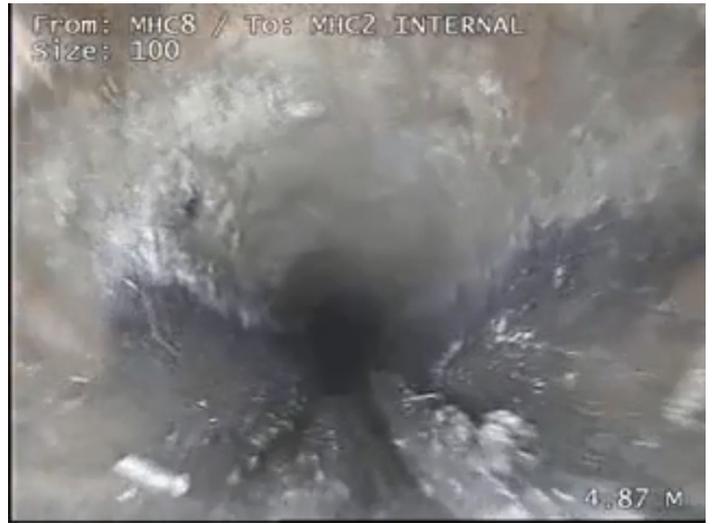
Roots fine, Start

Roots fine, Finished
