**REPORT TO CLIENT  
ASBESTOS REFURBISHMENT SURVEY**

**WITHIN  
SPECIFIC AREAS OF  
UPRN L03329 - Rivers House  
Blandford Forum DT11 8ST**

**On Behalf Of  
Environment Agency  
Contract Code: 607-03329  
Date of Issue: 3rd December 2015**

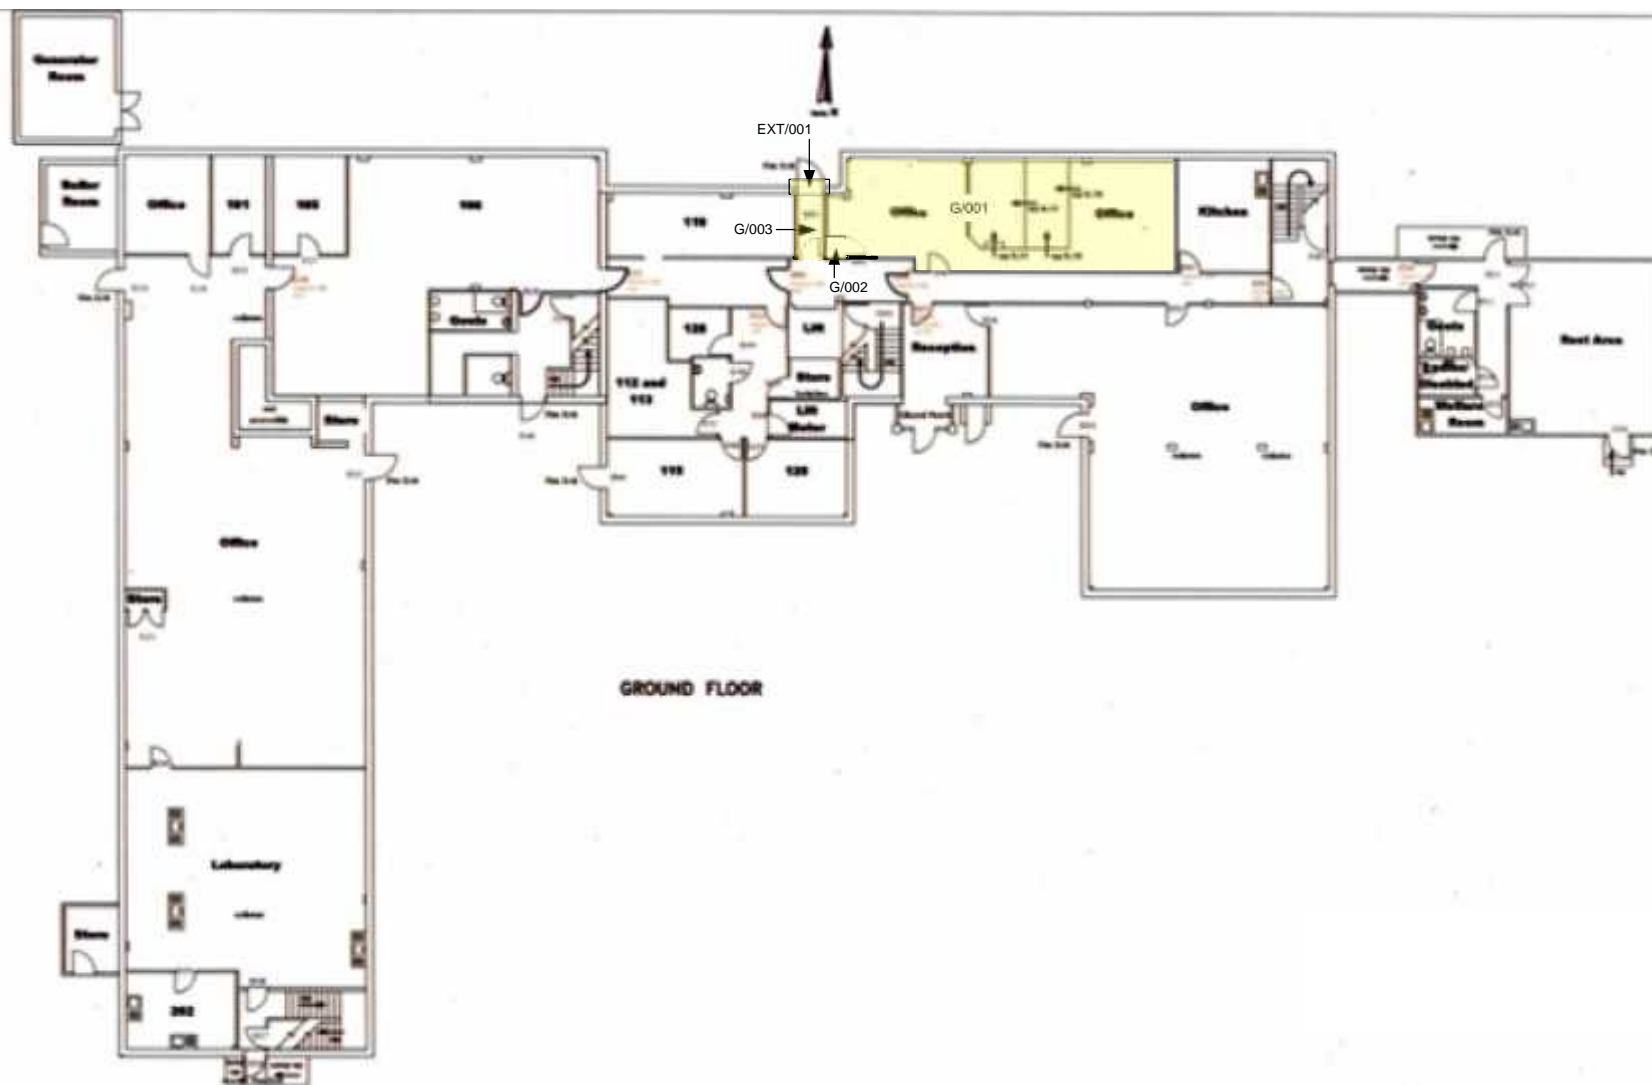
Rivers House – Ground Floor

= Areas surveyed
