Pre-Construction Information

CI-343605 - [REDACTED] Eckington Rd, Coal Aston, S18 3AT

Address:	██████ Eckington Rd, Coal Aston, Dronfield, Derbyshire, S18 3AT	Claim No:	S S125385
Claim Date:	22/6/2011	Date of Inspection:	5/7/2011
Claimant:	Mr ██████████	Tenant:	N/A
Tel No:	██████████	Tel No:	
Surveyor:	██████████	Agent:	N/A
		Tel No:

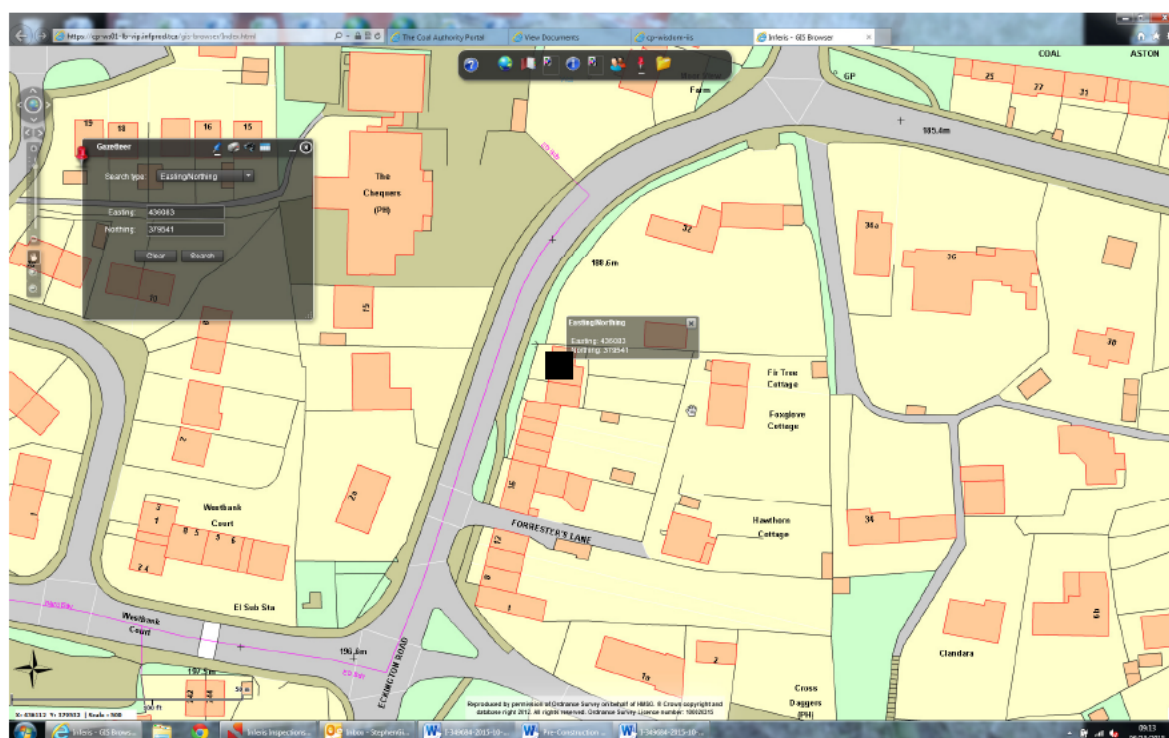
Original inspection report 2011 prior to any investigations etc. The shaft has now been dilled and grouted.

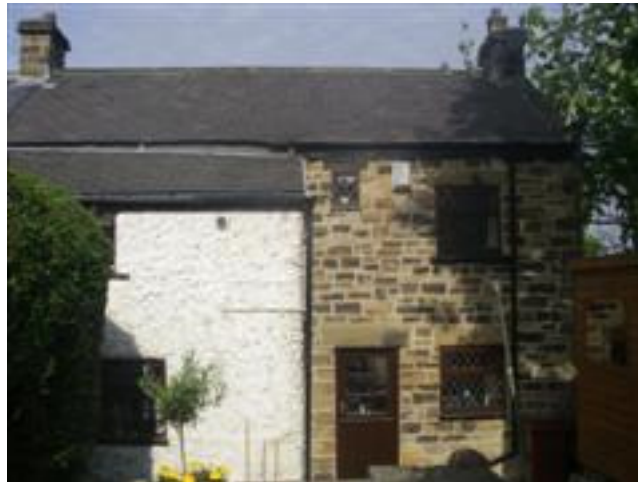
There has been no recorded past mine workings within the zone of influence of the property. The property is within an area of possible unrecorded shallow coal mine workings. There is a shaft ref: 436379-001 Treatment unknown. The defects are directly over the area where the shaft is shown; I would therefore recommend bore hole investigations to establish the cause of the damage (compaction of fill material or voiding)

Site inspection. The property is a semi detached cottage built circa 1880's. Stonework construction probably built off a spread stone foundation. Traditional pitched roof covered in slates. Rear outrigger is rendered construction. The defects are distortion to the lounge floor and door frame. Distortion to the kitchen floor and door frames and depression around the rear entrance in the paved area. All of the distortion looks old, however there is some new cracking around the lintel ends in the lounge. The owner has been informed by the proactive team that there is a shaft on his property. The shaft is located directly below the area that is being affected. He is concerned that the movement is ongoing and also that his property value will have been affected.

<u>Location</u>	<u>Decoration</u>	<u>Defects</u>	
Rear Elevation	•	• There is a depression around the rear entrance doorways. This is directly where the shaft is shown on MRSDS.	•
LHS Elevation.	•	• The gable is bowing probably due to a lack of lateral ties at 1 st floor and roof levels.	•
Kitchen	• EP and beam ceiling. • EP walls.	• Undulating wall plasters. • The floor is sloping and distorted around the entrance to the lounge, and garden.	•
Lounge.	• EP and beam ceiling. • EP walls.	• Hairline wall cracks over doors and windows. • Distortion to the floor over the area where the shaft is shown on MRSDS. • Also hairline wall angles and ceiling cracks.	•
Front Elevation	•	• NRMD	•
	•	•	•
	•	•	•
	•	•	•
	•	•	•
	•	•	•
	•	•	•
	•	•	•
	•	•	•
	•	•	•

There is a definite depression around the rear lounge floor and kitchen floors extending into the patio area where the shaft is shown on MRSDS. Although this is considered to be historical distortion there is some minor cracking in the lounge. I would therefore recommend borehole investigations are carried out externally to the patio area, to establish if there is any voiding at this point.
