ASBESTOS MANAGEMENT PLAN

Lodge Park Sports Centre

**CBC Asbestos Re-Inspection Report
Lodge Park Sports Centre, Corby
8th January 2020**

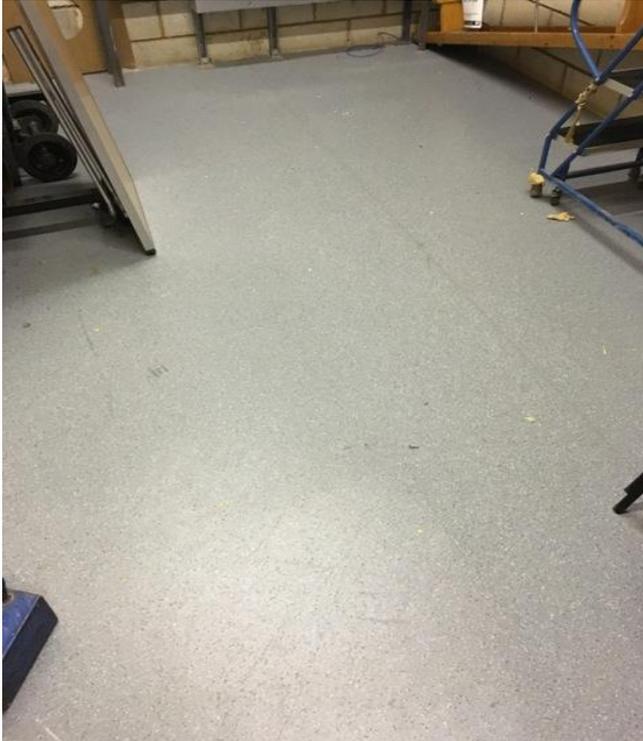
Photo Number	1	Reference number	080120RI01
Inspection / Sample	Inspection	Inspection Cross Reference / Visual I.D.	Visual Identification

Notes	Reference to sample: 190215MW01

Building	Lodge Park Sports Centre	Condition	Good	0
Floor Level	Ground	Surface Treatment	Composite materials, reinforced plastics, resin, vinyl materials	0
Location	G.12 Switch Room	Material Friability	Low	1
Feature	Brown floor tiles and ashesive (beneath screed)	Asbestos Type	Presumed Chrysotile (White)	1
Material Type	Floor Tile / Covering			
Extent	8 sq. m.			
Recommendation	Manage in-situ via periodic re-inspection	Assessment Score		2
		Assessment Band		D

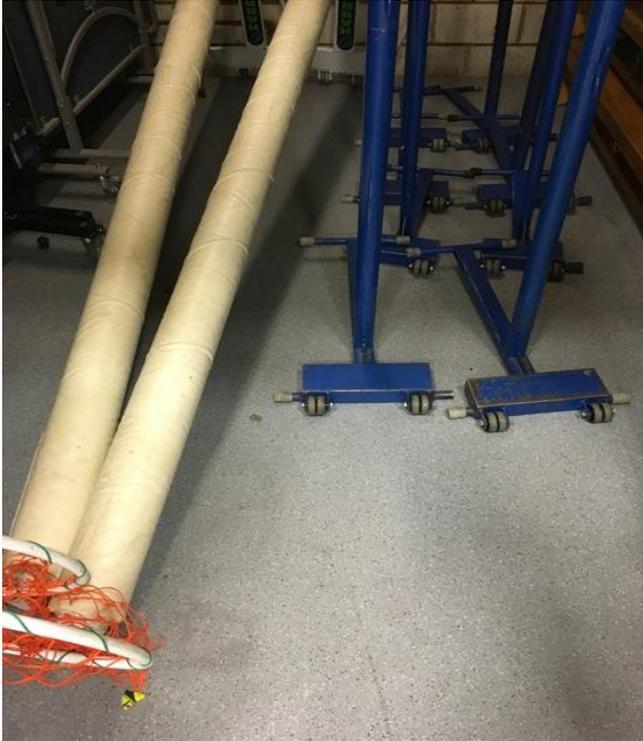
Photo Number	2	Reference number	080120RI02
Inspection / Sample	Inspection	Inspection Cross Reference / Visual I.D.	Visual Identification

Notes	Reference to sample: 14/5/B/12/SG26

Building	Lodge Park Sports Centre	Condition	Good	0
Floor Level	Ground	Surface Treatment	Composite materials, reinforced plastics, resin, vinyl materials	0
Location	G.14 Equipment Store	Material Friability	Low	1
Feature	Floor tiles	Asbestos Type	Presumed Chrysotile (White)	1
Material Type	Floor Tile / Covering			
Extent	4.5 sq. m.			
Recommendation	Manage in-situ via periodic re-inspection	Assessment Score		2
		Assessment Band		D

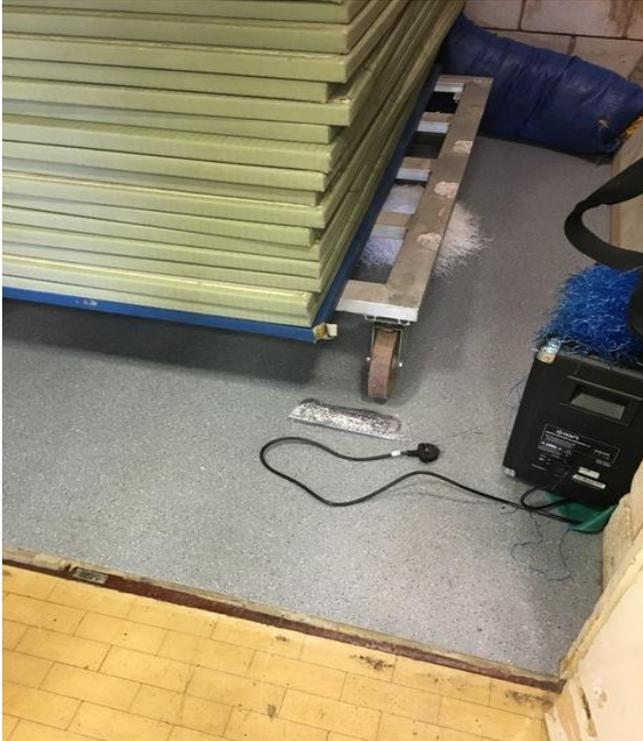
Photo Number	3	Reference number	080120RI03
Inspection / Sample	Inspection	Inspection Cross Reference / Visual I.D.	Visual Identification

Notes	Reference to sample: 14/5/B/12/SG27

Building	Lodge Park Sports Centre	Condition	Good	0
Floor Level	Ground	Surface Treatment	Composite materials, reinforced plastics, resin, vinyl materials	0
Location	G.19 Equipment Store	Material Friability	Low	1
Feature	Bitumen adhesive to floor	Asbestos Type	Presumed Chrysotile (White)	1
Material Type	Bitumen			
Extent	4.5 sq. m.			
Recommendation	Manage in-situ via periodic re-inspection	Assessment Score		2
		Assessment Band		D

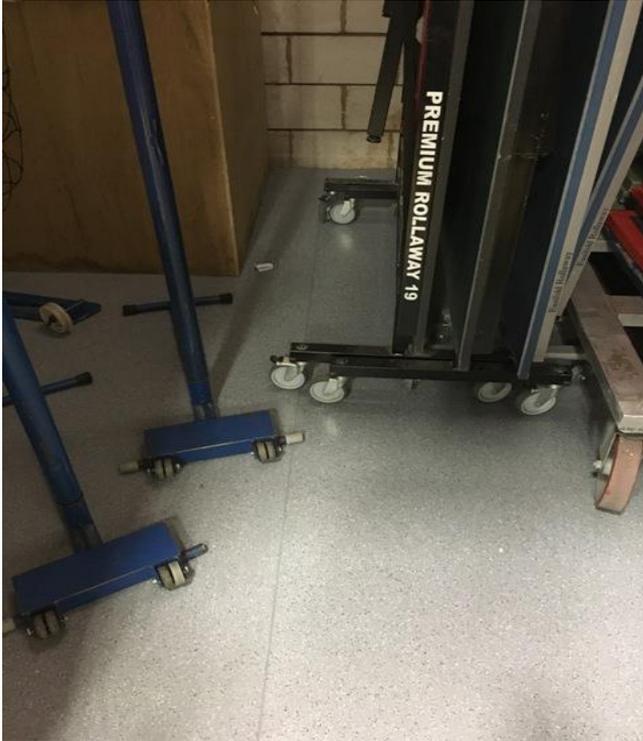
Photo Number	4	Reference number	080120RI04
Inspection / Sample	Inspection	Inspection Cross Reference / Visual I.D.	Visual Identification

Lodge Park Sports Centre, Ground, G.22 Equipment Store	Bitumen adhesive to floor	Bitumen - (Low)	4	Presumed Chrysotile (White Asbestos)	Good / Composite materials, reinforced plastics, resin, vinyl materials	4.5 sq. m.	High / Internal	080120RI04 (Visual Identification)	Risk Band D Very Low Risk	Manage in-situ via periodic re-inspection
Lodge Park Sports centre, Lift,	Woven Textiles	Textile - (Medium)	5	Strongly Presumed Chrysotile (White Asbestos)	Good / Composite materials, reinforced plastics, resin, vinyl materials	4 No.	Low / Internal	080120RI05 (Same as Sample Reference to sample 280319DP07)	Risk Band D Very Low Risk	Manage in-situ via periodic re-inspection

Notes	Reference to sample: 14/5/B/12/SG27

Building	Lodge Park Sports Centre	Condition	Good	0
Floor Level	Ground	Surface Treatment	Composite materials, reinforced plastics, resin, vinyl materials	0
Location	G.22 Equipment Store	Material Friability	Low	1
Feature	Bitumen adhesive to floor	Asbestos Type	Presumed Chrysotile (White)	1
Material Type	Bitumen			
Extent	4.5 sq. m.			
Recommendation	Manage in-situ via periodic re-inspection	Assessment Score		2
		Assessment Band		D

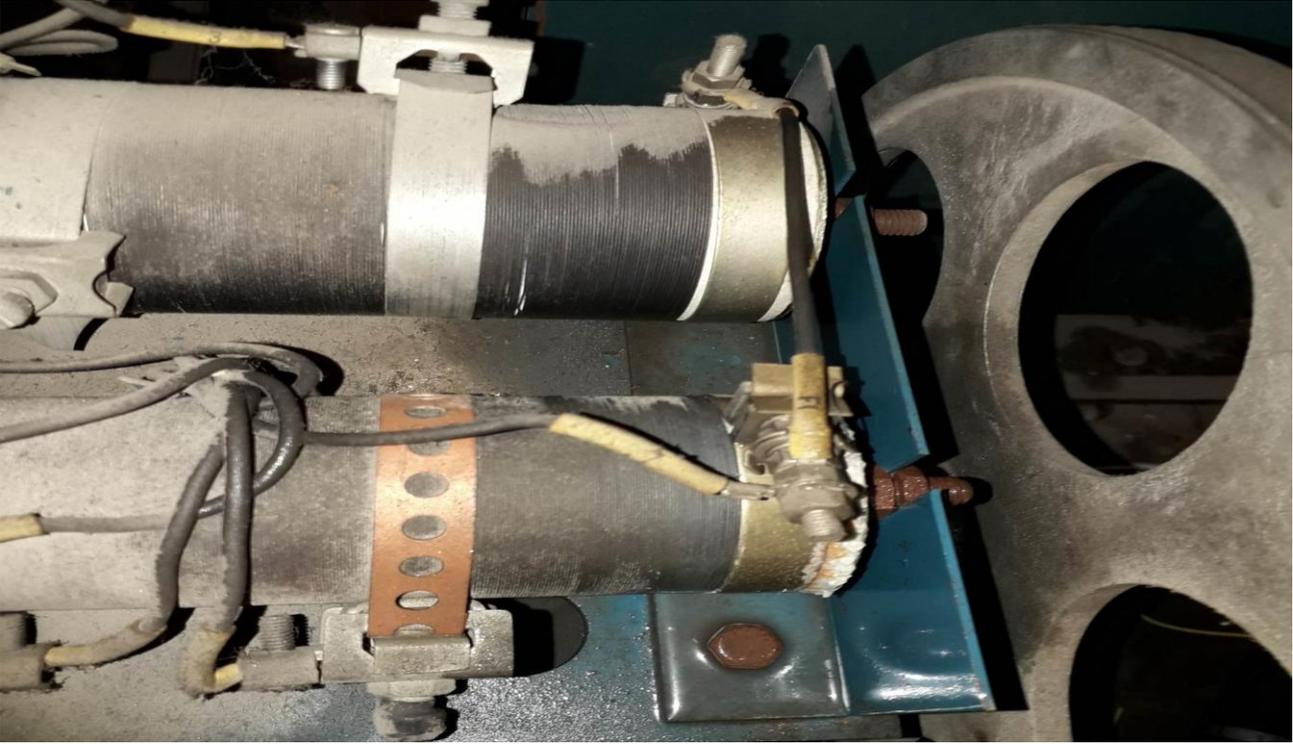
Photo Number	5	Reference number	080120RI05
Inspection / Sample	Inspection	Inspection Cross Reference / Visual I.D.	Reference to sample 280319DP07

Notes	Reference to sample 280319DP07

Building	Lodge Park Sports Centre	Condition	Good	0
Floor Level	Ground	Surface Treatment	Composite materials, reinforced plastics, resin, vinyl materials	0
Location	Lift	Material Friability	Medium	2
Feature	Woven Textiles	Asbestos Type	Strongly Presumed Chrysotile (White)	1
Material Type	Textile			
Extent	4 No.			
Recommendation	Manage in-situ via periodic re-inspection	Assessment Score		3
		Assessment Band		D
