JUNIPER STREET BUILDING 1 – ROOF CONDITION REPORT
NATIONAL MUSEUMS LIVERPOOL
AUGUST 2020

JUNIPER STREET ROOF CONDITION REPORT

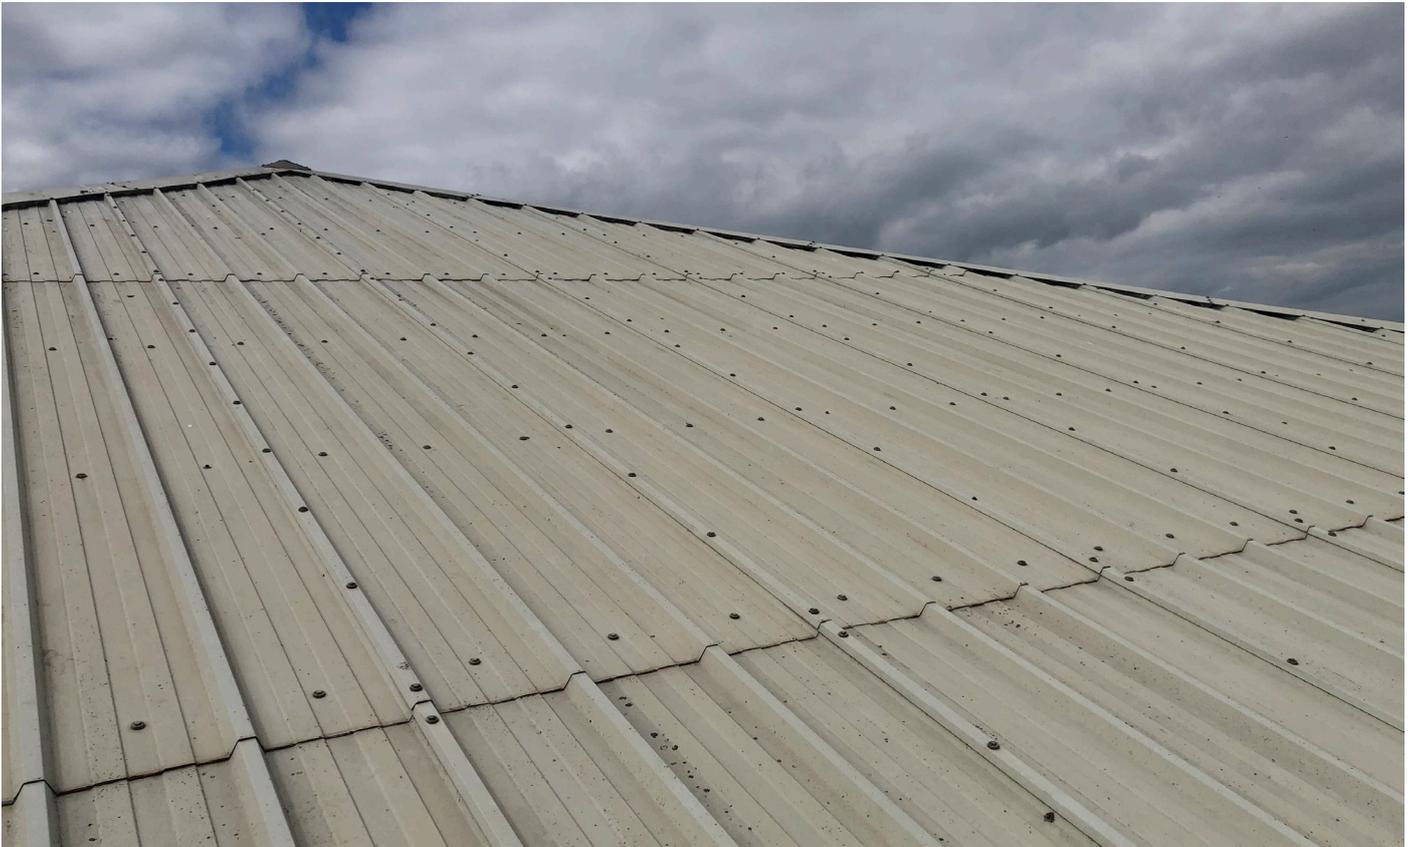
The roofing sheets all appeared to be in good condition, there were no significant defects, or penetrations noted which would contribute to water ingress. [Photo 3.2.1]

3.2.1 – roof sheets in good condition (Roof A)

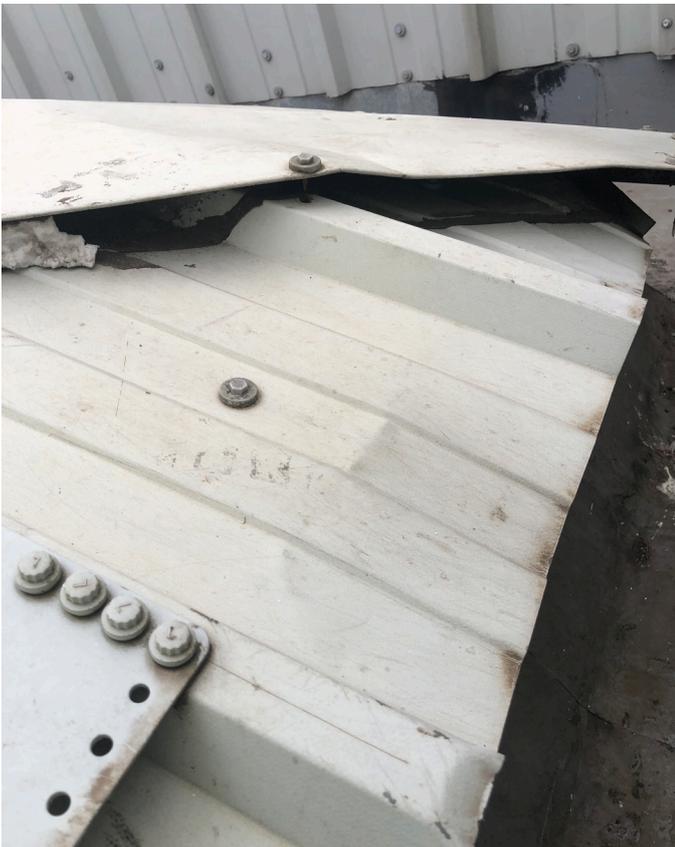
There were several areas where the edges of the panels have been depressed, likely due to being stood on during routine maintenance. This does not appear to be affecting the integrity of the system and cannot be seen unless on the roof. [Photo 3.2.2].

3.2.2 – depressed sheet edges due to being stood on

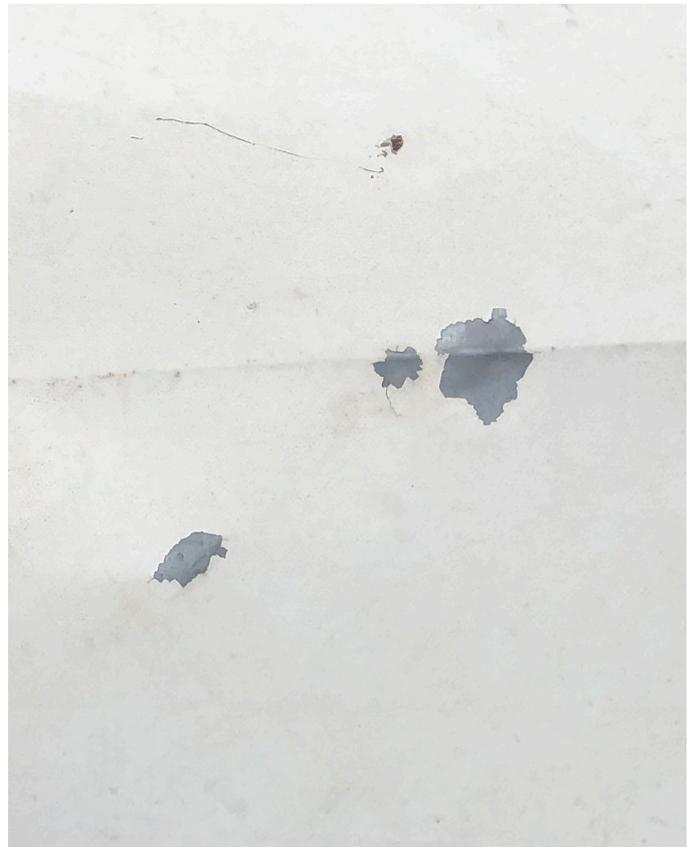
We noted a few isolated locations where the protective coating of the panels has been scratched, exposing bear metal below. In some locations this has begun to rust, and some remedial works should be considered. [Photo 3.2.3]

3.2.3 – protective coating removed and bare metal exposed (roof sheets)

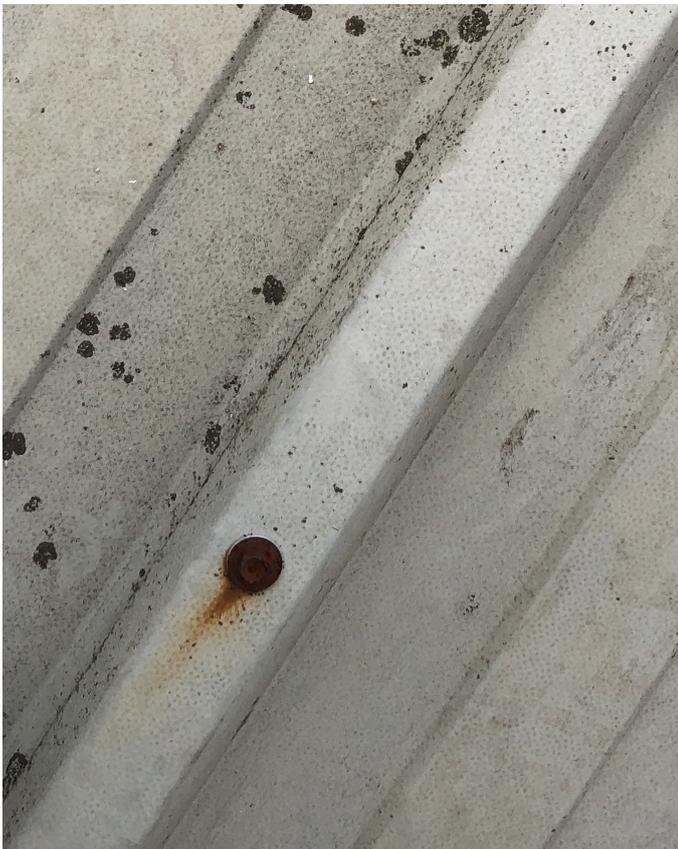
Aluminium panels are fixed down the steel roof structure with metal fixings. The fixings have self-sealing washers and waterproof caps, many of which have been lost or damaged. The corrosion to these fixings may be contributing to the high level of water ingress and further investigation by a specialist is required to confirm whether fixings should be resealed, replaced or covered by other maintenance works. [Photo 3.2.4]

3.2.4 – rusty fixings due to waterproof caps removed (roof sheets)

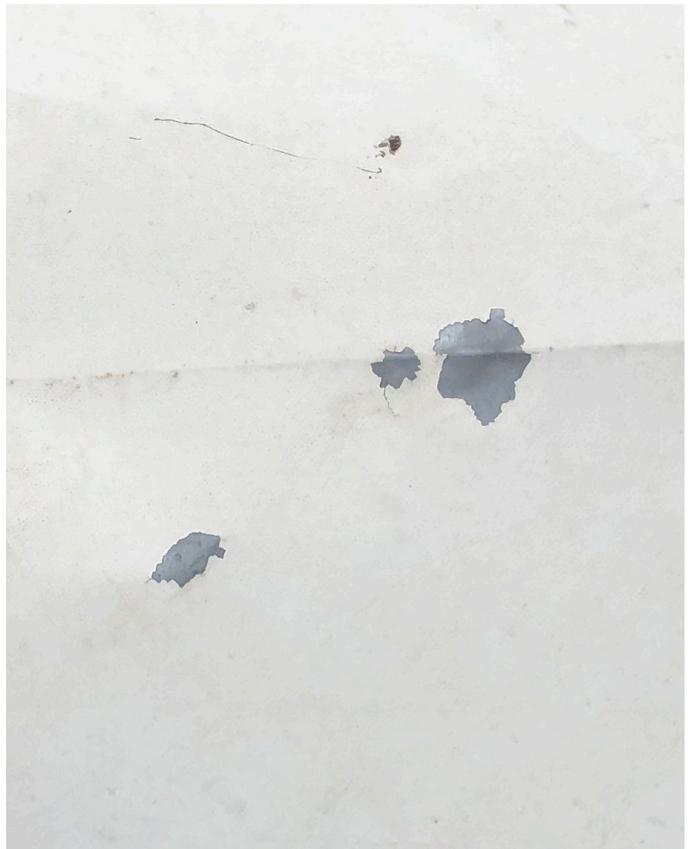
In general, the copings and parapets are in good condition. Similarly, to the roofing sheets there are isolated locations where the protective coating has been scratched leading to rusting. [Photo 3.3.1]

3.3.1 – protective coating removed and bare metal exposed (parapets and copings)

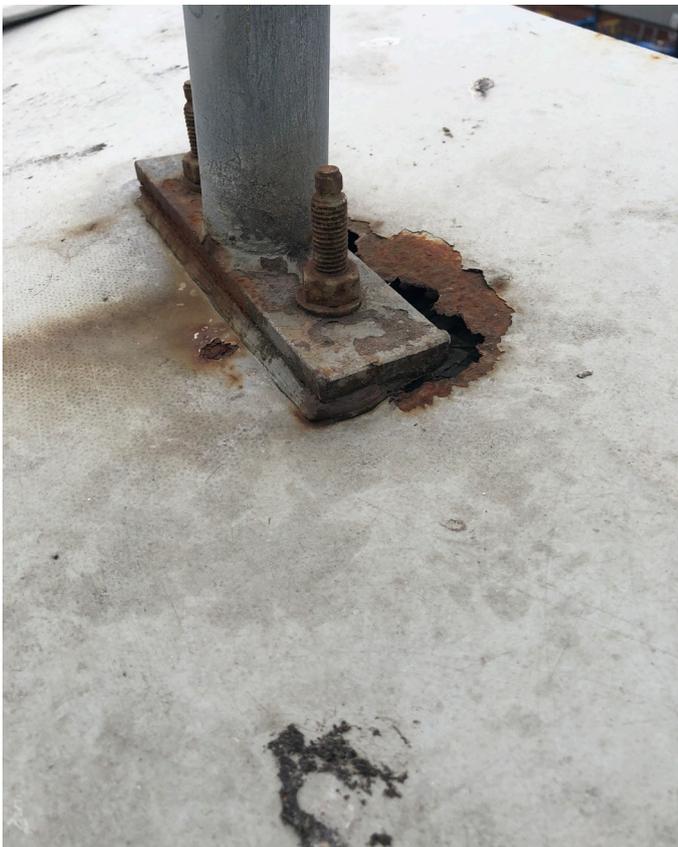
There were a few more significant defects noted, these were all in locations where fixings have been made through the surface, for example at the location of the roof access ladder, significant openings and rusting in the metal sheets have developed, allowing water to penetrate through the coping. These sheets should be replaced/repared. [Photo 3.3.2]

3.3.2 – parapet has corroded due to inappropriate fixings

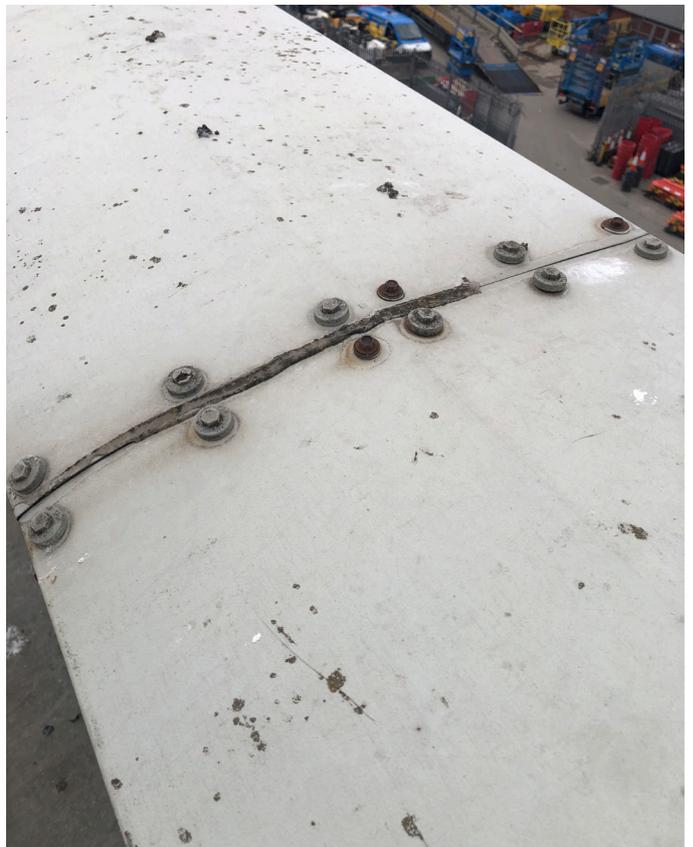
It also appears that some earlier remedial repair works have been carried out, attempting to seal the joints between the sheets. This sealant has failed/been picked away by seagulls. [Photo 3.3.3]

3.3.3 – earlier remedial works in an attempt to seal the gaps (parapet joints)

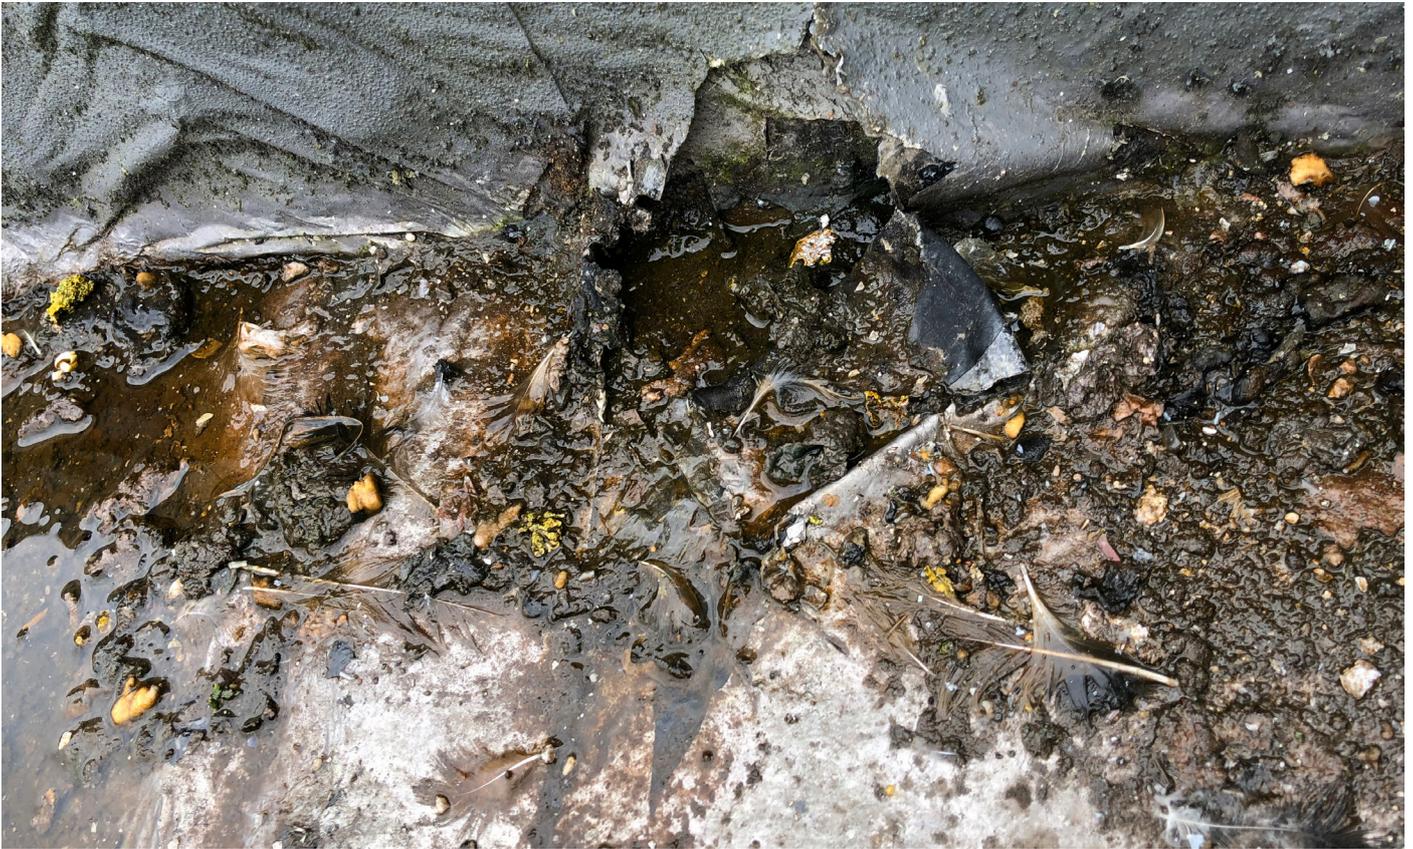
The gutters to roofs 1, 3 & 6 are insulated aluminium parapet gutters, secured to a parapet with secondary steel from beneath. Gutter panels are approximately 3m in length and therefore there are multiple joints along each gutter run. At each joint, the panels are fixed together with rivets and sealed with a heat welded membrane laid over the joint. At almost every panel joint the waterproof membrane has failed, in some locations they have been lost altogether. We believe this is the primary cause of the water ingress into the building at Roof Area A and remedial work is required as a high priority. [Photo 3.4.1]

3.4.1 – failed membrane at most joint locations

The prevailing solution seems to be that wholly lining the existing gutters with a new system was the appropriate and common resolution for the gutter repairs, a suggestion by Kingspan that each of the joints could be individually repaired was not considered a feasible solution given the work required to prepare the existing gutters for this work, and that this type of repair appears to have been attempted without success in several locations on the roof. Sharman's has a product called Plygene (other systems are available), a membrane on a roll which is laid in the gutters and is fixed at the abutment under the flashing, and under the metal roofing sheets with a combination of mechanical fixings and hot air welds. The system would include the insertion of liners into the rainwater outlets are heat welded into place.

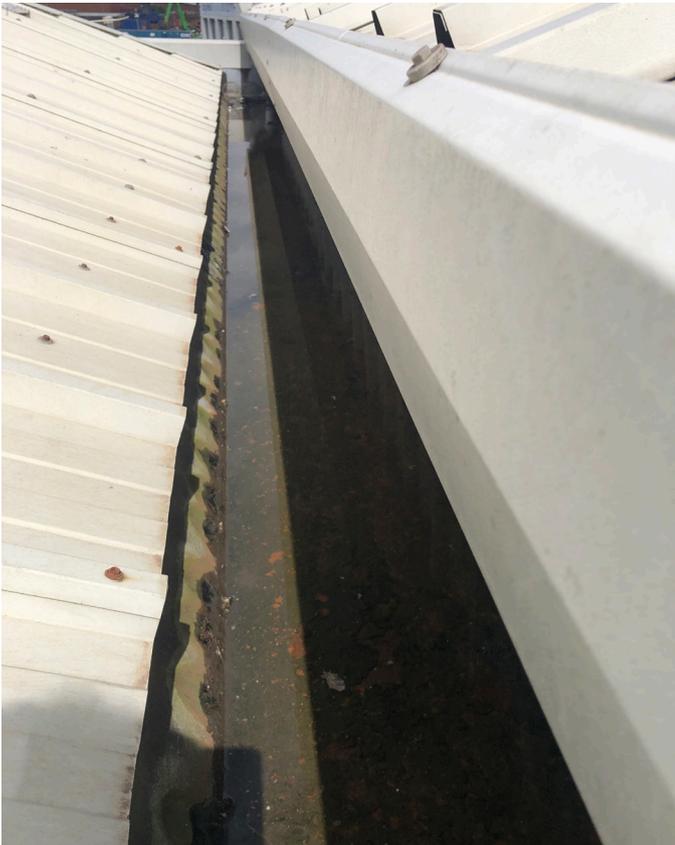
There was quite a lot of debris in the gutters and water is pooling in several of them. This is not considered to be a significant issue contributing to the water ingress, however the presence of the debris and water prevented full inspection of the condition of the panels. It is anticipated that similarly to the roofing sheets and parapet panels, there are areas of the gutters which have minor damage such as scratched protective coating. [Photo 3.4.2]

3.4.2 – water ponding which made it difficult to inspect the gutter

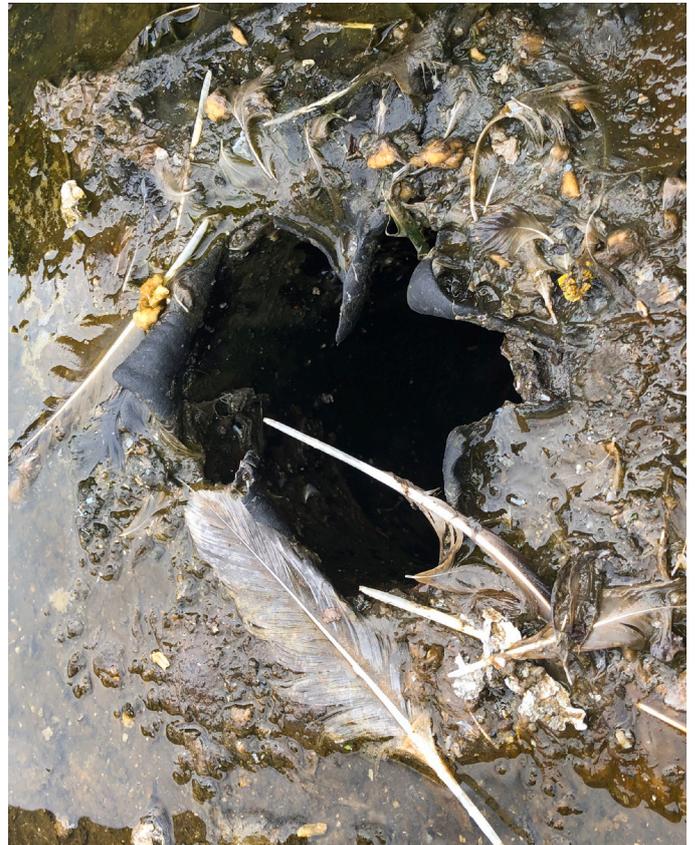
The rainwater outlets to Roof Area A direct all water to internal gravity-fed downpipes, through outlets in the base of the gutters. These outlets consist of preformed spigots with face plates which are fitted over and through a hole in the gutter. These outlets are fixed down and covered in a waterproof membrane as the gutter joints are. Similarly, to the gutter joints, almost every outlet is in poor condition, leaf guards are missing, and the waterproof membranes have failed. Remedial work should be carried out as a high priority. [Photo 3.5.1]

3.5.1 – rainwater outlet in poor condition, with missing leafguard

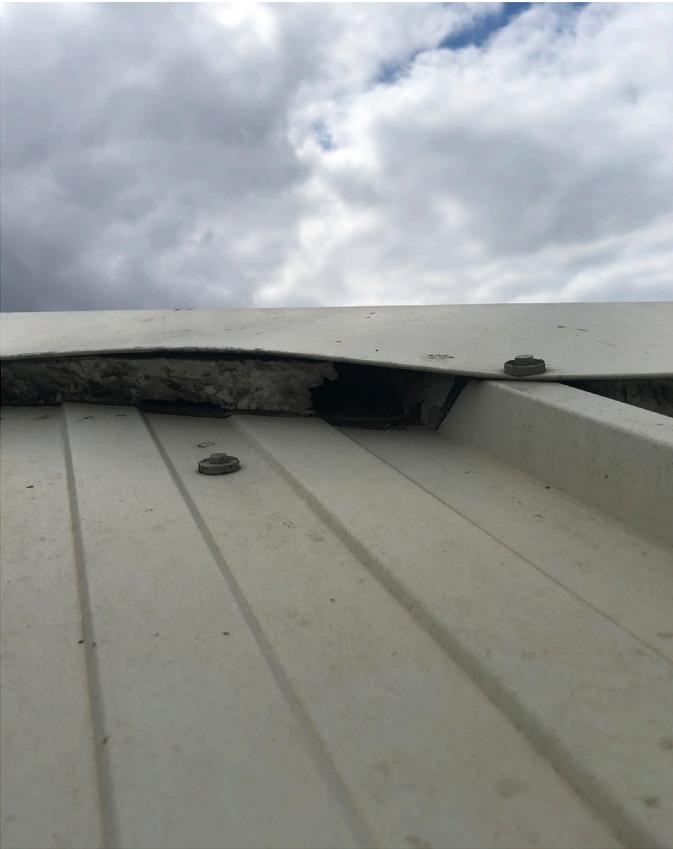
Many of the foam fillers have been lost or decayed. We believe that this may be contributing to the water entering the building at high level, this would explain how the water appears to be entering above the line of the gutters in areas such as 1C, 3B and 3D as identified by NML during out walkaround the building. The width of the flashing sheets may also be the problem and only now the foam fillers have been lost has the issue become apparent [Photo 3.6.1]

The water ingress through at high level in the storage units, has been a little more difficult to diagnose. Our initial diagnosis that water is being driven under the flashings due to loss of compressible foam profile fillers is likely contributing to the problem, however is not the main issue, rather the problem is that the flashings are a little too narrow, or the panels under the flashings do not meet closely enough. The loss of the fillers has exposed this problem. Failure of the fixings may also be contributing to this water ingress [see also below], it was noted during the inspection that many of the metal fixings which secure the panels and flashings down have lost their protective caps and have begun to rust, over time movement in these failed fixings can allow water into the building.

3.6.1 – Missing foam fillers at ridge lines

The long term solution would be to remove and replace the flashings and all of the fixings. However in order to fully diagnose the problem, some shorter term measures could be undertaken, including; Replacing the foam profile fillers and encapsulating the bolts.

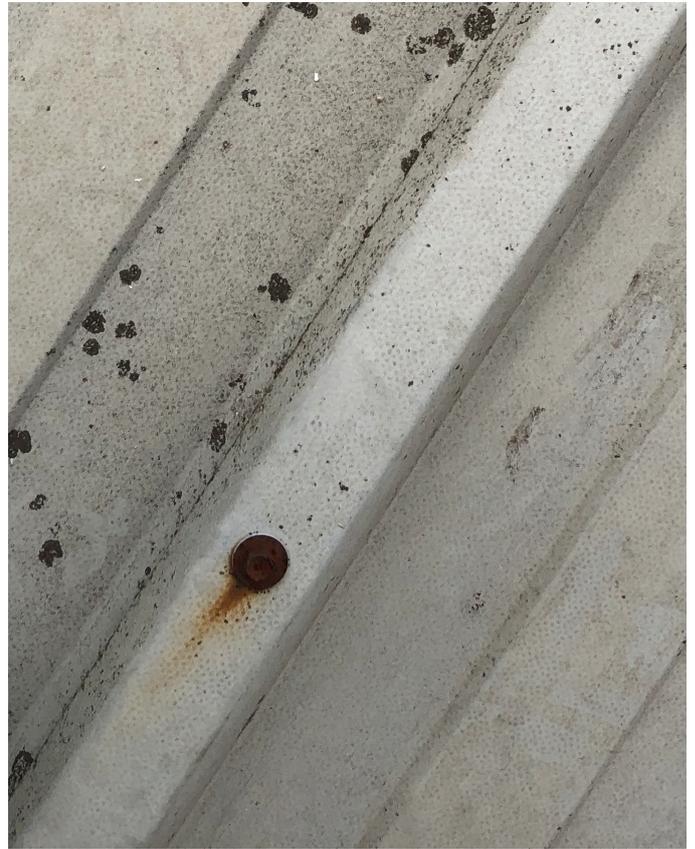
Aluminium flashing sheets are fixed down to the roofing sheets with metal fixings. The fixings have self-sealing washers and waterproof caps, many of which have been lost or damaged. The corrosion to these fixings may be further contributing to the high level water ingress and further investigation by a specialist is required to confirm whether fixings should be resealed, replaced or covered by other maintenance works. [Photo 3.6.2]

3.6.2 - rusty fixings due to waterproof caps removed (ridges)

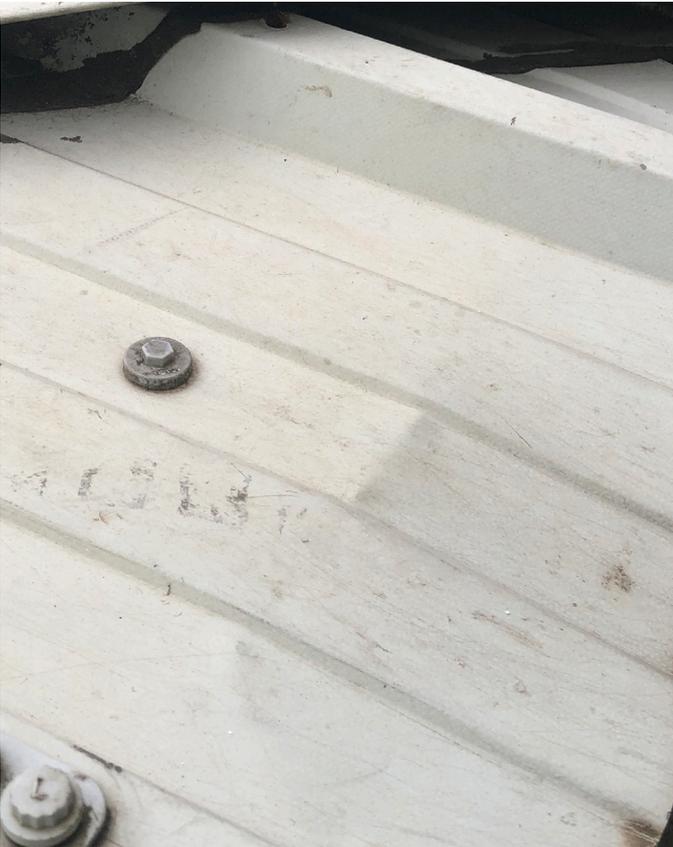
There are a number of isolated locations where the flashing sheets have been damaged, likely due to being trodden on during routine maintenance. We do not believe that this is a cause of water ingress, however, may be prudent to repair. [Photo 3.6.3]

3.6.3 – damaged or depressed flashings

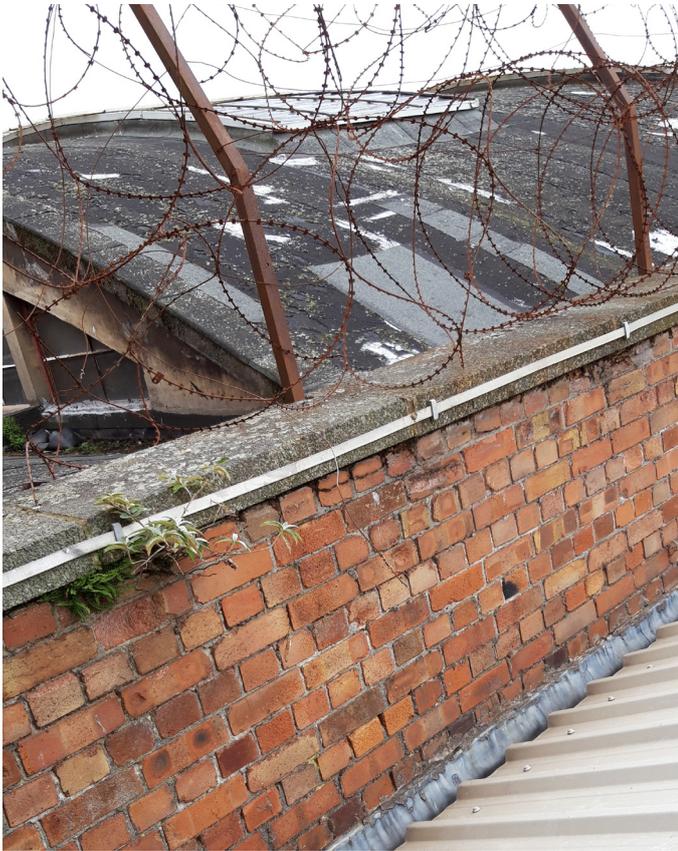
The presence of concertina razor wire for security purposes made it difficult to access roof 4C and gutter 4.3, however an overall impression of the condition was noted. [Photo 4.1.1]

4.1.1 – access was made difficult because of the concertina razor wire

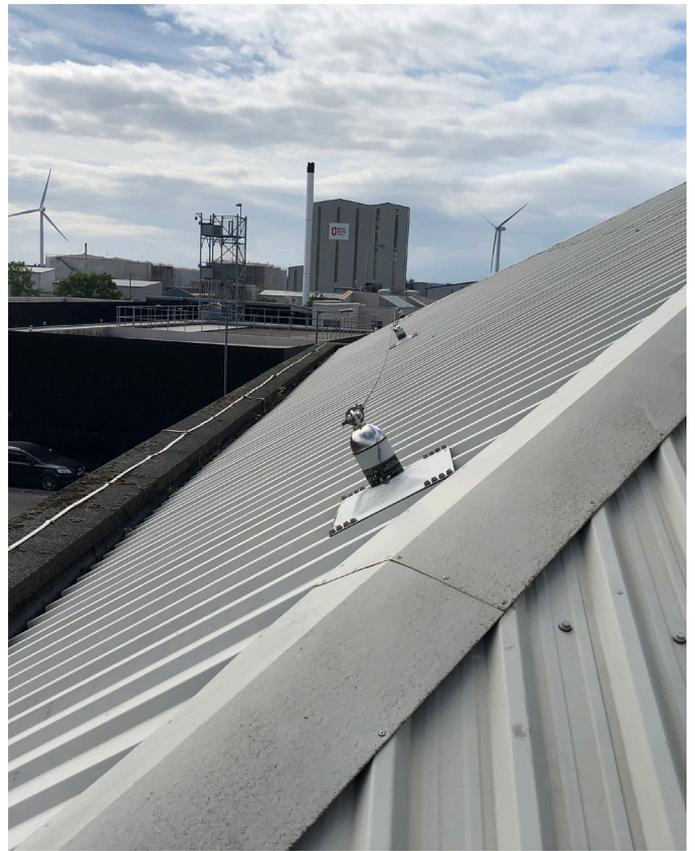
The roofing sheets all appeared to be in good condition, there were no significant defects, or penetrations noted which would contribute to water ingress. [Photo 4.2.1]

4.2.1 - roof sheets in good condition (Roof B)

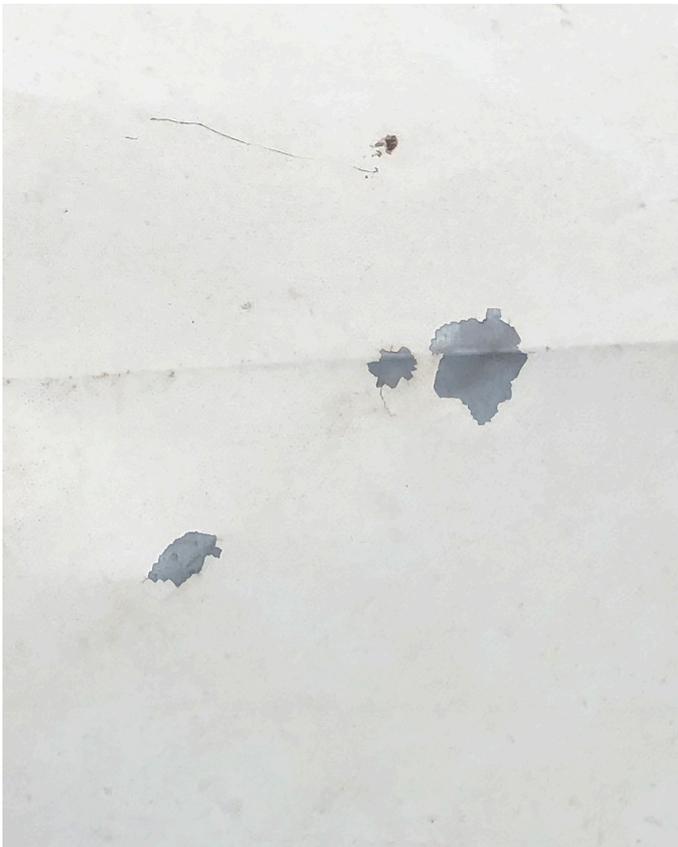
A few isolated locations where the protective coating of the panels has been scratched were noted, this has exposed bare metal and, in some locations, has begun to rust. Some remedial works should be considered. [Photo 4.2.2]

4.2.2 - protective coating removed and bare metal exposed (roof sheets)

The effectiveness of the protective coating of the steel panels deteriorates over time due to the weather and exposure to UV light. In addition to this the cut edges of the panels have exposed steel which suffers from water damage through capillary action. The long term effect of this is corrosion to the roof sheets. In the early stages of the aging process, the cut edges can be sealed to repair them and prolong the life of the roof. Once those repairs are at the end of their life span (or if they were not carried out in due time) a later repair to entirely recoat the roof can be carried out which will further prolong the life of the roof. Whilst not urgent, we feel that carrying out these 2 repairs over a period of several years would maximise the life span of the roof (approximately every 15 years).

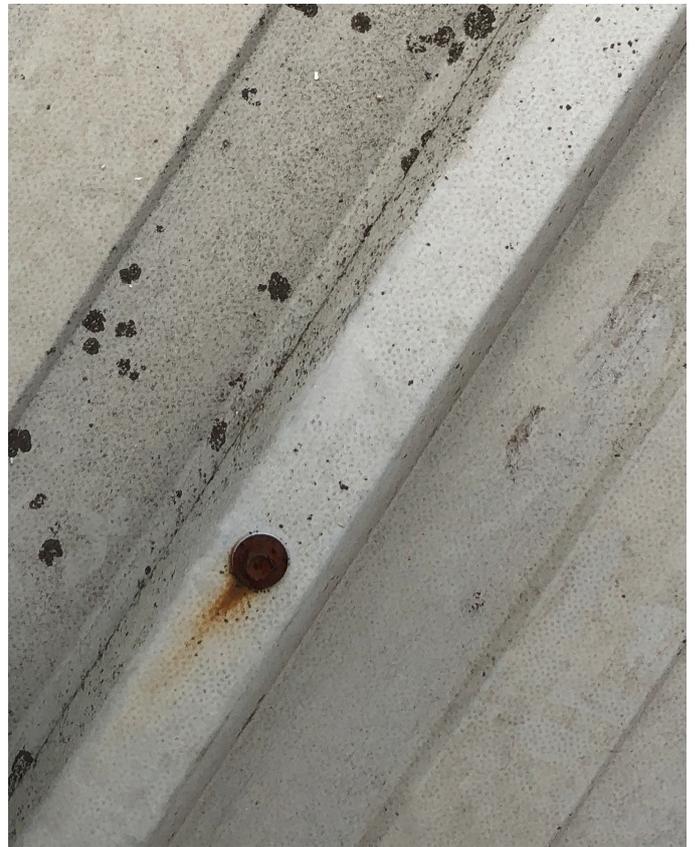
Aluminium panels are fixed down the steel roof structure with metal fixings. The fixings have self-sealing washers and waterproof caps, many of which have been lost or damaged. There is no particular evidence that this has allowed water to enter the building, however, repairing/replacing these fixings would prolong the life of the roof. [Photo 4.2.3]

4.2.3 - rusty fixings due to waterproof caps removed (roof sheets)

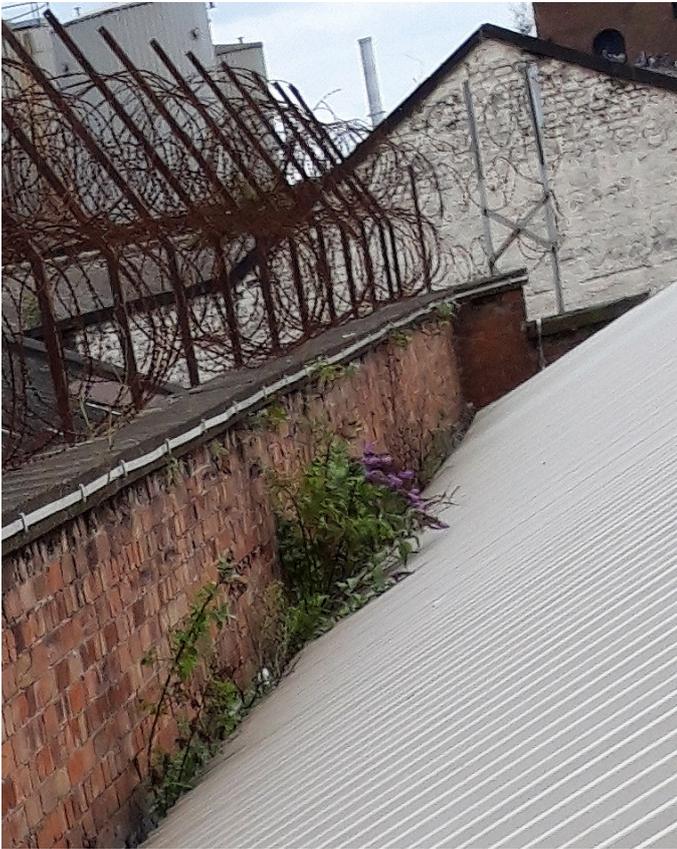
The parapets and copings look to be in generally good condition; however, some vegetation requires removing. [Photo 4.3.1]

4.3.1 – vegetation needs to be removed from masonry parapet and copings

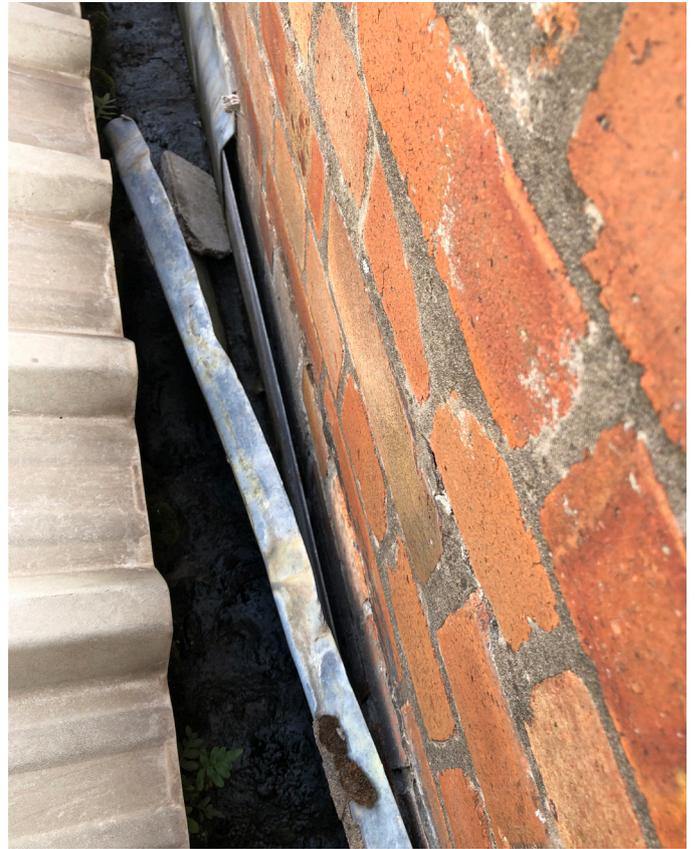
Where on Roof Area A, aluminium cladding has been used to cover the masonry upstands, the same has not been carried out to Roof Area B. Instead the weathering is relying on lead flashings which appear to be contemporary with the asbestos cement roof. These flashings in places have been lost or are falling out of the mortar joints in the masonry which is allowing water to stream into the

building in wet conditions, indeed from the inside daylight can be seen as some of the abutment locations where flashings have been lost. [Photo 4.3.2]

4.3.2 – failed lead flashings

As noted earlier, roofs 4 & 5 were treated differently to the others, these were encapsulated and over-boarded. Failing lead flashing being the primary issue caused as a result of these not being renewed at a higher level when the height of the roof was lifted slightly. Our initial reaction was that renewing these flashings in lead is sound, however is not the most cost effective solution. Lead is expensive and usually used where a good quality aesthetic finish is preferred or when replicating significant historic detailing. The flashings to these roofs are not seen from anywhere and this is not an architecturally significant building. Another point to note is that when the encapsulation was carried out, it appears that a flashing which is supposed to conceal the edges of the existing asbestos sheets has been missed (the edges are visible). With this in mind, we propose that these gutters are lined in the same Plygene (or similar) system as to Roofs 1, 3 & 6. A steel flashing, to match the steel roofing sheets will be used to cover the edges of the new gutter lining, this will be more cost effective than using lead.

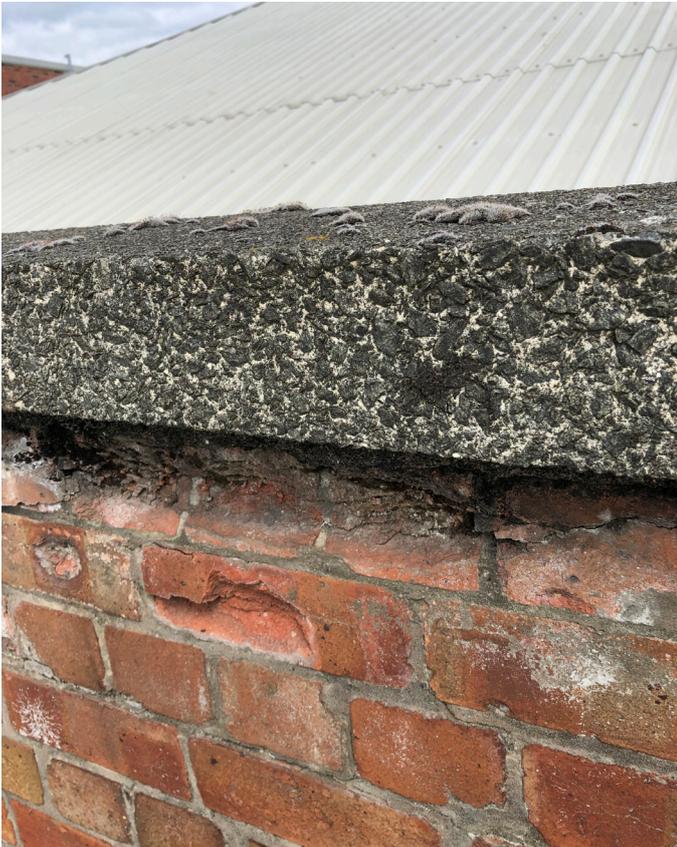
Additionally, as a result of the over-boarding exercise, these older flashings no longer achieve the required minimum 150mm upstand above the surface of the roof. Water is splashing off the roof, over the top of the flashings and saturating the masonry. Lots of mortar has been lost, contributing to the failure of the flashings and there is spalling of masonry. [Photo 4.3.3]

4.3.3 – Spalling of masonry

We are confident that this is the primary cause of water ingress into the lower building and would recommend that repairs are carried out. It would be worth carrying out some masonry maintenance, such as repointing to the parapet walls at the same time.

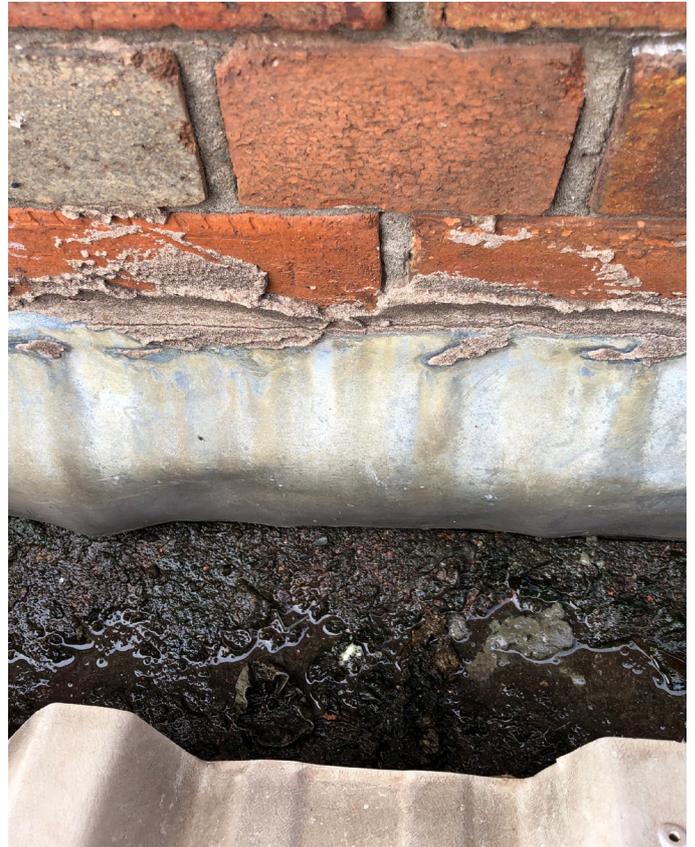
The gutters do not appear to have been cleaned out for some time, evident by up to 2 inches of sludge sitting in them, this may be a direct result of the proximity of the asbestos containing material which should have been concealed at the time the encapsulation was carried out. [Photo 4.3.1]

4.4.1 – thick sludge in gutters

All the outlets that were inspected were significantly blocked by sludge and debris and should be cleaned. A further inspection will be required after this has been carried out to determine whether there are any significant defects.
